*June 28, 2010*

**Local Government Energy Program  
Energy Audit Report**

***Township of Livingston***  
***Township Garage***  
***235 South Livingston Avenue***  
***Livingston, NJ 07039***

***Project Number: LGEA50***

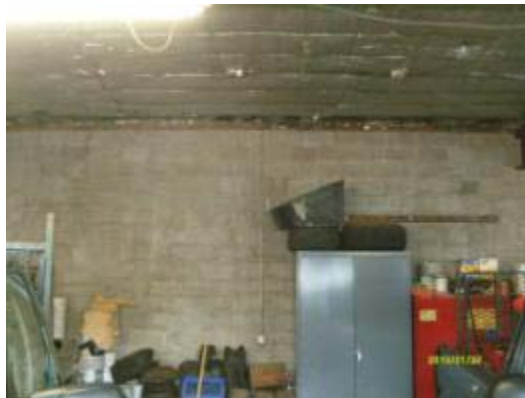
Typical Unfinished interior concrete block wall

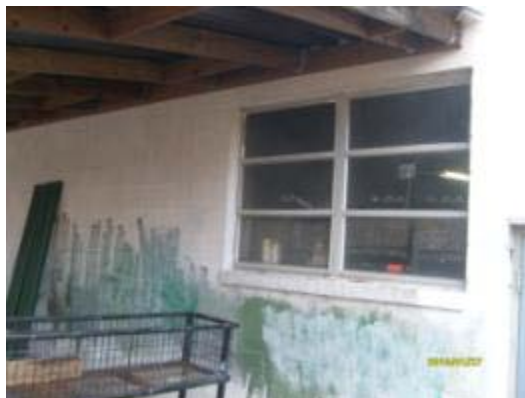
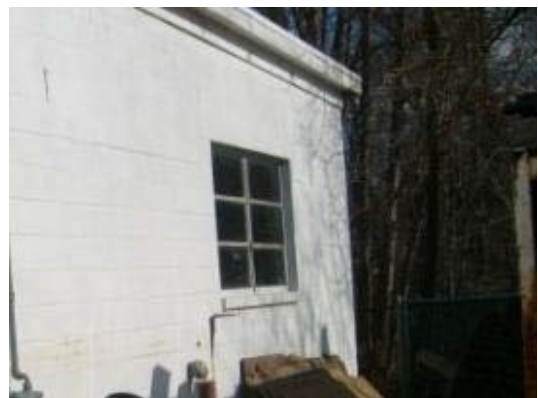
1. Fixed type windows with a non-insulated aluminum frame, clear double glazing and no interior or exterior shading devices. The windows are located on either side of the building.

Typical window installations at the rear garage building.
