**Local Government Energy Program
Energy Audit Report**

***Township of Livingston
Sewage Treatment Plant and Animal Shelter
81 Naylon Avenue
Livingston, NJ 07039***

Project Number: LGEA50

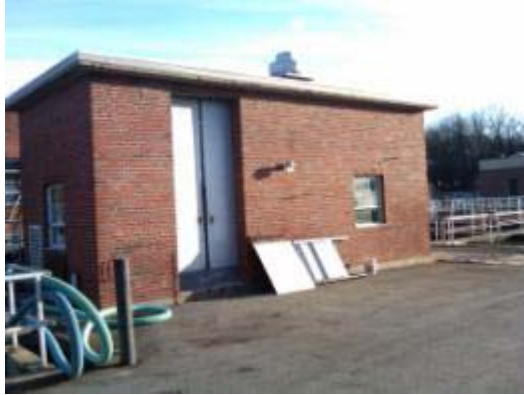
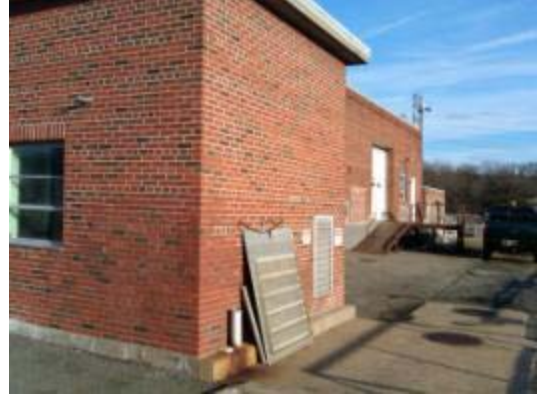
Exterior and interior wall surfaces were inspected during the field audit. They were found to be in overall good condition with no signs of uncontrolled moisture, air-leakage or other energy-compromising issues detected on all facades.

Typical primary pump building exterior walls

1. Conduct biannual maintenance inspections to inspect the exterior walls with a focus on cracks and pointing of the masonry, degraded caulking, and locating sources of water and air leakage.

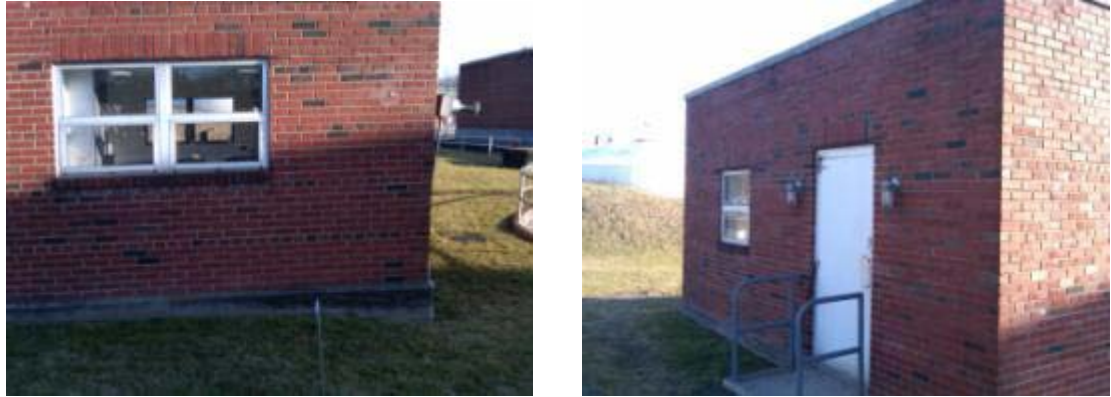
Exterior and interior wall surfaces were inspected during the field audit. They were found to be in overall good, age-appropriate condition with only a few signs of uncontrolled moisture, air-leakage or other energy-compromising issues detected on all facades.

Typical exterior wall surface

1. Replace broken/deteriorated bricks and re-point cracked mortar joints.
2. Inspect and replace cracked/ ineffective caulk.
3. Seal and insulate exposed building penetration.
4. Conduct biannual maintenance inspections to inspect the exterior walls with a focus on cracks and pointing of the masonry

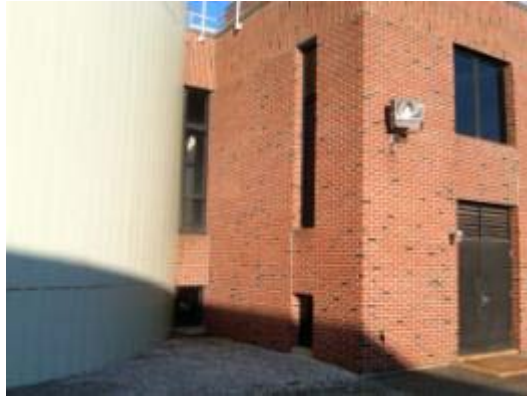
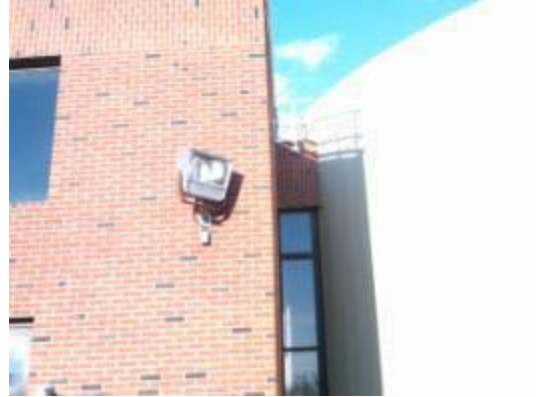
Exterior and interior wall surfaces were inspected during the field audit. They were found to be in overall good condition with no signs of uncontrolled moisture, air-leakage or other energy-compromising issues detected on all facades.

Typical exterior wall surface

1. Conduct biannual maintenance inspections to inspect the exterior walls with a focus on cracks and pointing of the masonry

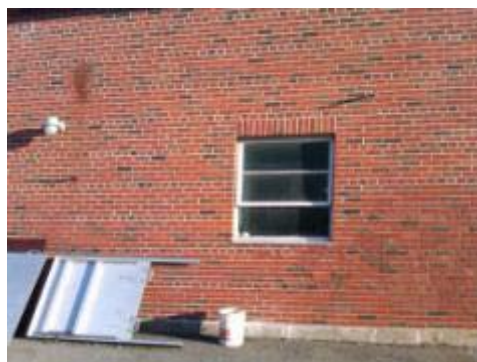
Exterior and interior wall surfaces were inspected during the field audit. They were found to be in overall good, age-appropriate condition with no signs of uncontrolled moisture, air-leakage or other energy-compromising issues detected on all facades.

Typical exterior wall surface

1. Conduct biannual maintenance inspections to inspect the exterior walls with a focus on cracks and pointing of the masonry

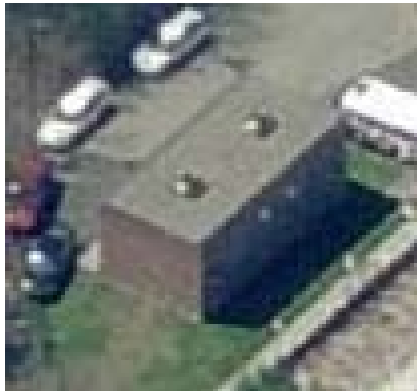
Exterior and interior wall surfaces were inspected during the field audit. They were found to be in overall good, age-appropriate condition with no signs of uncontrolled moisture, air-leakage or other energy-compromising issues detected on all facades.

Typical exterior wall surface

1. Conduct biannual maintenance inspections to inspect the exterior walls with a focus on cracks and pointing of the masonry

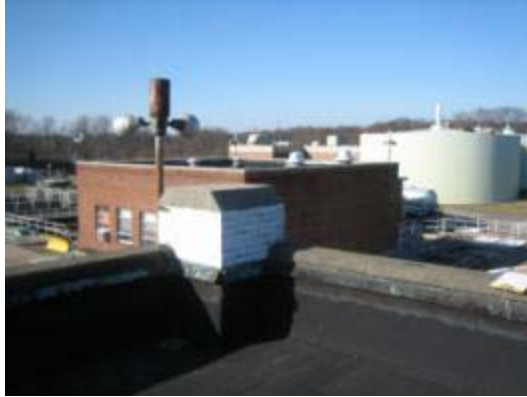
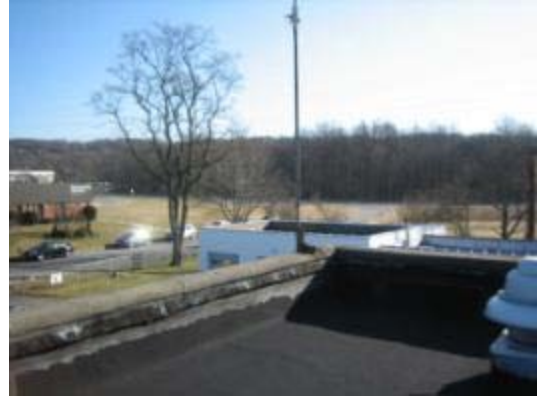
Roofs, related flashing, gutters and downspouts were inspected during the field audit. They were reported to be in overall good condition, with no signs of uncontrolled moisture, air-leakage or other energy-compromising issues detected on all roof areas.

Typical roofing systems

1. Maintain/ inspect all roof surfaces on a regular basis with a focus on the condition of the flashing, roofing membrane, drainage, signs of water pooling, signs of infiltration and locations that correspond to water damaged ceiling tiles.

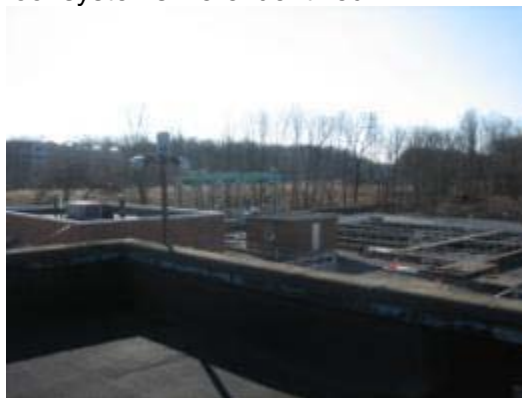
Roofs, related flashing, gutters and downspouts were inspected during the field audit. They were reported to be in overall good condition, with no signs of uncontrolled moisture, air-leakage or other energy-compromising issues detected on all roof areas.

Typical roofing systems

1. Maintain/ inspect all roof surfaces on a regular basis with a focus on the condition of the flashing, roofing membrane, drainage, signs of water pooling, signs of infiltration and locations that correspond to water damaged ceiling tiles.

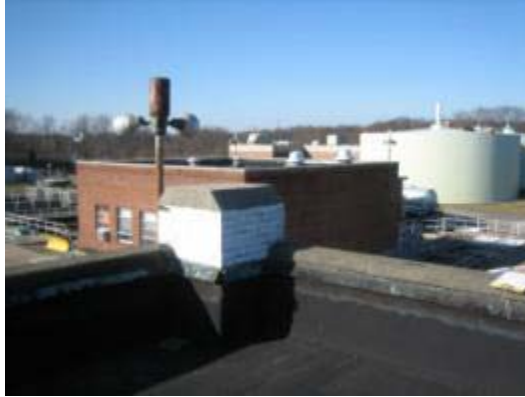
Roofs, related flashing, gutters and downspouts were inspected during the field audit. They were reported to be in overall good condition, with no signs of uncontrolled moisture, air-leakage or other energy-compromising issues detected on all roof areas.

Typical roofing systems

1. Maintain/inspect all roof surfaces on a regular basis with a focus on the condition of the flashing, roofing membrane, drainage, signs of water pooling, signs of infiltration and locations that correspond to water damaged ceiling tiles.

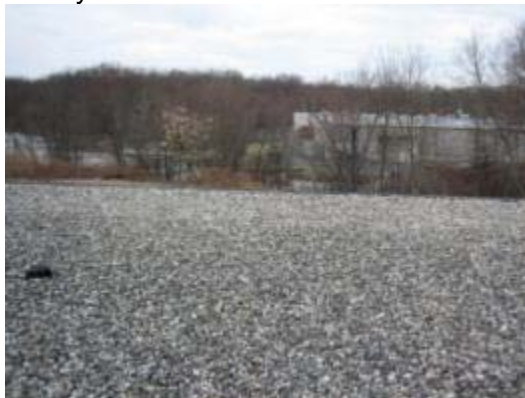
Roofs, related flashing, gutters and downspouts were inspected during the field audit. They were reported to be in overall good condition, with no signs of uncontrolled moisture, air-leakage or other energy-compromising issues detected on all roof areas.

Typical roofing systems

1. Maintain/ inspect all roof surfaces on a regular basis with a focus on the condition of the flashing, roofing membrane, drainage, signs of water pooling, signs of infiltration and locations that correspond to water damaged ceiling tiles.

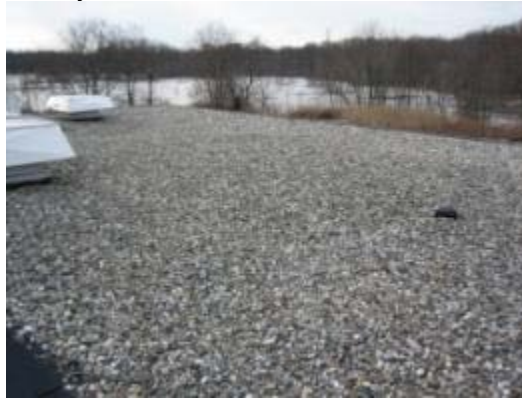
Roofs, related flashing, gutters and downspouts were inspected during the field audit. They were reported to be in overall good condition, with no signs of uncontrolled moisture, air-leakage or other energy-compromising issues detected on all roof areas.

Typical roofing systems

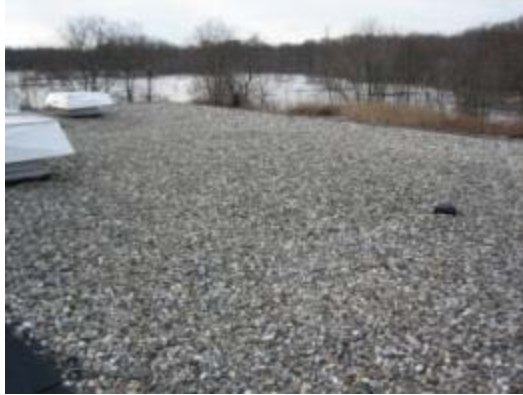
Roofs, related flashing, gutters and downspouts were inspected during the field audit. They were reported to be in overall good condition, with no signs of uncontrolled moisture, air-leakage or other energy-compromising issues detected on all roof areas.

Typical roofing systems

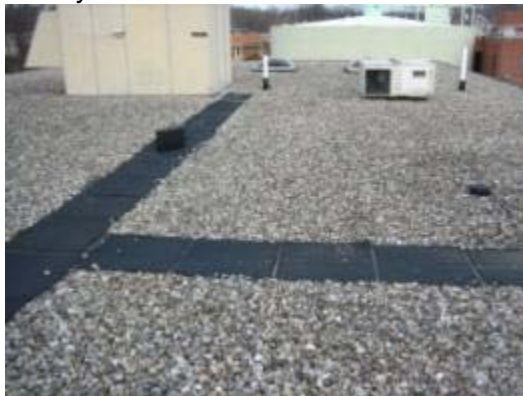
Roofs, related flashing, gutters and downspouts were inspected during the field audit. They were reported to be in overall good condition, with no signs of uncontrolled moisture, air-leakage or other energy-compromising issues detected on all roof areas.

Typical roofing systems

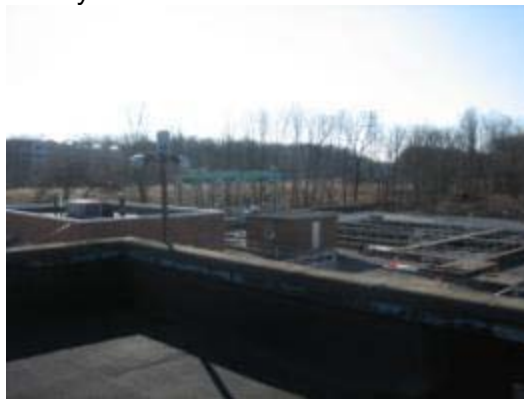
Roofs, related flashing, gutters and downspouts were inspected during the field audit. They were reported to be in overall good condition, with no signs of uncontrolled moisture, air-leakage or other energy-compromising issues detected on all roof areas.

Typical roofing systems

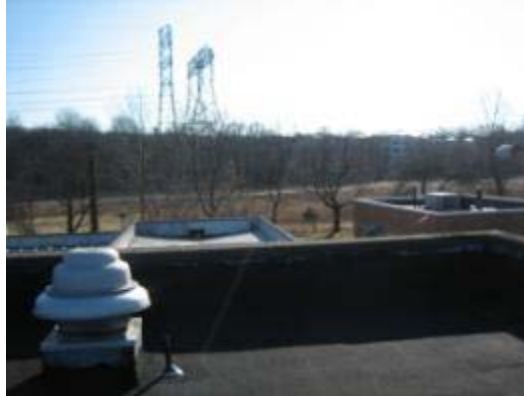
Roofs, related flashing, gutters and downspouts were inspected during the field audit. They were reported to be in overall good condition, with no signs of uncontrolled moisture, air-leakage or other energy-compromising issues detected on all roof areas.

Typical roofing systems

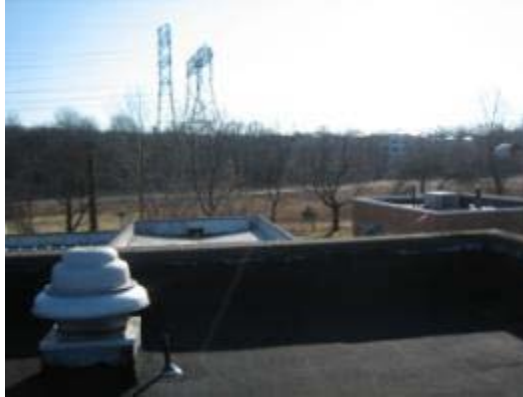
Roofs, related flashing, gutters and downspouts were inspected during the field audit. They were reported to be in overall good condition, with no signs of uncontrolled moisture, air-leakage or other energy-compromising issues detected on all roof areas.

Typical roofing systems

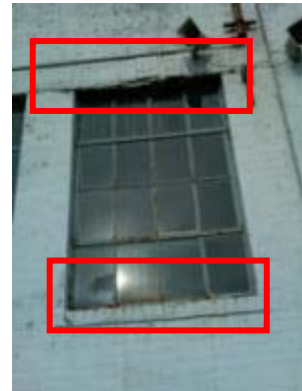
Windows, shading devices, sills, related flashing and caulking were inspected as far as accessibility allowed for signs of moisture, air-leakage and other energy compromising issues. Overall, the windows were found to be in poor/ age appropriate condition with numerous signs of uncontrolled moisture, air-leakage and/ or other energy-compromising issues.

Exterior water damage signs on areas around windows, damaged/aged window frame single-glazed window with ineffective frame, exposed window lintel, missing window sill and drip-edge detail and air-leakage at sleeved window/wall air-conditioning units

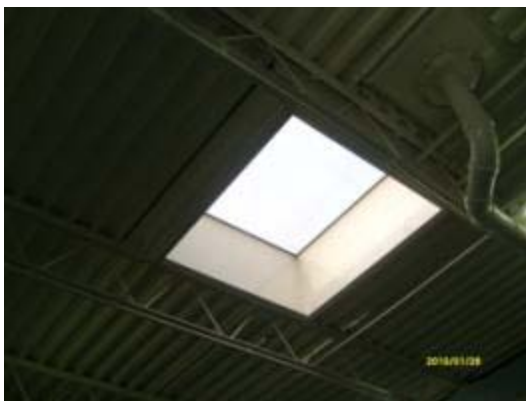
Windows, shading devices, sills, related flashing and caulking were inspected as far as accessibility allowed for signs of moisture, air-leakage and other energy compromising issues. Overall, the windows were found to be in good condition with no signs of uncontrolled moisture, air-leakage and/ or other energy-compromising issues.

Typical skylight window

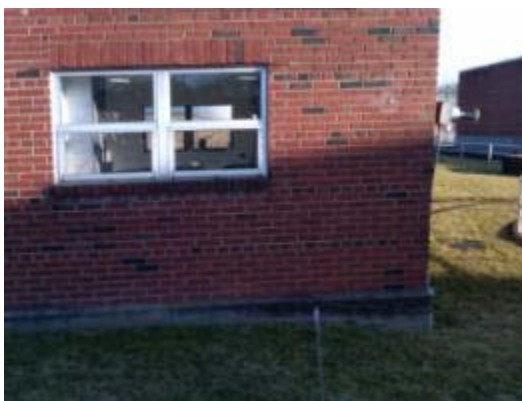
Windows, shading devices, sills, related flashing and caulking were inspected as far as accessibility allowed for signs of moisture, air-leakage and other energy compromising issues. Overall, the windows were found to be in good condition with no signs of uncontrolled moisture, air-leakage and/ or other energy-compromising issues.

Typical window

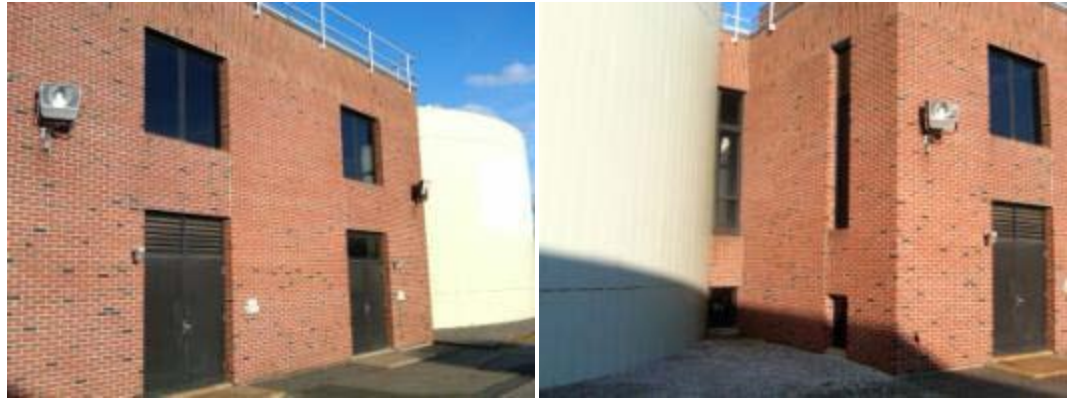
Windows, shading devices, sills, related flashing and caulking were inspected as far as accessibility allowed for signs of moisture, air-leakage and other energy compromising issues. Overall, the windows were found to be in good condition with no signs of uncontrolled moisture, air-leakage and/ or other energy-compromising issues.

Typical window installations

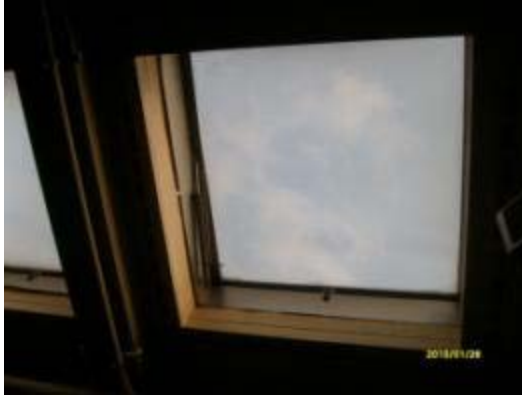
Windows, shading devices, sills, related flashing and caulking were inspected as far as accessibility allowed for signs of moisture, air-leakage and other energy compromising issues. Overall, the windows were found to be in good condition with no signs of uncontrolled moisture, air-leakage and/ or other energy-compromising issues.

Typical skylight window

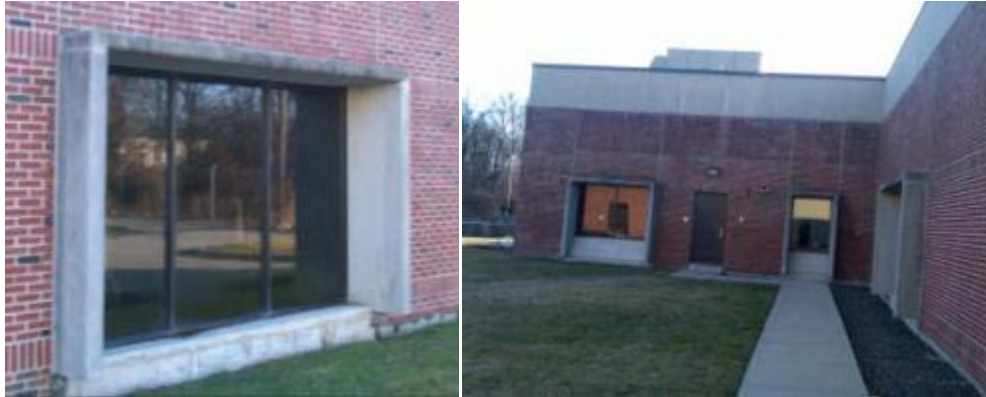
Typical window installations

1. Maintain and inspect all exterior windows with a focus on the condition of the frames, water damage from the sills, air tight seal, and proper hardware operation.

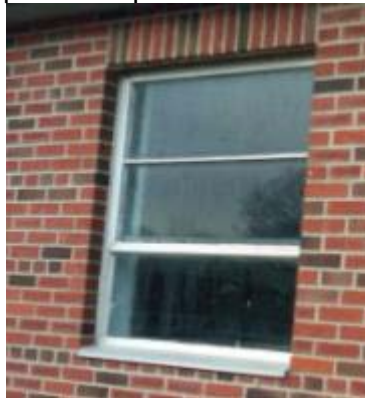
Typical window installation with exposed lintel

1. Properly seal and insulate window lintel to eliminate thermal break.
2. Maintain and inspect all exterior windows with a focus on the condition of the frames, water damage from the sills, air tight seal, and proper hardware operation.

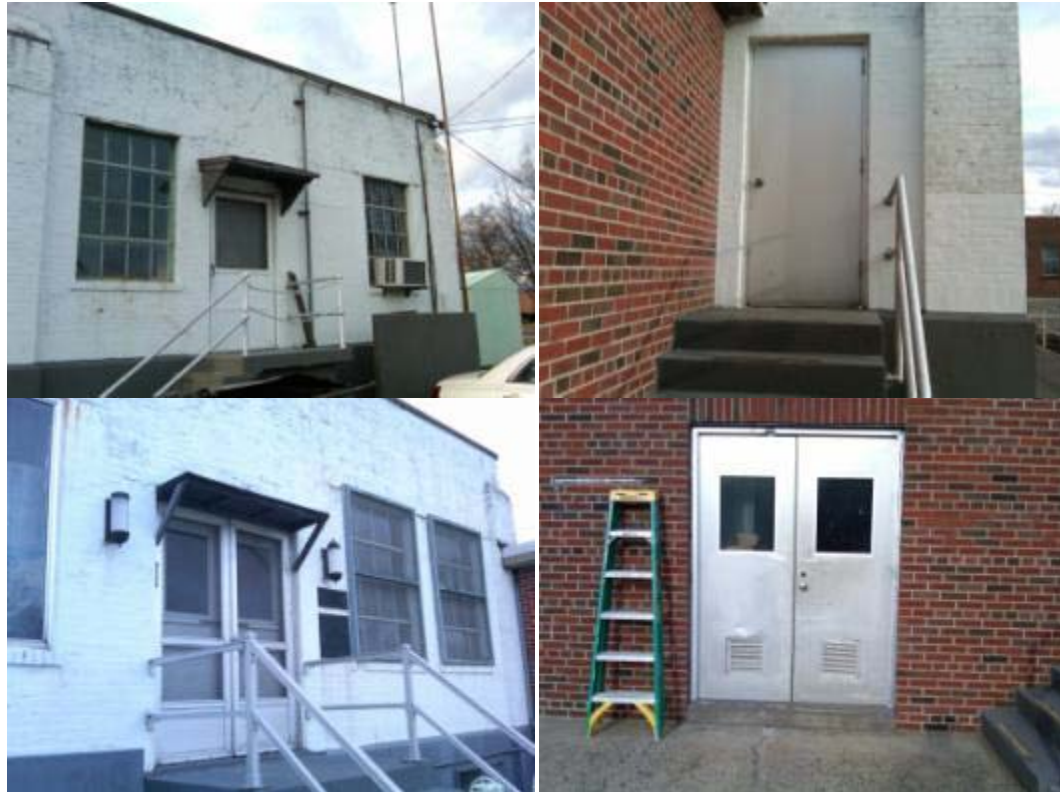
Typical Exterior Doors

1. Replace missing or damaged weather-stripping.
2. Maintain and inspect all doors with a focus on the condition of the weather-stripping, door frame, air tight seals and signs of water damage and infiltration.

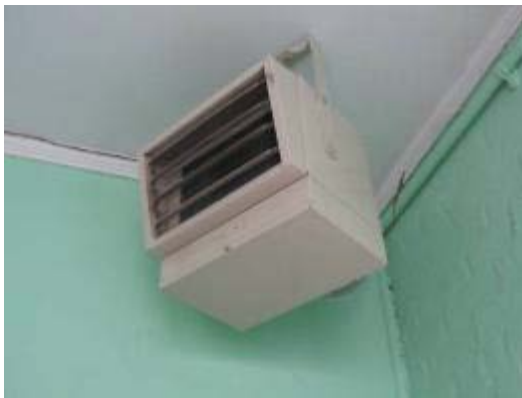
Building 1: Old Control Building & Locker room – This was originally one of the plant's control buildings, but the controls portion has since been abandoned and the only functioning space of the building is the small locker room at the front. There is a small electric unit heater in the corner of the locker room area which is estimated to be at 50% of its expected useful life. No other heating is provided for the building. The abandoned portion of the building houses a boiler that is no longer in use. This boiler previously provided heat to the several hot water radiators located throughout the small building.

Electric unit heater in locker room

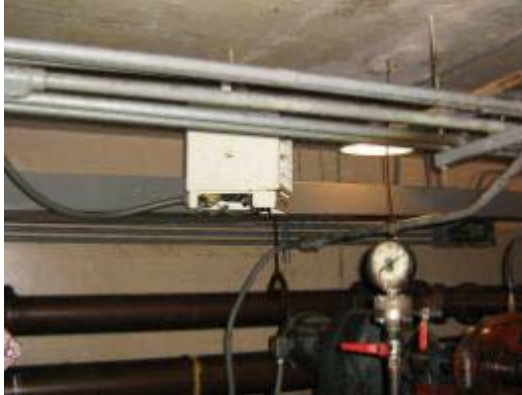
Building 3: Primary Pump Building – This is heated by an electric unit heater mounted from the ceiling. Nameplate information was inaccessible, but the heater appears in fair to good condition and provides adequate heating to the space.

Electric unit heater

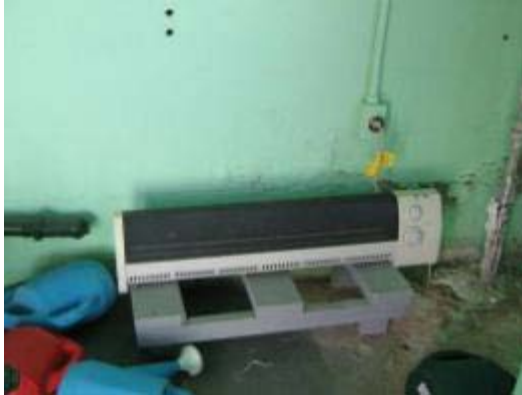
Building 6: Chlorine Building – The chlorine building is heated by a portable, electric baseboard heater. This unit is less than a year old and is in very good to excellent condition.

Portable electric baseboard heater

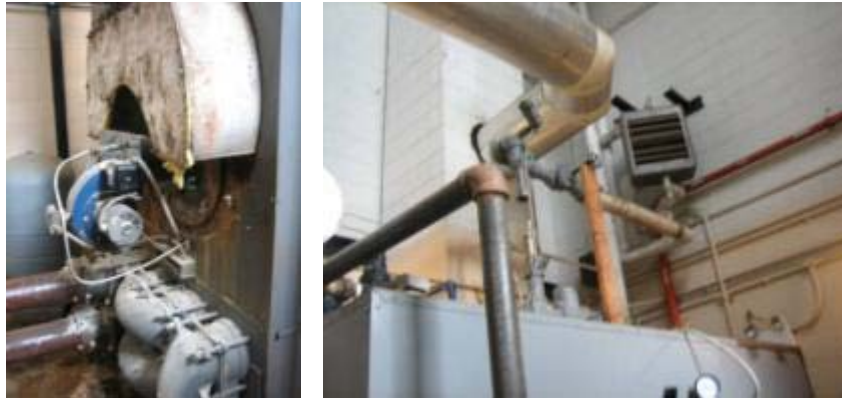
Building 7: Digester Building – This building is built between two large digester tanks, both over two stories tall. The building itself is a two story structure and houses a gas-fired, hot water boiler in the lower level. No nameplate data was available on the boiler, making capacity indeterminable. The boiler serves a single hydronic unit heater in the boiler area and provides hot water for the sewer treatment processes of the building/digester tanks. Despite its appearance, the boiler is said to have been serviced or installed in 2008 and has approximately 90% of its estimated useful life remaining.

Hot water boiler; Hydronic unit heater

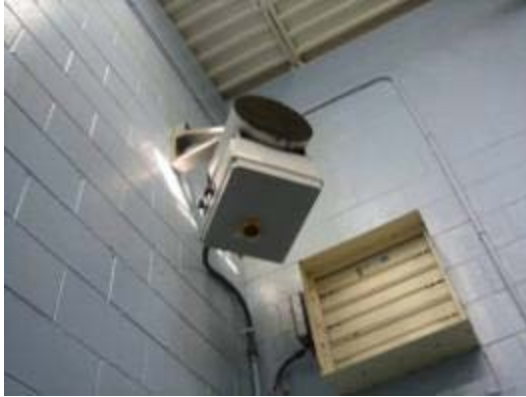
Building 9: Chemical Feed Building – Two (2) electric unit heaters, mounted at the ceiling, provide heating for this building. These units were installed in 2001 and are in fair to good condition. The building houses the chemical feed pump equipment for the facility.

Electric unit heater

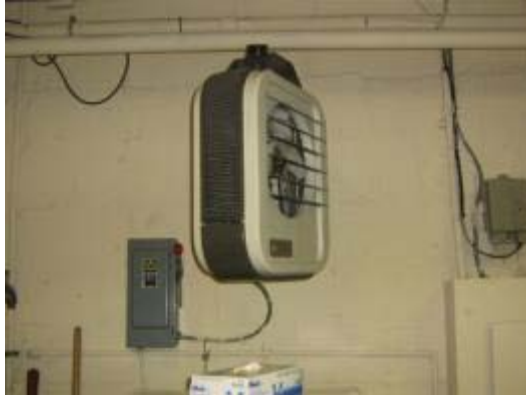
The Animal Shelter is heated by an electric unit heater (10 KW). All other heaters within these buildings are old hydronic heaters, which are connected to an abandoned boiler and no longer operational.

Electric unit heater

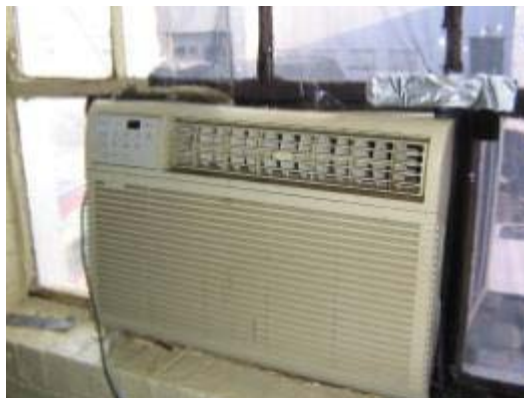
Building 1: Old Control Building & Locker room – A small thru-the-wall air conditioner located in the front of the locker room provides cooling. The air conditioner appeared to be in fair condition; however, SWA recommends that the unit be replaced with an Energy Star rated unit to improve efficiency. The abandoned portion of the building receives no cooling.

Thru-wall AC unit

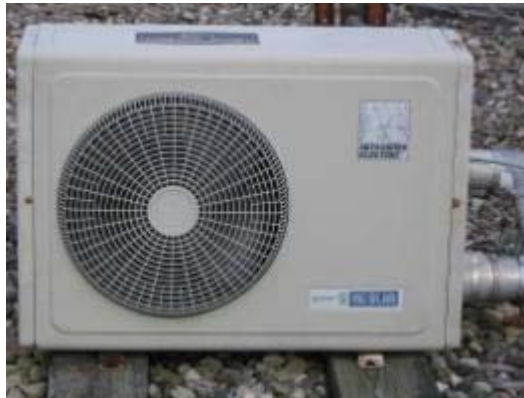
Building 10: Advance Treatment Building – The control room of the building is cooled by a split system air conditioner. The air-cooled condensing unit is located on the roof of the building and appears to be in fair to good shape. Exact age of the unit is unknown due to a lack of a serial number on the nameplate of the unit, however, based on the condition, style, and model number of the unit it has been estimated that the unit is roughly twenty (20) years old and is approaching its expected useful life. SWA recommends that the unit be replaced in kind. The remainder of the building does not receive any cooling.

Air-cooled condensing unit on roof for Control Room cooling

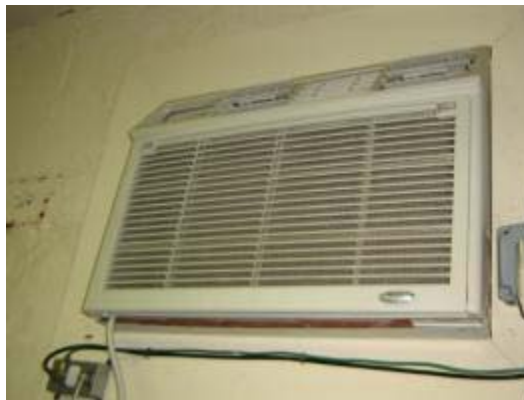
The animal shelter has a thru-the-wall air conditioning unit. Nameplate was not visible, age of unit unknown. This is the only cooling in these buildings.

Through the wall A/C unit

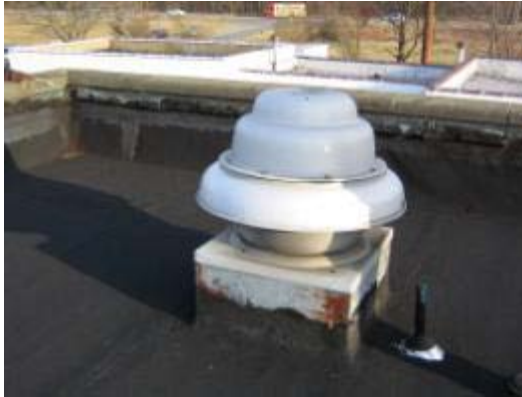
Building 1: Old Control Building & Locker room – There is a single exhaust fan located on the roof above the locker room. The fan is believed to serve the toilet room in the locker room, as well as rooms in the abandoned controls portion of the building. It was unable to be determined if the exhaust fan is still operational, but appears to be in good to fair condition.

Roof mounted exhaust fan

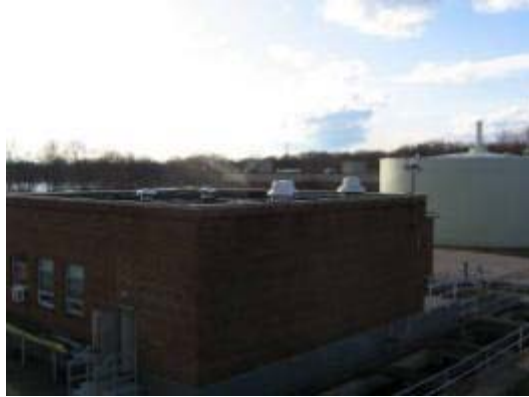
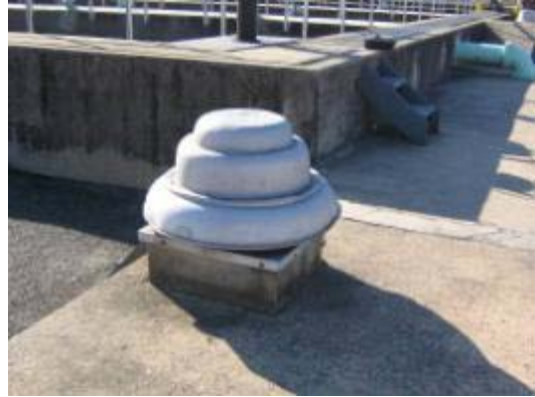
Building 4: Maintenance Building – The maintenance building has five (5) exhaust fans located on the roof of the building. It is reported that some of the fans only operate while welding is taking place in the shop. Age and condition of the fans on maintenance building were unable to be determined due to lack of roof access during the survey period. The underground tunnel connected to the maintenance building is ventilated by a single exhaust fan located in the ceiling space of the tunnel, which is on grade level.

Roof of Maintenance building; Exhaust fan for underground tunnel

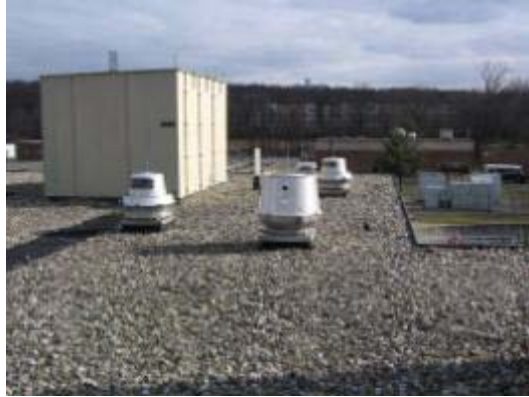
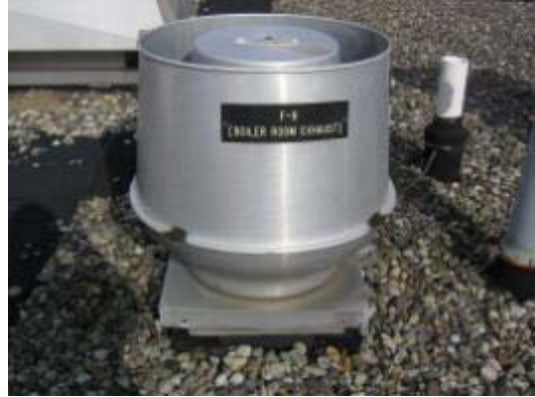
Building 10: Advance Treatment Building – Two (2) large intake units, labeled “thickener and filter supply” and “basement supply” provide the building with process ventilation. Seven (7) roof mounted exhaust fans provide mechanical ventilation for the different rooms and processes of the building. No nameplate data was available on the various exhaust fans, but all are in good condition and reported to be functioning in an adequate manner. Due to the reported continual use of these exhaust fans, SWA recommends that if the fans are not currently equipped with high efficiency motors, but are replaced as such when needed as an energy conservation measure for the building.

Various exhaust fans and HV-3 unit; Close-up of F-9 boiler room exhaust fan

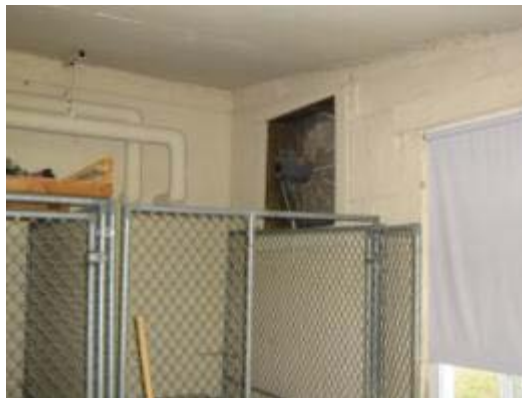
There is a thru the wall exhaust fan in the active animal shelter section. No other ventilation was evident.

Exhaust fan in wall

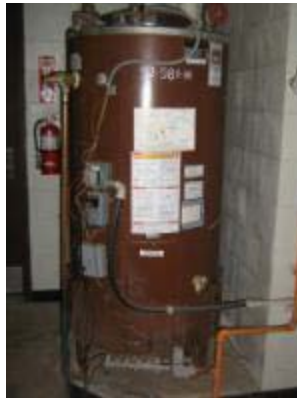
Building 10: Advanced Treatment – A large 100 gallon gas-fired water heater is located in the electrical/boiler room of this facility. Hot water is provided to sinks and showers in the building. The 199000 btu/h input heater was installed in 1988 and is beyond its

Domestic water heater

expected useful life of 10-13 years. SWA recommends that the unit be replaced with a new heater of the same capacity.

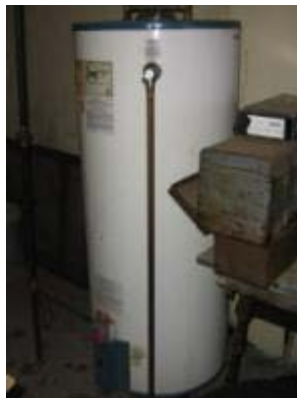
The domestic hot water for the building is provided by a gas-fired, 75 gallon, 75 MBH tank-type water heater, located in the inactive kennel section. This heater serves fixtures in the kennel section. This water heater is from 1986 and has exceeded its expected life span.

Domestic water heater
