## Rear Muffler Panel “Rust”

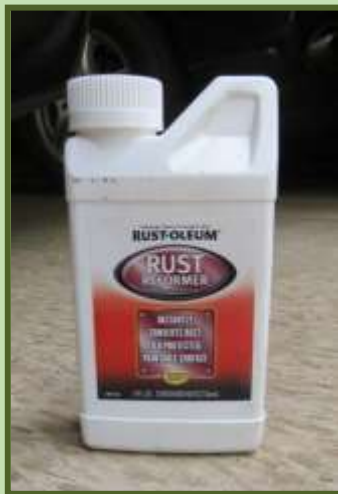
The rust is only visible on the rear muffler panel. With four, 4 inch OD 304 polished stainless muffler tips filling the center opening there is not much visibility behind them. I considered painting the parts black, in fact bought an 8 ounce can of black high temperature barbeque paint. However looking at the access, unless the rear bumper was removed, it would very difficult to paint. Also, my experience with painting exhaust systems indicated if not applied very thinly it can peel. Using a spray can is not possible without removing the bumper.

A better solution was to use a rust converter or rust reformer. I purchased an 8 ounce container at Walmart for just over \$5.00. This product is not like paint. It has the consistence of milk and is applied very simply. It only changes the brown rusted areas to a dull black. It does not affect areas that are not rusted. If the material has loose flaky rust, it should be removed with a wire brush. But the tight rust on the 409 did not need prior cleaning.

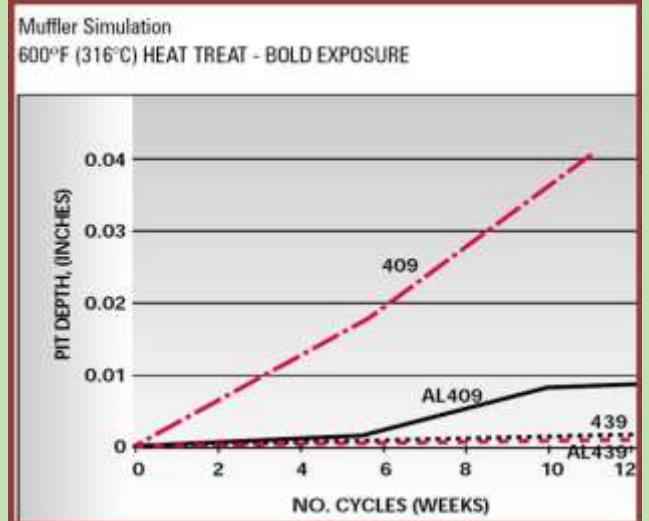
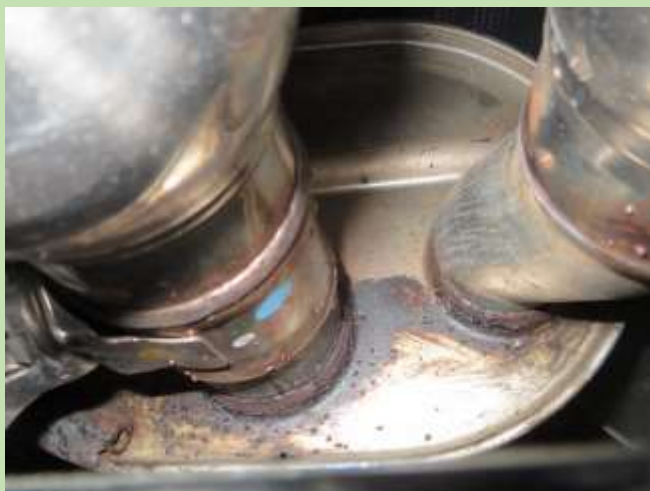
This is a graph provided by the aluminized stainless steel manufacturer showing what they referred to as bold exposure. It quantifies corrosion by measuring and plotting the depth of pits that form over the exposure time. Note the aluminized 409 stabilized at under 0.01 inch deep pits while the uncoated material progressively formed deeper pits. Plain carbon steel would be significantly worse.
