**Tartan 4100 (#6) Triforce**

## Raymarine Electronics' Upgrade (June 2023)

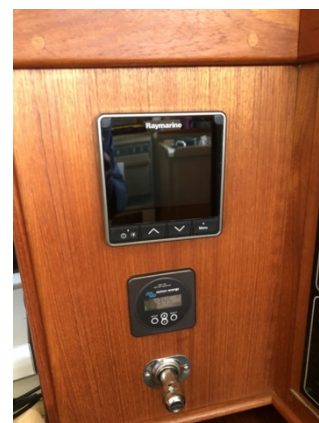
The SeaTalkNG power cable was led aft into a 6-way junction block. 16 AWG black wire (DC -) was led to the negative bus on the distribution panel and 16 AWG red wire (DC +) was led to a Blue Sea Systems ATC fuse box (5A ATC fuse) and then to the Navigation 5A thermal breaker on the distribution panel. The RF ground was connected to DC- at the junction block.

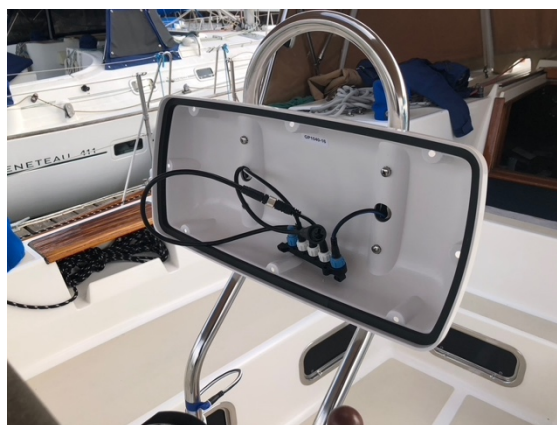
A 0.25 inch hole was drilled in two 9/16 in rubber stoppers and then a slit was made along the length in order to fit the back bone cable and the power cable to the Axiom +9. The rubber stoppers were inserted into the holes at the bottom of the pedestal guard. In addition, 5/8 inch with ¼ hole rubber grommets were installed in the nav pod where the back bone cable, Axiom power cable, and P70s spur cable exited the pedestal guard to prevent chaffing. An additional rubber grommet was installed in the pedestal guard where the P70s spur cable entered the pedestal guard on the port side.

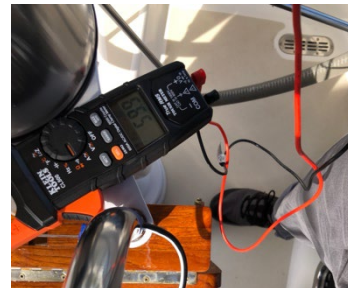
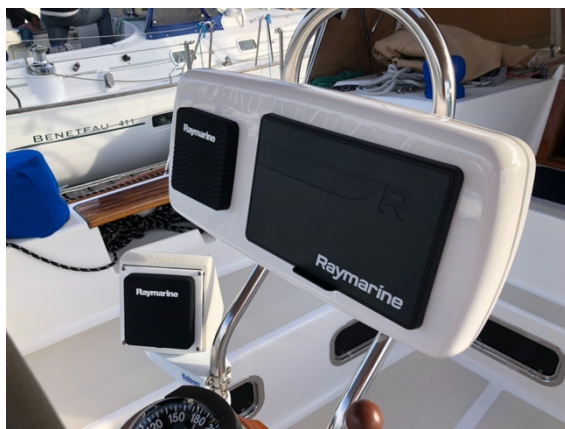
Prior to installing the I70s in the nav pod, resistance checks were done on the back bone cable to ensure there was 60 ohms. The resistance check between Can A and Can B on the I70s spur cable read 59.9 ohms.
