# Sidewalk Inventory Findings The Big Picture

# Sidewalks Inventory Findings The Nitty Gritty

# Crossing Treatment Findings

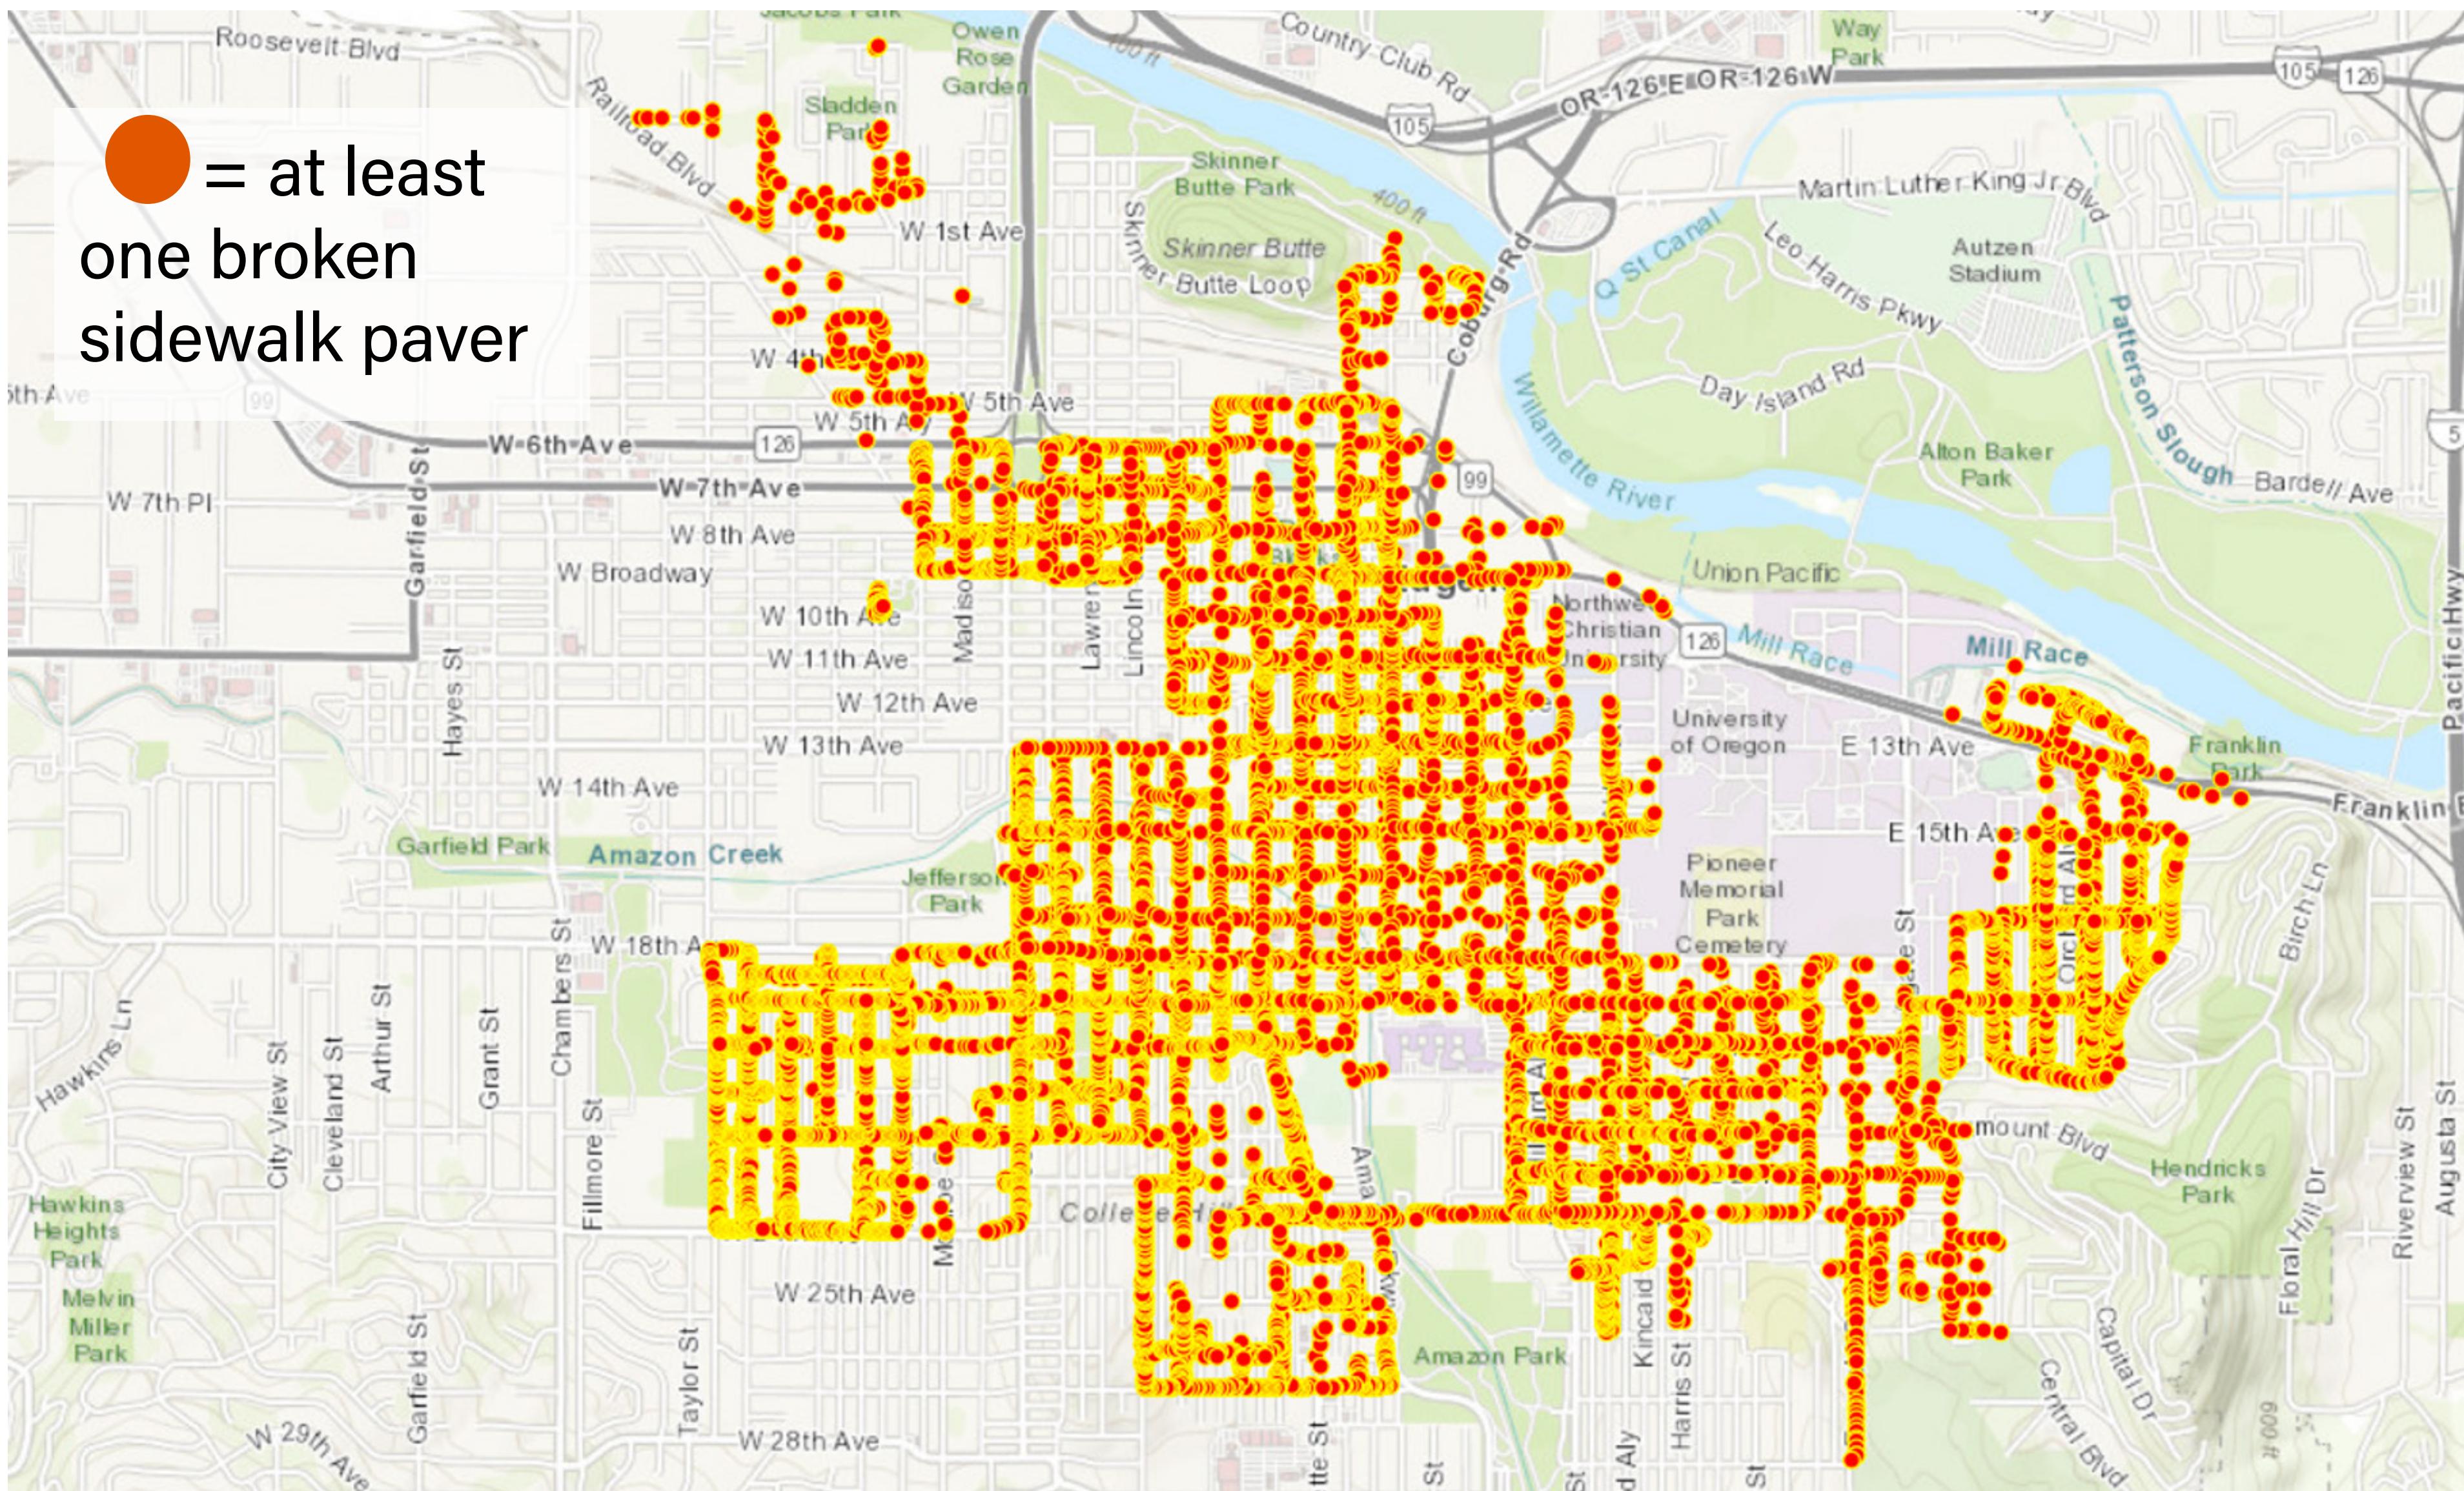
We identified over **56,000 linear feet** (over ten miles!) of **ADA non-compliant sidewalk**, which is like a broken sidewalk stretching all the way from the EMU to the airport!

Most pavers surveyed were **ADA non-compliant** in at least one dimension, including passable width, slope, uplift and/or gaps between pavers, and uneven surface conditions.

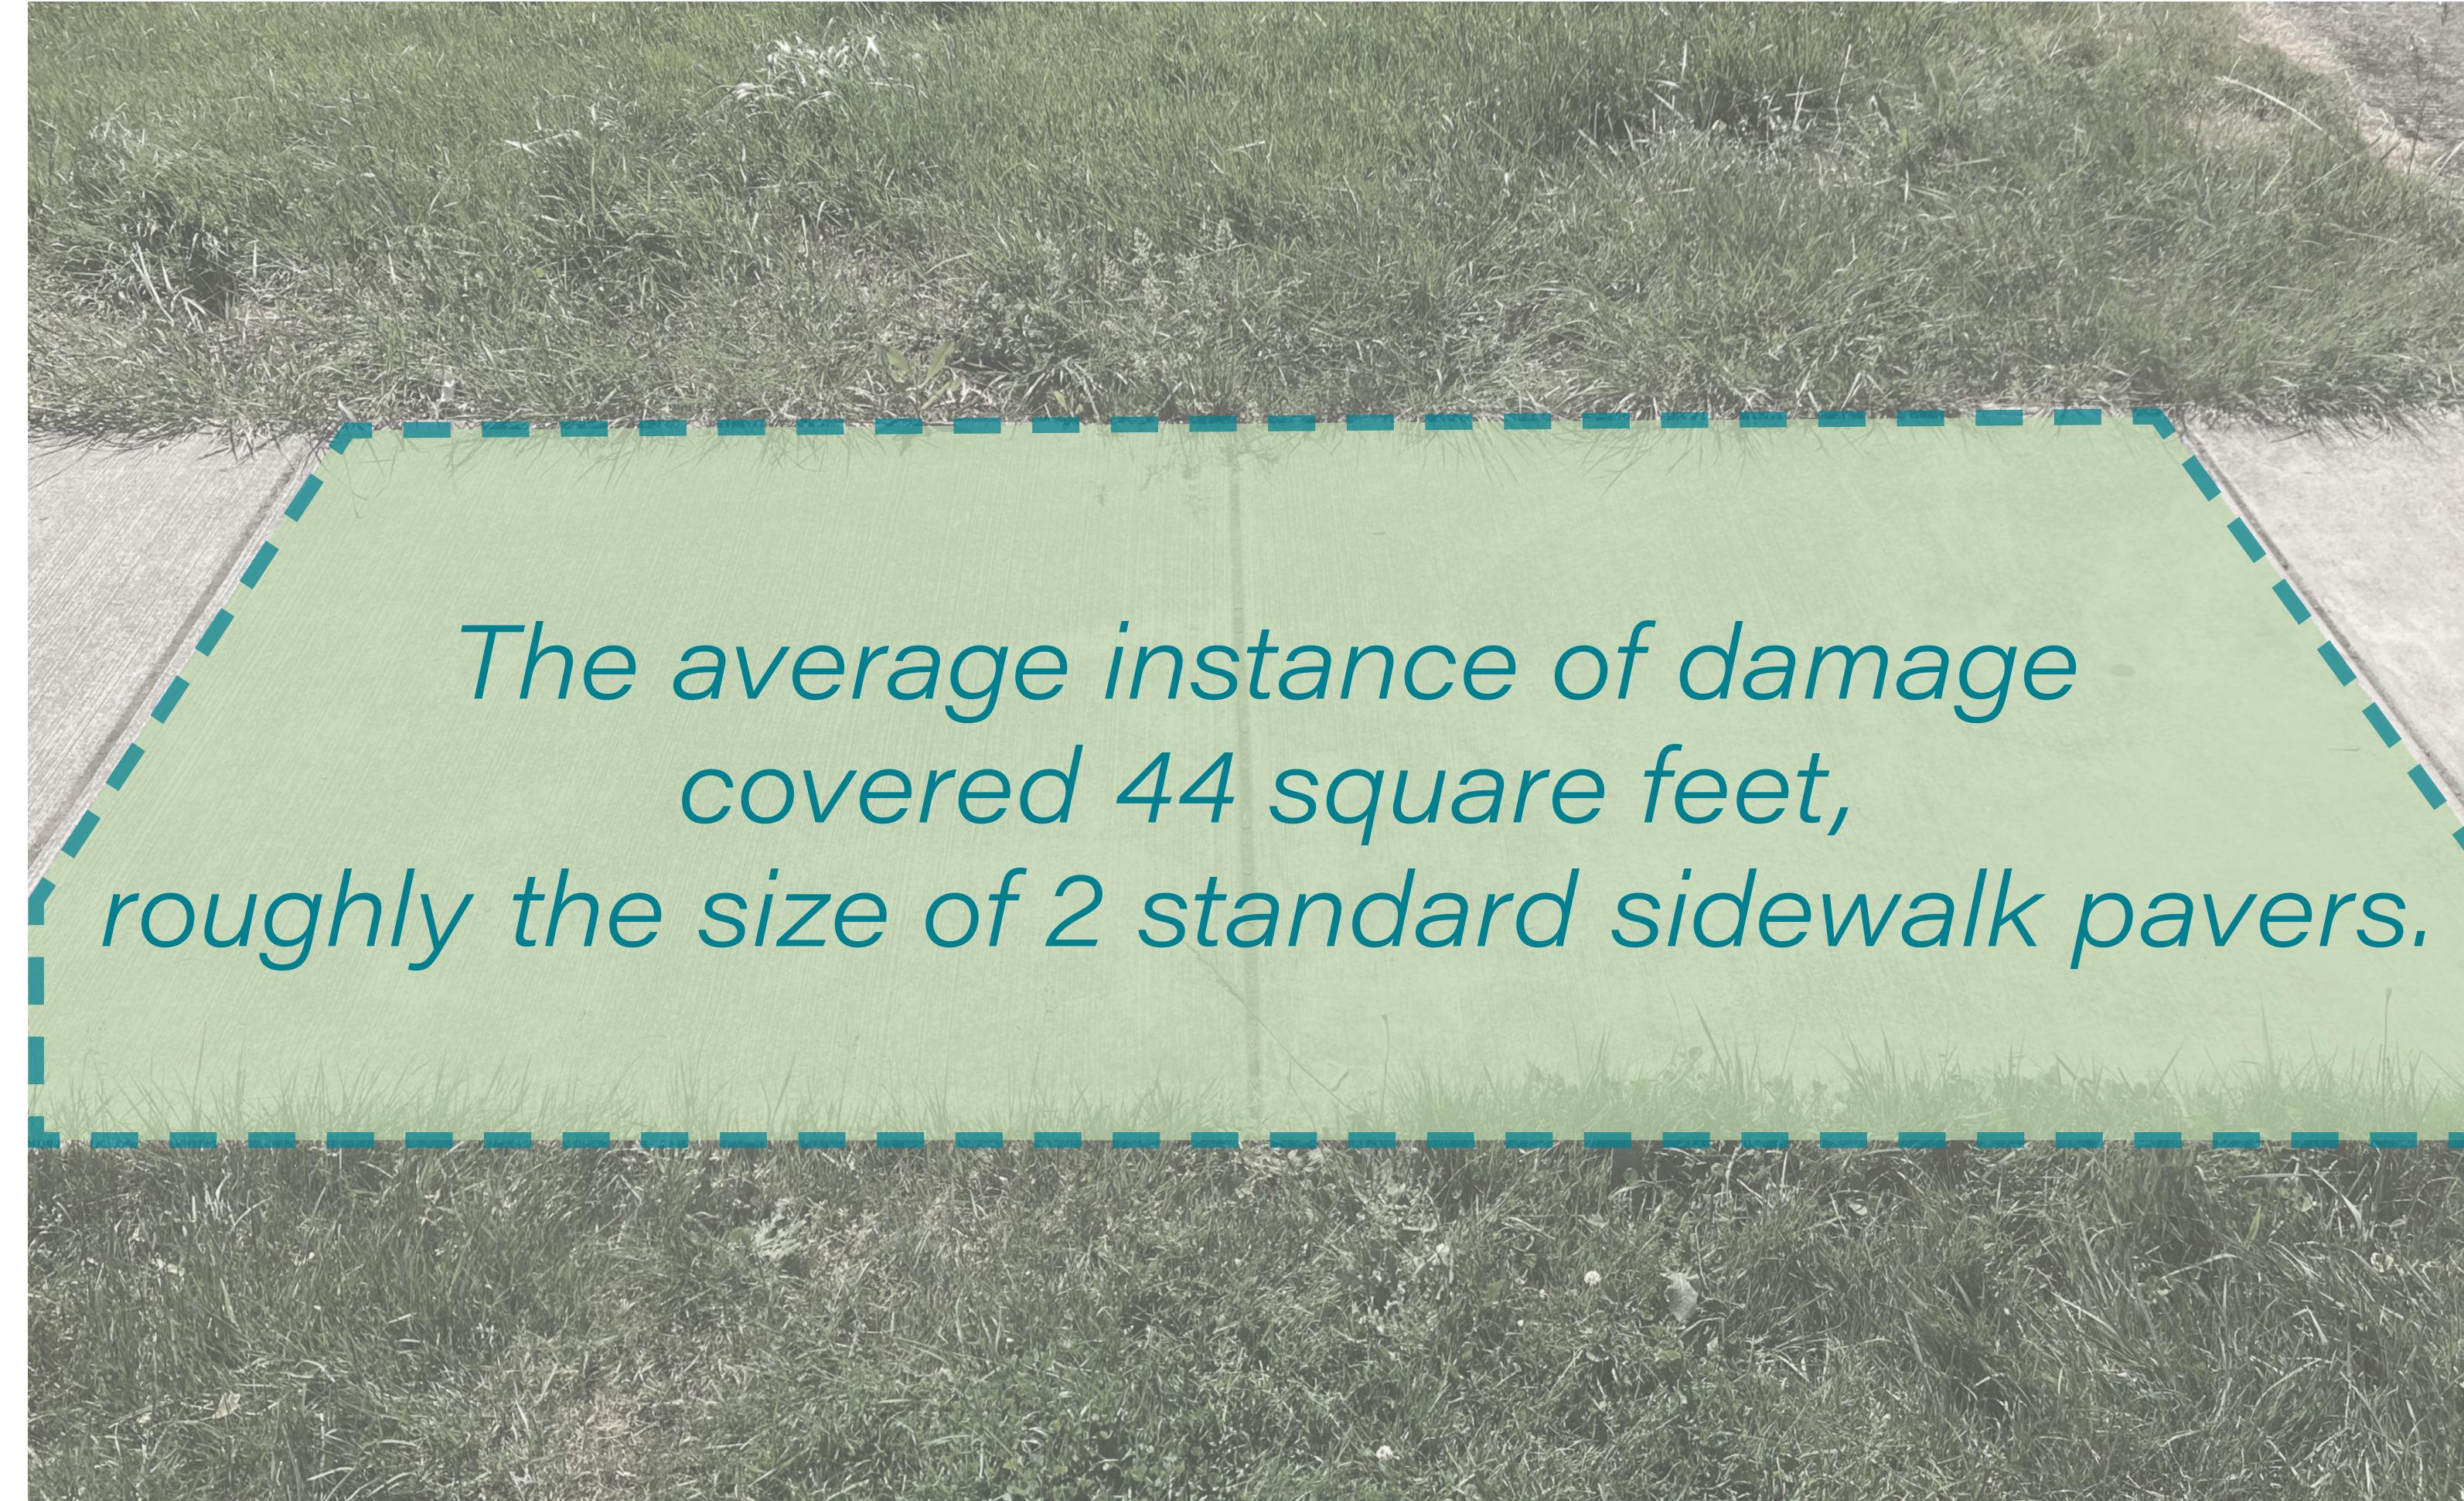
In general, the **EXTENT** of the damage increased as the **SEVERITY** of the damage increased. This tells us that **small issues** effecting individual pavers could become **larger issues** effecting a **larger area** as the pavers deteriorate.

Approximately **50%** of recorded Square Footage was assessed as '**Moderate**'

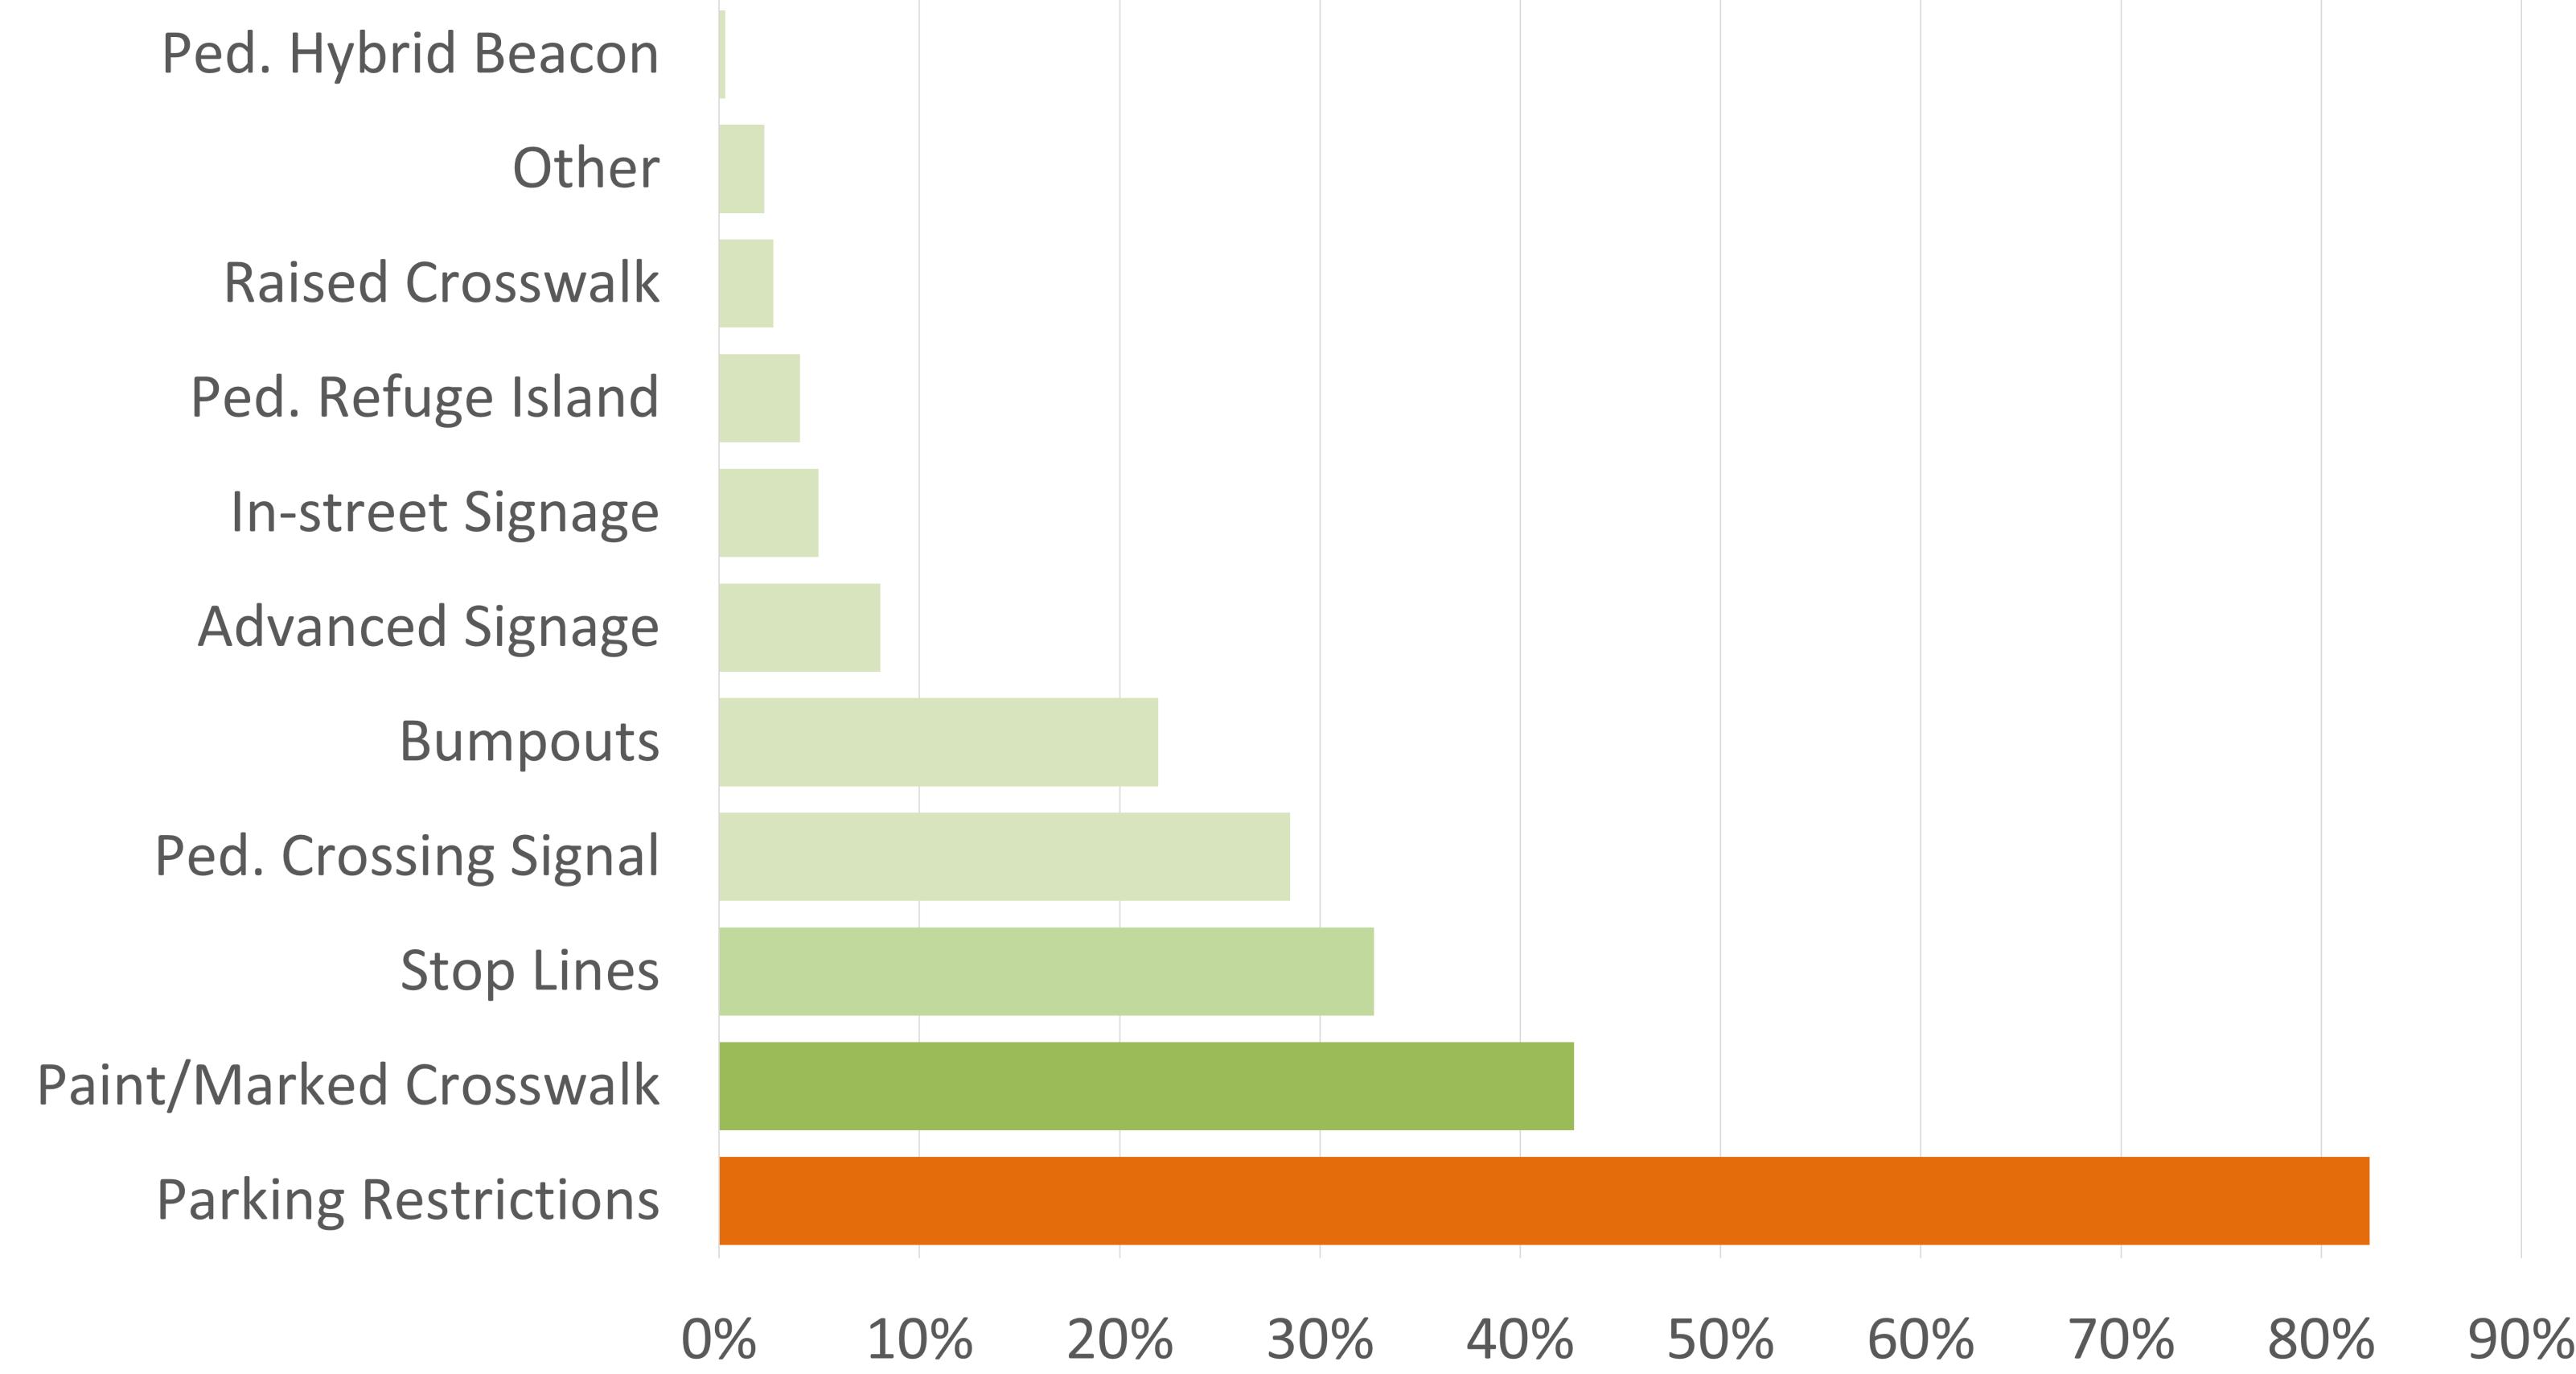
This Crossing Treatment appears X% of the Time...

The yellow line at left is a **Parking Restriction on Crosswalk approach** and is the only thing protecting the crosswalk for you to cross while visible to drivers!
