OPERATIONAL & MANAGEMENT ASSESSMENT BALTIMORE CITY FIRE DEPARTMENT

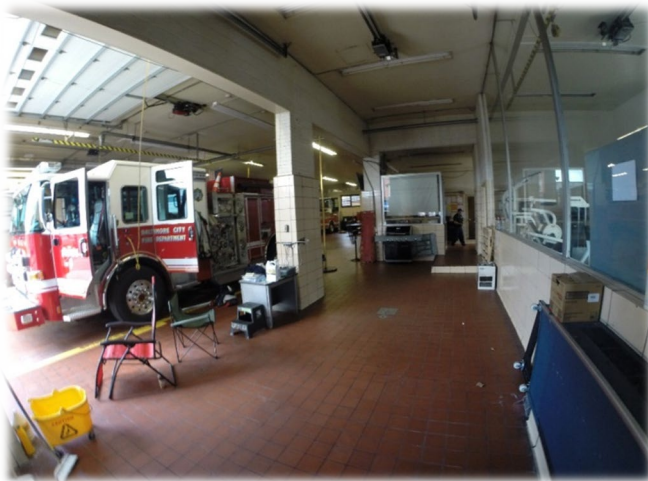
Apparatus bays viewed from the front right corner

A.9.1.5 - NIOSH recommendations for limiting carcinogen exposure in apparatus bays: *Diesel exhaust removal system (Plymovent) in place, but not functional.*

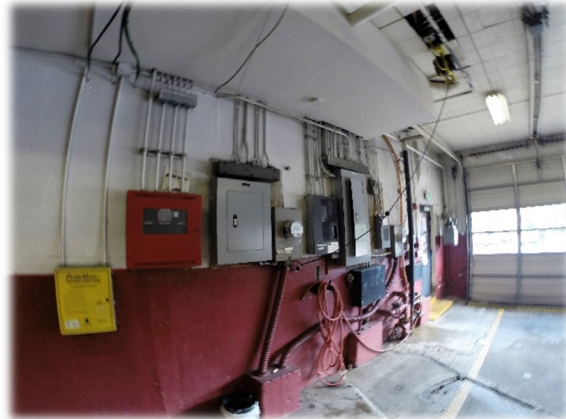
This station does not have the typical ornamentation common in firehouse construction in the late 19th century. The station has had the entire 2nd floor remodeled and it has been architecturally updated. The remodeling has definitely extended this station's functionality and useful life. It lacks a fire sprinkler system as well as a fire alarm system. HVAC, plumbing, and electrical systems could be updated.

Main electrical service

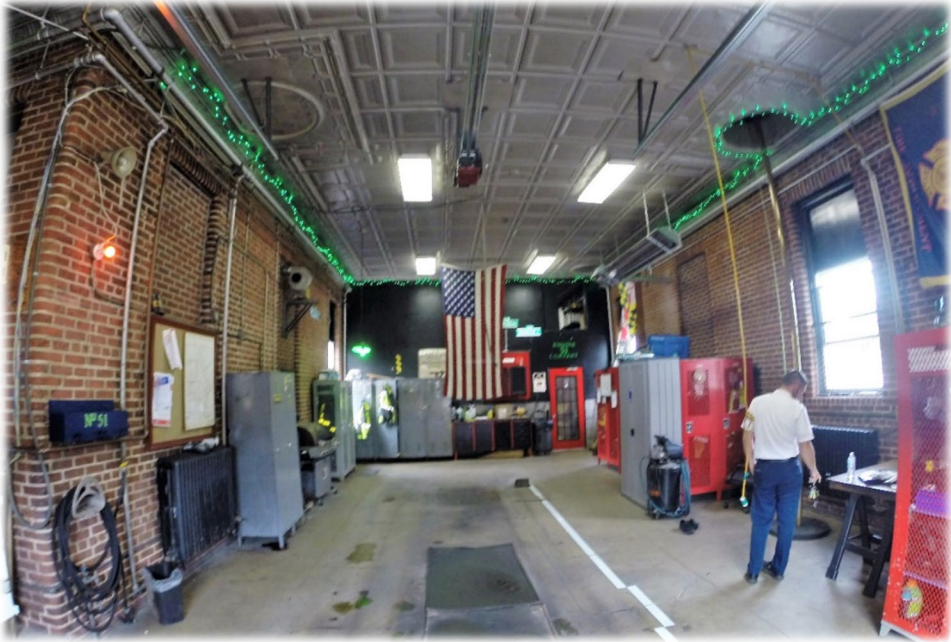
Station 51 is a historic, red brick firehouse. This station features stone masonry core with arched bay door and frames the windows above. It lacks a fire sprinkler system as well as a fire alarm system. HVAC, plumbing, and electrical systems could be updated.

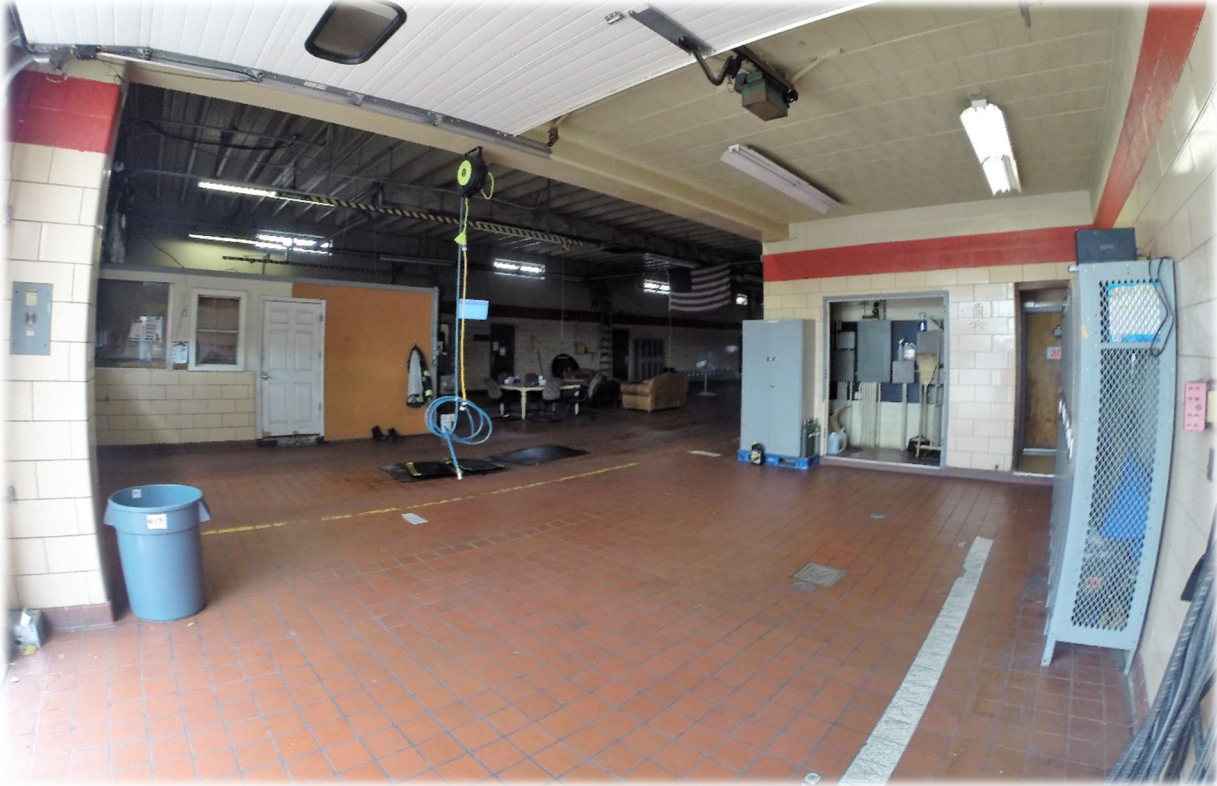
The two middle bays are “pull-through” and the station quarters flank the two middle bays, behind the two side bays. It lacks a fire sprinkler system as well as a fire alarm system. HVAC, plumbing, and electrical systems could be updated.

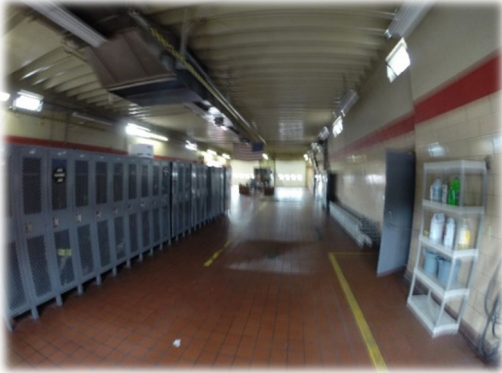
Turnout lockers are in the apparatus bays

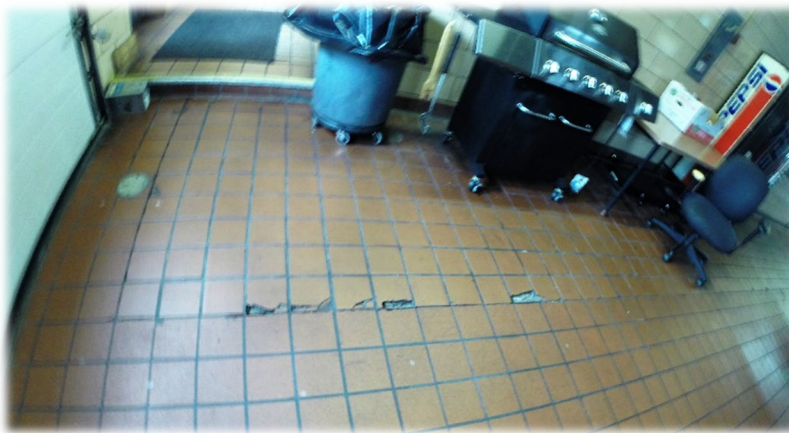
Terra cotta tile bay floor with BBQ and vending machine

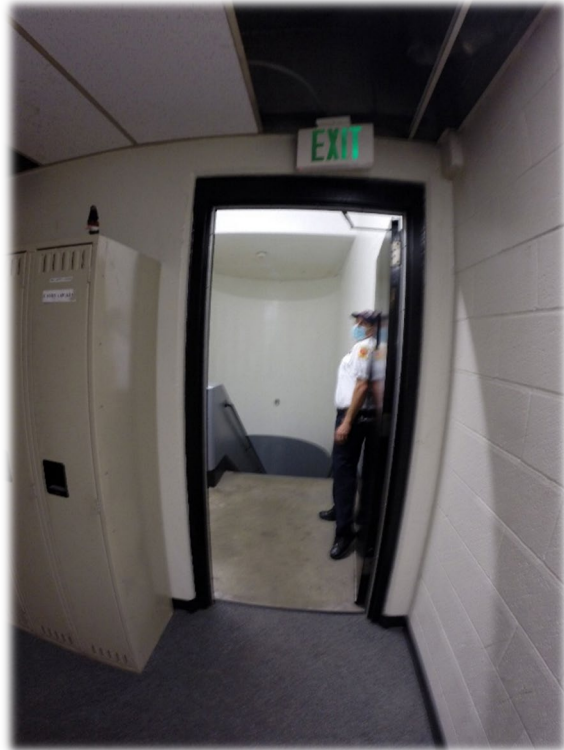
2nd floor stair landing vestibule

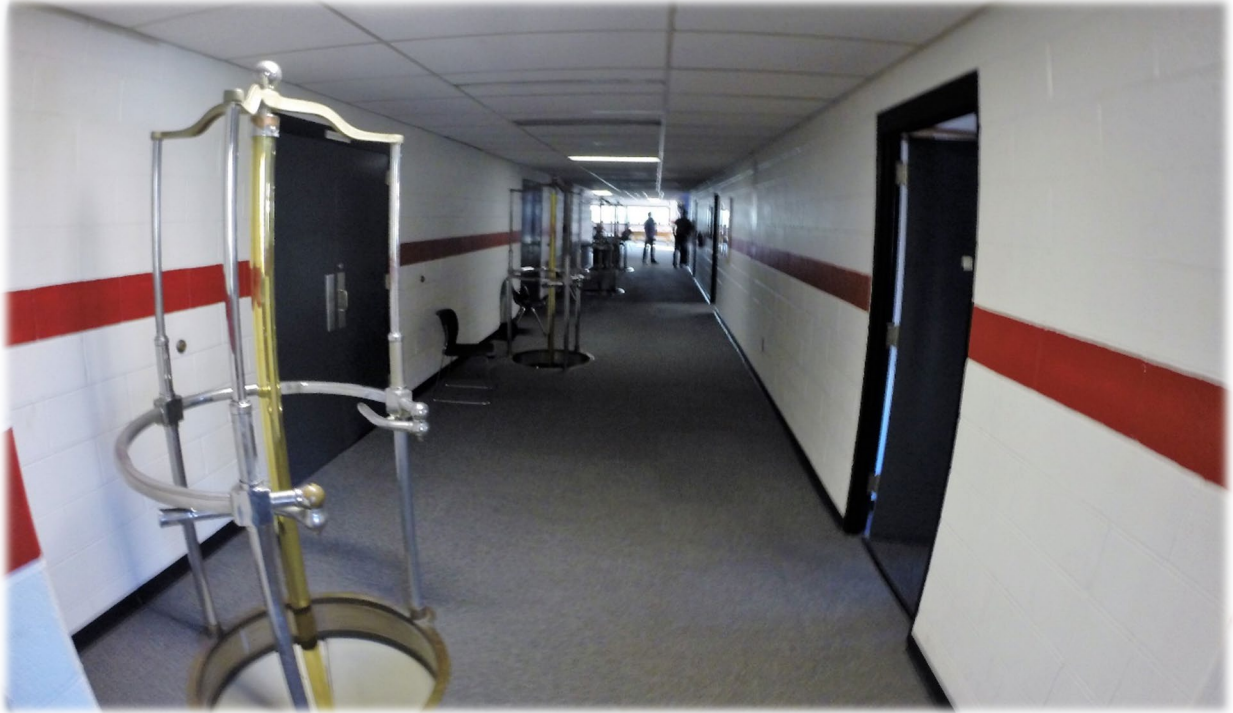
Main hallway and pole holes

Pole hole “covers” are present but are not airtight. Pads exist and are in fair condition.

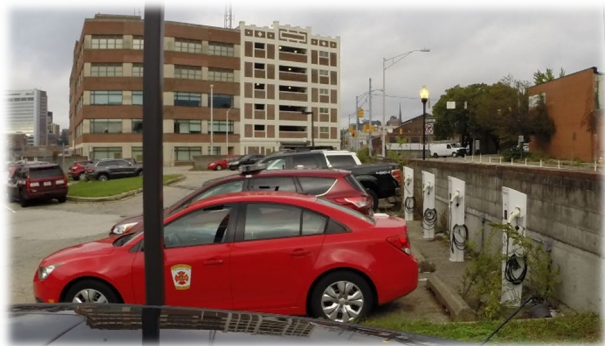
Electric Vehicle charging stations

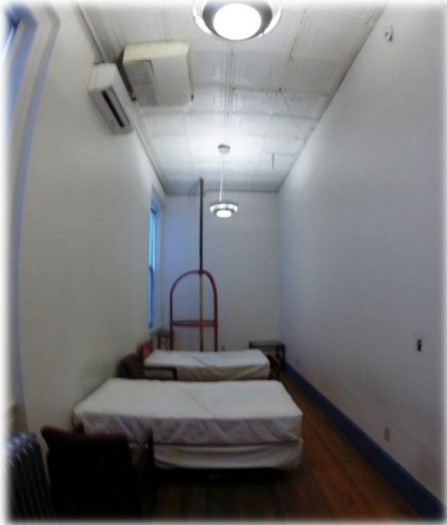
Renovated bunk room with pole access

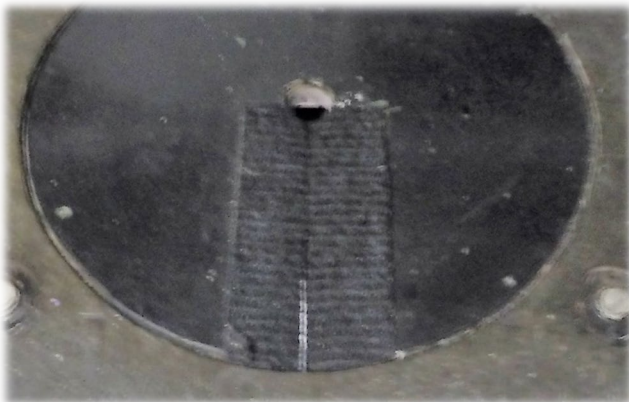
Abandoned pole hole is secured but not sealed

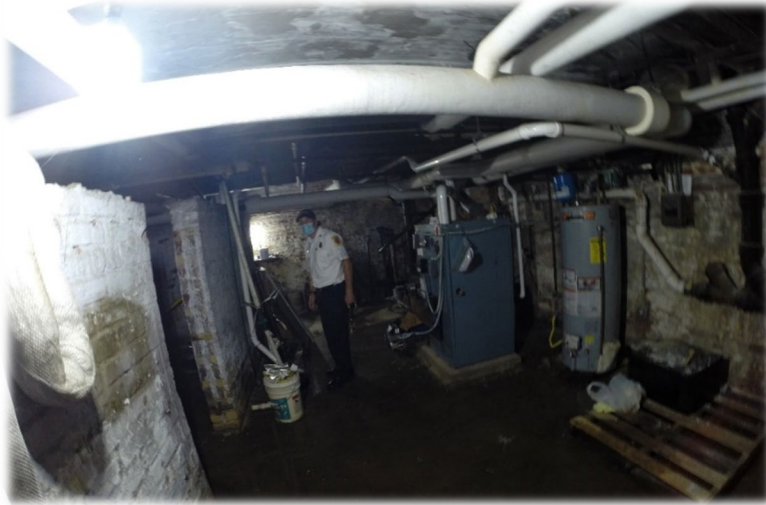
Basement has all utilities and a new furnace and water heater

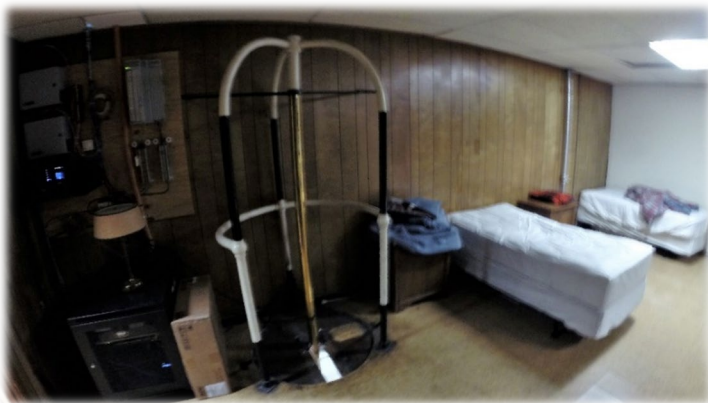
Pole hole “covers” are present but are not airtight. Pads exist and are in fair condition.

2nd floor dorm pole hole with typical plywood cover

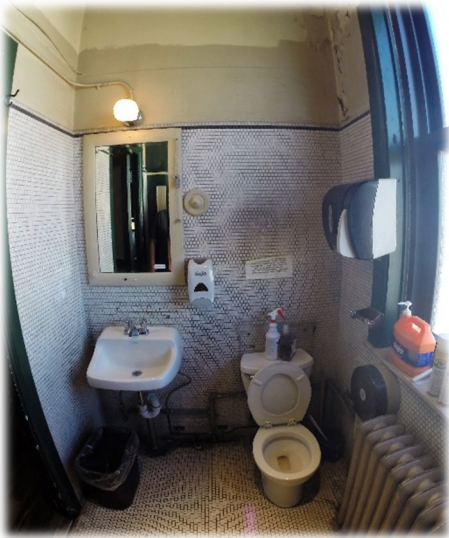
Adjacent restroom renovation

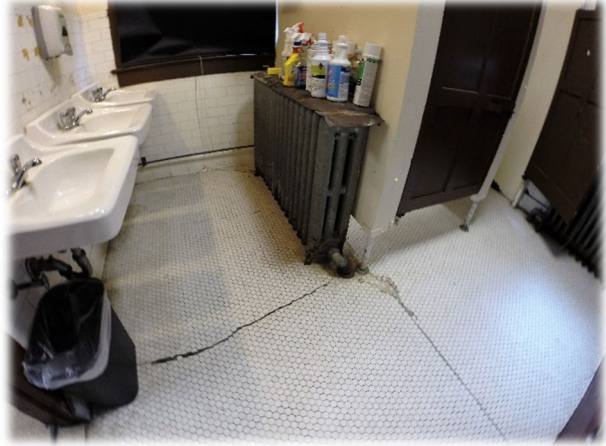
Cracks in floor and wall

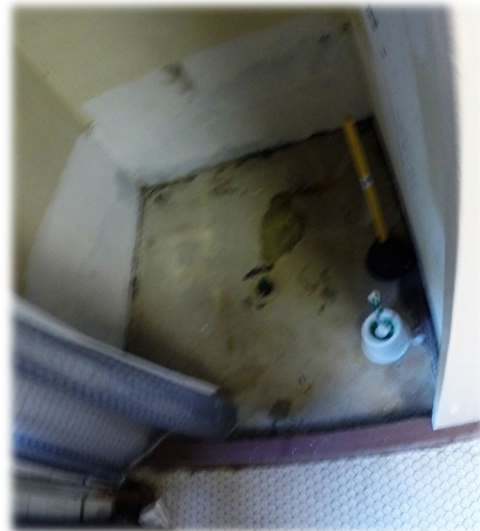
Shower floor repairs

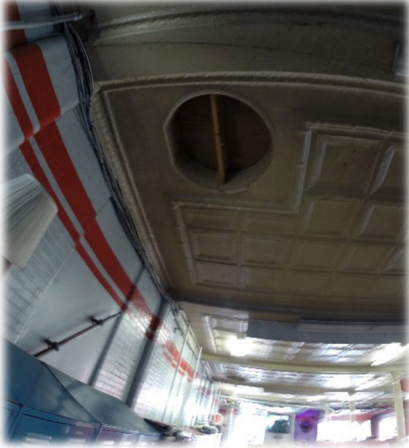
Abandoned pole hole

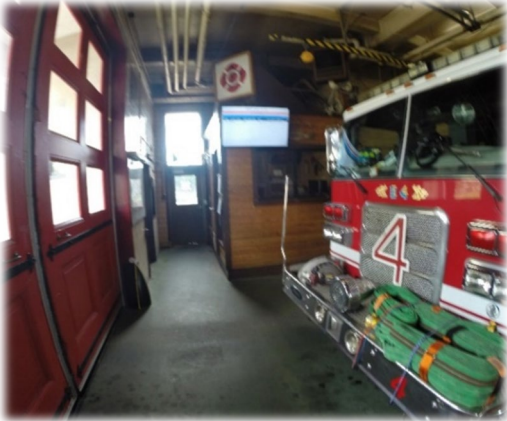
Station 4 is a traditional, red brick firehouse. It lacks a fire sprinkler system as well as a fire alarm system. HVAC, plumbing, and electrical systems could be updated.

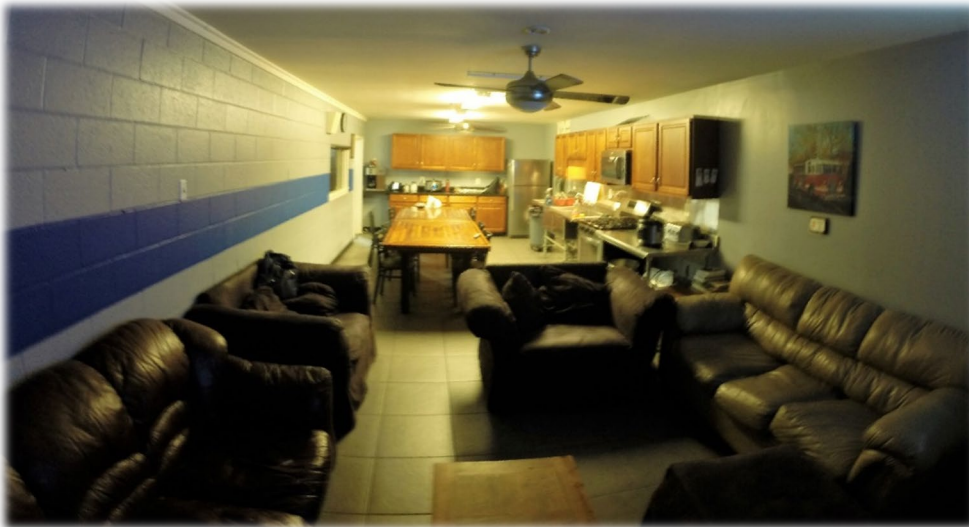
1st floor day room at back of kitchen and dining (single access/egress)

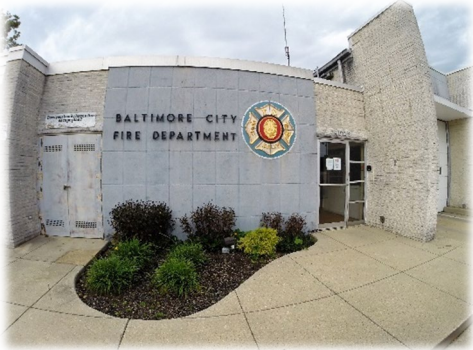
The station quarters flank the bays. It lacks a fire sprinkler system as well as a fire alarm system. HVAC, plumbing, and electrical systems could be updated.

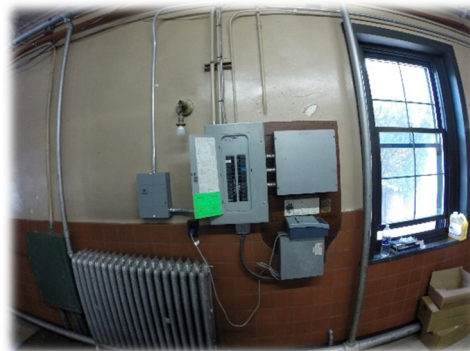
Electrical panel in bay

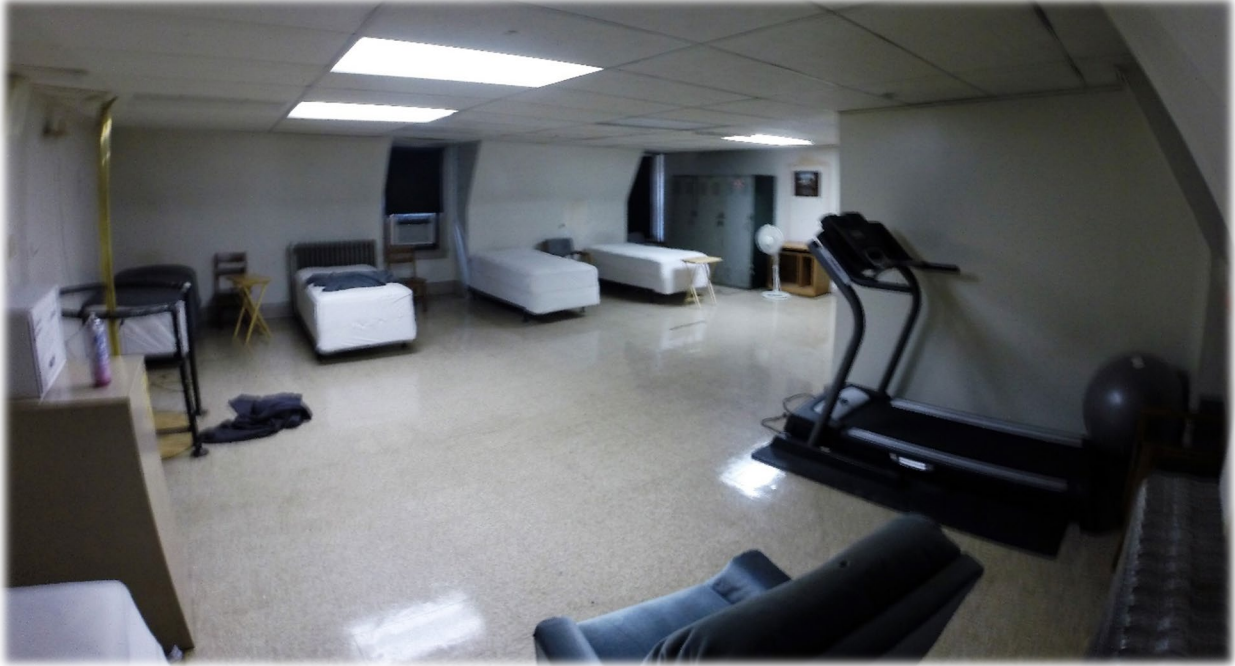
2nd floor bunk room

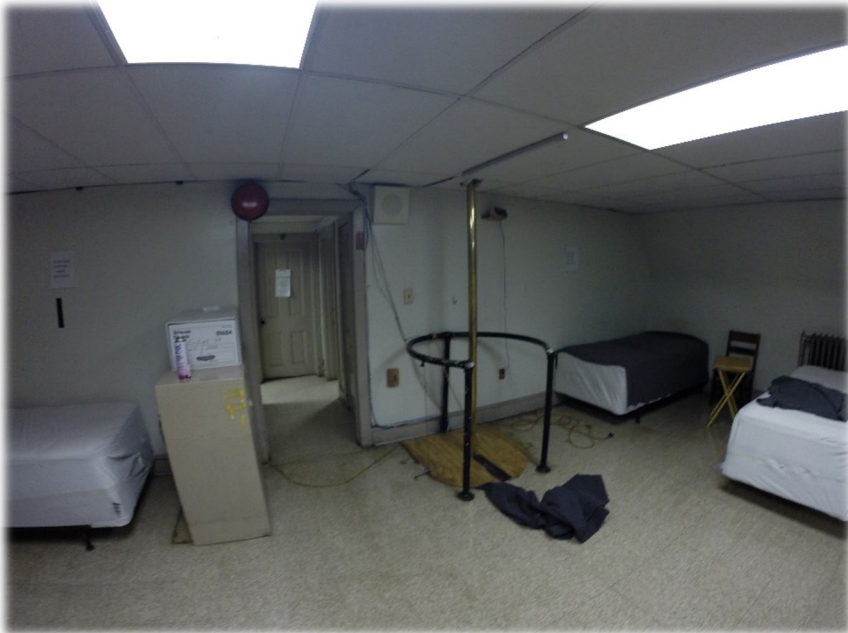
Bunk room pole hole

Pole hole “covers” are present but are not airtight. Pads exist and are in fair condition.

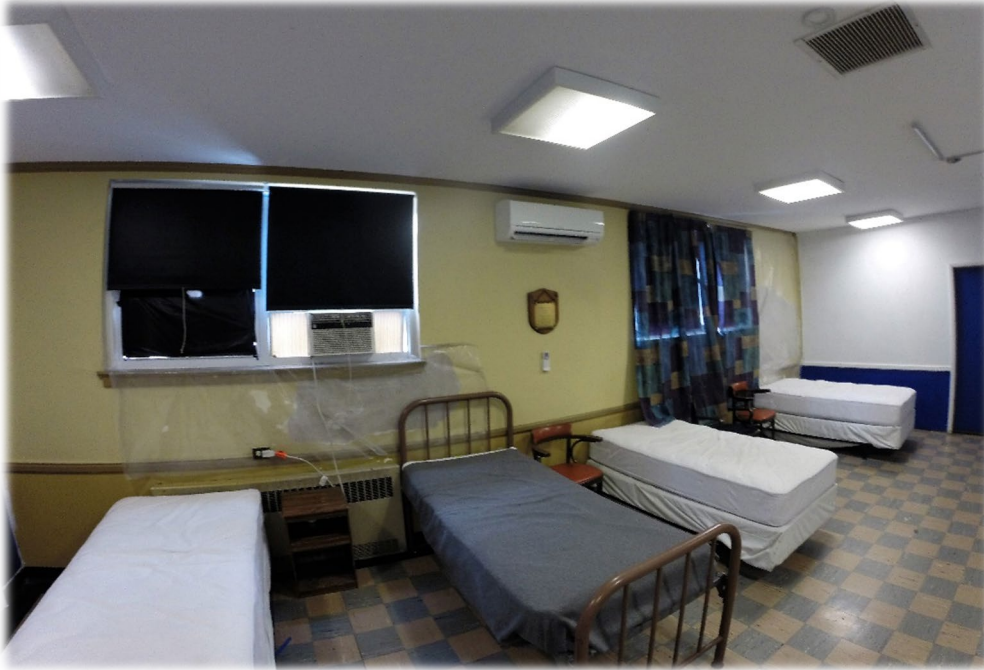
Dorms are located right off the apparatus bay; the door in the back corner leads to the restrooms/showers.

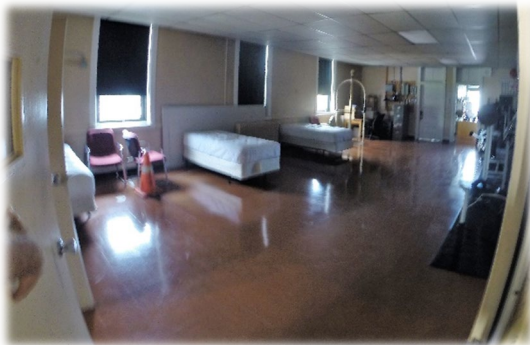
Pole hole “covers” are present but are not airtight. Pads exist and are in fair condition.

2nd floor bunk room and pole holes

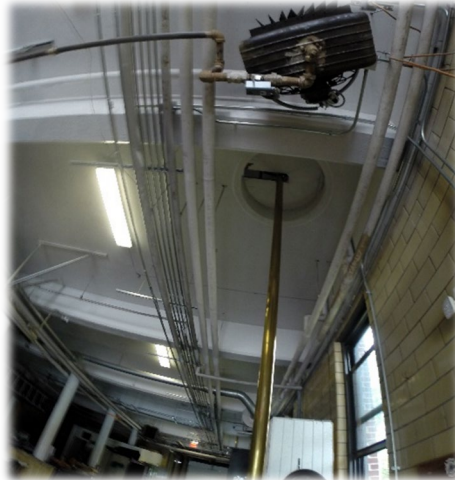
Pole hole with typical plywood "lid"

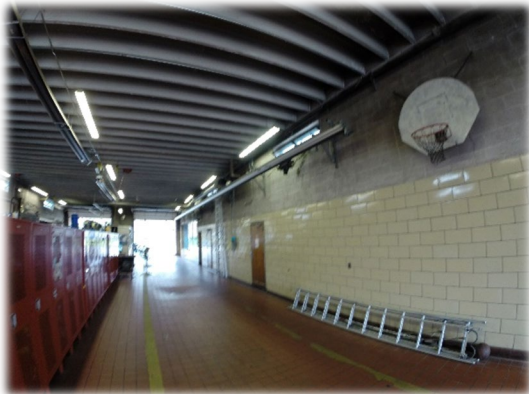
Turnout lockers are in apparatus bays

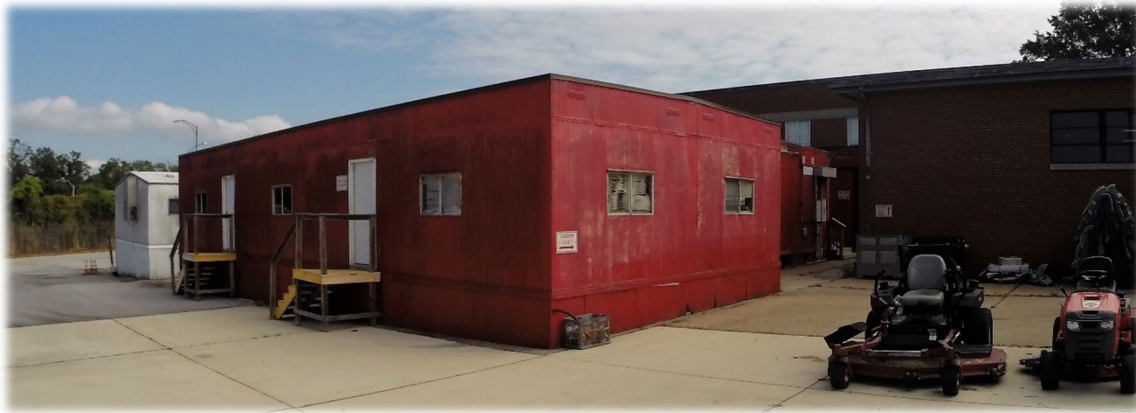
Modular classroom, storage, and locker space

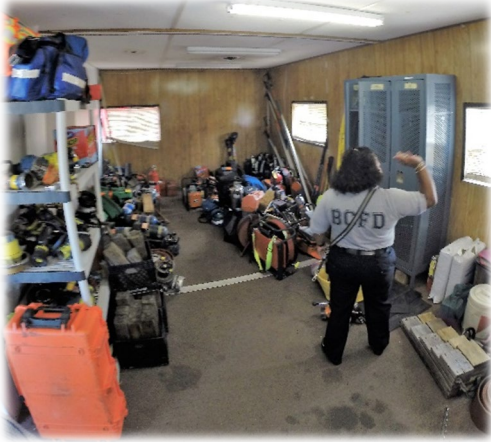
SCBA & equipment storage

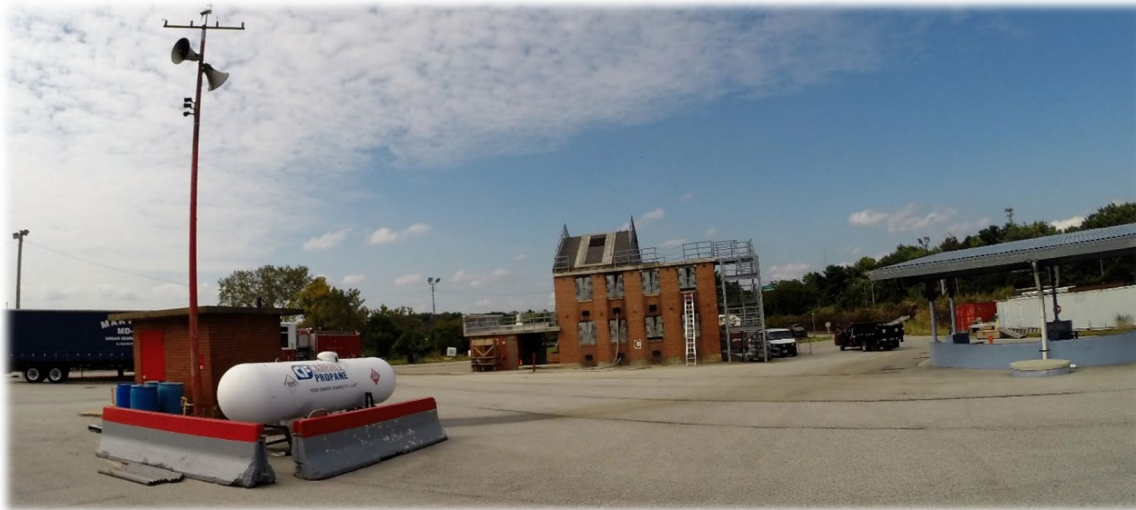
Propane prop on left, burn building in middle, and outdoor classroom area on the right

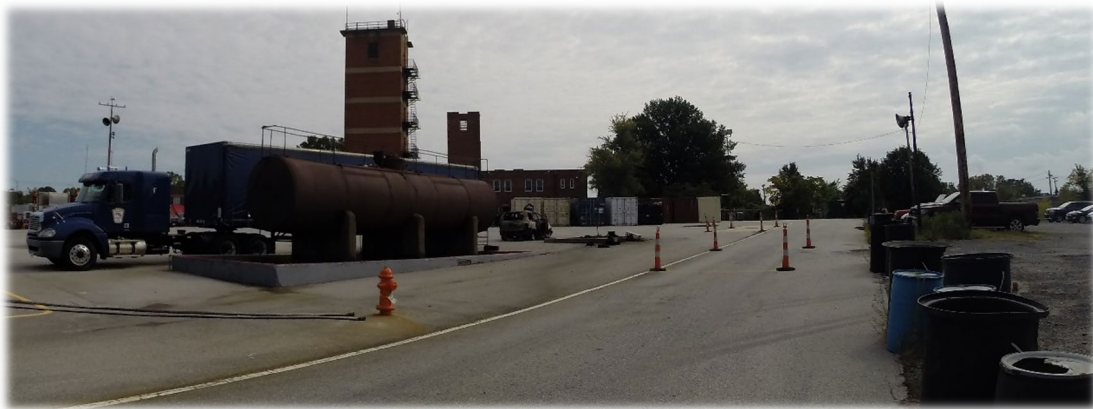
Tanker prop and main access driveway
