5210 LINDEN HEIGHTS AVE

INCIDENT REVIEW TEAM

FEBRUARY 26, 2026

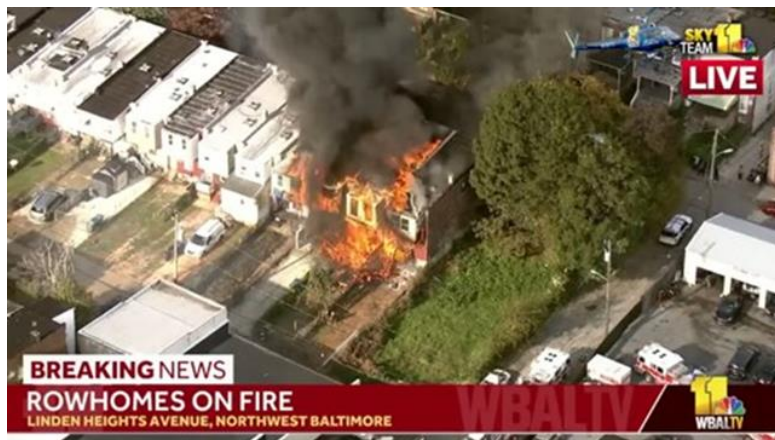
Engine 29 advanced a charged, 1-3/4" attack line into the dwelling from the ALPHA side first floor, front door. Following the right-hand wall, they made it to an entertainment center. There was a narrow opening that led to the rear of the dwelling, but the crew did not enter it. The attack line was found circling back to the front ALPHA side first floor window. There was no evidence that water flowed from the original attack line.

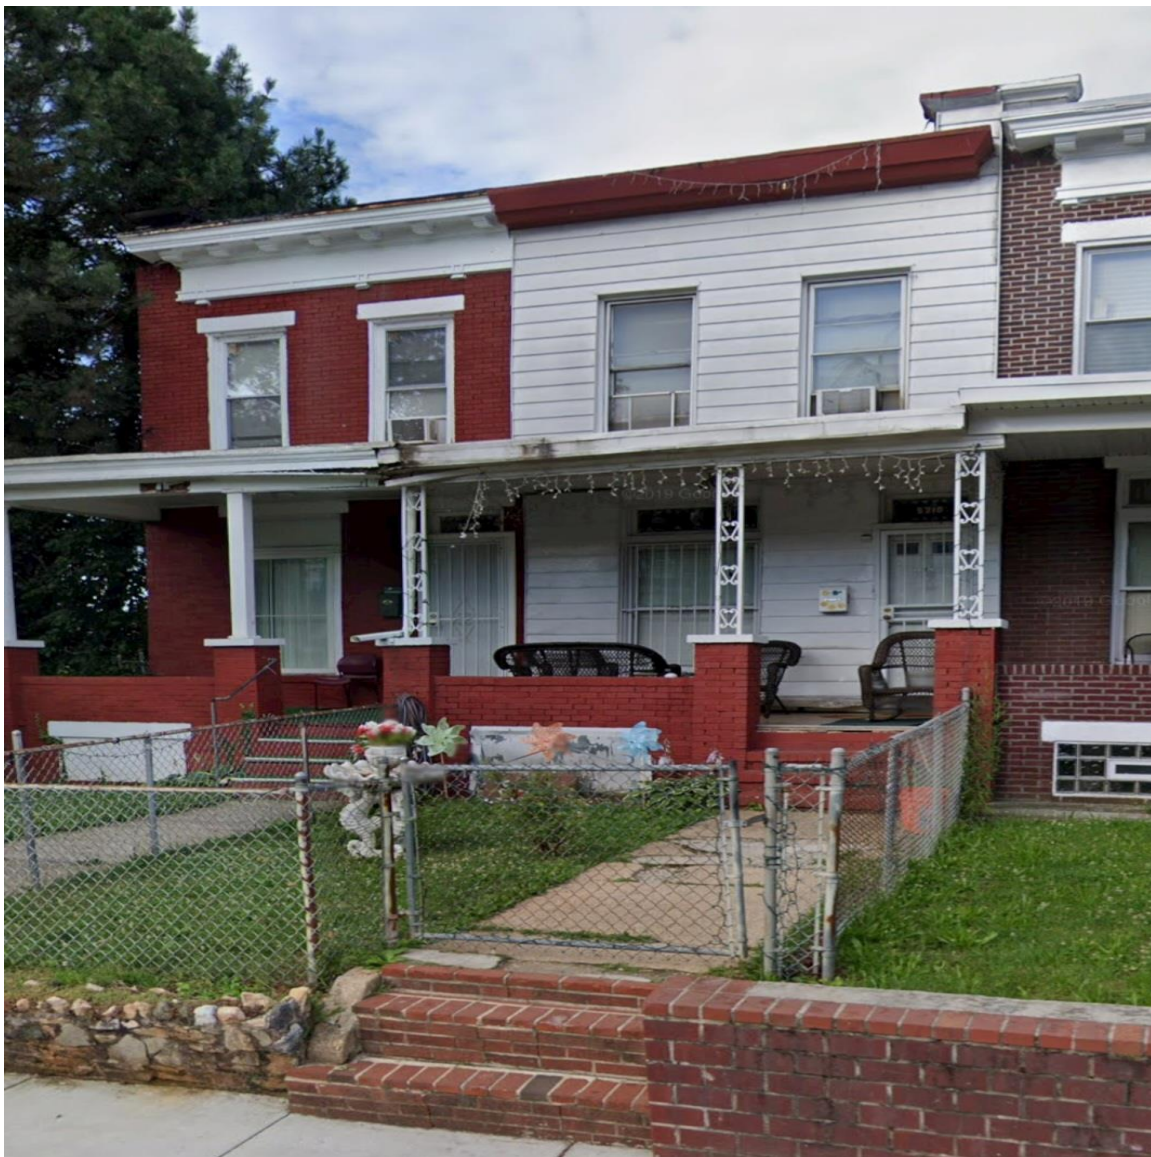
(Photo 1: front street view of 5208 {left}, 5210 {middle} and 5212 {right} of Linden Heights Ave prior to the incident. Photo circa 2021, Google Maps)

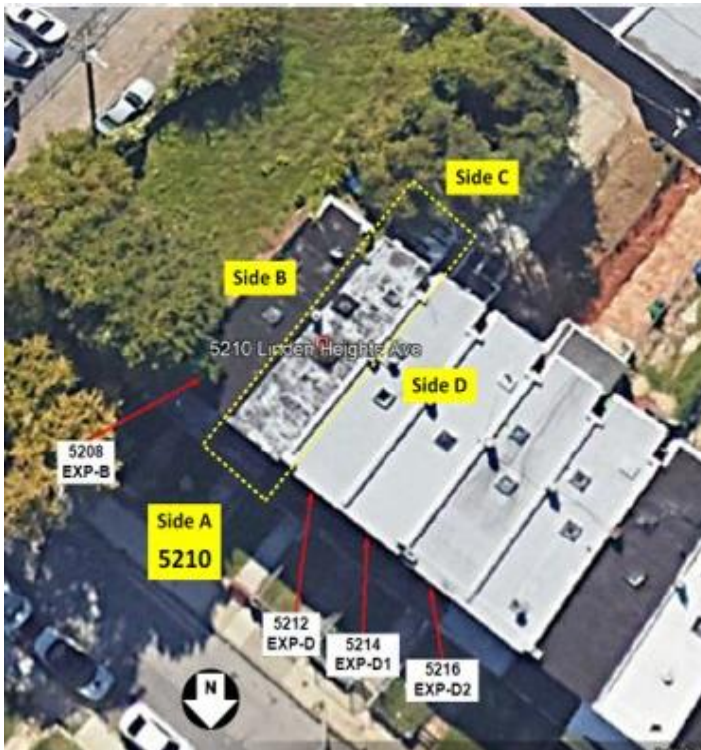
5210 Linden Heights is 1,788 square feet. The original dwelling dimensions were 13 feet wide by 40 feet in length. An addition to the first floor was added later (*photo 2*) which increased the length of the dwelling by 15.6 feet and a had nominal width of 11.6 feet.

(*Photo 2: Pre-fire aerial view of the incident location. Sides of the structure denoted by yellow boxes*)

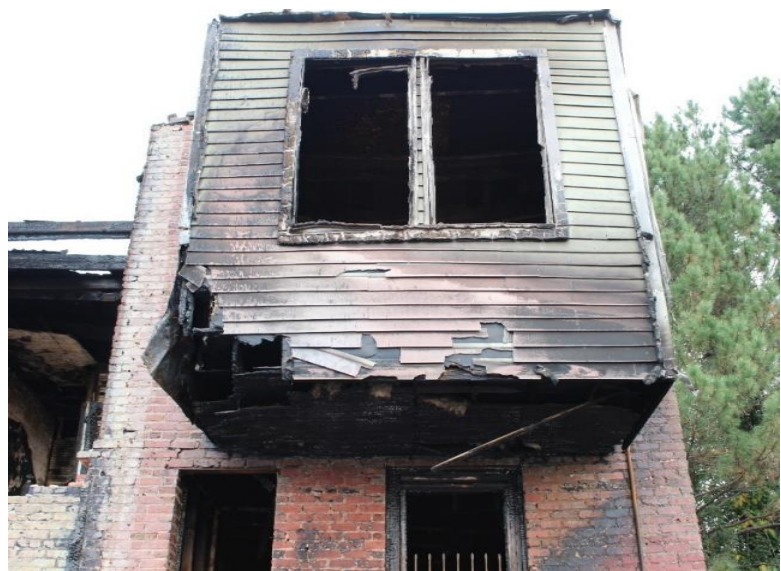
(*Photo 3: “bump out” example on the rear of the adjacent [corner dwelling] 5208 Linden Heights Ave. [Bravo Exposure]*)

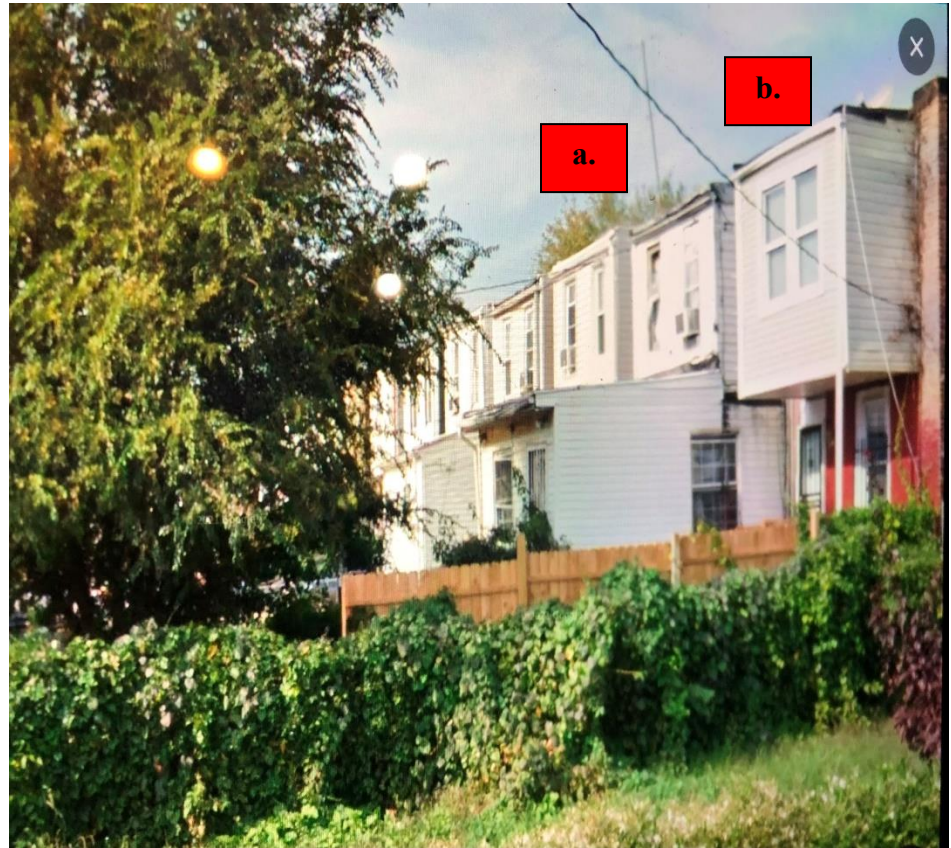
(Photo 4:)

- a. 5210 Linden Heights with 1st floor addition, pre-incident photo
- b. 5208 Linden Heights, corner dwelling, pre-incident photo. Image shows the 2nd floor “bump out”

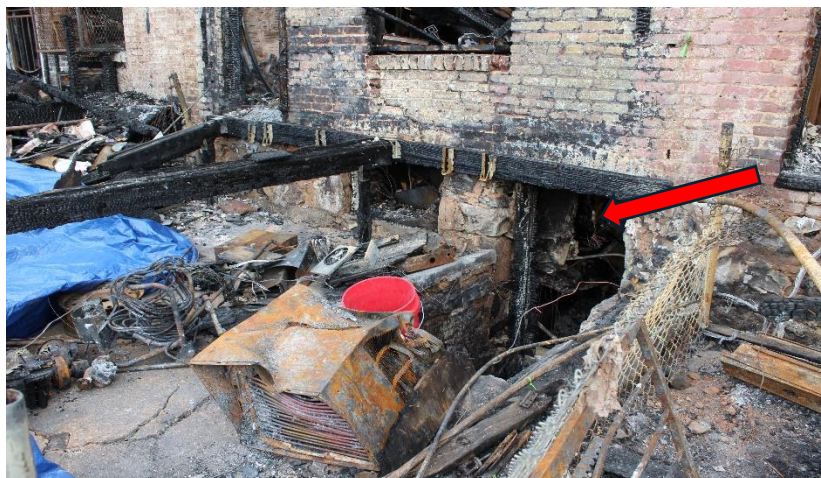
(Photo 5: 5210 Linden Heights deck joists and ledger board from previous deck construction that served as a base upon which the addition was built.

Note the joist hangers still attached to the ledger.

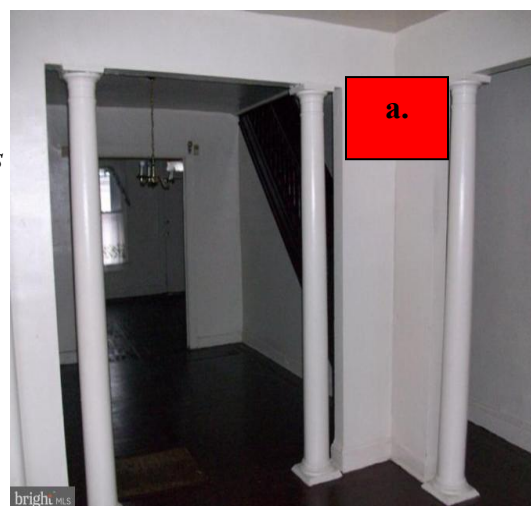
(Photo 6: Original style of interior construction for homes in the 5200 block of Linden Heights Ave) Photo courtesy of MLS -Multiple Listing Service

- a. Component in originally built structures that was not present at the incident address.*

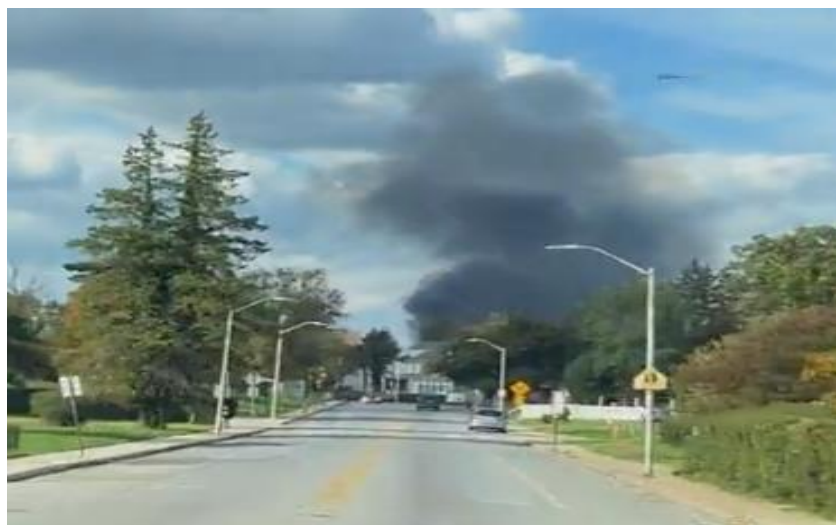
(Photo 9: View traveling north on Garrison Avenue while units were enroute. Photo courtesy of Jason Watson-Dorsey.)

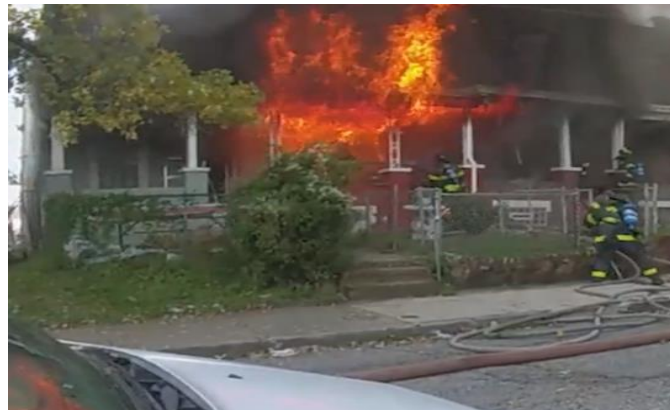
Baltimore City Police Department body-worn camera’s still-shot was obtained showing the fire involvement on Side Alpha. At timestamp 15:50:33, it is approximately 1 minute, 21 seconds after the Mayday, that the BCPD body cam captured the image. (Photo 12)

(Photo 12: BCPD body worn camera image capture. Side Alpha)

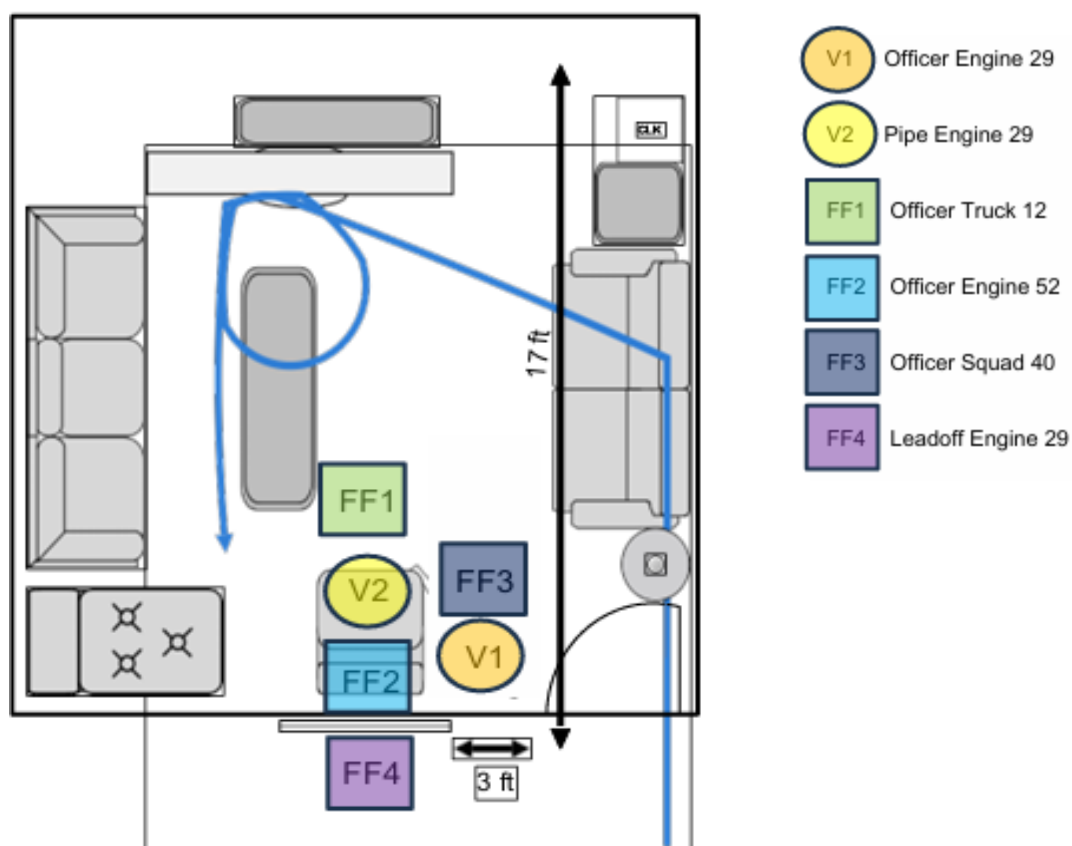
(Figure 2: Rescue Efforts- Member Location(s))

The Leadoff member from Engine 29 was helping move hose at the front door when the MAYDAY was called. He assisted by flowing water from Squad 40’s line and then aided in the removal of EMT/FF Pitts. The Pump Operator from Engine 29 ensured sufficient water supply and provided equipment as requested.

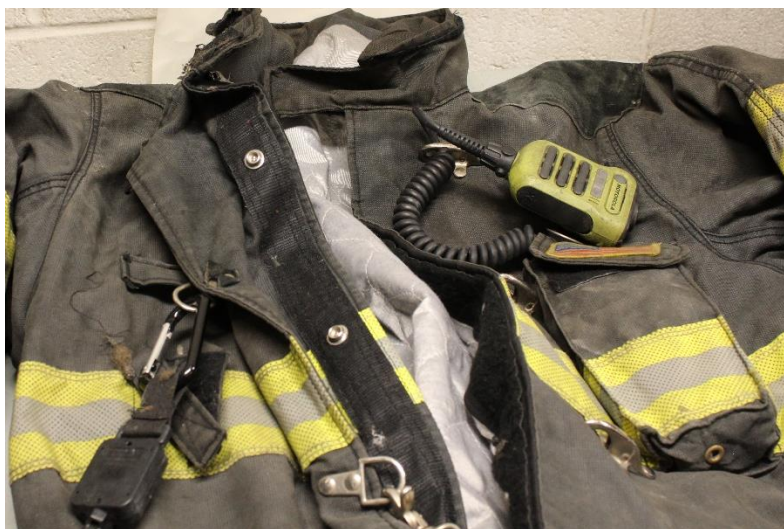
Both Captain Rinaldo and EFF Pitts suffered significant damages to their portable radios while operating at 5210 Linden Heights Ave. Both radios were worn utilizing a leather sling with the RSM exposed. Lt. Rinaldo's radio was worn in a sling, *under* his personal protection ensemble (PPE) jacket while FF Pitt's was worn in a sling, *over* his PPE jacket.

While both radio units suffered severe thermal damage, Capt. Rinaldo's radio remained functional for the duration of the incident. EFF Pitt's radio RSM cord suffered a complete failure detaching into two separate pieces. As has been documented in other firefighter injuries both regionally and nationwide, when EFF Pitt's RSM failed, it caused the radio to short in the open transmission position, temporarily hampering communications.

Currently, the BCFD PPE specification offers a "radio pocket" located on the left chest of the jacket as shown below:

This position only offers minimal abrasion protection of the radio; however, it does not protect the RSM and cord from thermal properties. Additionally, this radio positioning is reliant on the Velcro flap as the sole means of securing the radio to the user. During recent BCFD Advanced Firefighter Removal Course training, a large majority of firefighters who utilized the radio pocket lost their radio during inverted bailout procedures or window hangs. Additional findings cited that the RSM cord is prevalent to get caught during entanglement hazards.

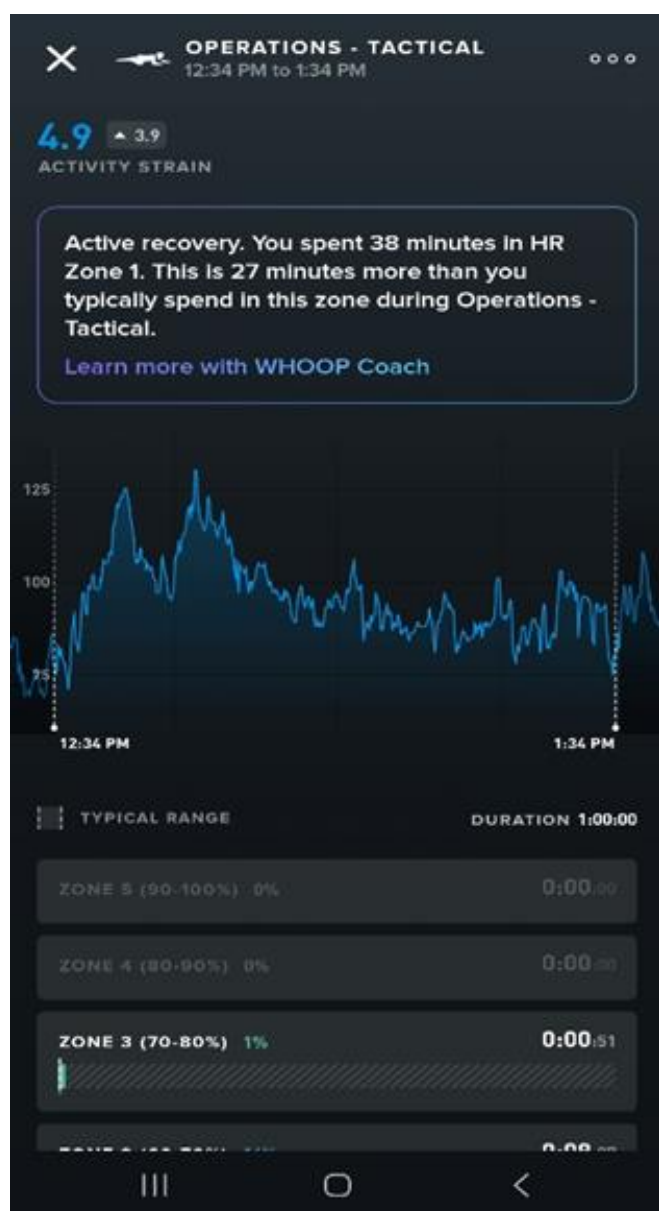
Figure 2: Incident Commander's biometric data for a "typical" fire.

The IC has been a Battalion Chief since 2010 and has commanded or assisted on over 900 fires. He provided biometric data for what would be a “typical” fire occurring prior to this incident as Figure 2. This data shows him reaching a maximum heart rate of about 130 beats per minute (bpm). The activity of commanding a typical fire for the IC usually registers as an Active Recovery, staying in Zone 1 or below 60% of his maximum heart rate.

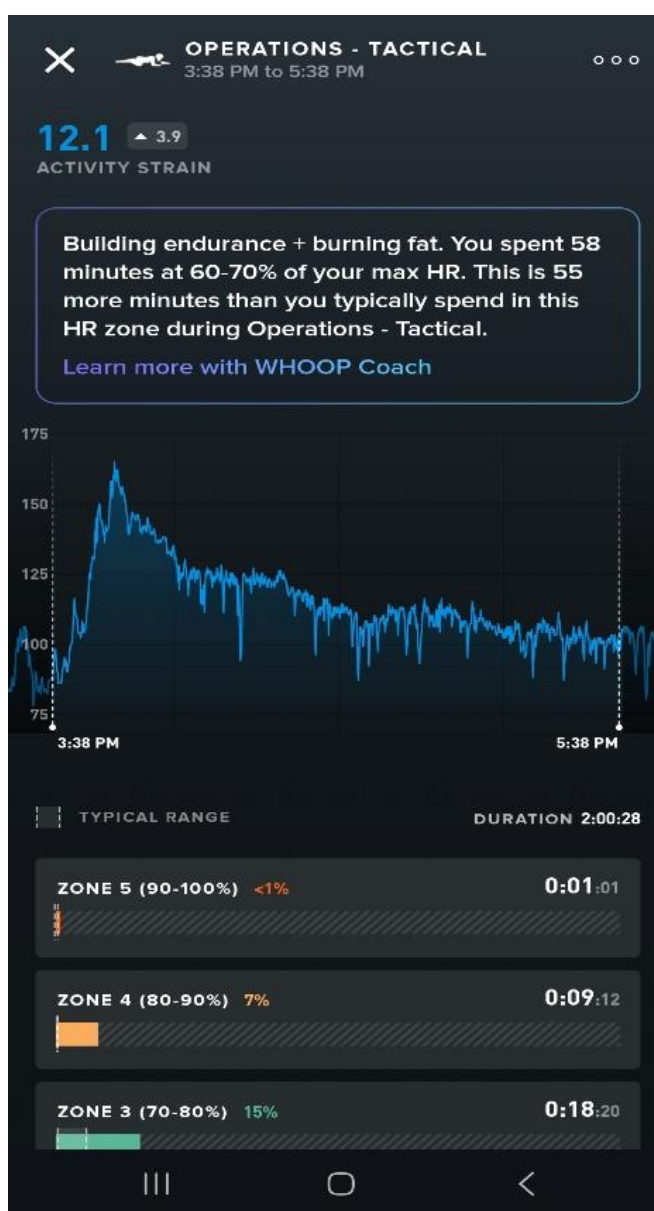
Figure 3: Incident Commander's biometric data for the Linden Heights Incident

On the Linden Heights Incident, the same IC reached 166 bpm, or Zone 5 (See Figure 3). Despite this higher-than-usual peak, the IC was able to quickly recover, reducing his heart rate below 150 bpm for the remainder of the MAYDAY operation. During this time, while the mental and physical stress of the incident was highest, the IC was able to utilize proper techniques to slow his breathing, re-focus his efforts, and maintain poise to appropriately command within policy during an extremely intense situation.

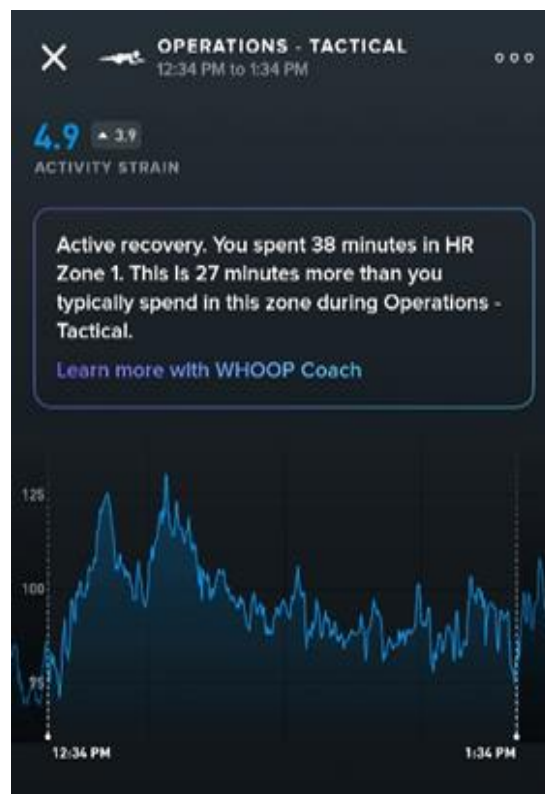
The Captain of Truck 12 was directly involved in the rescue and removal of EMT/FF Pitts. The Captain’s heartrate peaked at 193 bpm, which according to many charts would prove catastrophic to the member. This member was able to perform at extremely high levels within ‘Zone 5’ (90-100% Maximum Heartrate) for 27 minutes, making multiple, clear radio transmissions (*Figure 5*). This fire was far from “typical” for the Captain, as shown by his data in *Figure 4*. The adrenaline, physicality and experience of this member were tremendous factors in this incident. The member performed optimally both physically and mentally, while compartmentalizing the emotional strife that must be considered during the rescue of a fellow firefighter.

Figure 4: Captain of Truck 12’s biometric data for a “typical” fire.

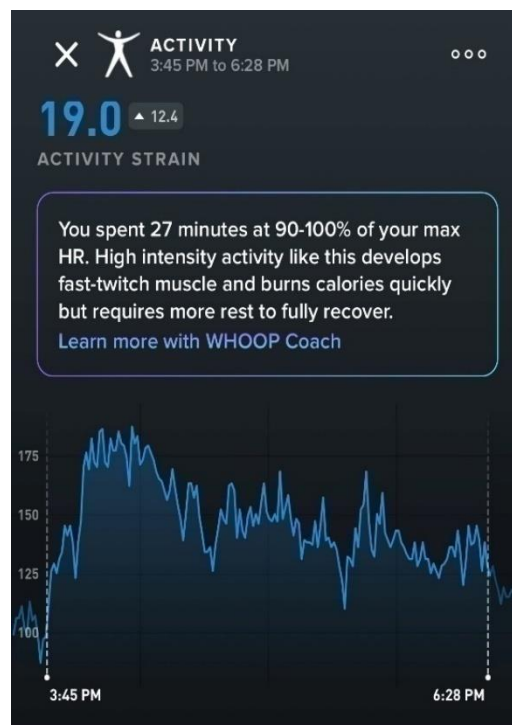
Figure 5: Captain of Truck 12's biometric data for the Linden Heights Incident.

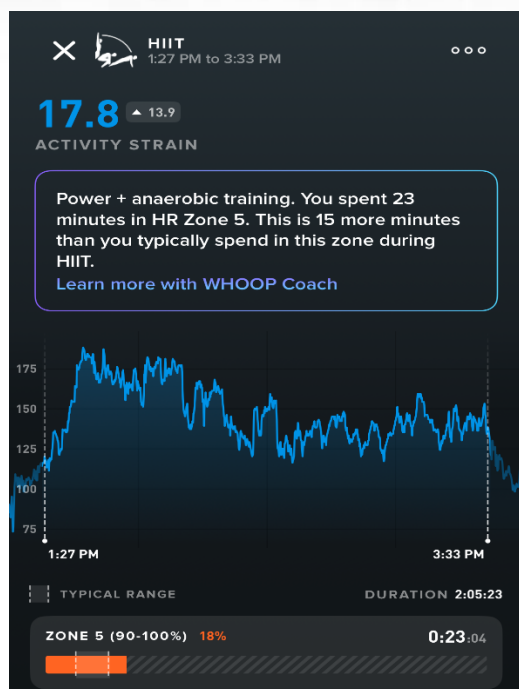
Figure 7: Member from E52 RIT Biometric data for a “typical” fire

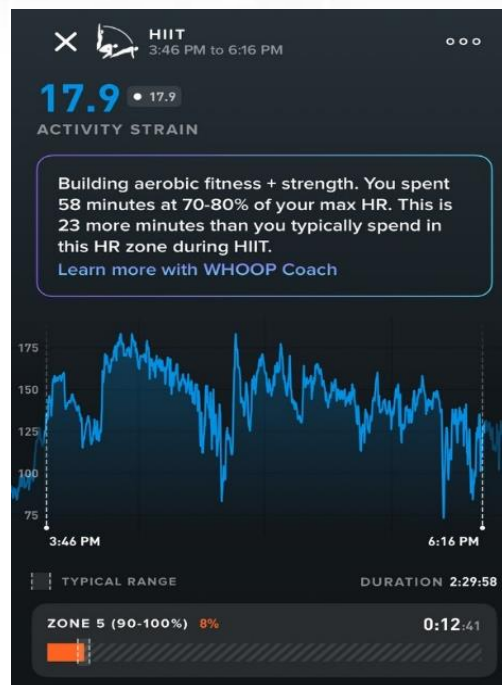
Figure 8: Member from E52 RIT Biometric data for the Linden Heights Incident

A third member wearing a biometric device was assigned to the Rapid Intervention Team (RIT). This member experienced similar stress mentioned previously by the other members wearing biometric devices. His data showed him in Zone 5 heart rate for upwards of 12 minutes and Zone 4 for 47 minutes (see Figure 8). The difference between this fire and a “typical” fire for the RIT team member was not as significant as found with the other two members. In fact, the member spent more time in Zone 5 on a “typical” fire than on this incident (see Figure 7). This is likely due to the RIT Member achieving flow state during the mental receipt of the MAYDAY. Flow state is described as the optimal performance during an experience where a human is fully immersed on completing a single activity or task. During a “typical” fire, there are many tasks that each individual needs to accomplish simultaneously. During a MAYDAY, all focus moves towards the common goal of removing the downed firefighter under any-and-all circumstances.

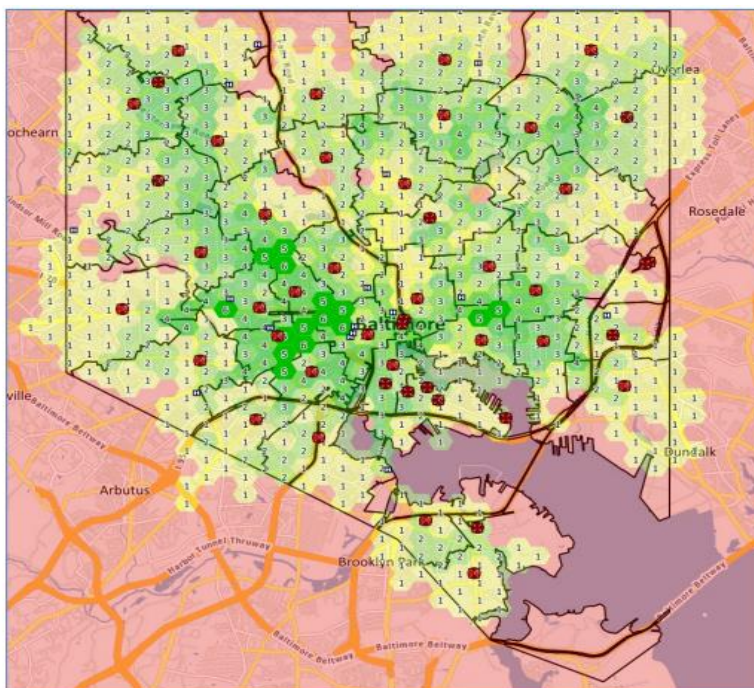
Staffing: Figure 1: FACETS Map

The FACETS Report evaluated the BCFD for NFPA 1710 compliance. Pictured below is the number of engines that will arrive in 480 seconds, with deeper green indicating more engines meeting that time frame (see *Staffing Figure 1: FACETS Map*). The red indicates NFPA 1710 non-compliance, even when every unit in the BCFD is available for response.

(Red indicates No Coverage, Other Colors and Numbers indicate Depth of Coverage calculated at 4 minutes of Drive Time for Engine and Squad Units)

The BCFD was within NFPA 1710 recommendations for this incident except for the Safety Officer and the ALS unit. Engine 29 arrived 193 seconds after dispatch. Squad 40 arrived 208 seconds after dispatch. The entire first alarm arrived 465 seconds after dispatch except for Safety Officer 4 (SO4) and Medic 11. SO4 took 1190 seconds to arrive after dispatch. Medic 11 took 757 seconds to arrive after they were dispatched. Medic 11's true response time was longer, since there was no EMS unit on the initial dispatch. Medic 11 was a separate dispatch that occurred 75 seconds after the initial alarm. That means the time that transpired from the initial alarm to the first ALS unit arriving was 832 seconds in total.

1. The BCFD should increase its complement of EMS transport units and Incident Safety Officers to satisfy NFPA 1710 recommendations.
2. The BCFD should evaluate and consider increasing the number Engines and Trucks to ensure adequate critical response coverage to the City of Baltimore.

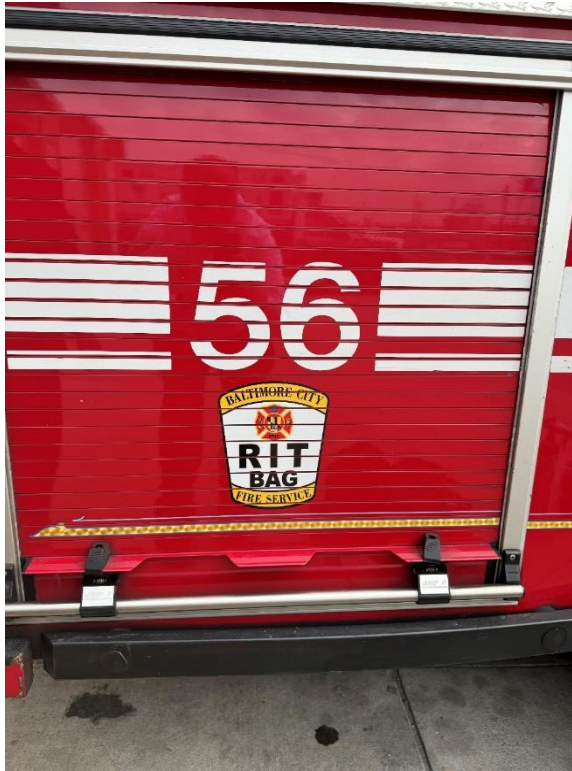
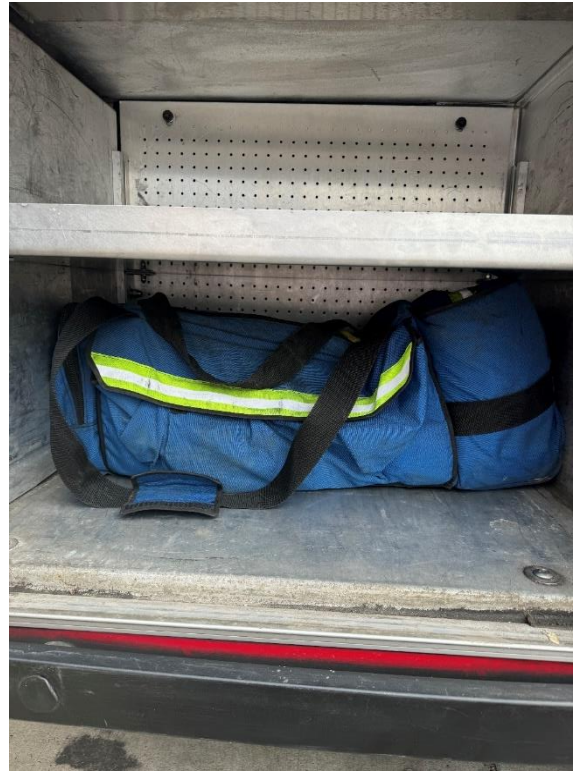
Equipment Photo #1
RIT Compartment
L: Outside, R: Inside

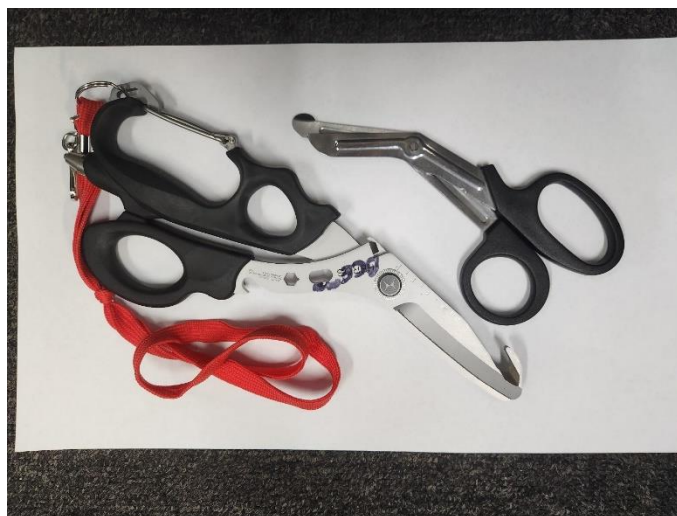
Equipment Photo #2

*Comparison of HEROS Shears (L)
with Typical trauma shears (R)*

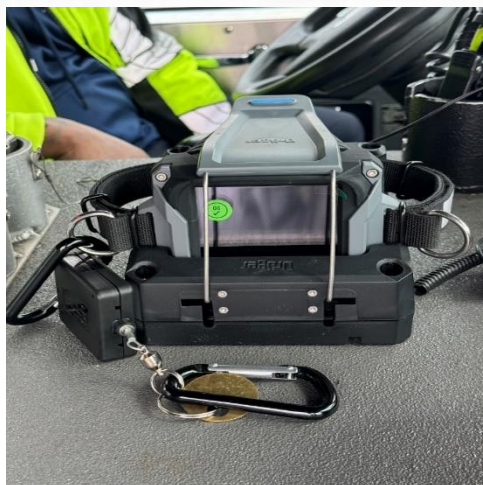
Equipment Photo #4
Draeger Fire Vista

The BCFD did not provide thermal imaging training in 2015 when the Engine Companies were provided the thermal imaging cameras nor in 2023 when all additional riding positions received the Seek thermal imaging cameras. This is important to note because any new officer or member promoted or hired after 2013 has not received formal training in the department's two types of thermal imaging cameras.

The BCFD acquired a third Thermal Imaging Camera in November 2024, the Draeger Fire Vista. This camera is smaller than the UCF 7000 but larger than the Seek Reveal Fire Pro. It does NOT have a recording feature. Similarly to 2015, no training was conducted other than the HEAT and AFR courses, which are optional. Instructions for its use have been added to the Training Manual on November 13, 2024; T.M 131-1.

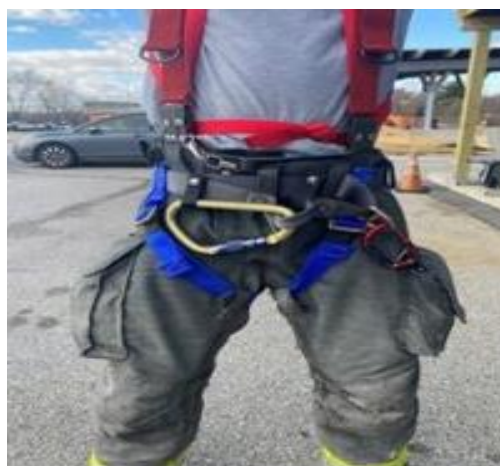
Equipment Photo #6

Gemtor Harness

| 2. The BCFD should maintain its commitment to firefighter rescue initiatives, particularly the Gemtor harnesses and Bailout Kits, which have proven effective during operations. |

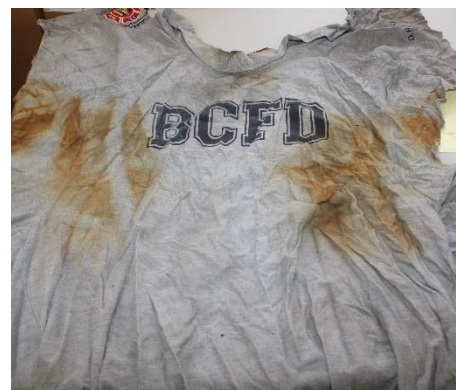
Equipment Photo # 11

Captain Rinaldo's Uniform Shirt

1. The BCFD create a working group consisting of Fire Department representatives, both Local 734 and 964 Union representatives and the Fire Departments Research and Development team (*See also Equipment #9 in this document*) to propose new options of fire resistive (FR) uniform attire that will the BCFD and its members into compliance with NFPA 1975.

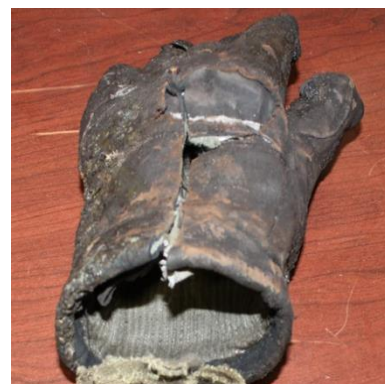
Both of Captain Rinaldo's gloves remained intact to his hands for the duration of the incident. Once he was removed and attended to, his left glove shrunk to the point that medic crews could not remove it. The glove was finally able to be removed at the hospital, by staff cutting the glove in half to remove it from around his hand. (*Equipment photo #12*). Additionally, the glove can be seen to have obvious shrinking, melting on the outer material, and separation.

Equipment Photo # 12
Capt. Rinaldo's left turnout glove with cut placed by hospital staff to remove it

While we can say that the crews operated within an extreme environment on Linden Heights, we found during interviews that other members experienced shrinking in their gloves. During interviews with Departmental members, several personnel mentioned that their gloves were unequal sizes and had noted that one or both gloves had shrunk while wearing them during both training academy burns and live fires.
