Date of Inspection: 5/11/2022

Property Inspection Report

2615 Old Logan Rd SE, Lancaster, OH 43130

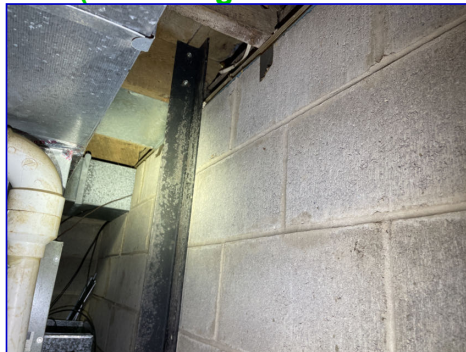
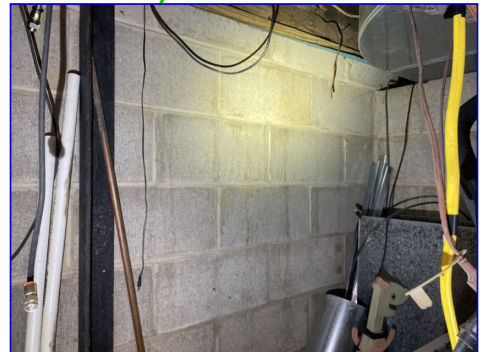
• **Monitor:** Foundation repairs were observed along the (east, south and interior basement) wall(s). Recommend consulting with the the current owners regarding these repairs and any warranties or guarantees that may apply.

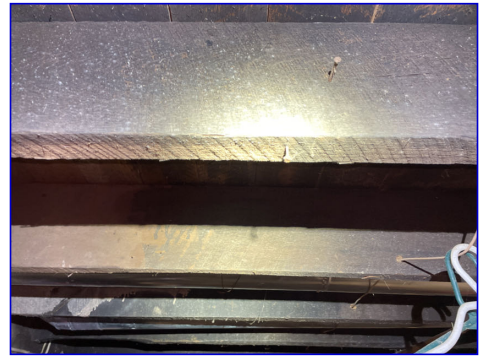
Floor structure

Support posts for the floor structure should be attached with proper hardware at top and bottom to help prevent displacement.

• **Repair:** Support posts for the floor structure should be attached with proper hardware at top and bottom to help prevent displacement.

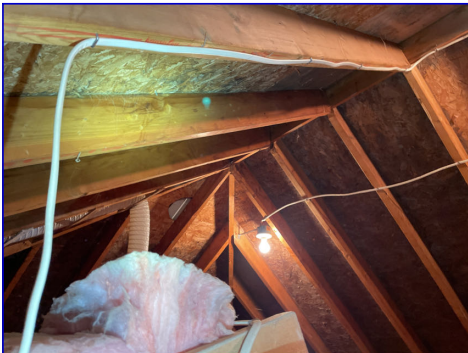
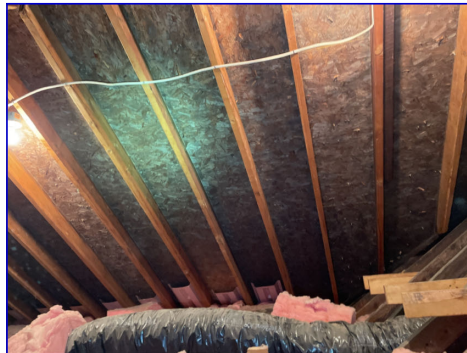
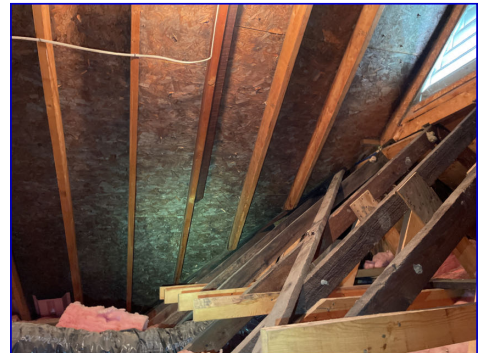
• **Monitor:** Evidence of condensation was observed on the underside of the roof sheathing. This can weaken the sheathing and ultimately necessitate replacement. Improved roof and attic ventilation (see [Insulation and Ventilation](#)) can reduce condensation. During re-roofing, the sheathing should be investigated to determine if replacement is needed.

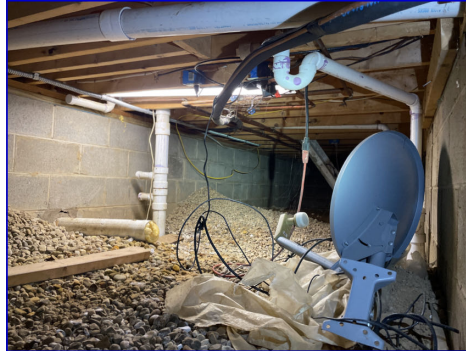
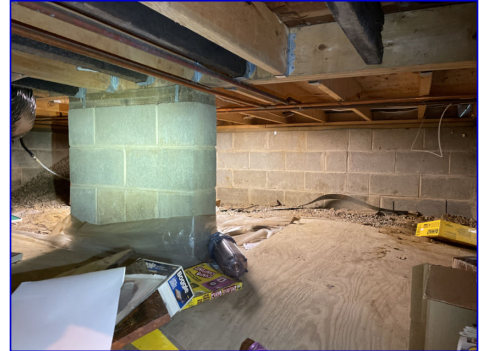
All wood debris and/or trash should be removed from the crawl space.

Page 13	Crawl space	<ul style="list-style-type: none"> • Repair: All wood debris and/or trash should be removed from the crawl space. Organic debris around a property increases risk of insect or rot damage.
Roofing		
Page 15	Roof flashing observation	<ul style="list-style-type: none"> • Repair/Replace: The flashing is rusting. It should be painted to extend its life. • Repair/Replace: The flashing is damaged and should be repaired to avoid leaks. • Repair/Replace: The flashing is loose and should be re-secured to avoid leaks. • Repair/Replace: The installation of the flashing is incomplete and should be repaired to avoid leaks.(Eastside at gable vent)
Exterior		
Page 17	Exterior wall observation	<ul style="list-style-type: none"> • Repair/Replace: The siding is damaged at (south) and should be repaired or replaced.
Page 19	Driveway observation	<ul style="list-style-type: none"> • Replace: The driveway surface is in a deteriorated condition. Resurfacing is necessary to correct this condition.

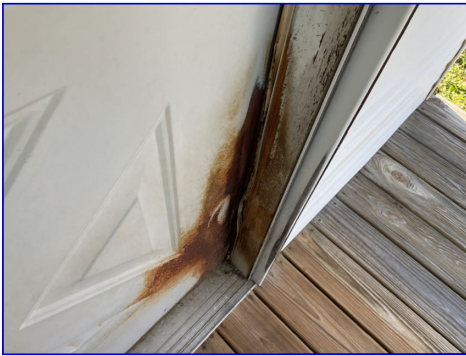
- Maintenance Item: The door frames require painting.

The door frames require painting.

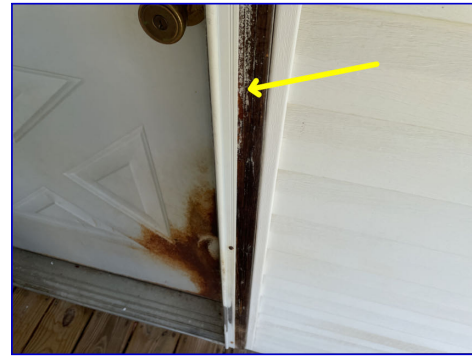
• Improve: Exterior doors are lacking maintenance and should be improved.

Exterior doors are lacking maintenance and should be improved.

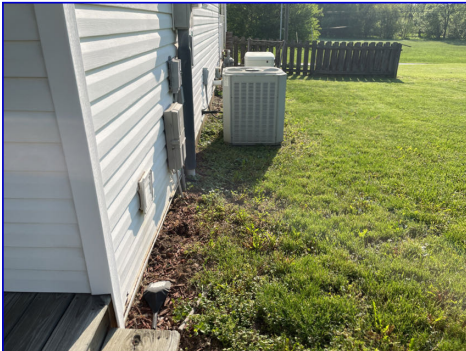
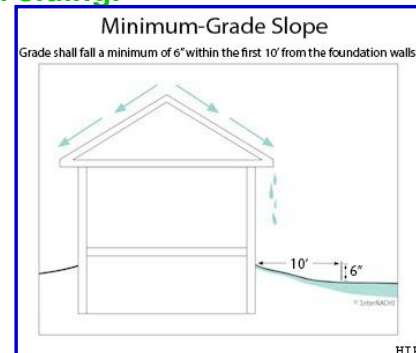
The grading should be improved to promote the flow of storm water away from the house.

- **Improve:** The grading should be improved to promote the flow of storm water away from the house. This can often be accomplished by the addition or re-grading of top soil. The ground should slope away from the house at a rate of one inch per foot for at least the first ten feet. At least eight (8) inches of clearance should be maintained between soil level and the bottom of exterior wall siding.

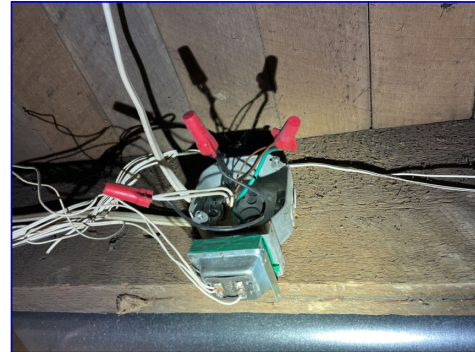
All junction boxes should be fitted with cover plates, in order to protect the wire connections (Basement).

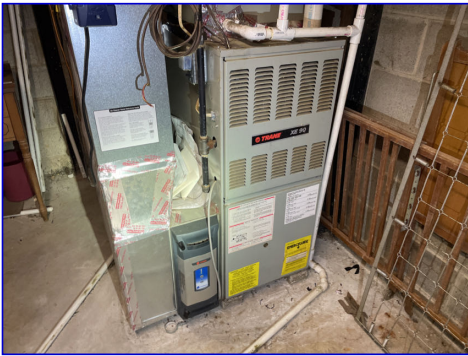
• **Repair:** The heating system requires servicing (did not respond to operating controls). This should be a regular maintenance item to assure safe, operation.

- **Repair:** The dirty air filter should be replaced.

1995 Trane furnace

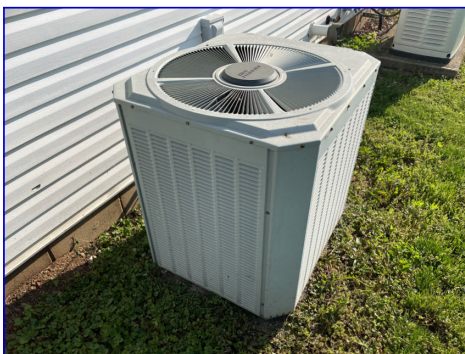
• **Repair: Damaged and or missing insulation on refrigerant lines should be repaired. These outside lines should be insulated all the way to the compressor unit to prevent loss of temperature in the lines.**

- **Repair: The outdoor unit of the air conditioning system requires cleaning.**

1995 Trane AC unit

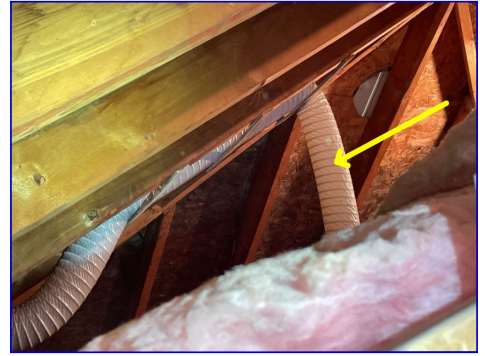
Consider wrapping shower vent duct in insulation to help prevent condensation forming in extreme cold temperatures.

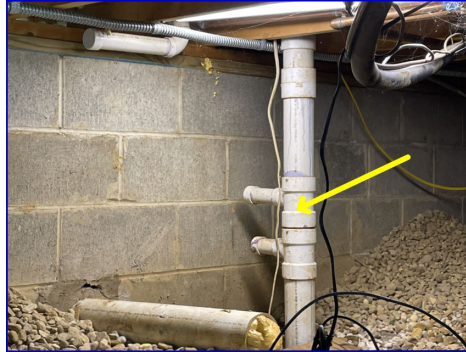
Main waste pipe observation

- **Monitor:** No clean out for the main drain was found. Clean outs are useful when attempting to remove obstructions within the drainage piping. It may be prudent to have a clean out installed now, or verify its location with the existing owner.

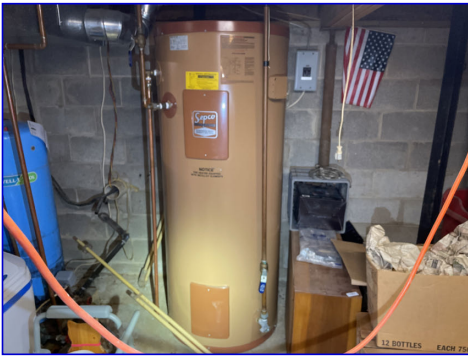
Water heater observation

- **Model number and serial number**
- **Water heater was working and no visible evidence of leaks at time of inspection.**
- **Deferred Cost Item:** The water heater is an old unit (27)that may be approaching the end of its useful life. It would be wise to budget for a new unit. One cannot predict with certainty when replacement will become necessary.
- **Maintenance Item:** It is recommended that the water heater be serviced. This is recommended by the manufacturer to help ensure safe, reliable operation of the appliance.
- **Water heater was rented. Recommend contacting the company it was rented through.**
- **Repair:** Wiring serving the electric water heater should be protected by a conduit.

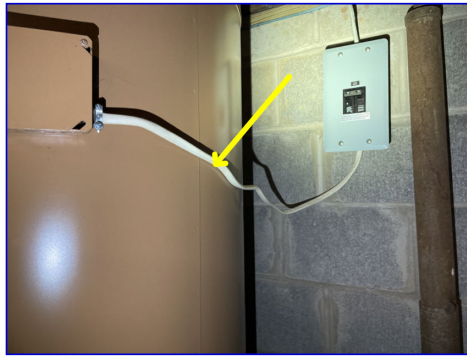
Wiring serving the electric water heater should be protected by a conduit.

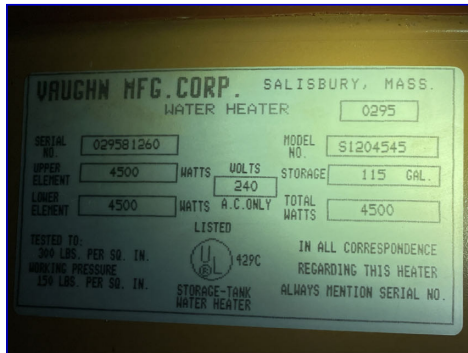
Water heater was working

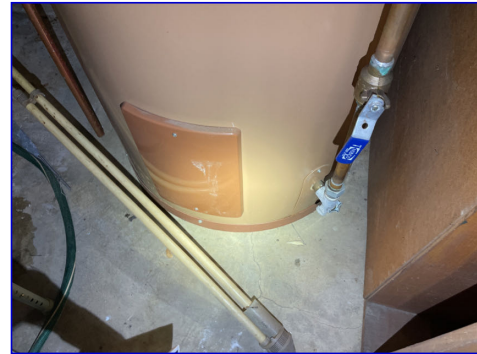
Model number and serial number

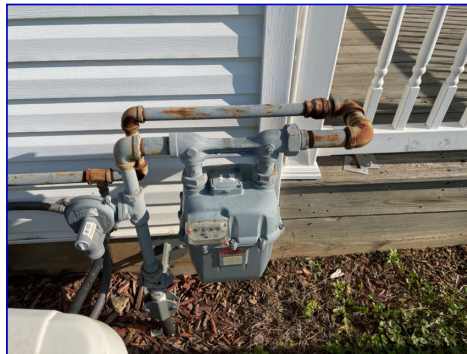
Fuel storage Natural Gas Main Valve At meter outside south wall

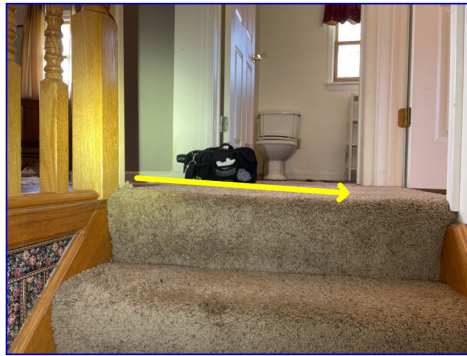
- **Monitor:** Floor slopes are apparent.

Floor slopes are apparent.

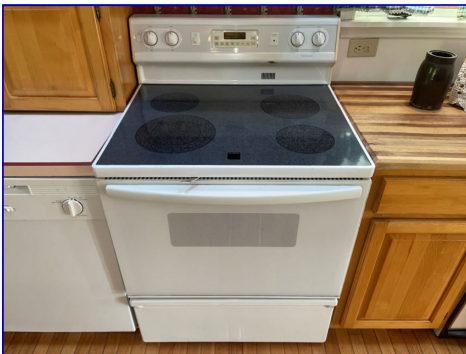
Range observation

- **Safety Issue: The range / stove is missing the anti tip device. This is a device that will prevent unit from tipping forward from small child or older adult putting additional weight on door when open.**

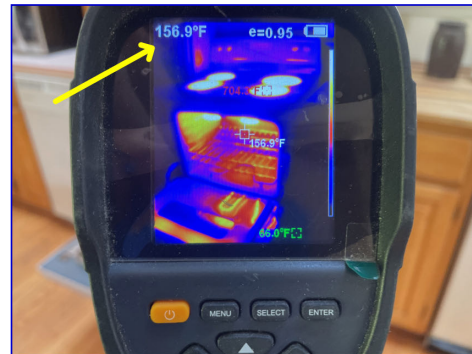
All burners and oven heating element were operational at time of inspection.

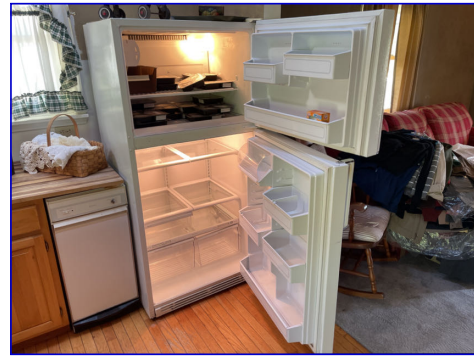
The refrigerator was functioning at the time of inspection.

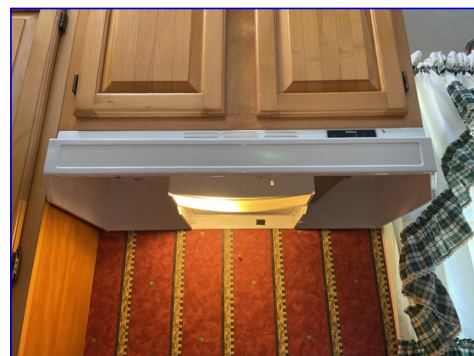
The kitchen exhaust hood operated
