Confidential Inspection Report
901 Elmwood Court
Bowling Green KY 42103

August 25, 2022

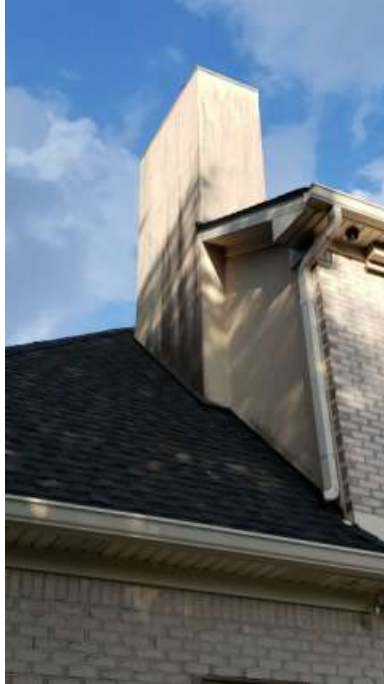
Chimney Exterior:

- ☒ ☐ Chimney is constructed of stucco materials. Observed portions of the chimney exterior appear serviceable at the time of inspection. The chimney was viewed from the ground with binoculars. This limits viewing and no comment can be made as to the possible condition of any portion of the chimney that is not visible from the ground with binoculars.

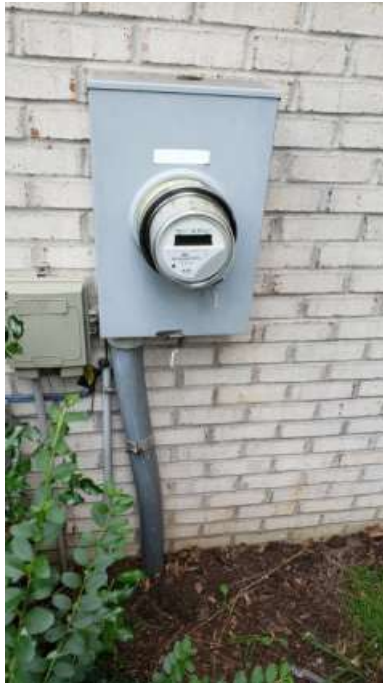
☒ ☐ Underground, 110/220 Volt, Circuit breakers, Appears serviceable.

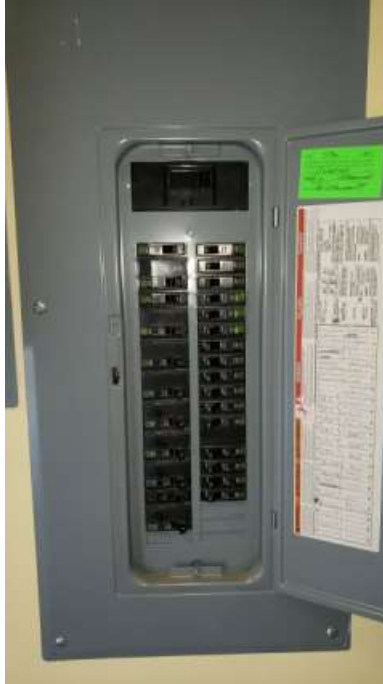
Main Panel Location:

☒ ☐ Garage.

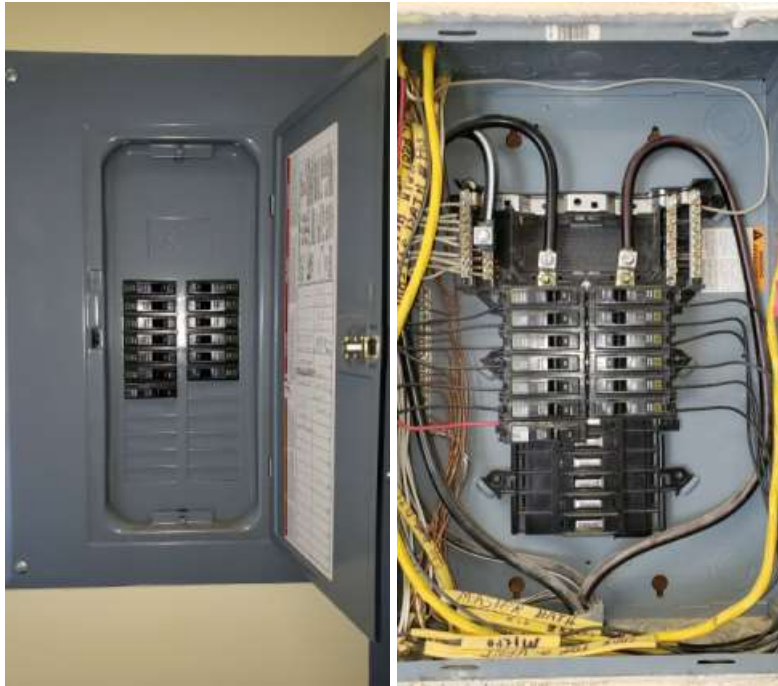
Subpanels- Garage:

The wiring in this subpanel appears serviceable at the time of inspection.

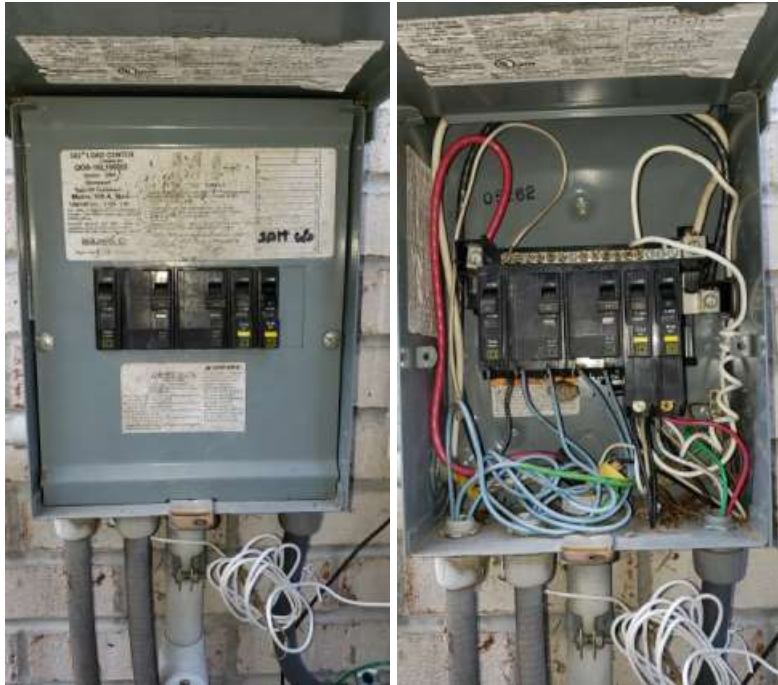
**Subpanels- Pool:**

The wiring in this subpanel appears serviceable at the time of inspection.

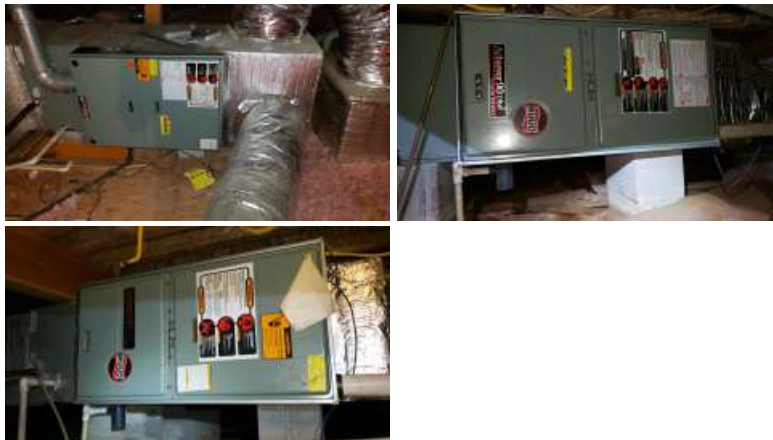
Type & Location:

There is a Ruud brand forced air furnace in the attic and two Ruud brand forced air furnaces in the crawlspace.

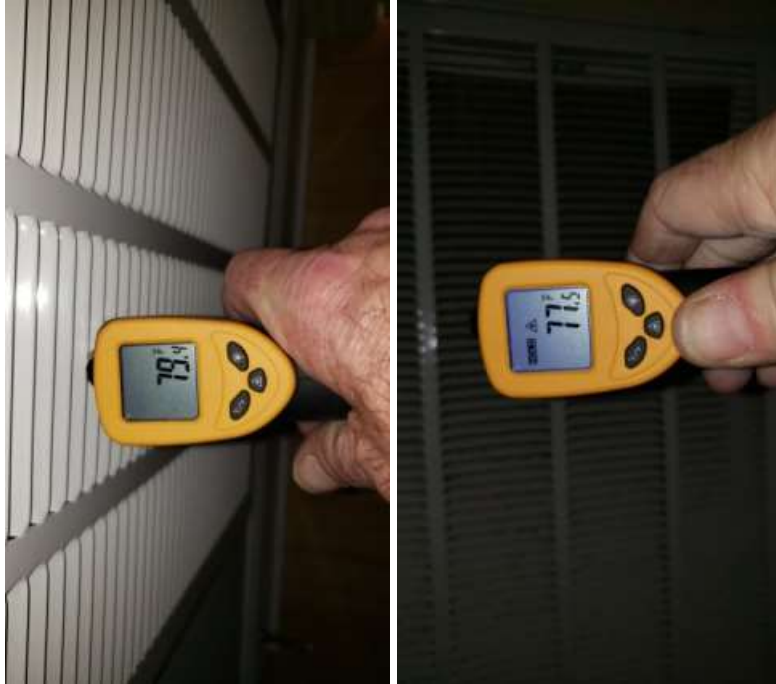
Return Air Temp:

Master Bedroom approximately 2 degrees. This is not within the acceptable range of between 14 and 22°. Further action will be recommended in a following portion of the report.

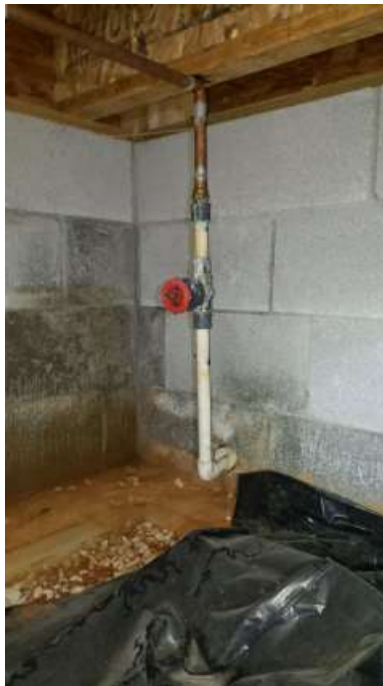
Shut Off:

The main shut off valve is located in the crawlspace near the front foundation wall. The valve was not tested or operated during the inspection.
