### Home Inspection Report

8883 Sam Snead Hwy, Hot Springs, VA 24445

Thursday March 2, 2023

16-03-2023

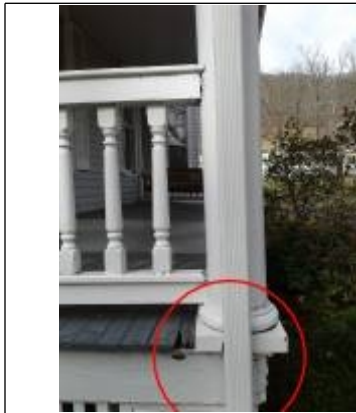
Post support damaged

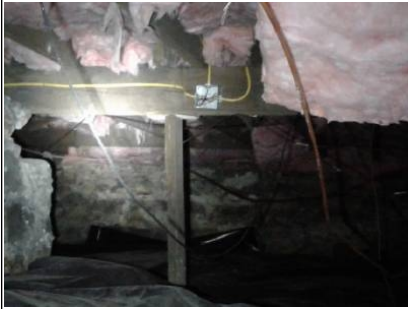
Post support installed

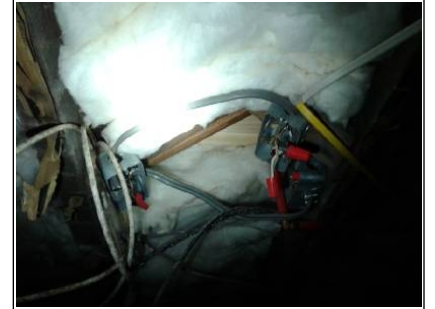
Open junction boxes

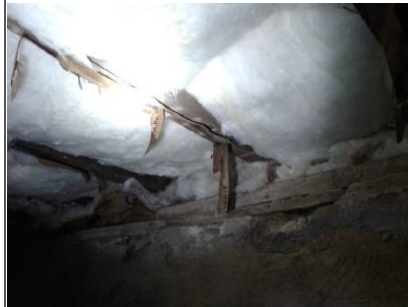
Sill not visible therefore no inspection possible to that area.

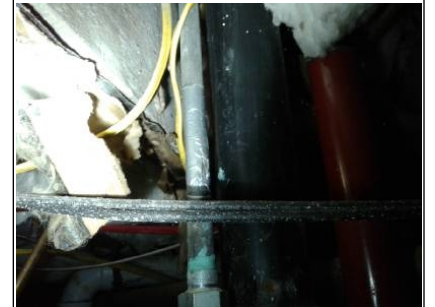
Tape on plumbing

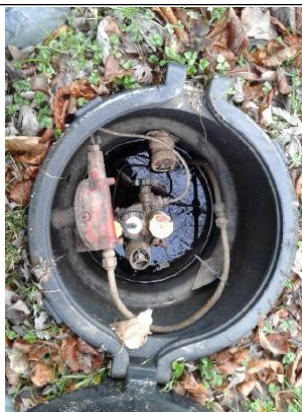
**Comments** Water in propane tank tank access. Recommend repair to reduce risk of moisture damage.

Water in access

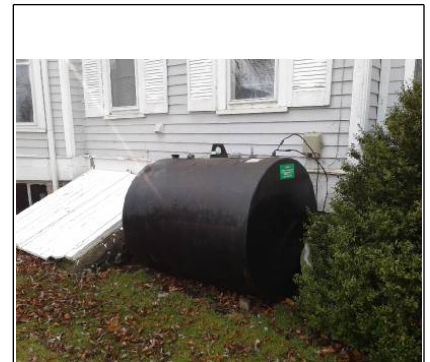
Not level. Oil line not secured
