THIRD GENERATION SUSPENSION UPGRADES: PART THREE

by Doug Leno

LET'S GET STARTED: PART THREE

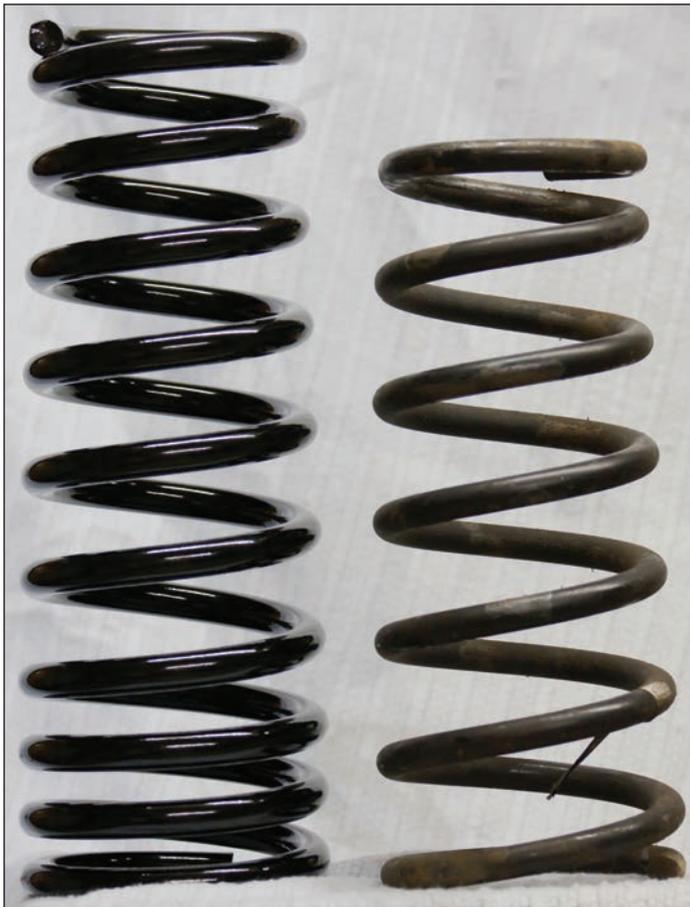
Figure 1: Carli Suspension multi-rate coil spring (left) installed in 2012, provided approximately three inches of lift compared to the factory spring (right)

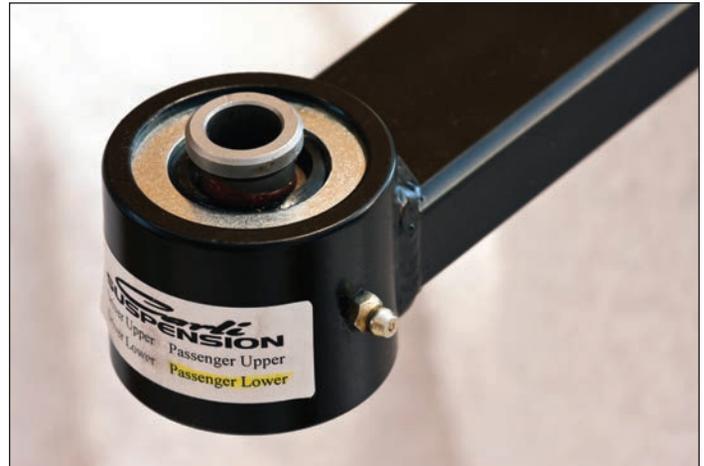
Figure 2: Carli suspension lower control arm, installed in 2012. The serviceable bearing eliminated the friction caused by the rubber bushings in the factory control arm.

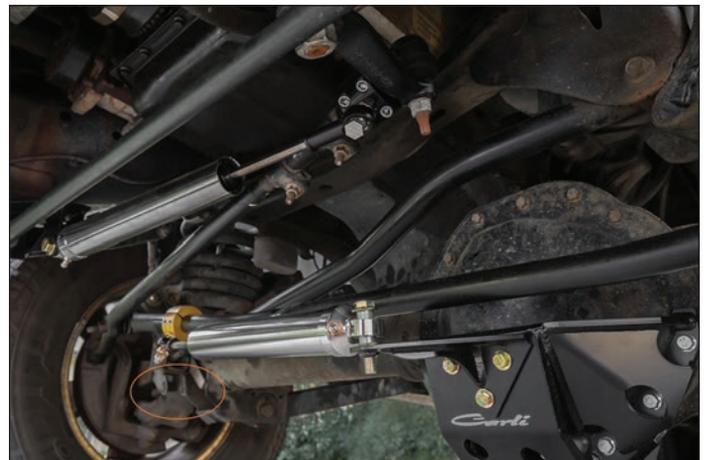
Part Two of the project was covered in February 2015, TDR Issue 87 (pages 13-17). In this article I described the Carli Suspension "dual-opposing steering stabilizer" solution. This upgrade greatly reduced the risk of stabilizer damage in off-road situations by locating both stabilizer bodies above the bottom of the axle tube (see figure 3).

Figure 3: My (Issue 87) Installation of the Carli Suspension "Dual opposing steering stabilizers." Without using the factory mount point, the lower stabilizer is located above the bottom of the axle tube, reducing the risk of damage in off-road situations.

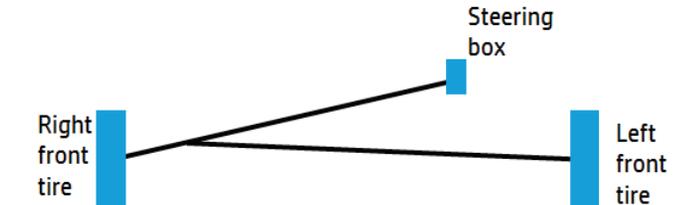
After 10 years and 150,000 miles, my factory steering system tie rod ends were showing the expected signs of deterioration and the wear produced some sloppy steering performance. To determine the repair, I first looked to see if there were any steering system recalls. I discovered "Safety Recall H46" which affected a small number of vehicles requiring a new drag link inner joint and/or pitman arm, but it turned out that this recall did not affect my vehicle. I was on my own for parts replacement.

Turbo Diesels from 2003 through the mid-2008 model year were manufactured with what is known as a "Y-type" steering system, illustrated in figure 4. In the illustration, note that the tie rod from the left front tire connects to the steering drag link, forming a "Y" configuration. Why is this important? Imagine, for example, that the steering box in Figure 4 moved upward. This action would pull the left and right steering knuckles closer together, causing the tires to "toe in" (pigeon-toed). Conversely, moving the steering box downward would push the steering knuckles farther apart, causing the tires to "toe out." The main point of interest for this geometry is that *suspension toe changes dynamically during normal vehicle operation.*

Figure 4: "Y-type" steering system supplied on 2003-2008 model year trucks. In this configuration, suspension toe changes dynamically during normal vehicle operation.

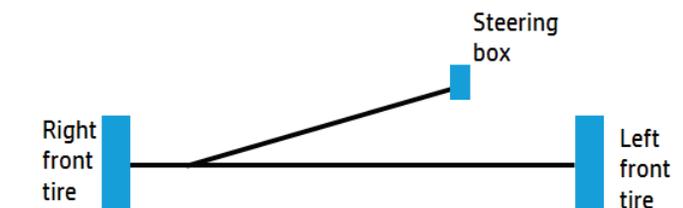
During the 2008 model year, Chrysler began to ship model 2500 and 3500 model Turbo Diesels with a different steering linkage geometry known as the "T-type", illustrated in figure 5. Note that for this geometry, the distance between the left and right steering knuckles is fixed, due to the rigid tie rod connecting the two together. *This means toe is not affected by suspension flex.*

Figure 5: During the 2008 model year, Chrysler introduced the "T-type" steering system, so named because the steering drag link "tees" into the steering tie rod. For this geometry, the distance between left and right steering knuckles remains fixed, keeping toe constant during suspension flex.

The "T-type" steering system, first introduced in 2008, presented an interesting option to me: Instead of repairing my 2004 steering system, why not upgrade my truck to the latest steering system?
