Southern

West Virginia Community and Technical College
www.southernwv.edu

Master Plan

May 5, 2014

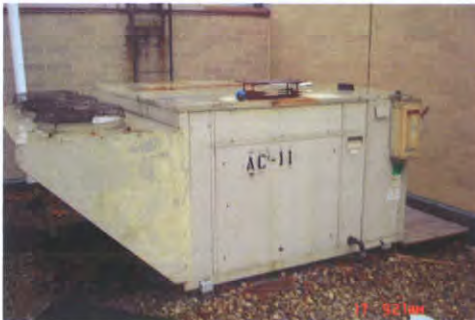
Existing Rooftop Air Handling Unit

This building is heated and cooled with a combination of rooftop air handling units, split dx systems, exterior wall unit ventilators and water-source heat pump units throughout the building. The rooftop units have dx-cooling coils and gas-fired heating coils. A Baltimore Air Coil cooling tower conditions the water for the water-source heat pump loop, and the pumps for the heat pump loop are in the adjacent Mechanical Room. Most of the equipment has reached the end of its service life. As heat pump units have failed, the maintenance staff has replaced them with similar units. Outside contractor performs water testing and chemical management of cooling tower and condenser loop water. Maintenance is performed by Logan Campus personnel.

3. A new HVAC system is needed that will replace the current equipment and provide ventilation air to all spaces: cooling would include the addition of a second air cooled chiller on the pad next to Building "B" in order to have a central chilled water system for the entire campus; heating would include the addition of high efficiency hot water boilers; airside systems would consist of variable volume air handling units with VAV boxes for individual spaces.

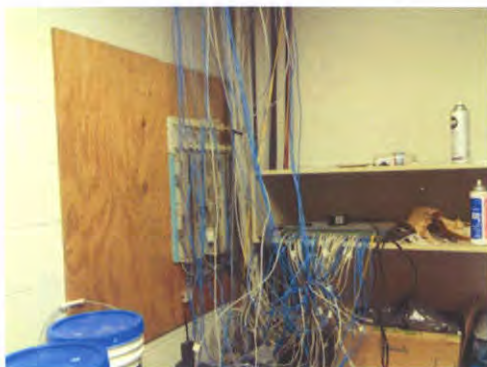
Data Cabling

1. A PONs fiber system is recommended for data and communications distributions to all the buildings on campus. This system would eliminate the need for large quantity data cabling and switching.

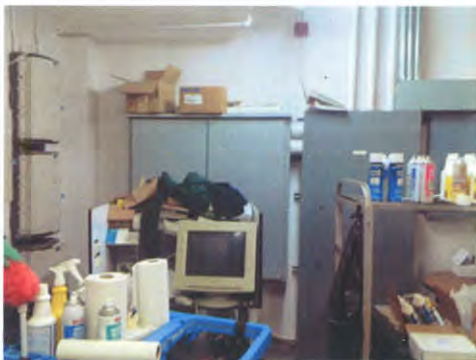
The electrical service for the building is fed underground to the building. The service coming into the building is 120/200 Amp 3 Phase service. The MDP (Main distribution panel) is in good condition with no notable damage. Panel schedules in the first floor Mechanical room are missing. The Mechanical room is very cluttered with storage items placed in front of the electrical panels (picture 1).

Storage in Front of Electrical Equipment

1. Confirm existing loads on panels and put new schedules together, place inside panels.
2. Remove all storage in front of electrical panels per NEC.
3. Replacement or repair of the elevator's hydraulic system is recommended.

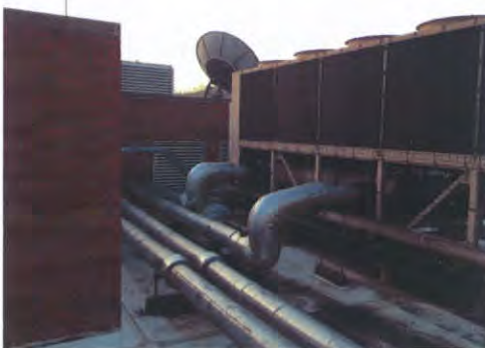
The 1978 addition is primarily served by AHU-1, a cooling-only Trane air handling unit in Mechanical Room 409. This air handling unit has a chilled water cooling coil. There is also a roof mounted unit, AHU-3, that

Rooftop Mechanical Equipment

served only the TV Studio but is no longer functioning. Throughout the 1978 Addition electric radiant heating panels have been installed in the ceiling.

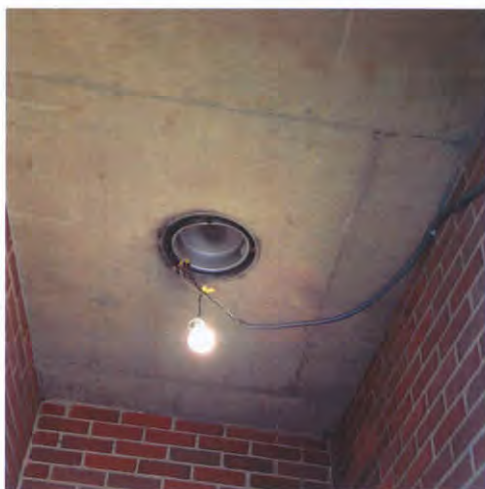
4th Level Open Stairwell Landing Lighting

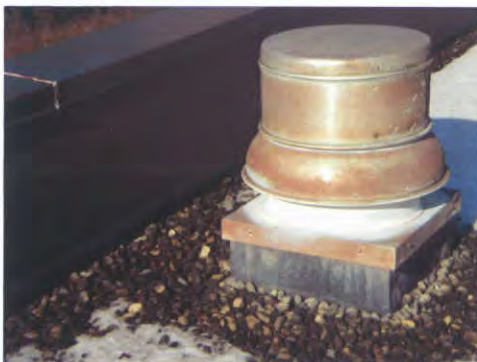
Exhaust Fan

All ductwork is provided with external wrap insulation. Fresh, outdoor ventilation air is provided by the rooftop mounted air handling unit (AHU). The chemical containment exhaust hood located in the Science Lab was exhausted by a roof mounted exhaust fan. The Lab chemical Prep rooms did not appear to have proper exhaust. Automatic gas shut-off valves were installed in the correct location. The AHU was replaced in 2009 and appears to be in very good condition. All exhaust fan are past their expected service life (15-20 years). Proper exhaust airflow is provided to toilet rooms and the custodian closet. Conditioned air is brought into the gang toilets by way of transfer grilles located in the corridor.

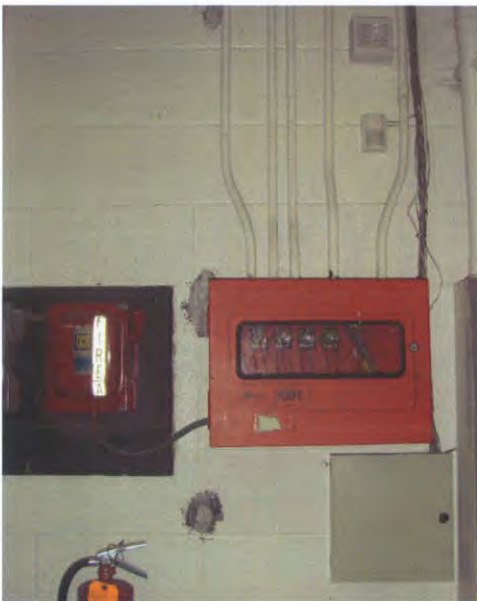
Fire Alarm Panel

Provide a new remote annunciator with zone indications and a school zone map mounted beside the annunciator.

2. Provide new horn/strobe devices.
3. Provide new manual fire alarm pull stations.
4. Provide new emergency lighting for path of egress integral to new lighting for both interior and exterior.

5. Provide and install additional emergency exit signs in corridors with directional arrows.
