Property Inspection Report: 11619 Dunlap

PROPERTY INSPECTION REPORT

Concerning: 11619 Dunlap
(Address or Other Identification of Inspected Property)

July 3, 2012
(Date)

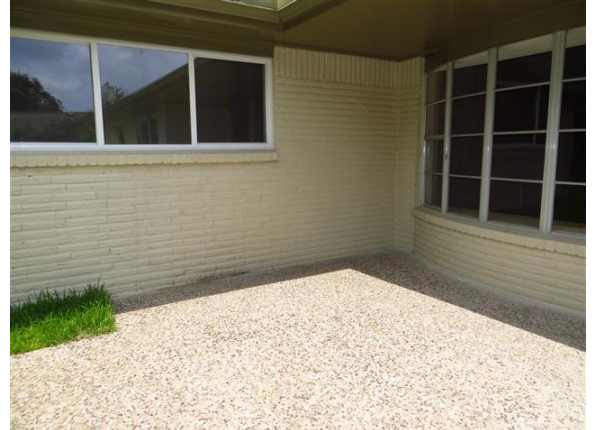
✖ Rear patio does not slope properly away from house and is or above interior floor elevation. Weep holes in brick wall are actually below the patio surface. This condition greatly increases the potential for water penetration during heavy wind-driven rains.

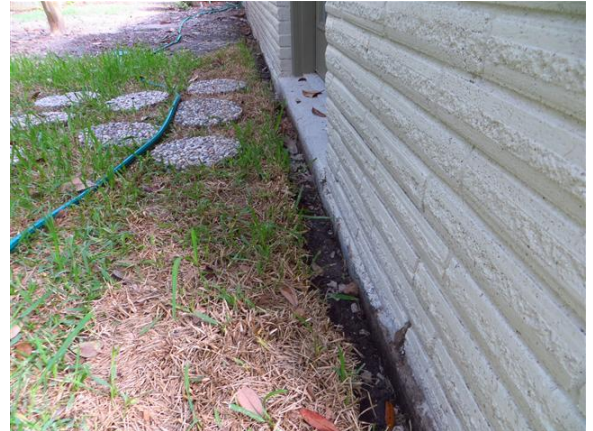
✘ Observed that soil has been trenched around some areas of house or garage foundation to maintain some foundation exposure (southeast). It is our experience that the soil soon fills up the trench resulting in soil at or above foundation, increasing potential for wood rot and/or water entry. Recommend lowering flower bed soil level several inches below level of foundation and carefully maintaining adequate foundation clearance above the soil line and proper slope to drain water away from the structure.

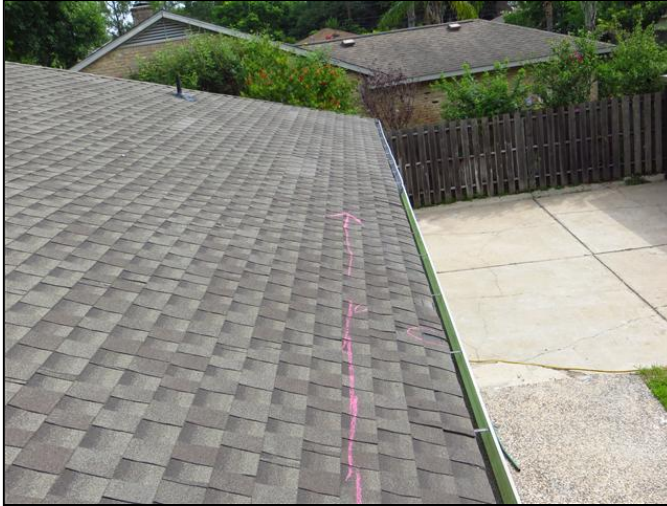
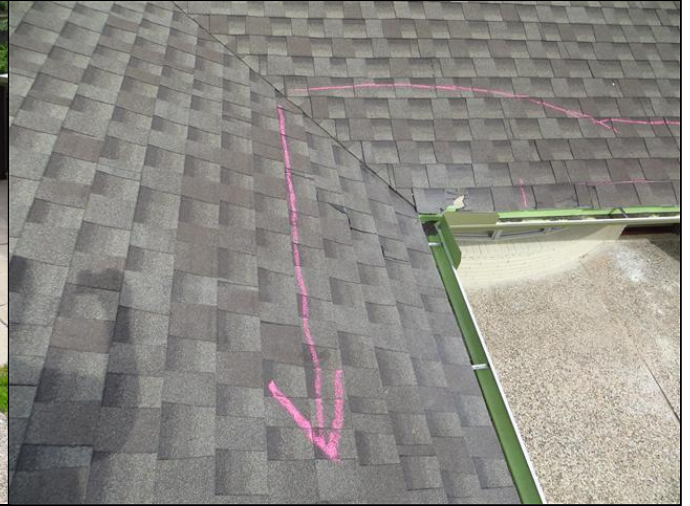
✂✂ Random inspection for proper installation of felt below shingles revealed no felt paper below the shingles. This installation does not comply with the manufacturer's installation standards or Asphalt Roofing Manufacturers Association recommended practices.

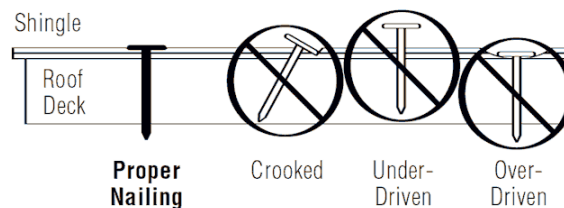
✂✂✂ Spot check of roof fasteners (e.g., nails, etc.) indicated improper roof fastener installation. Fasteners appear to be over driven and / or driven at an angle which causes the nail to cut into the shingle and substantially reduces the shingle's ability to remain secured during high winds. Some shingles show full tear through of nail heads and are not secured to the roof. Some show signs of slippage down the roof surface at rear.

Proper and improper nailing.

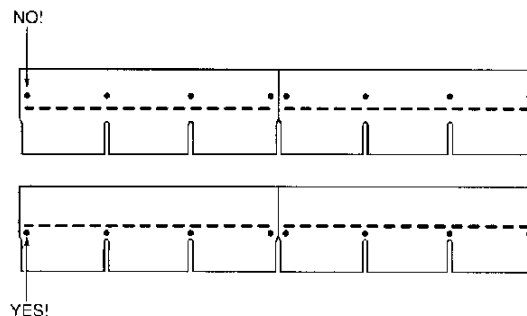
✂ Spot check of roof fasteners (e.g., nails, etc.) indicated some shingles have improper roof fastener placement. Observed high nailing (i.e., nailing above or through the line of the sealant strip).

High nailing: prohibited!

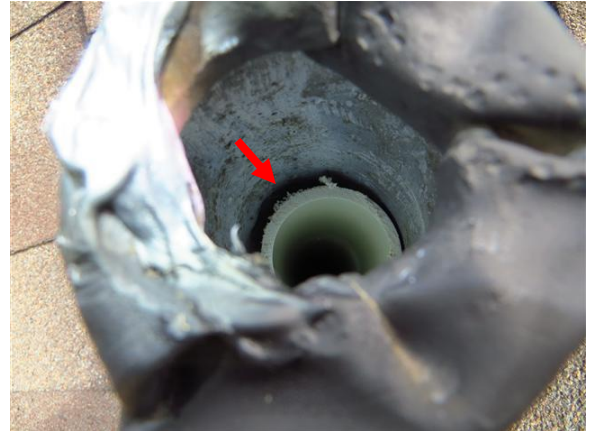
✖ Flashing of some plumbing vents are not properly rolled down interior of plumbing vent pipes and/or are damaged by squirrels, may allow rain water entry.

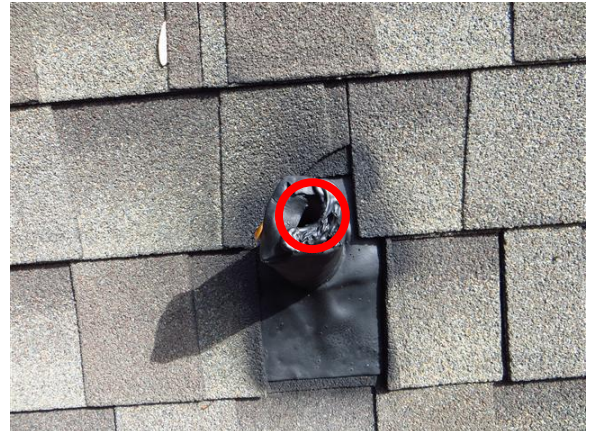
✖ Lead flashing improperly rolled down on plumbing vents. Flashing should not obstruct vent pipe.

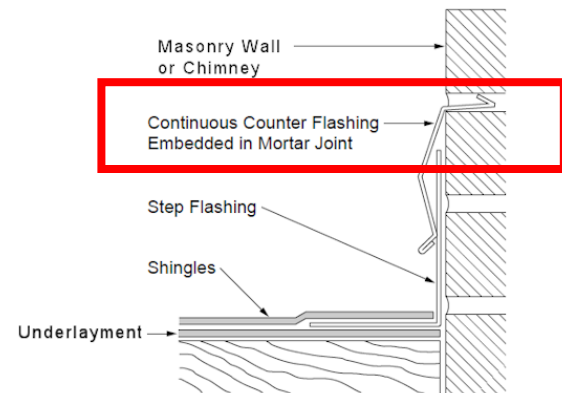
✖✖✖ Counterflashing is inadequately sealed, pulling away or missing from masonry chimney or wall. Counterflashing should be let-into into the brick or masonry a approximately 1¼ inches with and bead of high quality caulk placed along the top edge of the flange to keep water out. Surface application of flashing is an inferior method which depends entirely on the caulk joint to keep water from penetrating behind the flashing,

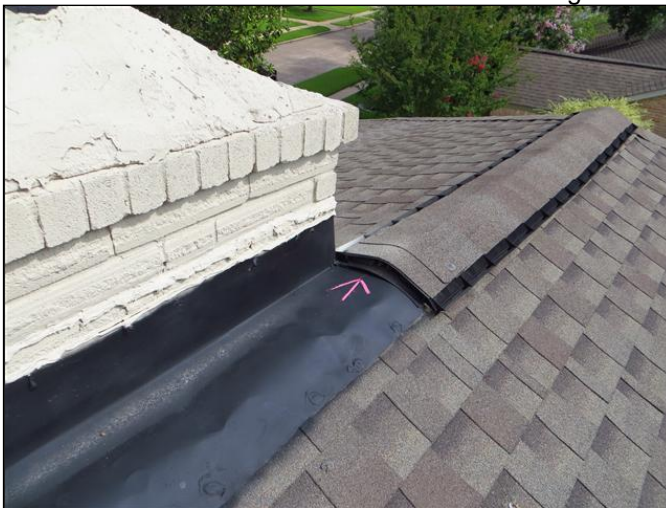
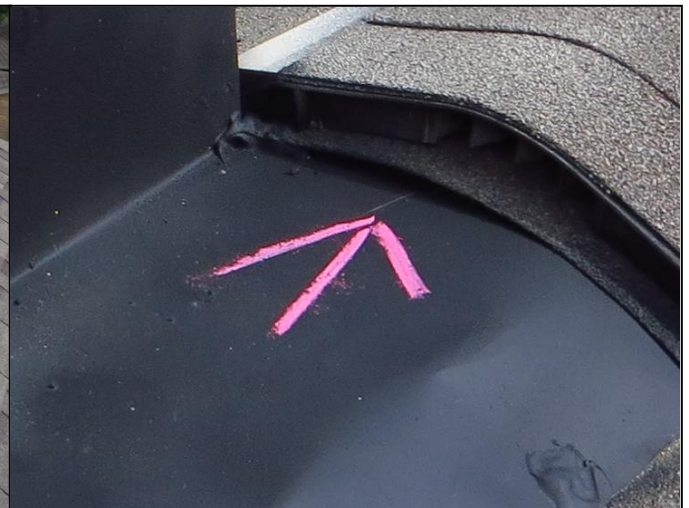
✖ Chimney flashing spanning the roof ridge has potential to direct water in to the roof under the ridge vent.

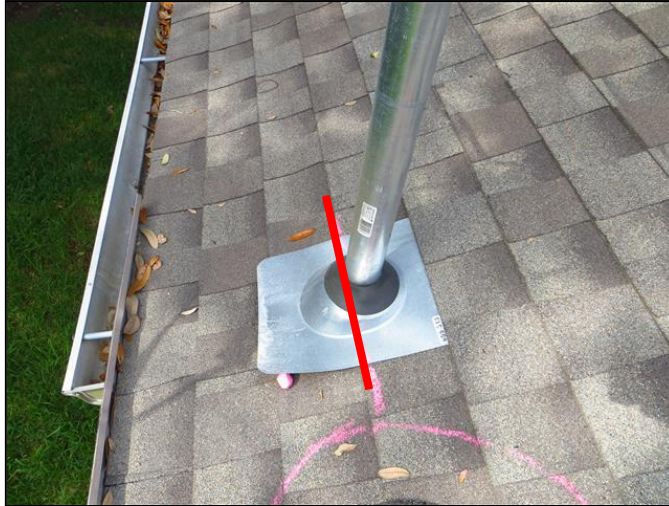
✂ Roof jack for electrical service mast is not installed properly, not interwoven into shingles and lower flange not secure.

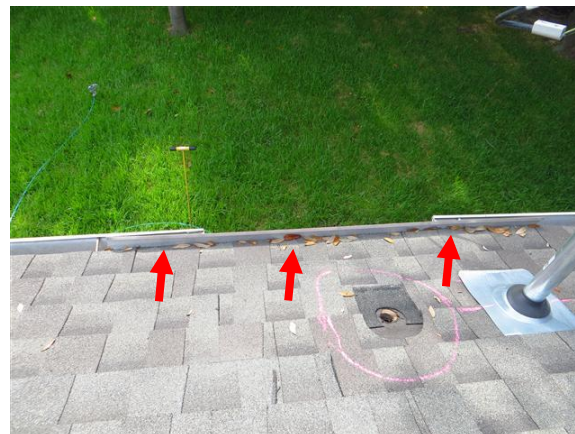
✂ Gutters are in need of general maintenance such as: cleaning out debris; re-securing gutters to fascia; tilting gutters toward drains, sealing leaks, etc.

Recommend removal of roof dams/deflectors and replacement with proper gutters. Roof dams trap debris, disrupt the natural flow of water off of the roof and increase the potential for water to seep back under shingles.

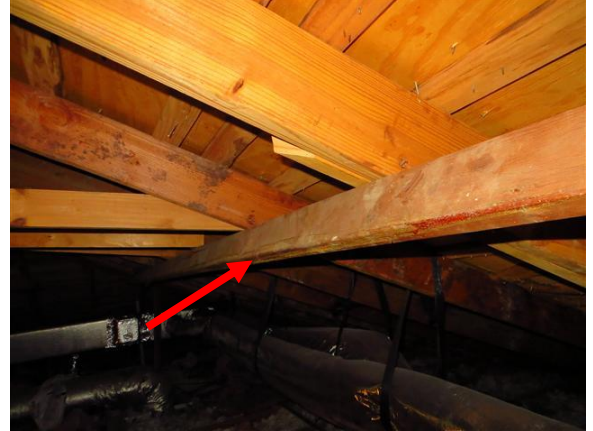
Observed purlin (roof bracing) of improper / inadequate size and/or not installed on strength axis in attic, needs repair by installing 2x6 purlins with bracing down to load bearing walls to arrest further movement/sagging of roof.

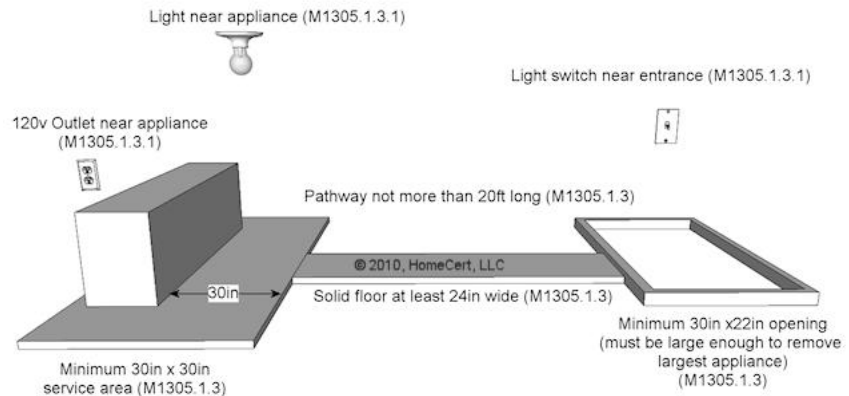
✘ Attic service passageway and/or platform to mechanical equipment do not meet building standards. IRC §M1305.1.3 specifies that attics containing appliances shall have an opening not less than 22in x 30in, a clear unobstructed passageway with solid flooring at least 24in wide and not more than 20ft long; a work area not less than 30in wide by 30in deep in front of all sides of appliances where access is required. IRC §M1305.1.3.1 stipulates that a light fixture with a switch at the required passageway opening and a receptacle outlet will be provided near the appliance.

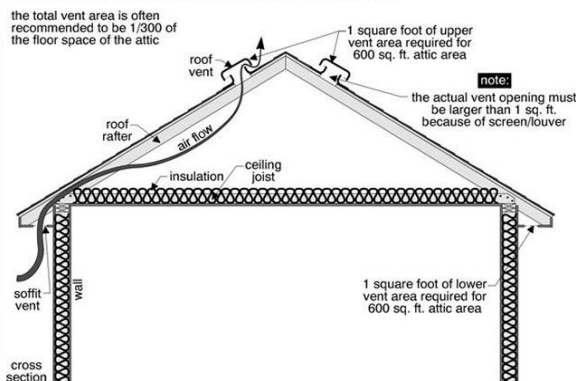
The inspector observed a total of approximately 10 linear feet of attic vent on an estimated 2800 square foot attic. In order to achieve the minimum ratio of 1:600 NFVA (Net Free Ventilated Area) to attic area, AirVent Inc. specifies that a minimum of 45 linear feet would be needed.

It is the inspector's opinion that due to the design of the roof, there is not enough ridge to adequately ventilate the attic using ridge vents (Note: ridge vents should not be mixed with other types of vents, such as static or power vents on the same roof)

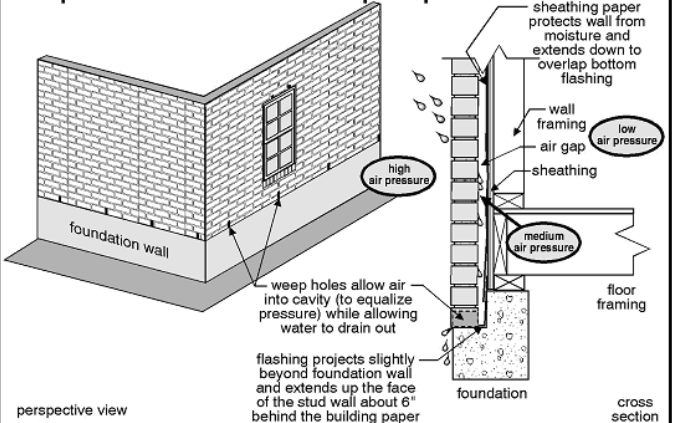
👁 Exterior bricks are painted. Paint can hide brick cracks very effectively.

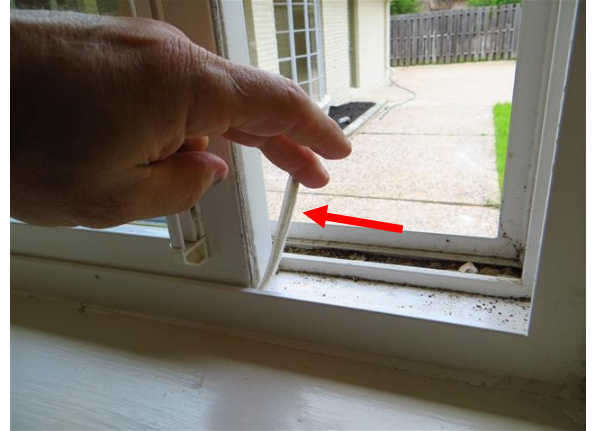
Weather stripping damaged / defective at several windows.

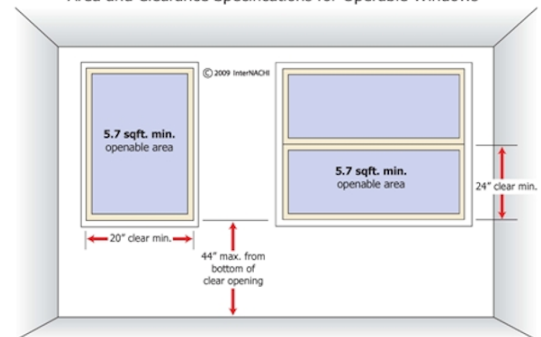
Observed one or more bedrooms having window(s) with sill height greater than 44 inches above floor and/or having less than a minimum opening area of 5 square feet which is considered difficult to maneuver through if used as emergency egress in case of fire. Ref IRC R310.1.

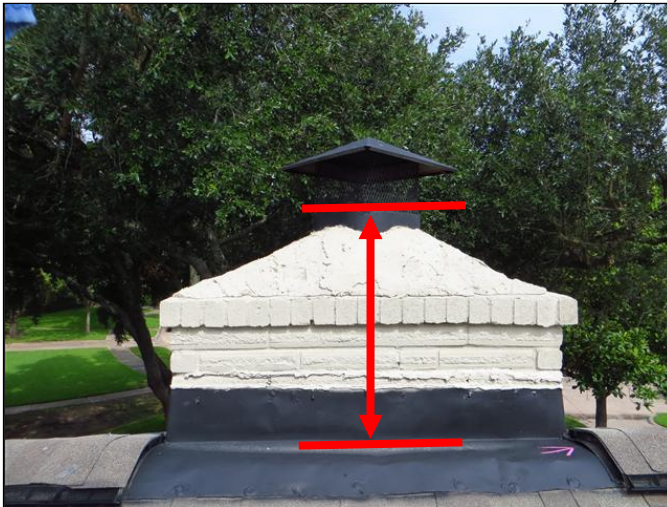
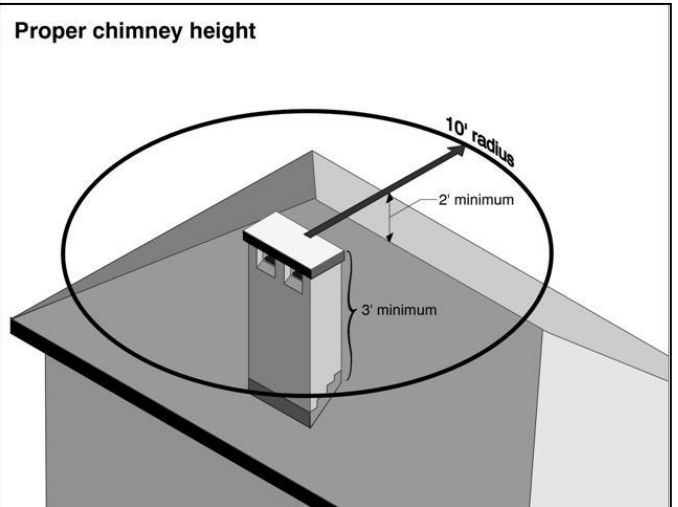
✘ Chimney height does not appear adequate per current industry standards to ensure proper draft of fireplace. Chimneys shall extend at least 2 feet higher than any portion of a building within 10 feet but shall not be less than 3 feet above the highest point where the chimney passes through the roof. (Ref: IRC 2003 Section R1001.6 Termination).

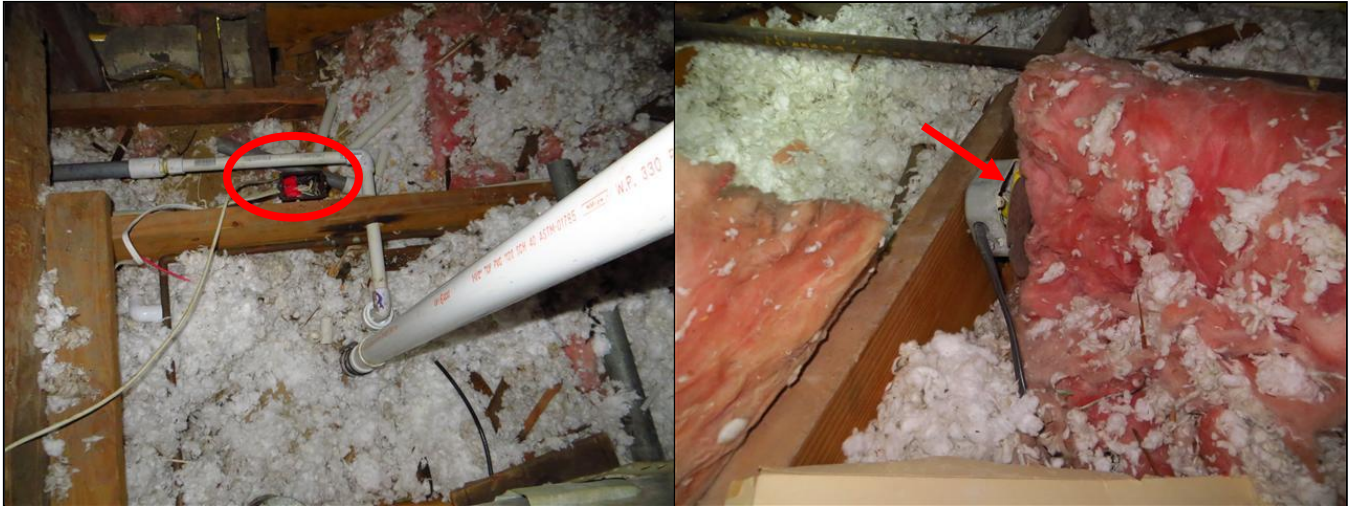
Wire connections are not enclosed in proper electrical junction box(s), or electrical junction box(s) do not have covers in place, including but not limited to attic.

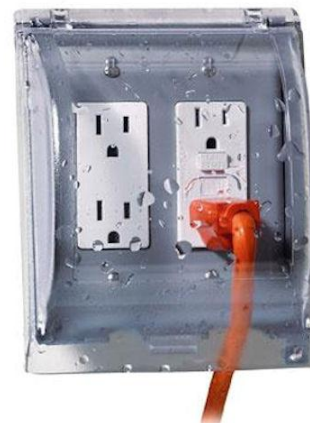
✘ Exterior outlet installed in "wet location" missing proper cover that remains weather tight when a cord/plug is connected. (Ref: NEC Article 406.8 Receptacles in Damp or Wet Locations, (B) Receptacles in Wet Locations). (1) 15 and 20A Receptacles. All 15 and 20A 125V and 250V receptacles installed in a wet location must be within an enclosure that is weatherproof even when an attachment plug is inserted.

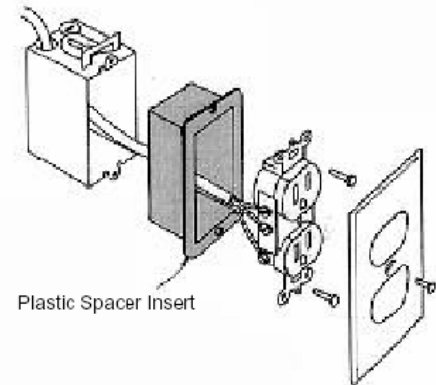
Space between face plate and edge of electrical junction box exceeds ¼ inch allowable by current building standards. Missing required spacer (spark ring) on kitchen / bath counter top outlets and switches with tile back splash. (Ref: NEC Article 314.20 In Wall or Ceiling). *In walls or ceilings with a surface of concrete, tile, gypsum, plaster, or other noncombustible material, boxes employing a flush-type cover or faceplate shall be installed so that the front edge of the box, plaster ring, extension ring, or listed extender will not be set back of the finished surface more than ¼ in.*

Also, receptacles shall be mounted so that the mounting yoke is held rigidly at the finished surface (Ref: NEC Article 406.4(A) Boxes that are set back). *Receptacles mounted in boxes that are set back from the finished surface as permitted in 314.20 shall be installed such that the mounting yoke or strap of the receptacle is held rigidly at the finished surface.*

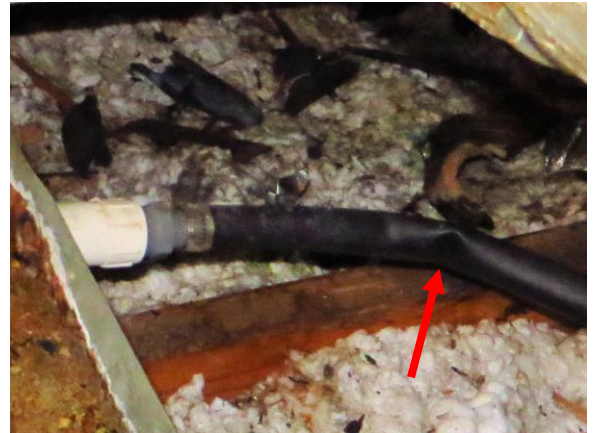
✘ Secondary drain line is kinked.

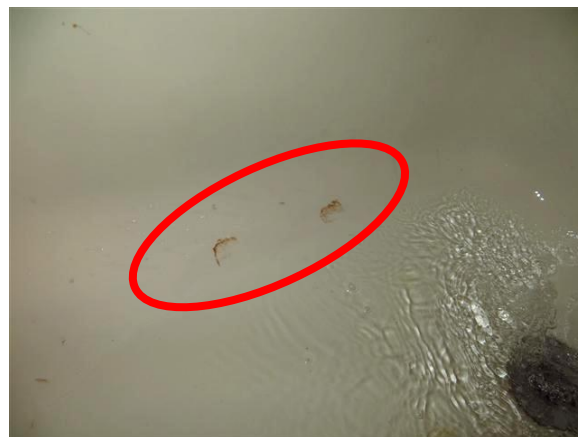
✘ Porcelain damaged/chipped on steel tub in hall bath.

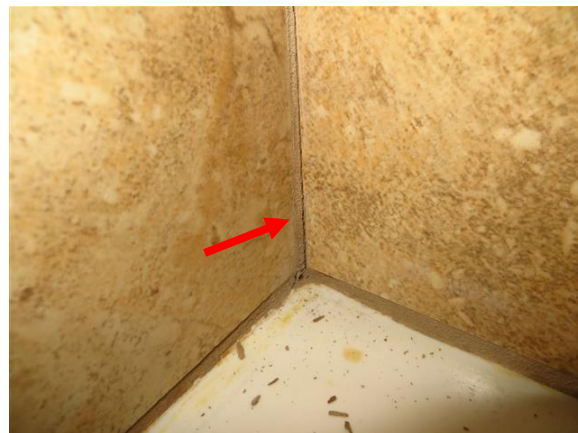
✘ Caulking needed at vertical tile corners, cracks in tile and/or grout between tiles, and where tile meets tub to prevent water entry behind wall.

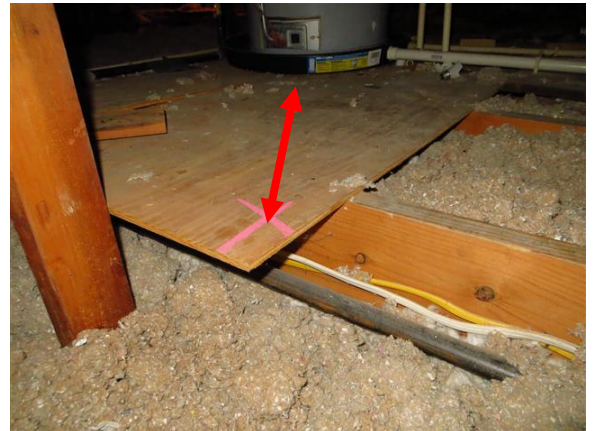
🔧+ 400+ pound water heater is inadequately supported on thin plywood that is not rated for use as flooring. Unit rocks easily due to flexing of the plywood.

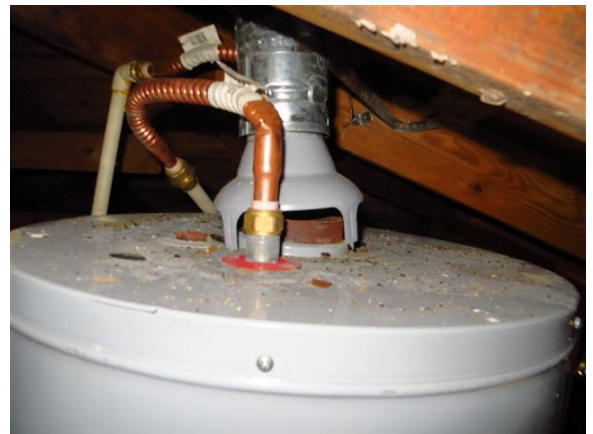
✖ Water heater does not appear to be installed per manufacturer's instructions regarding clearance on top of unit from combustible wood framing and roof decking. Most models from most manufacturer's specify minimum 12 inches clearance at the top.

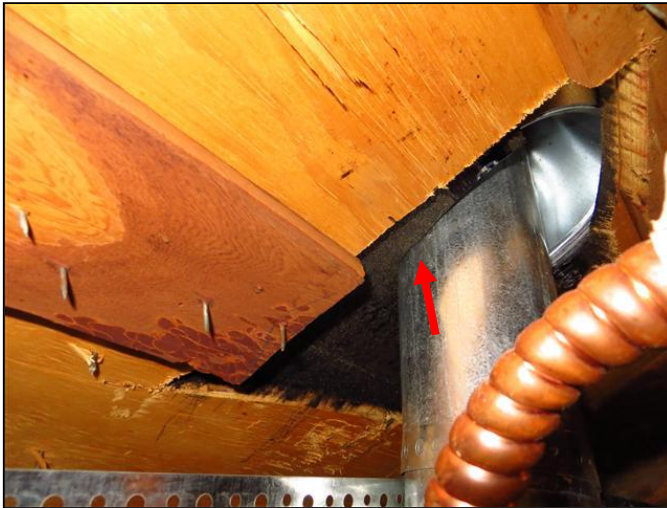
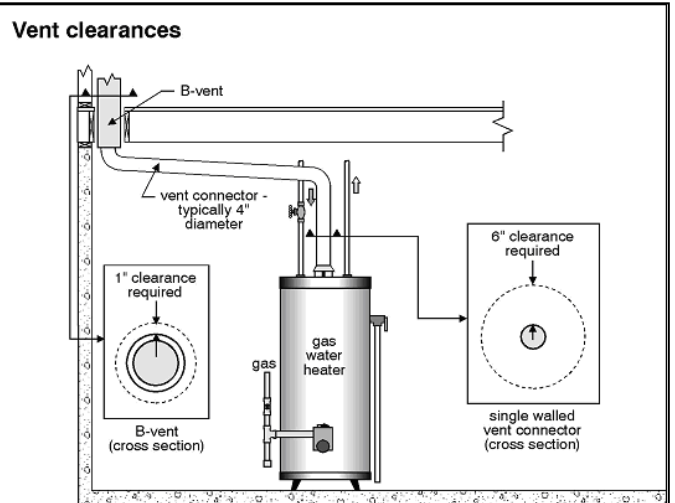
**Exhaust vent pipe is in contact or does not have required minimum 1" clearance from combustible material.**

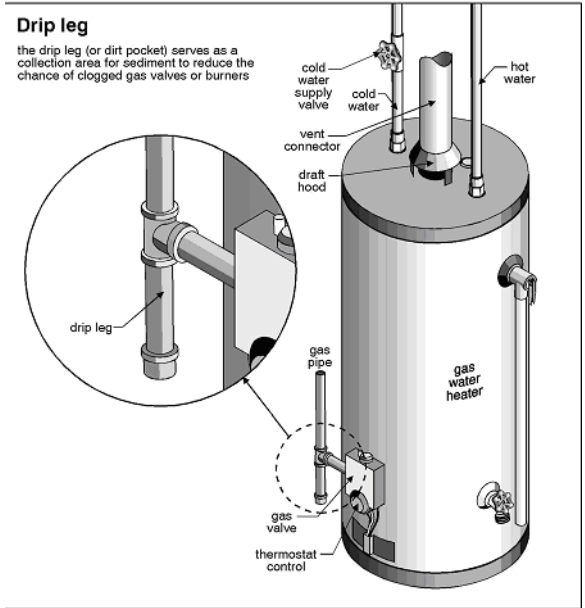
✘ Missing or improperly configured gas line drip legs on gas house heater and/or gas water heaters. (Ref: IRC Section G2419.4 (408.4) Sediment trap) *Where a sediment trap is not incorporated as part of the appliance, a sediment trap shall be installed downstream of the appliance shutoff valve as close to the inlet of the appliance as practical. The sediment trap shall be either a tee fitting having a capped nipple of any length installed vertically in the bottom-most opening of the tee or other device approved as an effective sediment trap. Illuminating appliances, ranges, clothes dryers and outdoor grills need not be so equipped.*

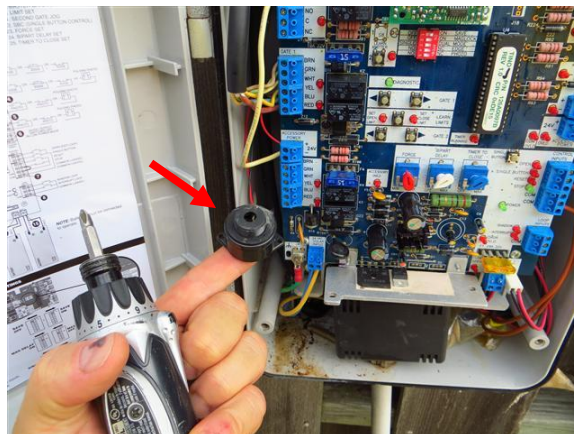
✘ Sensor or button not secure in gate controller.

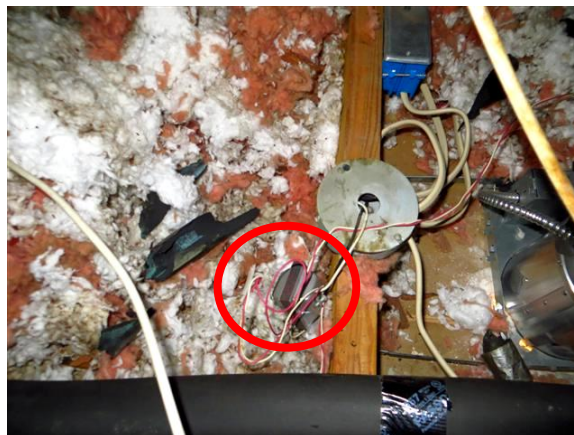
✘ Transformer hanging by wiring in attic.
