Performance of Concrete Pavements

Volume I: Field Investigation

PUBLICATION NO. FHWA-RD-94-177

JULY 1997

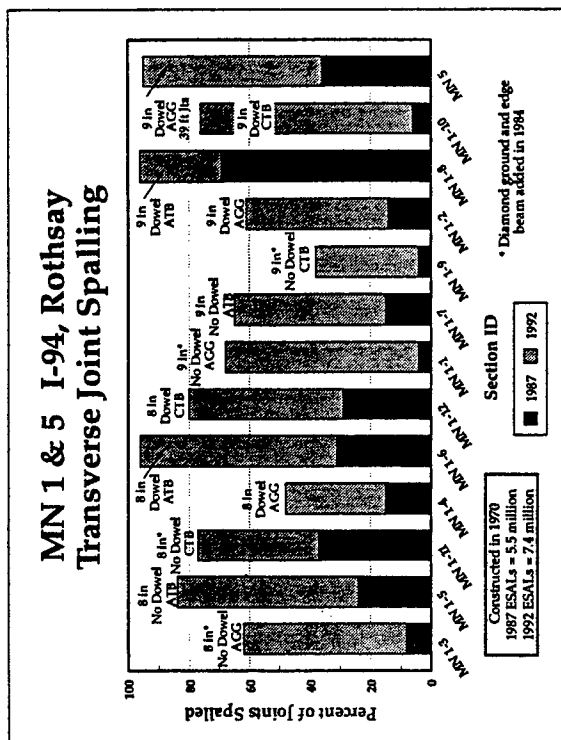
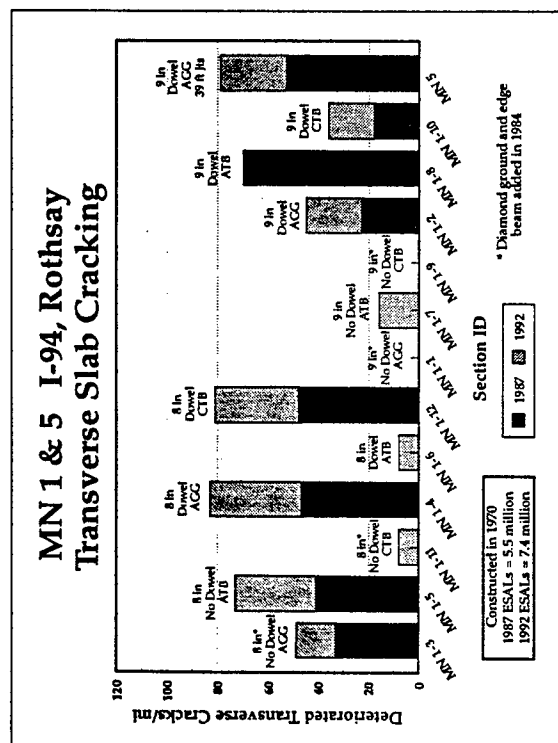
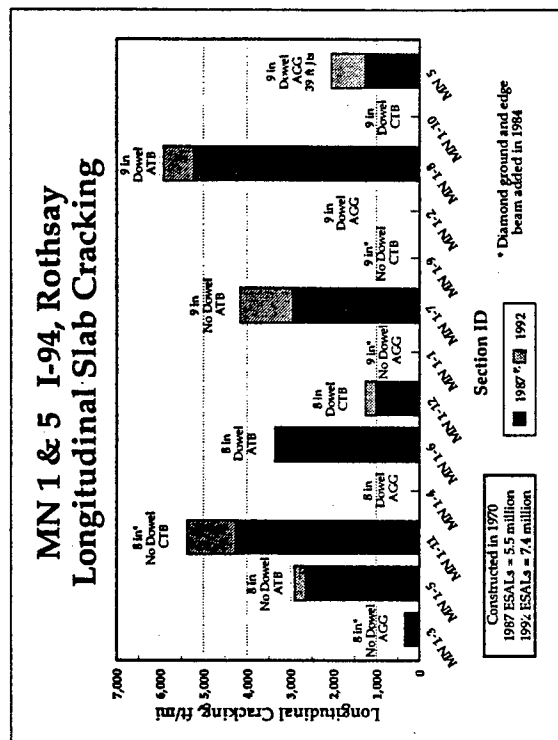
Figure 9. Performance summary for MN 1 & 5.

The 1992 data indicate, as did the 1987 data, that the sections constructed on the ATB developed a significant amount of longitudinal cracking, while the sections constructed on the AGG base display very little longitudinal cracking. This finding is confirmed by the replicate sections surveyed in the eastbound direction in 1992. In addition, nearly 90 percent of the joints on the sections constructed on the ATB exhibit joint spalling, whereas less than 50 percent of the joints on the CTB or on the AGG sections exhibit joint spalling. However, for a given method of load transfer, there are no discernible differences in joint faulting between the sections constructed on the different base types.

However, several of the doweled sections developed significant faulting, which is attributed to the small diameter of the dowel bars. Furthermore, many of the doweled sections exhibit more transverse cracking and joint spalling than the nondoweled sections, as shown in table 7 and figure 9. This phenomenon is probably due to corrosion of the noncoated dowel bars, which can lead to the transverse joint locking up, which creates tremendous forces in the slab that either spall the joint or open mid-slab cracks.

The effect of slab thickness is not readily apparent from an examination of table 7 or figure 9. The increased slab thickness appears to reduce spalling, faulting, and cracking for the nondoweled pavement sections, although it does not appear to provide those benefits for the doweled sections. This again suggests that the dowels may be contributing to joint spalling and crack deterioration, perhaps due to their corroding and locking up the joint.

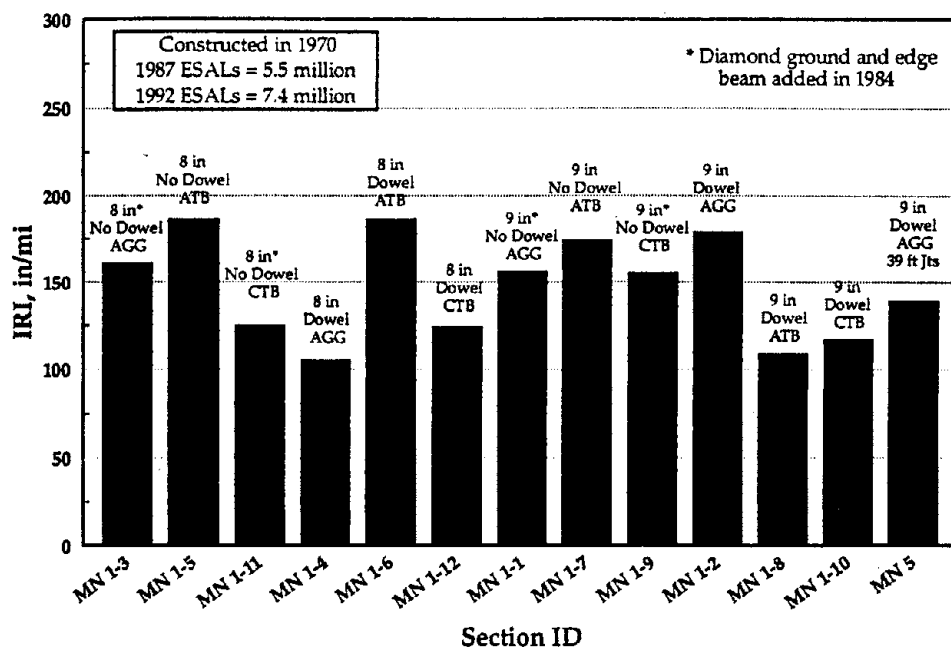
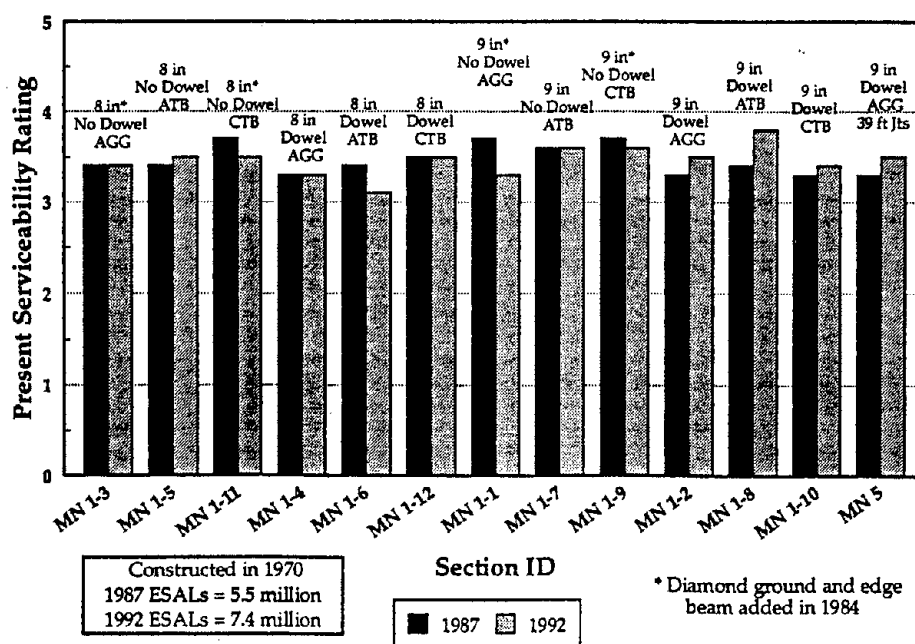
Figure 10. Roughness and serviceability for MN 1 & 5.

Pavement roughness and serviceability for these sections are given in figure 10. This figure shows that most of the sections are of about the same smoothness and serviceability level. Many of these are at or near critical levels in terms of IRI. Notable exceptions are MN 1-5, MN 1-4, MN 1-12, MN 1-8, and MN 1-10, all of which (except MN 1-5) contain dowel bars.

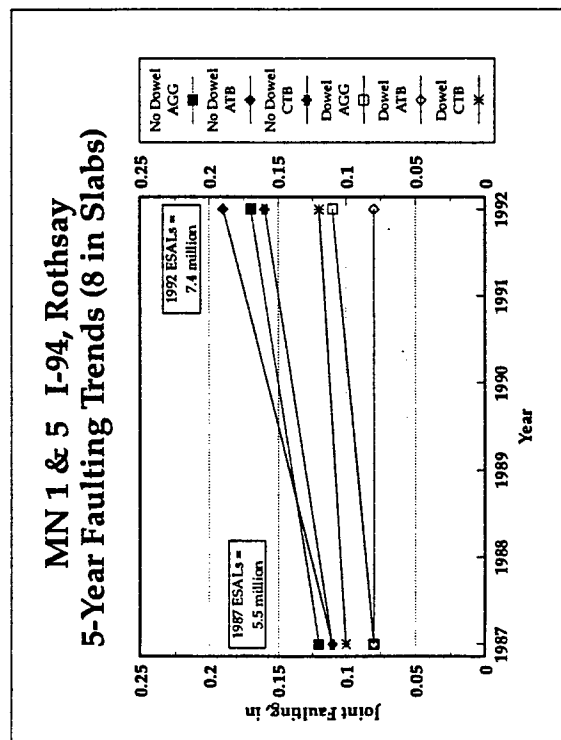
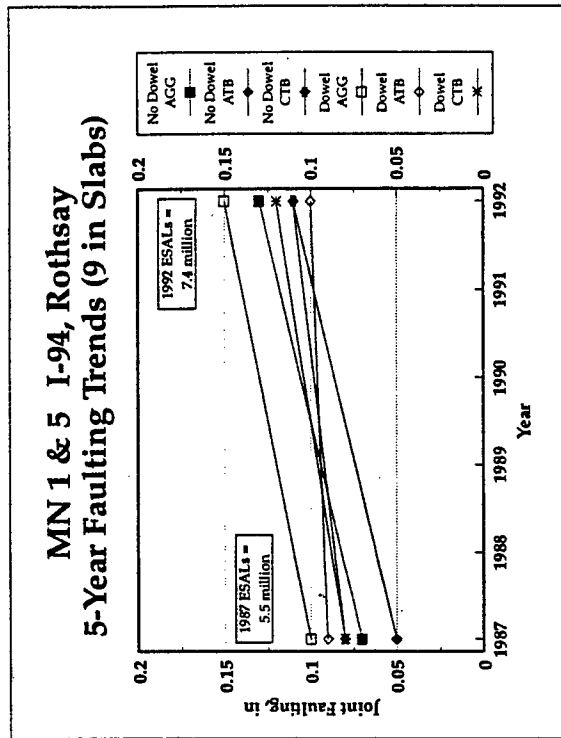
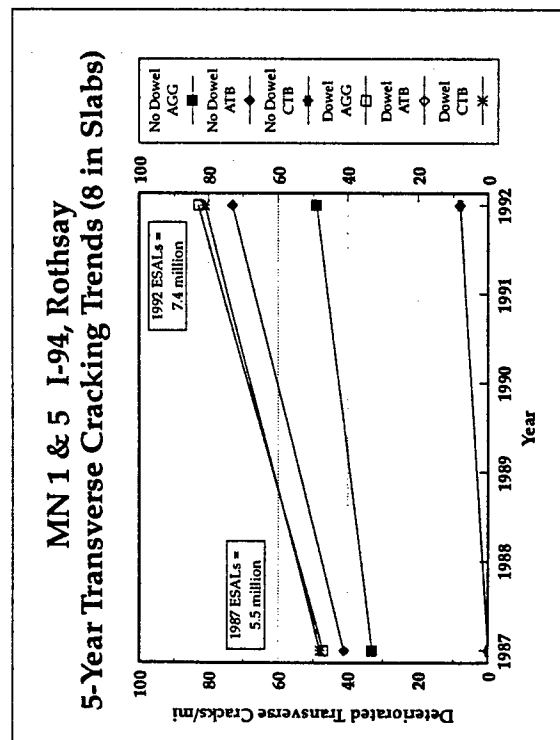
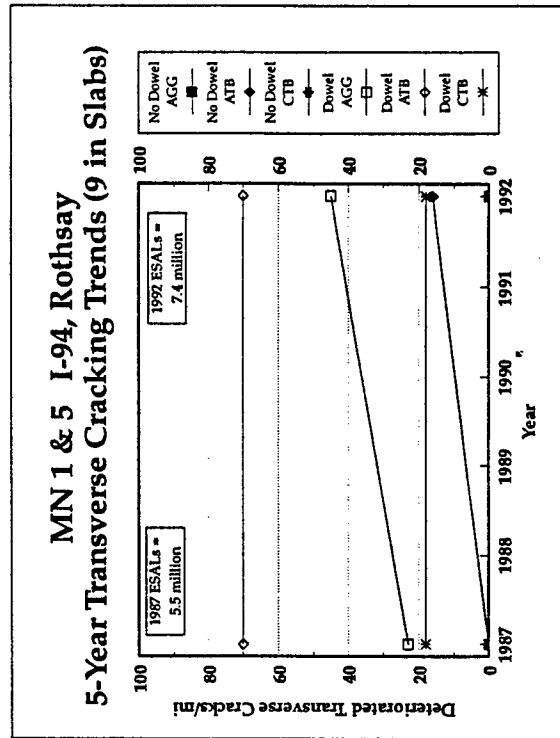
Figure 11. Faulting and transverse cracking 5-year performance trends for MN 1 & 5.

The performance of the sections from the 1987 surveys to the 1992 surveys follows a logical trend in that increased levels of deterioration are observed. Figure 11 provides 5-year performance trends for joint faulting and transverse cracking, broken out by 8- and 9-in (203- and 229-mm) slabs. This figure shows that faulting on doweled sections is increasing at a lower rate than faulting for nondoweled sections, especially for the 8-in (203-mm) slabs. In addition, the sections constructed on treated bases, particularly those constructed on ATB, appear to offer more resistance to faulting increases than the sections constructed on aggregate bases. However, all nondoweled sections, except those placed on ATB, were diamond ground in 1984.

Figure 11 also shows that transverse cracking is increasing at a more rapid rate on the 8-in (203-mm) slabs than on the 9-in (229-mm) slabs. This means that more cracks are breaking down and deteriorating on the thinner slab sections. Cracking generally is increasing more rapidly on the doweled sections than on the nondoweled sections.

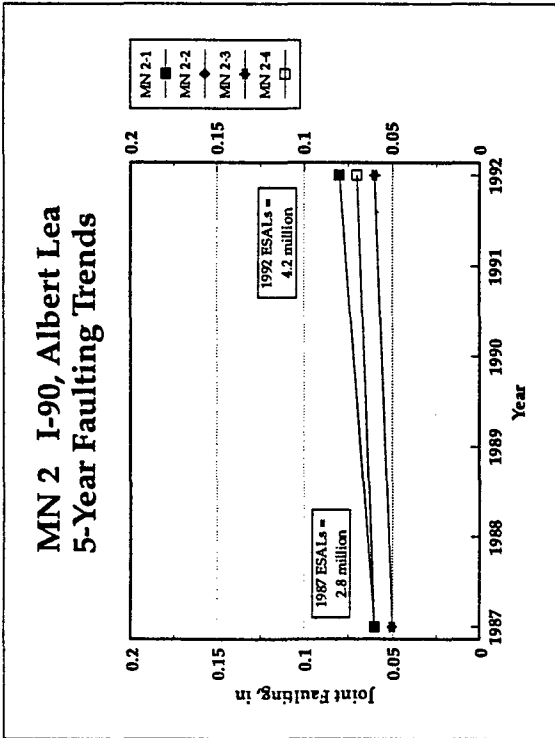
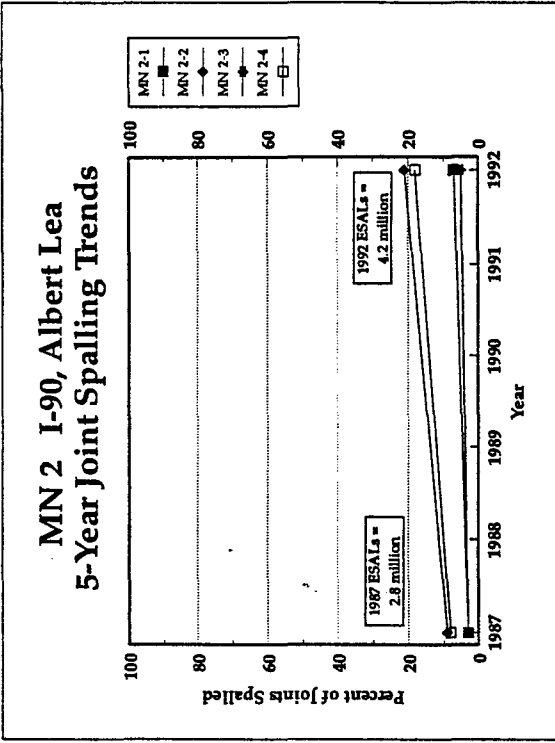
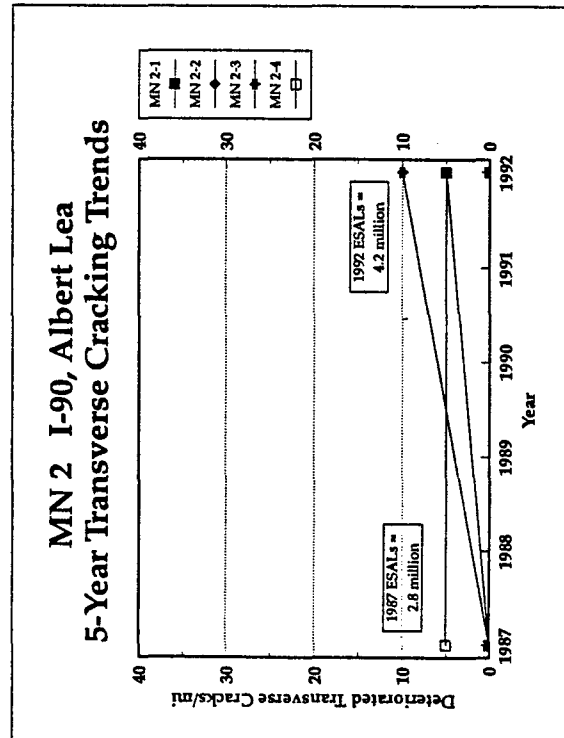
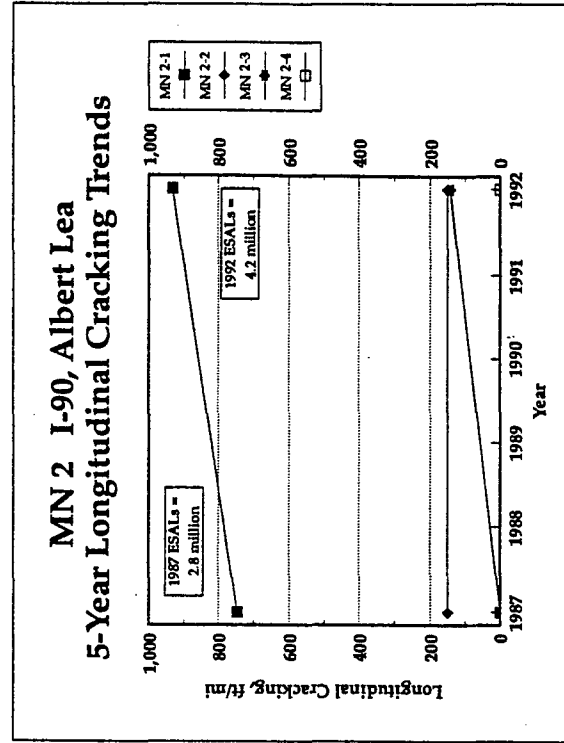
Figure 14. 5-year performance trends for MN 2.

As seen from figure 14, the MN 2 pavement sections are displaying a small increase in deterioration since being evaluated in 1987. Each of the sections shows a slight increase in joint faulting and joint spalling, with no single design exhibiting any obvious performance tendencies. In terms of transverse cracking, sections MN 2-2 (JPCP) and MN 2-3 (JRCP) have experienced a slight increase while the transverse cracking on sections MN 2-1 (JPCP) and MN 2-4 (JRCP) has remained the same. However, MN 2-1 and MN 2-3 show an increase in longitudinal cracking over the 5-year period, while MN 2-2 and MN 2-4 show no such increase. As mentioned before, the overall serviceability of these sections has changed very little since their evaluation in 1987.

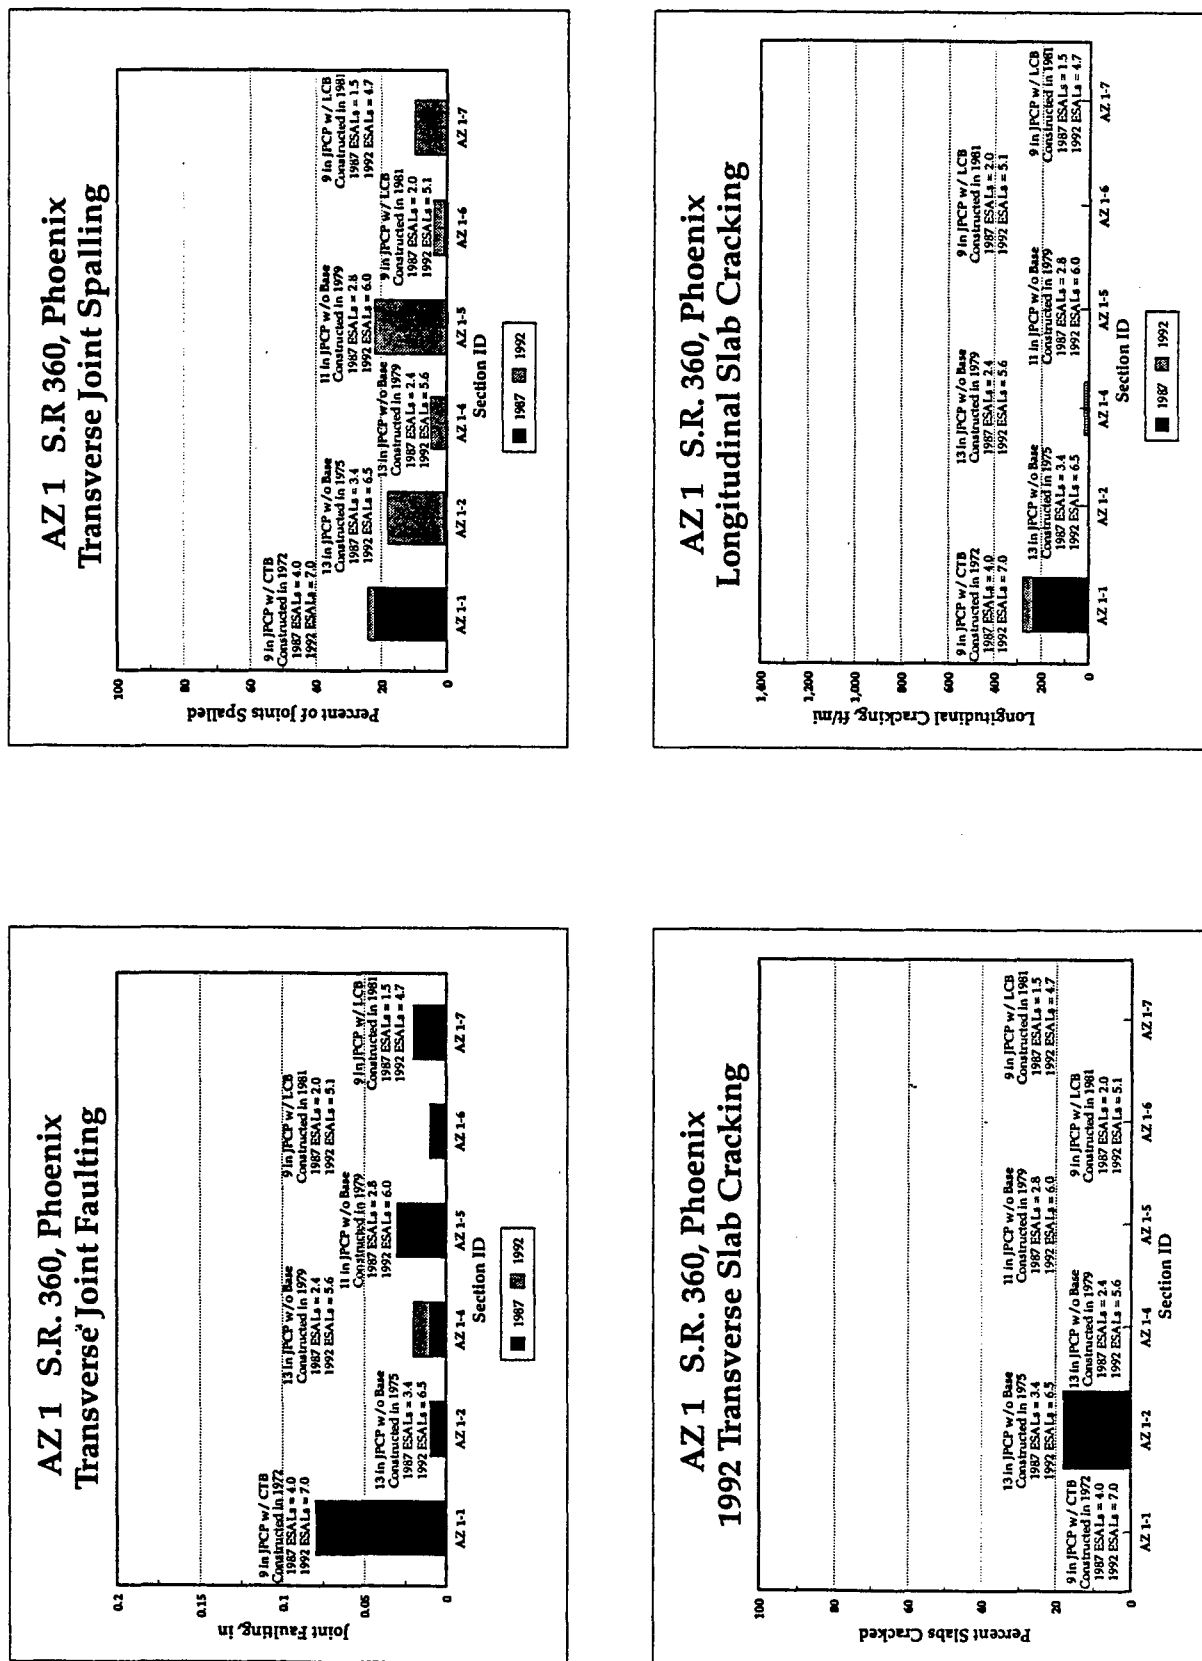
Figure 18. Performance summary for AZ 1.

Table 16 summarizes the performance data for the AZ 1 sections. Figure 18 presents those data in graphical format. Overall, these sections are performing very well, with only slight differences in performance. However, each section is a

different age and has been subjected to different traffic loadings, which makes direct comparisons difficult.

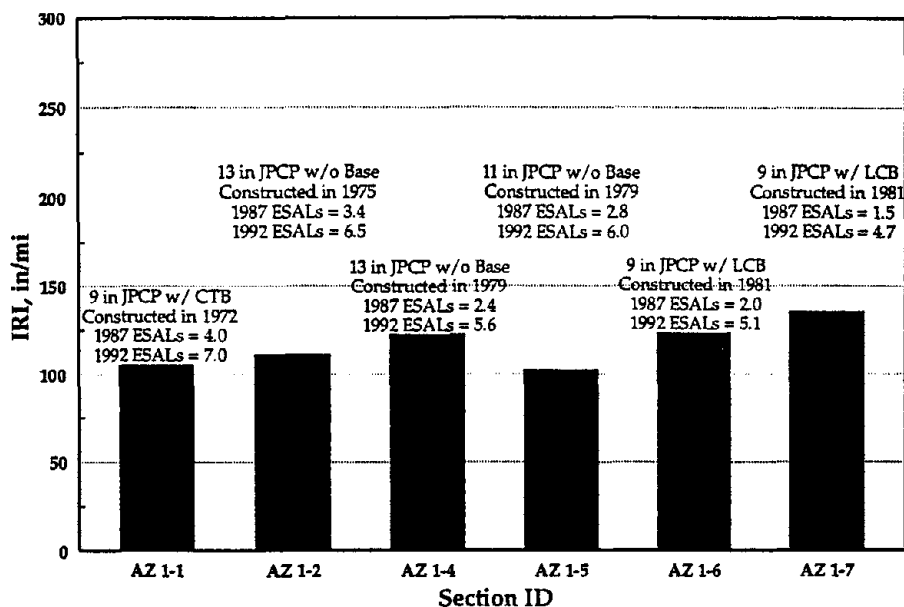
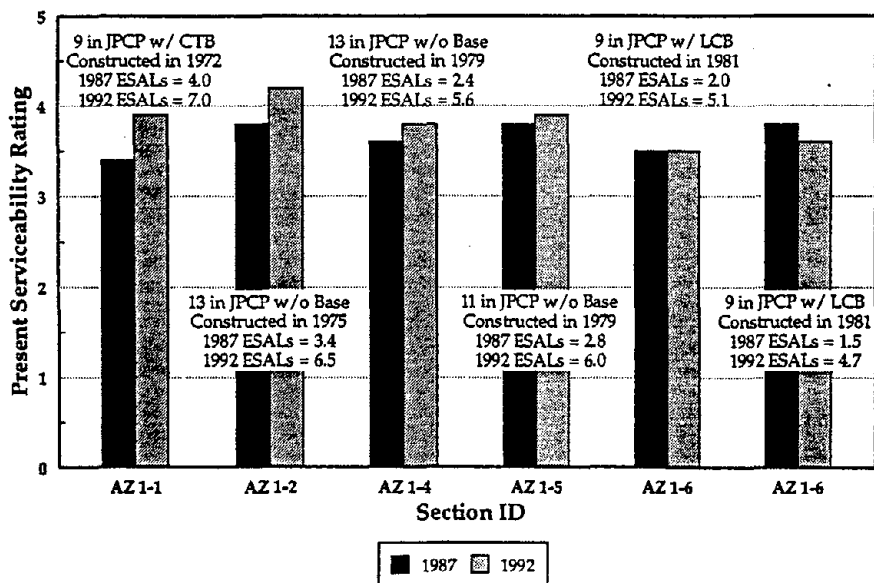
Figure 19. Roughness and serviceability for AZ 1.

Figure 19 shows the roughness levels and serviceability ratings for the AZ 1 sections. Overall, each section appears to be providing a smooth-riding pavement surface. The serviceability ratings indicate that the rideability has remained virtually the same since 1987. Surprisingly, the roughest sections in the project are the newest (AZ 1-6 and AZ 1-7).

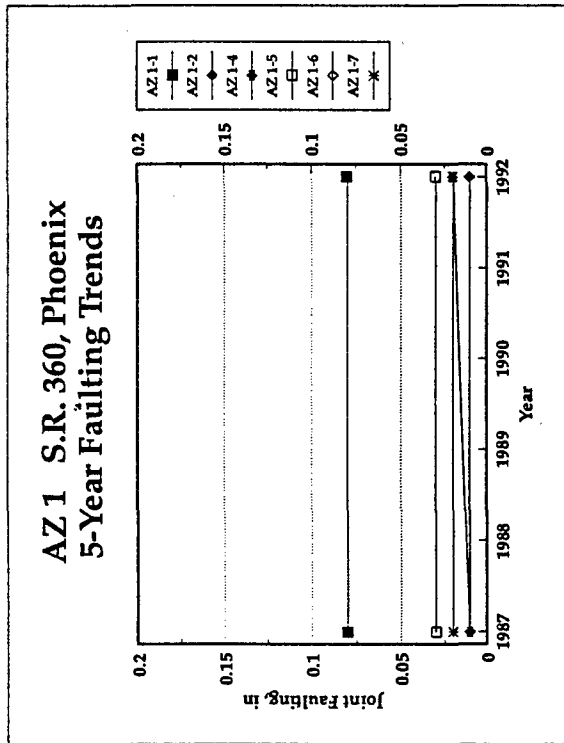
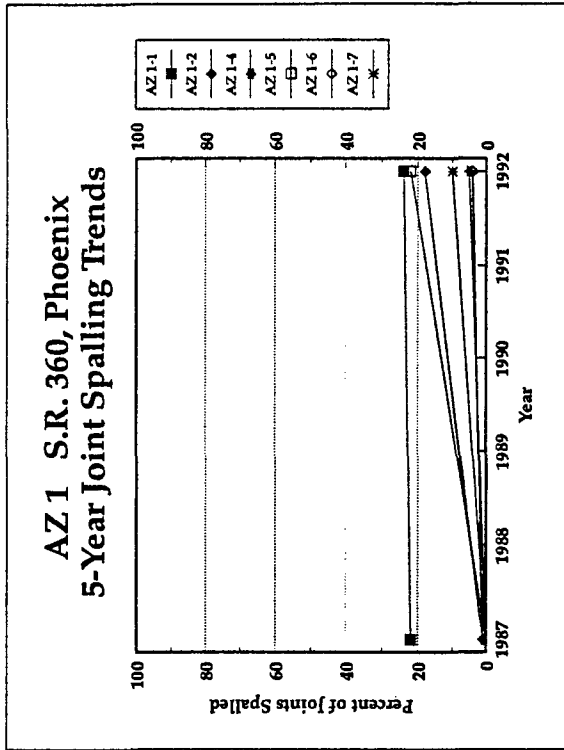
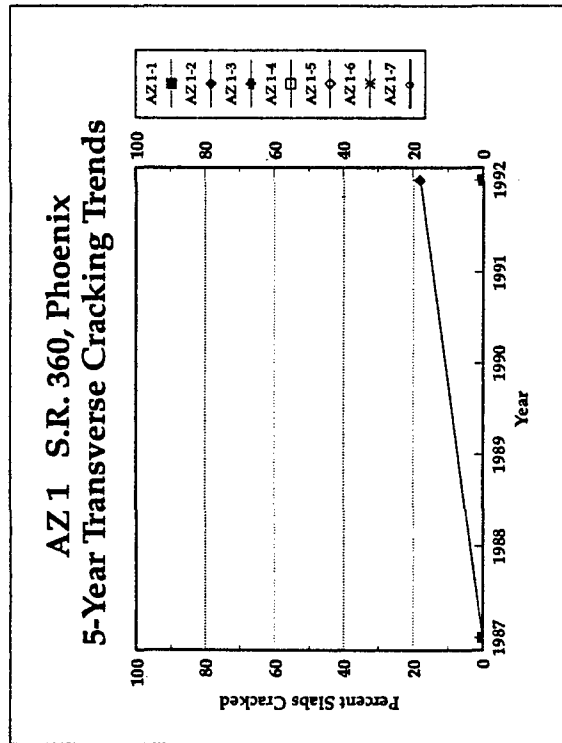
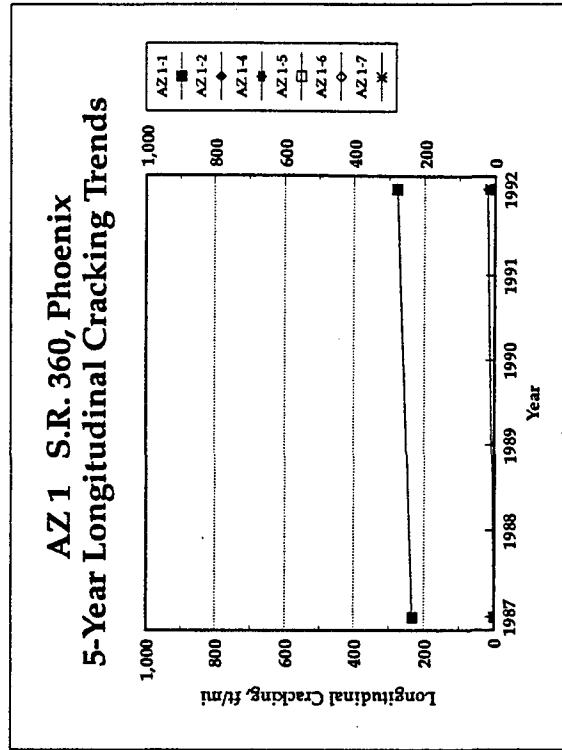
Figure 20. 5-year performance trends for AZ 1.

As shown in figure 20, none of the sections showed an appreciable increase in pavement distress over the period from 1987 to 1992. Faulting levels remained virtually the same over the 5-year period, and only one section (AZ 1-2) developed transverse cracking. Two sections (AZ 1-1 and AZ 1-4) exhibit longitudinal cracking, but the amount is not considered significant.

One performance indicator that has shown an increase over the 5-year period is transverse joint spalling. Every section shows some increase in spalling, although the increase is often not that substantial. Sections AZ 1-1 (24 percent of the joints) and AZ 1-2 (18 percent of the joints) display the most spalling, and these are also the oldest sections in the project. During the 1992 pavement surveys, the joint sealant was observed to be in poor condition for all sections.

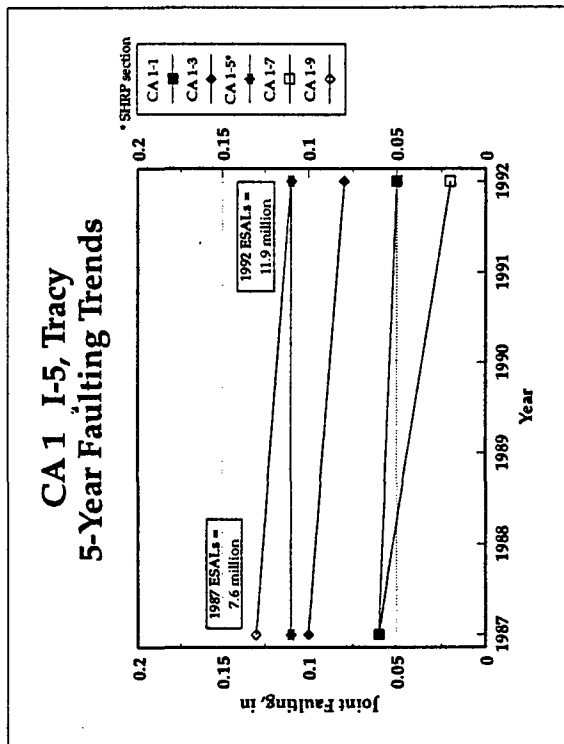
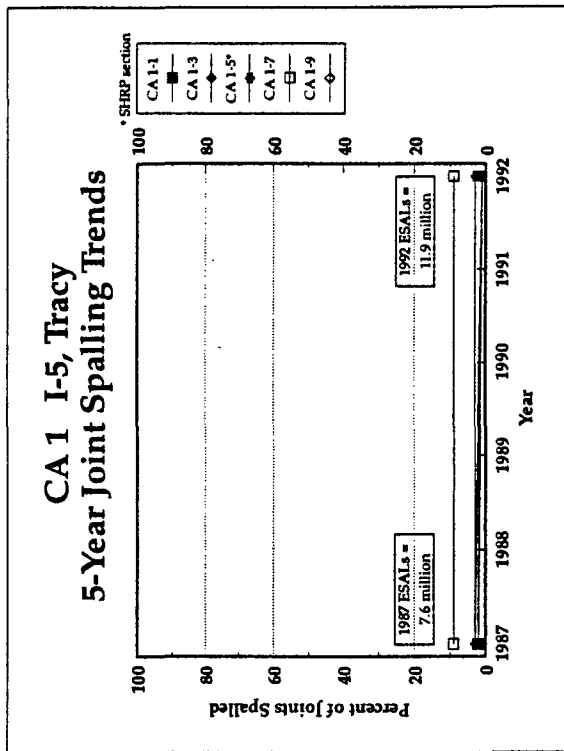
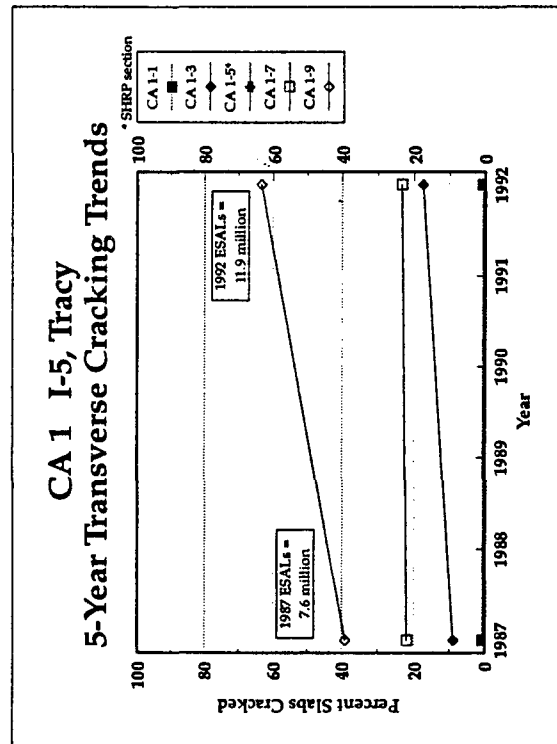
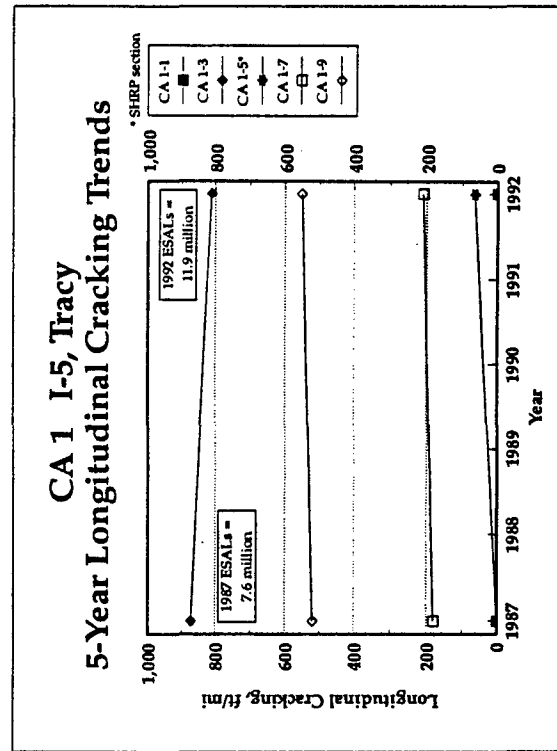
Figure 23. 5-year performance trends for CA 1.

The 5-year performance trends exhibited by these sections is illustrated in figure 23. None of the sections showed an increase in transverse joint faulting, and joint spalling remained virtually unchanged since 1987. Transverse cracking increased for most of the sections, with the biggest increase observed for CA 1-9 (high strength PCC). Longitudinal cracking also remained about the same for all sections over the 5-year period.

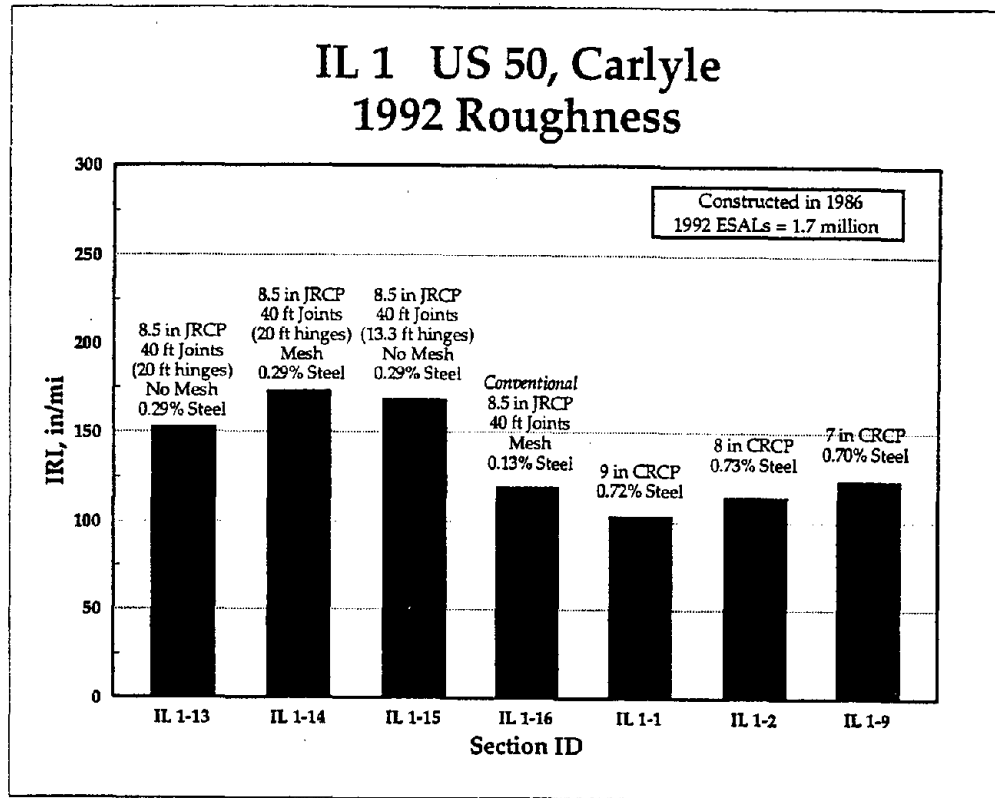
Figure 25. Roughness for IL 1.

Figure 25 illustrates the roughness measurements recorded for the IL 1 sections. With one exception, the roughness levels for the CRCP sections are much less than the JRCP designs. The lone exception is IL 1-16 (the conventional 40-ft [12.2-m] design), whose roughness levels were comparable to the CRCP sections. This result is somewhat surprising since IL 1-16 displayed a great deal of deteriorated transverse cracks. One explanation could be that the increased number of transverse joints on the hinge joint sections, even though not severely faulted, contributes to an increase in roughness. Another explanation could be related to the initial construction quality.

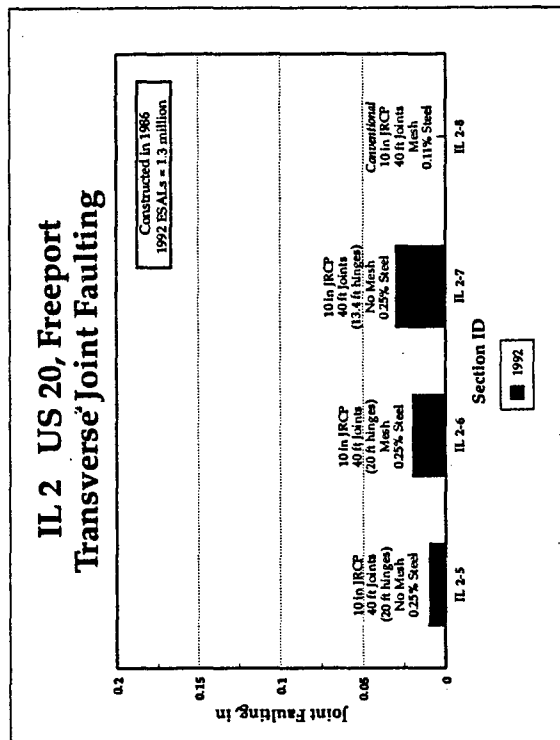
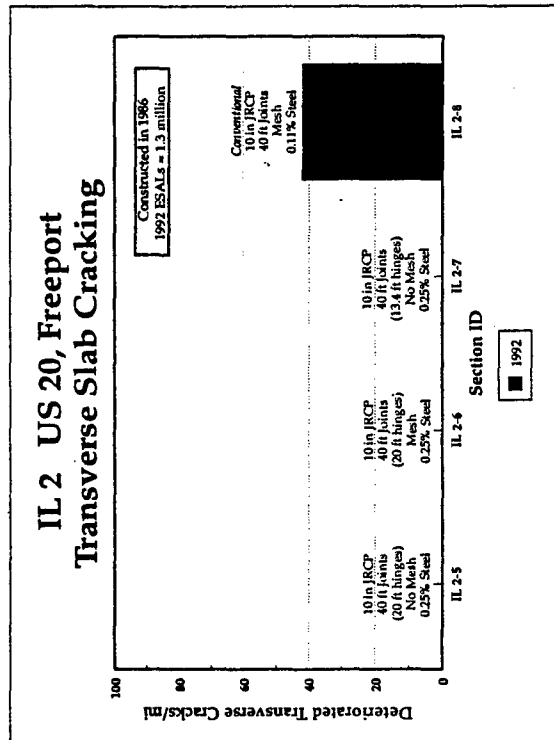
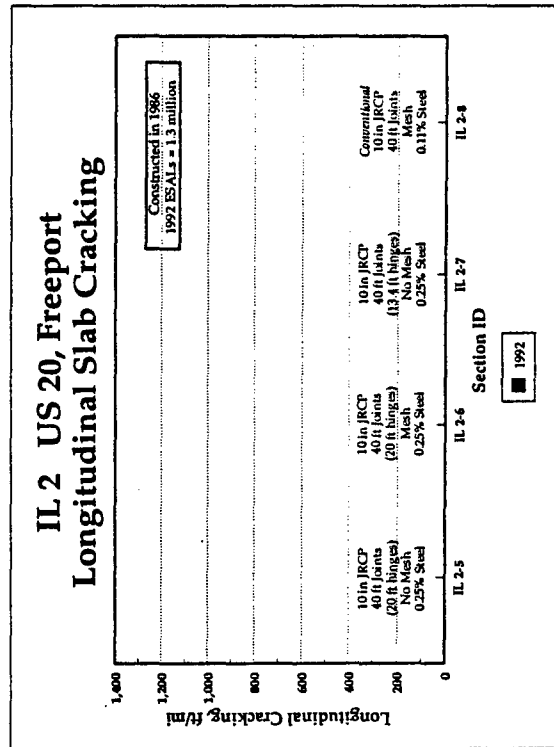
Figure 26. Performance summary for IL 2.

A summary of the performance of the IL 2 sections is provided below:

- The sections containing the hinge joint design are performing better than the conventional design in terms of the amount of deteriorated transverse cracking. However, there are no other significant differences in performance.
- No differences in performance exist between the different hinge joint designs.
- Roughness levels for each of the sections are not significantly different.

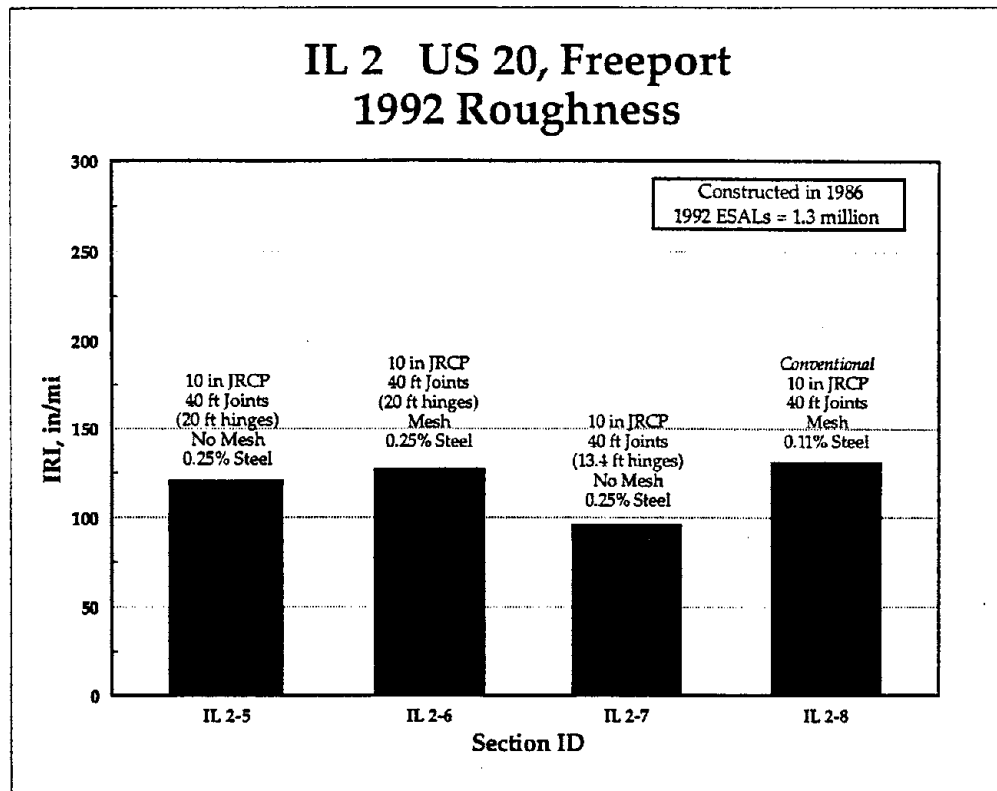
Figure 27. Roughness for IL 2.

Pavement roughness levels for these sections is shown in figure 27. This figure shows that the roughness of the hinge joint designs is less than that of the conventional design, although the differences are not significant. Interestingly, the smoothest-riding pavement is section 2-7, which contains the largest number of transverse joints. Again, this result may be related to the initial construction quality.

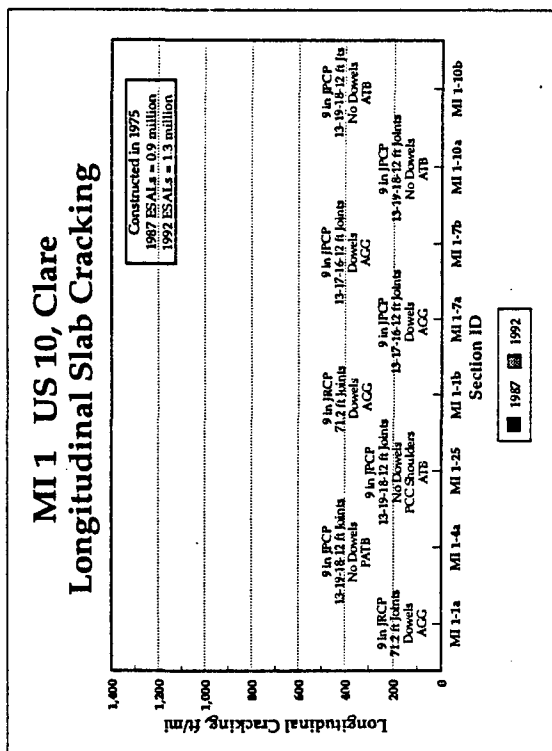
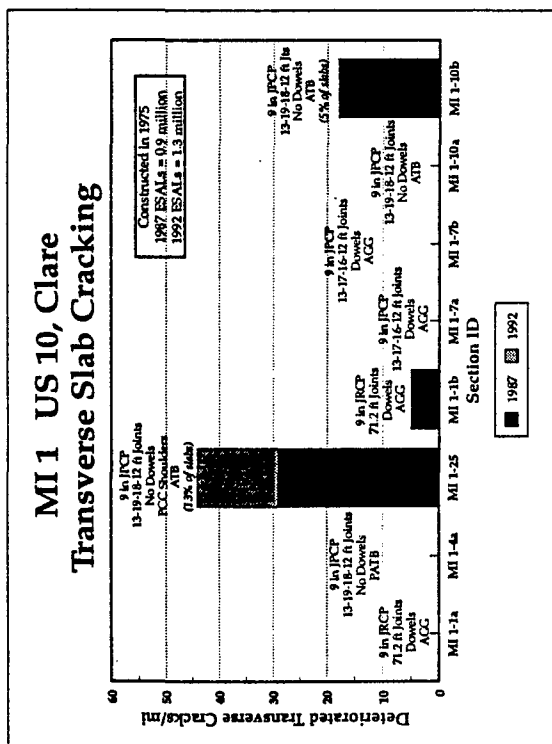
Figure 28. Performance summary for MI 1.

Table 30 summarizes the performance data for MI 1; this information is illustrated graphically in figure 28. This information clearly illustrates the poor performance exhibited by the pavements constructed on the dense-graded ATB. Not only did they exhibit the highest levels of faulting (0.13 in [3.3 mm] and higher), they also were the only sections to exhibit significant levels of transverse cracking and transverse joint

spalling. These ATB sections were constructed as a "bathtub" design with full-depth AC shoulders, which served to retain excess moisture within the pavement structure and resulted in the accelerated development of pavement distress.

Joint spalling on this project was caused by D-cracking, which was present throughout the project. However, the severity of the D-cracking (and hence the amount of spalling) was less on pavements constructed on either PATB or aggregate base course. This result is believed to be due to the drainage allowed by each of these base courses (the aggregate base course, even though dense-graded, allowed some degree of drainage). Sections constructed on the ATB apparently did not drain water very well because of the bathtub design and the impermeability of the ATB.

The nondoweled section constructed on PATB provided the best overall performance. It exhibited the least amount of joint faulting, displayed only minimal spalling, and showed no slab cracking. This result is surprising because 100 percent of the corners had voids, which may affect the long-term performance. A replicate section surveyed in the other direction exhibited similar performance. Both the long-jointed and short-jointed pavements placed on aggregate bases exhibited fairly good performance, although these sections all contained dowel bars.

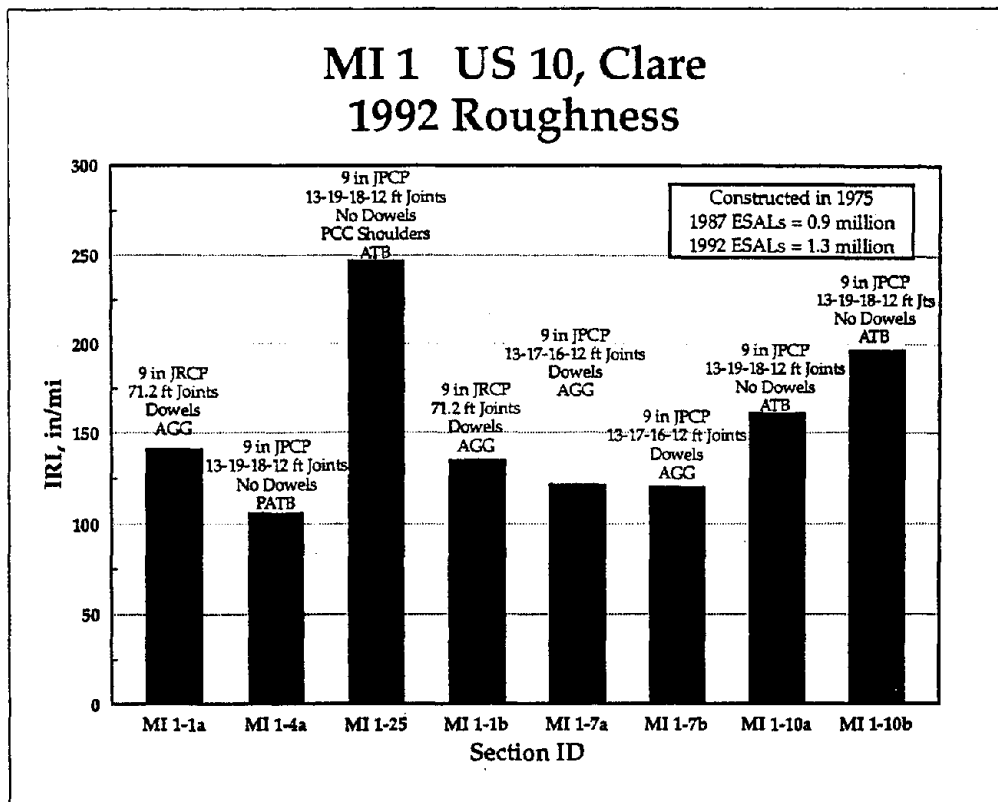
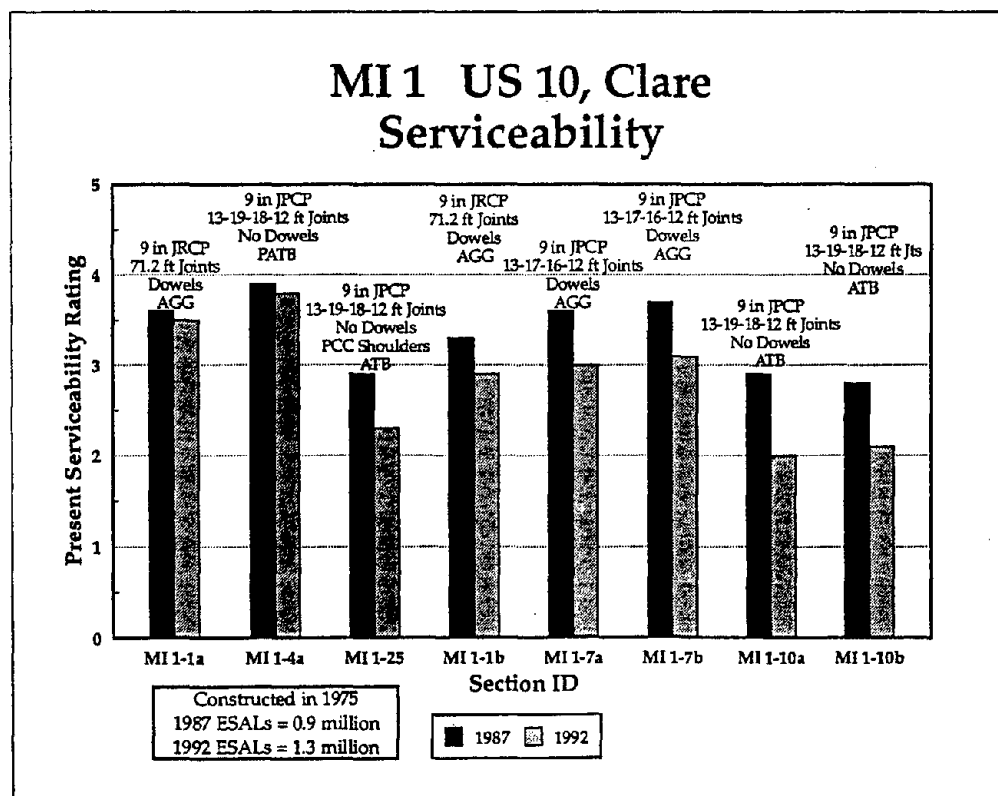
Figure 29. Roughness and serviceability for MI 1.

Roughness and serviceability for the MI 1 sections are shown in figure 29. This data appears to confirm that the sections constructed on ATB are performing the worst, as they are exhibiting the highest roughness levels and the lowest serviceability ratings. The smoothest-riding pavement is the section constructed on PATB, followed closely by the short-jointed pavements constructed on AGG.

Over the past 5 years, the sections showing the largest decrease in serviceability are those constructed on ATB. The section on PATB and the long-jointed JRCP sections show the smallest decrease in serviceability over that time period.

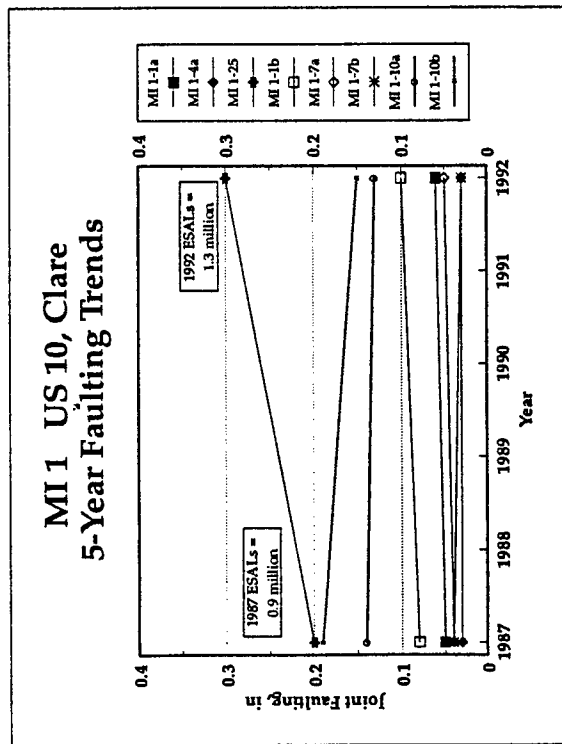
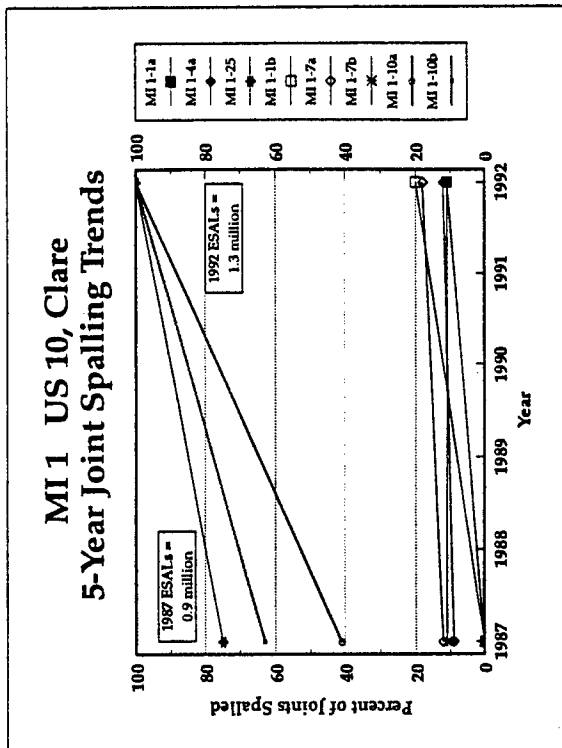
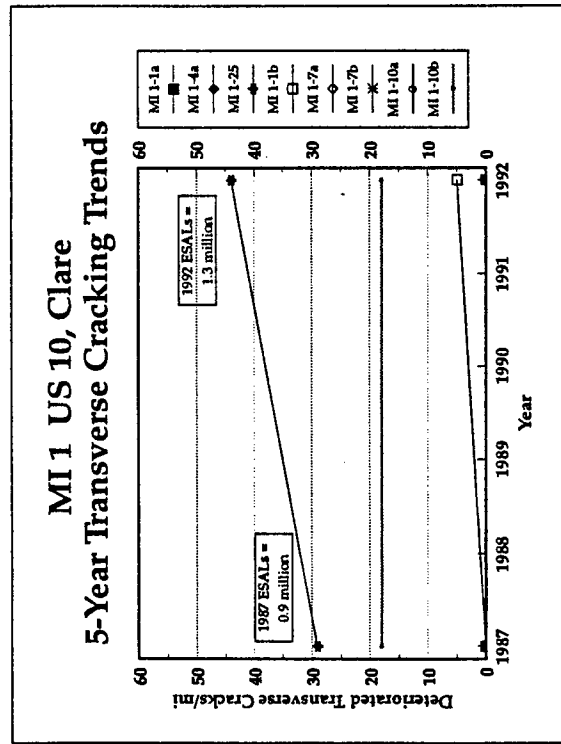
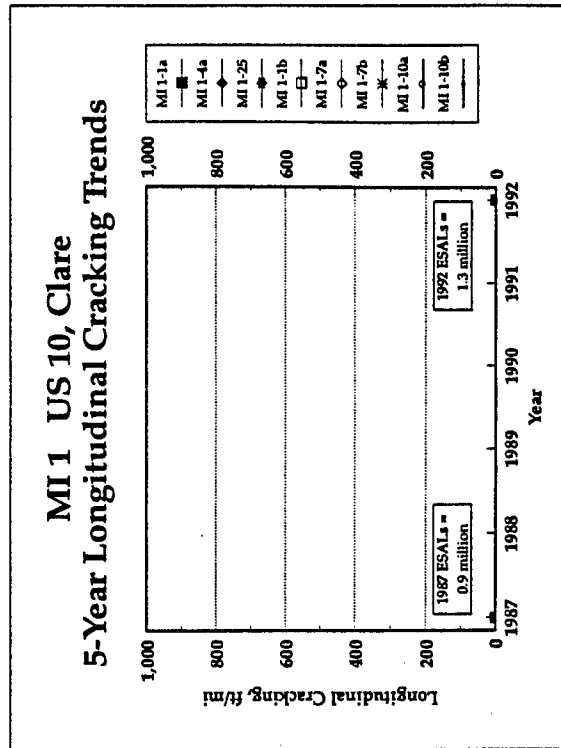
Figure 30. 5-year performance trends for MI 1.

The 5-year performance trends for the key distress types are given in figure 30. This figure indicates that the pavements showing the largest increase in every distress category are those constructed on ATB. Most notably, the levels of spalling for each of the ATB sections increased to 100 percent. Section MI 1-25 is the only section to show a significant increase in faulting and transverse cracking.

- Over the last 5 years, the ATB sections, particularly MI 1-25, are showing the most significant increases in pavement distress.
