Performance of Concrete Pavements

Volume I: Field Investigation

PUBLICATION NO. FHWA-RD-94-177

JULY 1997

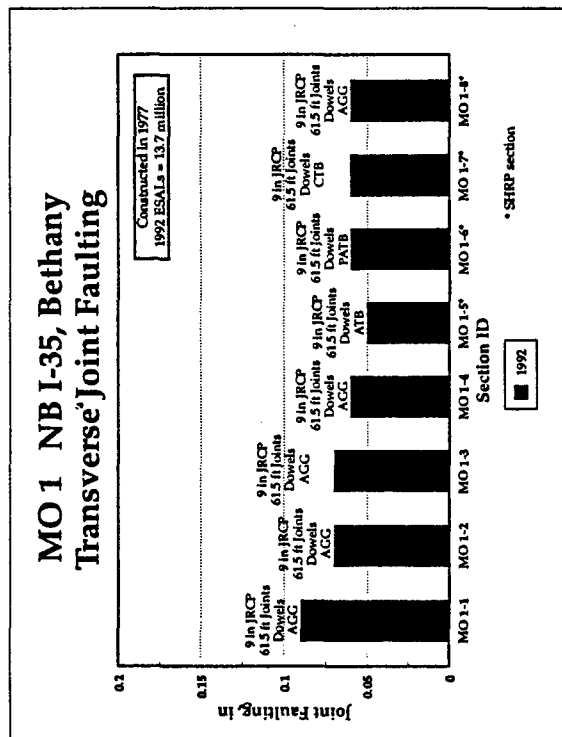
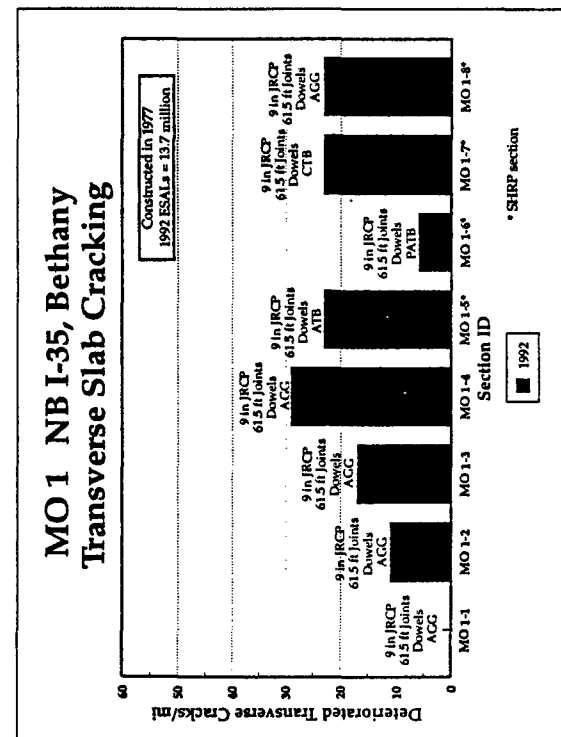
Figure 31. Performance summary for MO 1.

Table 34 summarizes the performance data for the outer lanes of the MO 1 sections. Figure 31 presents that performance data in graphical format. The distress data for MO 1 do not indicate any major differences in the performance of these sections. Considering the performance of the various base types, the levels of faulting, transverse cracking, and joint spalling do not appear to be significantly different. Pumping was observed on all sections constructed on aggregate bases, but not for those constructed on treated bases. However, the section constructed on PATB had fewer deteriorated transverse cracks. Nevertheless, differences in the overall performance of the various base types did not appear to be significant.

- No significant difference is observed between the performance of the pavement sections constructed on various base types. Levels of faulting, spalling, and transverse cracking are comparable for all sections, although pumping was

only observed on the AGG sections. The section constructed on PATB did exhibit less transverse cracking than the other sections, suggesting that a reduction in transverse crack deterioration is related to the removal of excess water from the pavement structure.

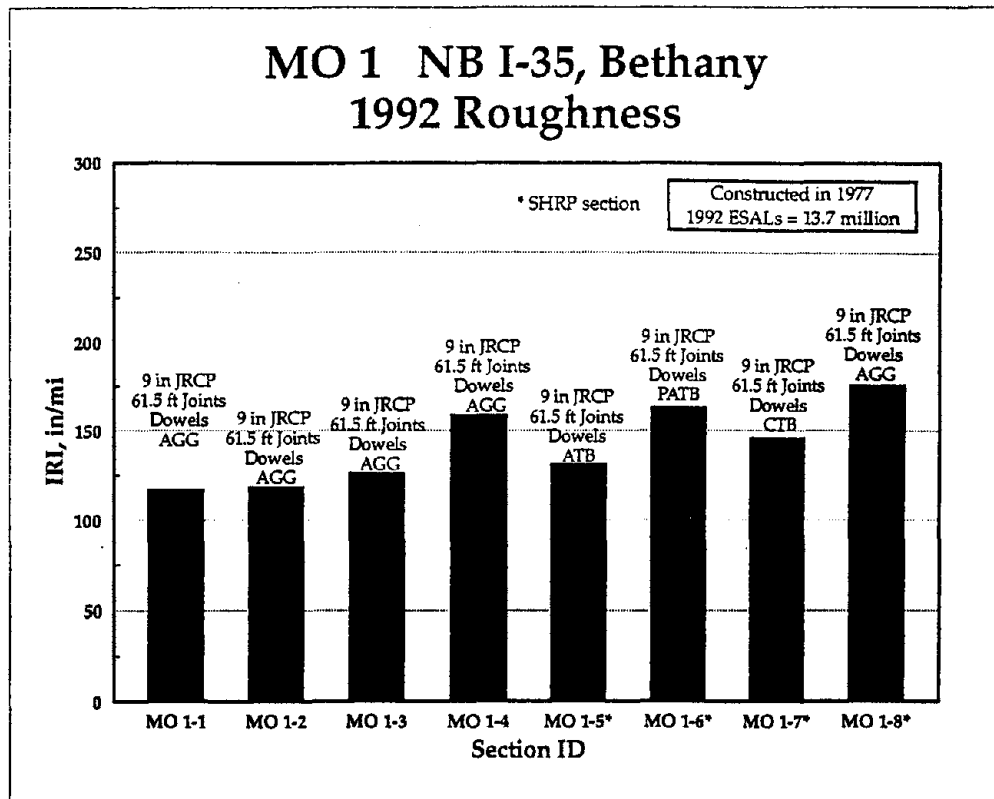
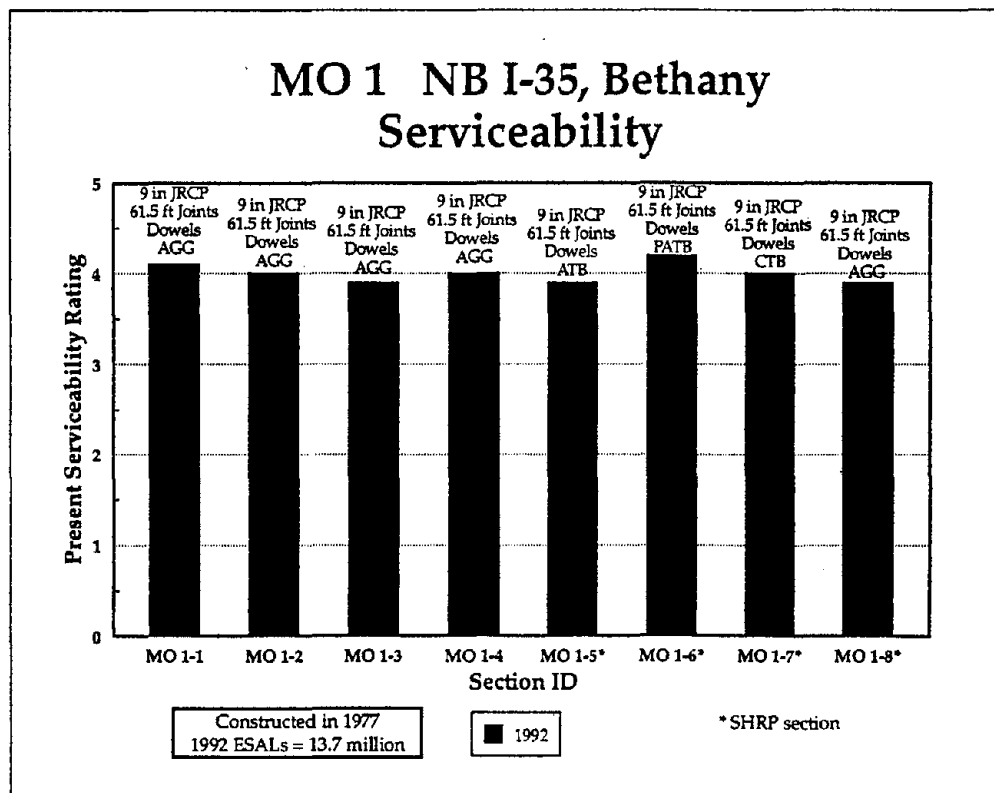
Figure 32. Roughness and serviceability for MO 1.

Figure 32 illustrates the roughness measurements and serviceability ratings for the MO 1 sections. Whereas the roughness values indicate a significant difference in smoothness between the sections (with the smoothest riding sections being three of

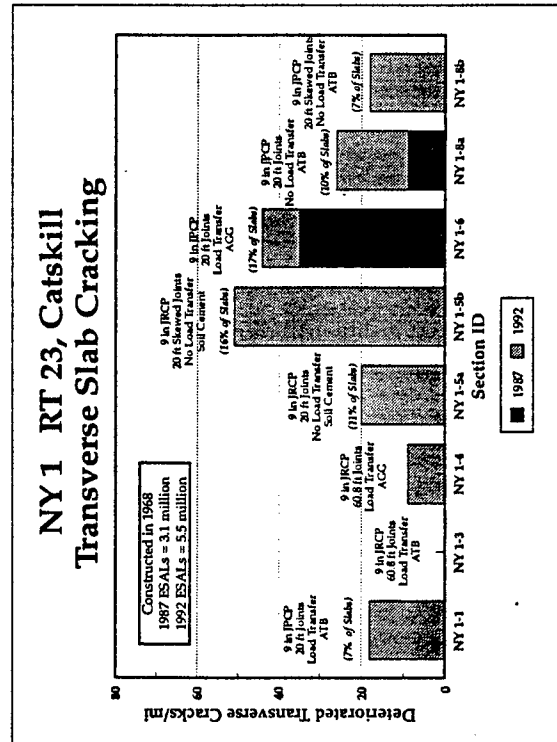
Figure 33. Performance summary for NY 1.

The performance data for the NY 1 experimental sections are summarized in table 39. The key distress data are illustrated in figure 33.

The effect of the ACME load transfer devices in reducing faulting can be observed by comparing the performance of NY 1-1 and 1-8a. The distress data indicate no significant difference in the performance of these sections, suggesting that the light traffic to which this project is exposed may not be a true test of the load transfer devices. Other studies conducted in New York have indicated that these devices corroded and could not be relied upon to provide positive, long-term load transfer, often failing within 5 years.⁽²⁹⁾

No definitive conclusions can be drawn regarding the effectiveness of skewed transverse joints. The section with the skewed joints displays more faulting than the corresponding section with perpendicular joints, although this difference is not significant. The section with perpendicular joints, however, displays more transverse slab cracking than the section with skewed joints.

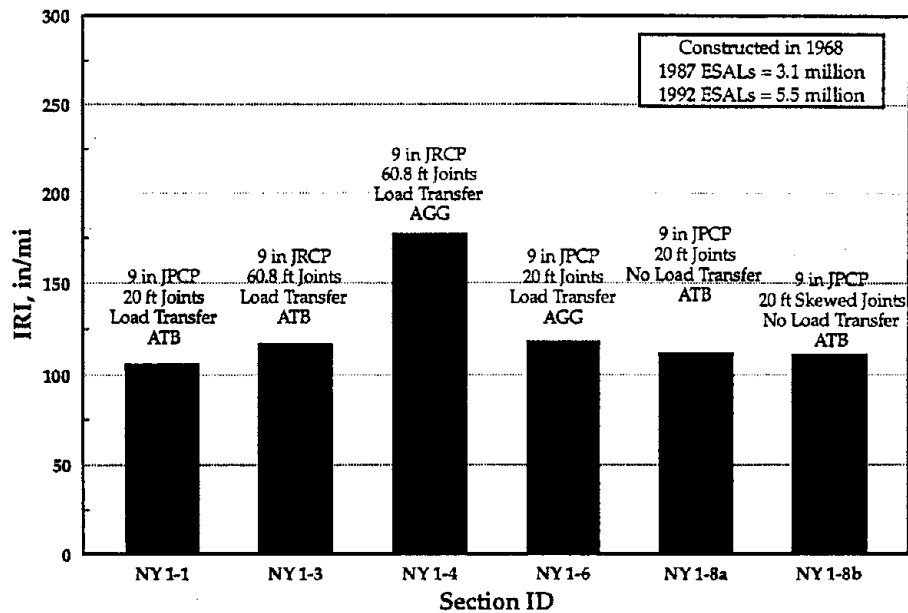
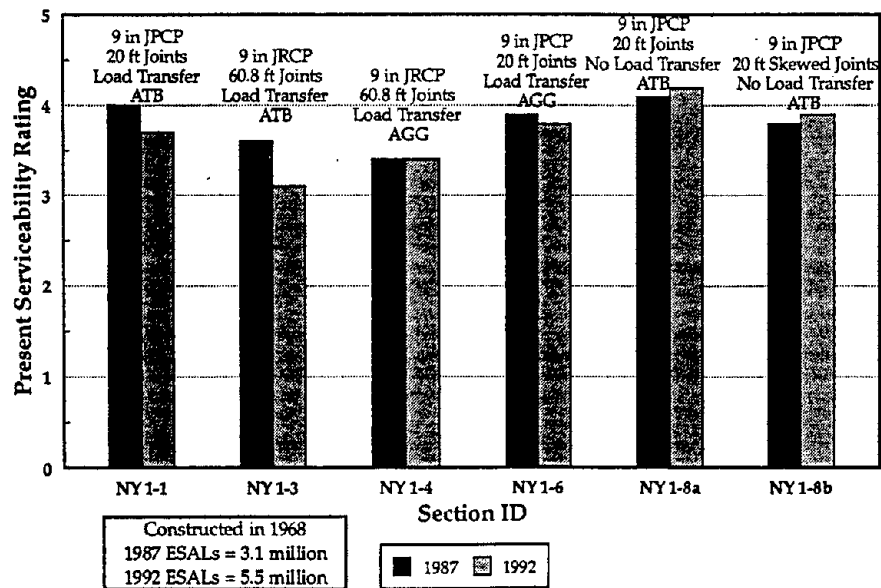
Figure 34. Roughness and serviceability for NY 1.

Roughness measurements and serviceability ratings for each section are illustrated in figure 34. The roughest section is NY 1-4, a long-jointed section on an aggregate base. The roughness levels for the other sections are all comparable and are representative of relatively smooth-riding pavements.

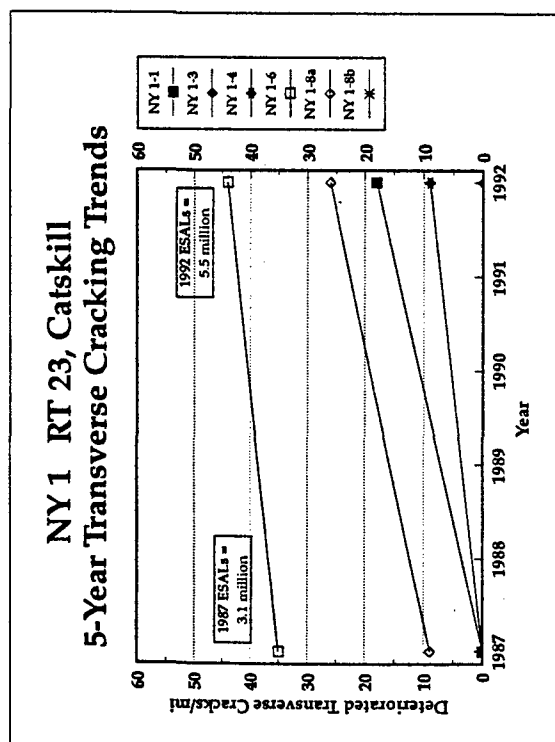
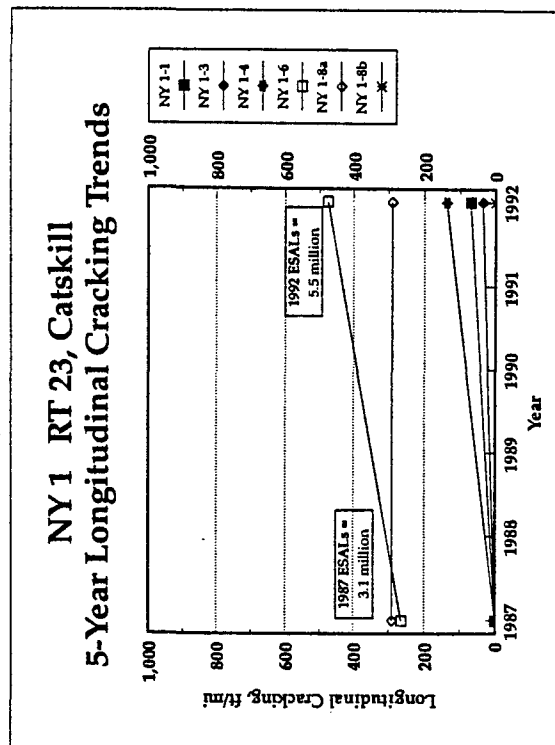
Figure 35. 5-year performance trends for NY 1.

The 5-year performance trends for these sections are shown in figure 35. No change in joint faulting or spalling has occurred for any of the sections. However, the number of deteriorated transverse cracks has increased for nearly every section, and the amount of longitudinal cracking has also increased slightly for a few sections.

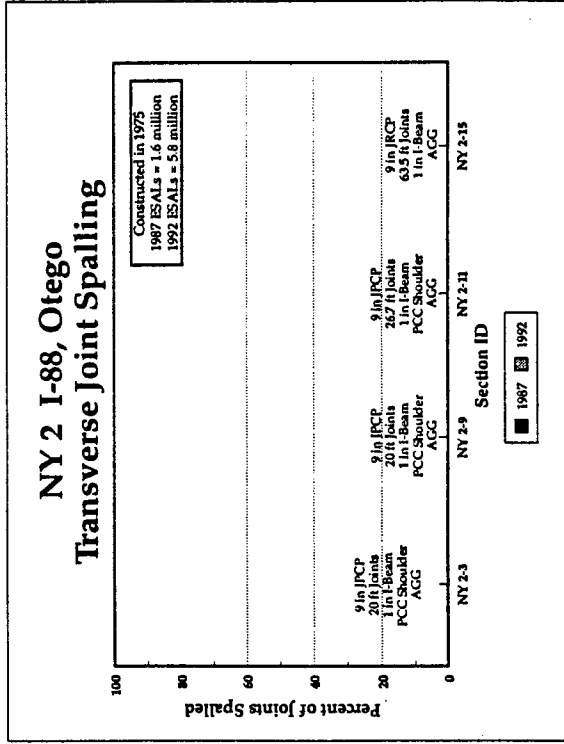
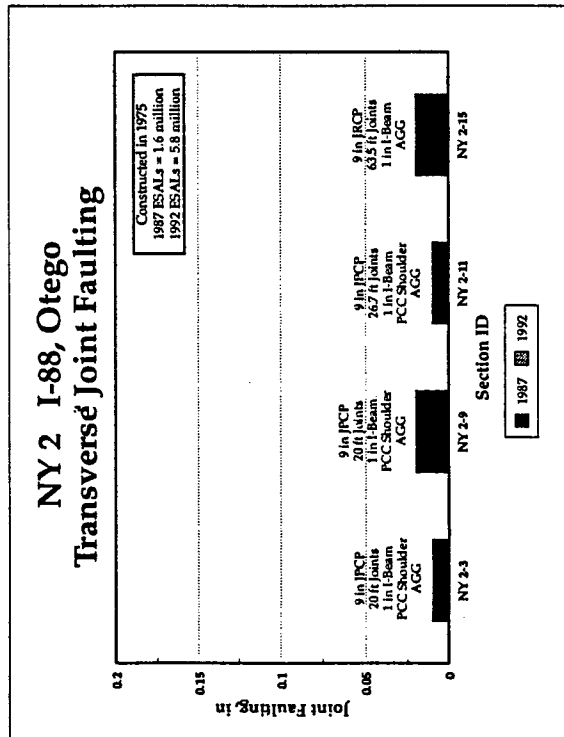
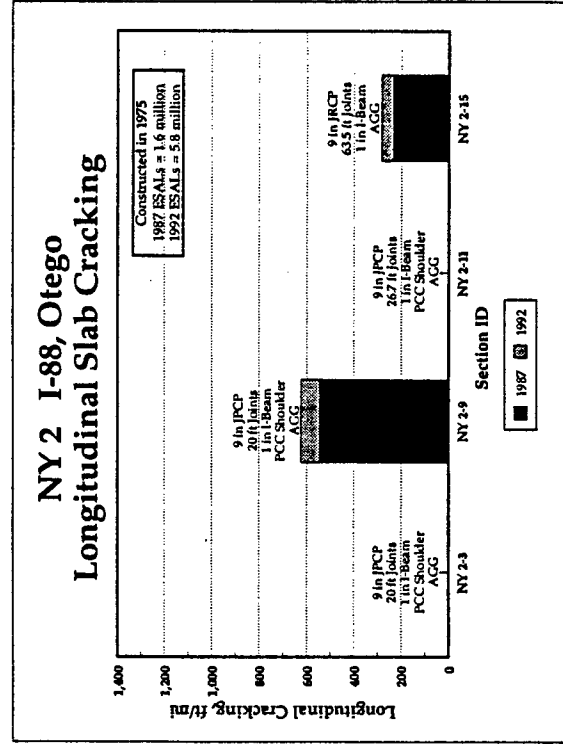
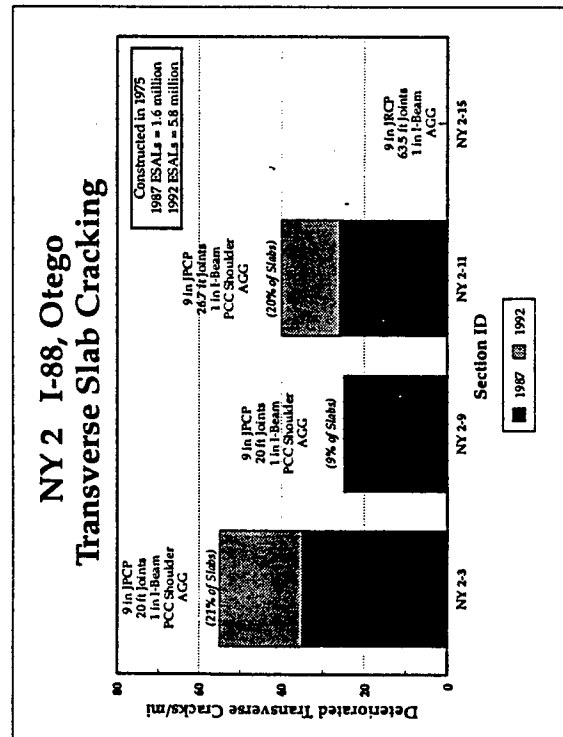
Figure 36. Performance summary for NY 2.

The performance data for NY 2 are summarized in table 41 and illustrated in figure 36. This information shows that all of the NY 2 sections are in excellent condition. Faulting is practically nonexistent on these sections, and joint spalling is also minimal.

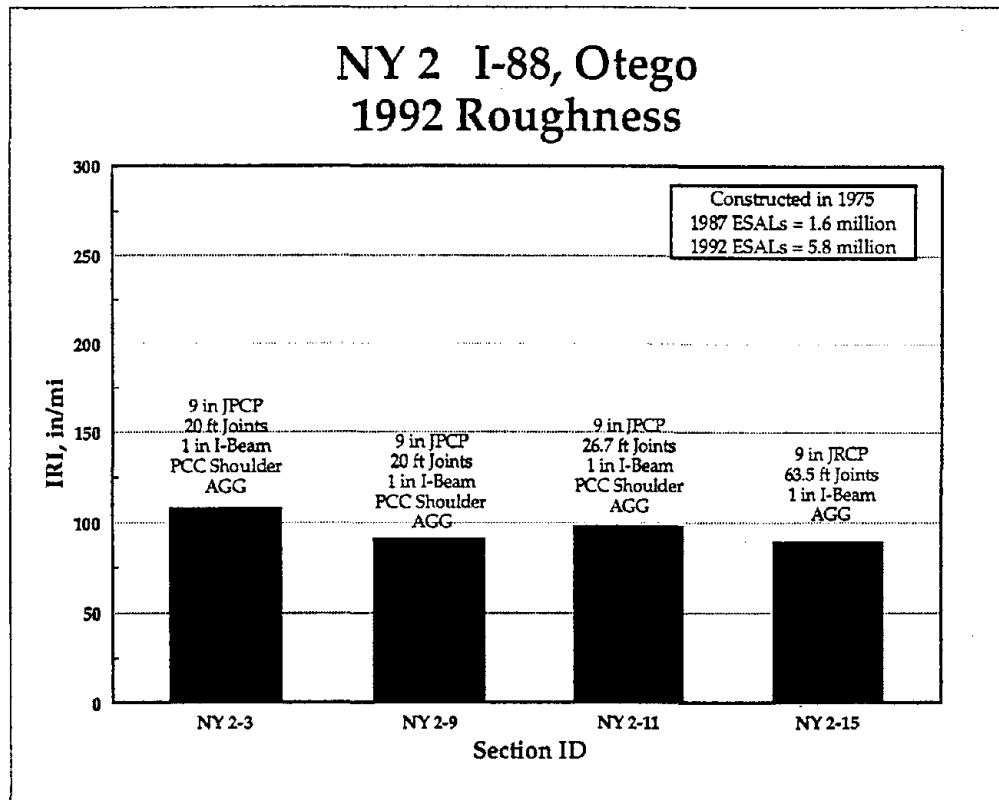
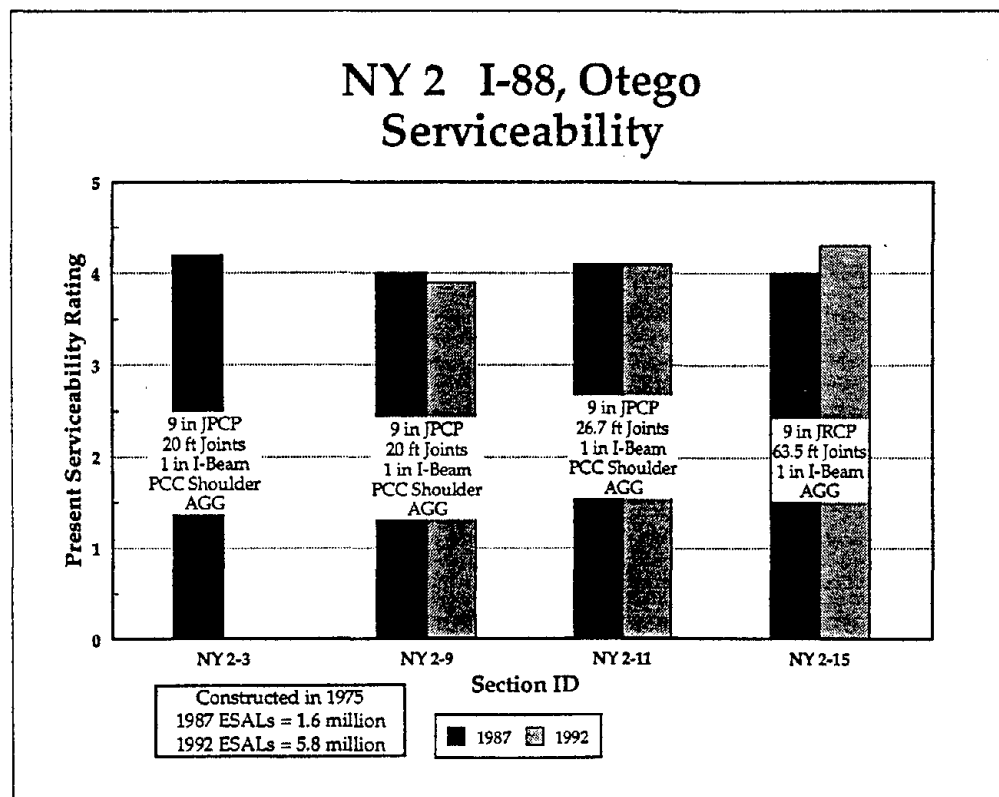
Figure 37. Roughness and serviceability for NY 2.

Roughness measurements and serviceability ratings for the NY 2 sections are illustrated in figure 37. This figure shows that the NY 2 sections are extremely

smooth, typically showing roughness measurements less than 100 in/mi (1.6 m/km) and PSR values near 4.0. Since 1987, no significant changes have occurred in the serviceability of the pavement.

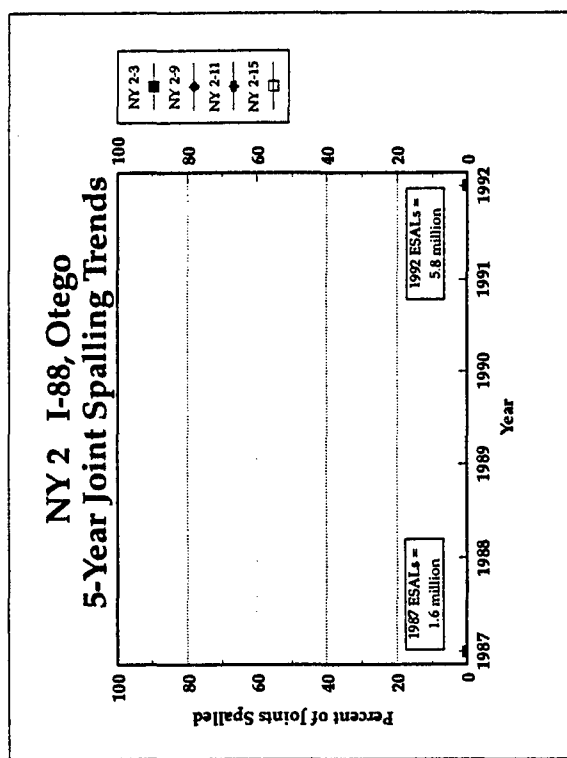
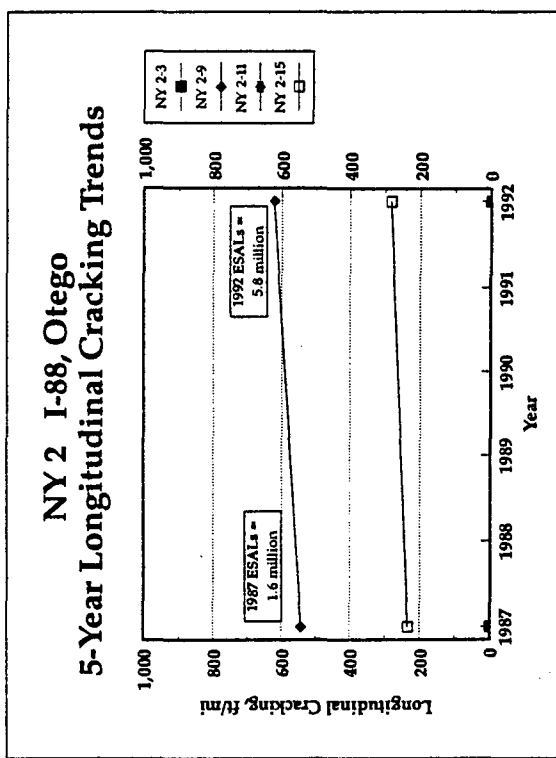
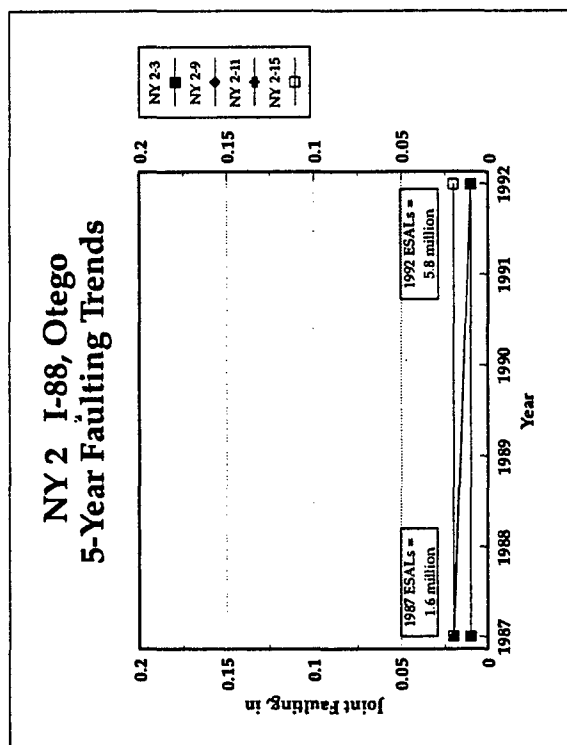
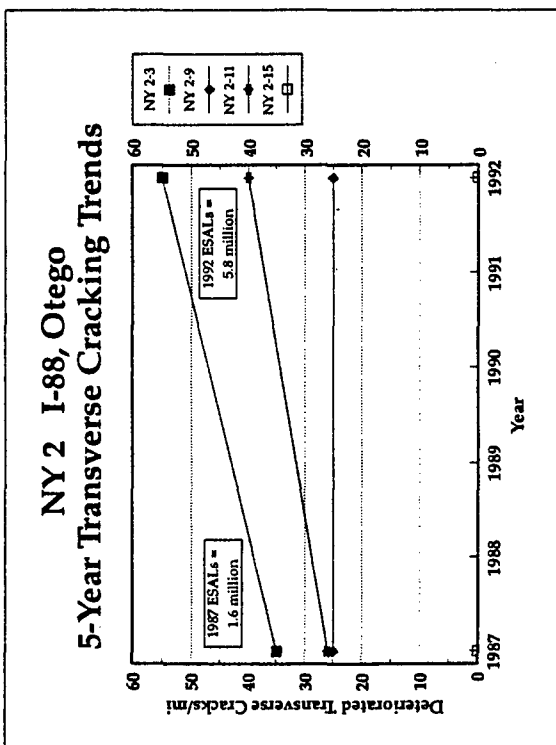
Figure 38. 5-year performance trends for NY 2.

Figure 38 illustrates the 5-year performance trends for the NY 2 sections. Virtually no changes have occurred in the amount of joint faulting or spalling, although some increase in transverse cracking has occurred for sections 2-3 and 2-11. In addition, sections 2-9 and 2-15 are showing a small increase in the amount of longitudinal cracking.

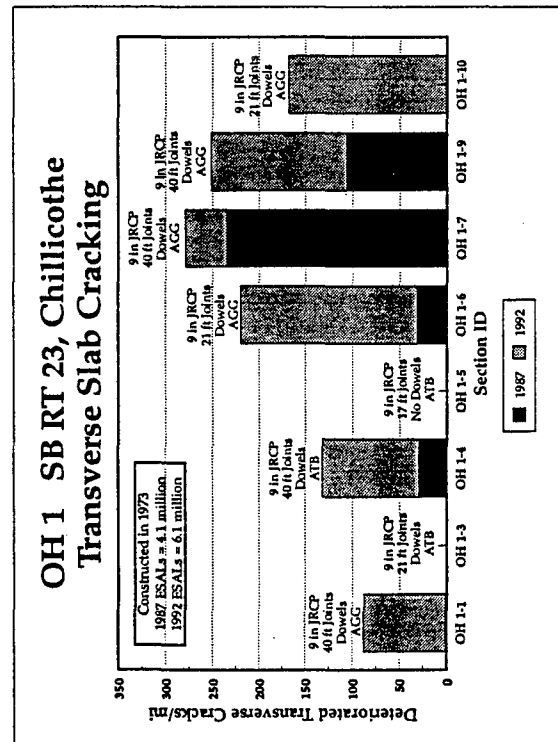
Figure 39. Performance summary for OH 1.

The performance data for OH 1 are summarized in table 43 and presented in graphical format in figure 39. With the exception of the apparent reduction in faulting with age, table 43 shows a number of logical trends. The peculiar trend exhibited in faulting may be attributable to possible differences in the environmental conditions (temperature and moisture) under which the measurements were taken.

Although the absolute faulting shown in table 43 may not be meaningful, relative faulting does show definite trends. Both 1987 and 1992 data show that faulting is less in the sections provided with plastic-coated dowels than the sections with standard (painted and greased) noncoated dowels. In addition, the faulting of the nondoweled section (OH 1-5) is significantly greater than that of the doweled sections, indicating the effectiveness of dowel bars in reducing faulting.

The sections constructed on ATB show fewer deteriorated transverse cracks and slightly less faulting than the sections constructed on aggregate base. This may speak to the ATB's greater resistance to moisture and erosion. Although one ATB section

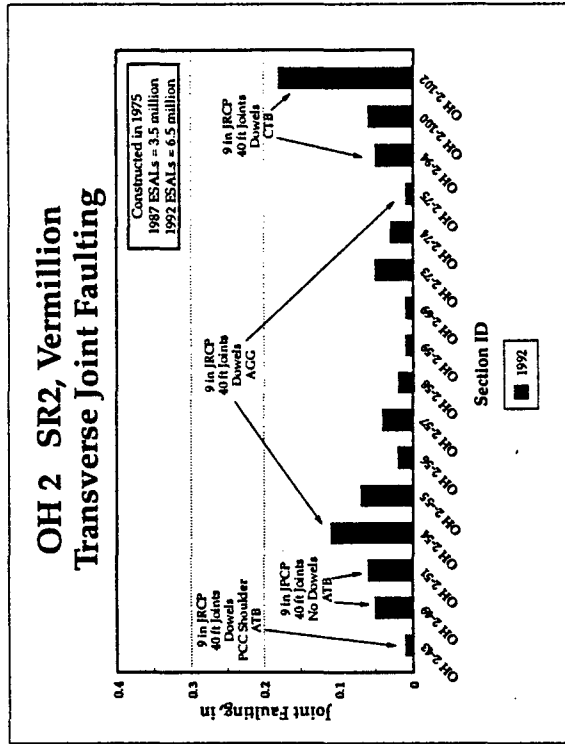
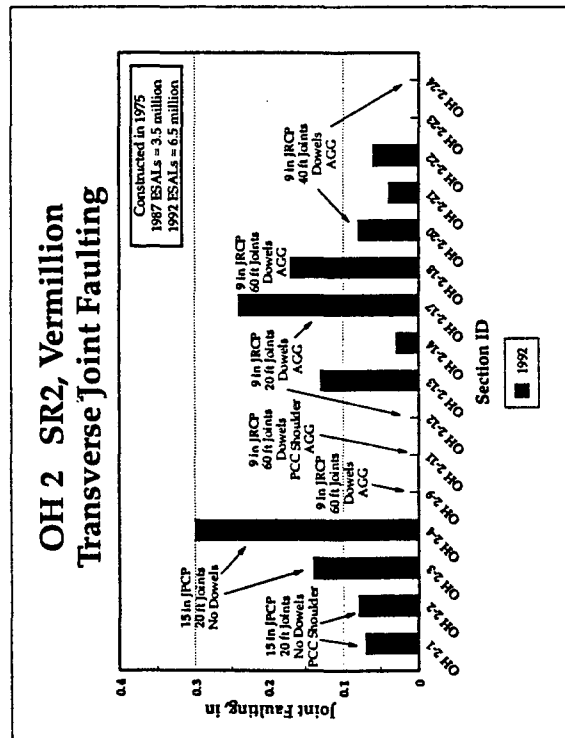
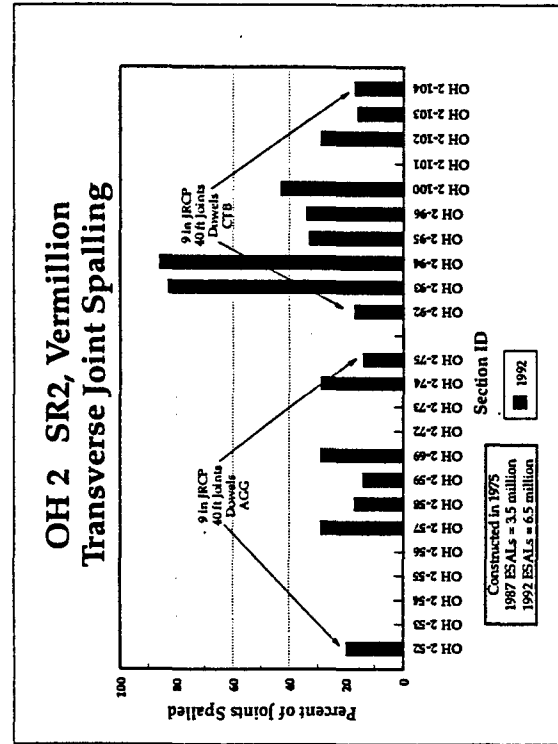
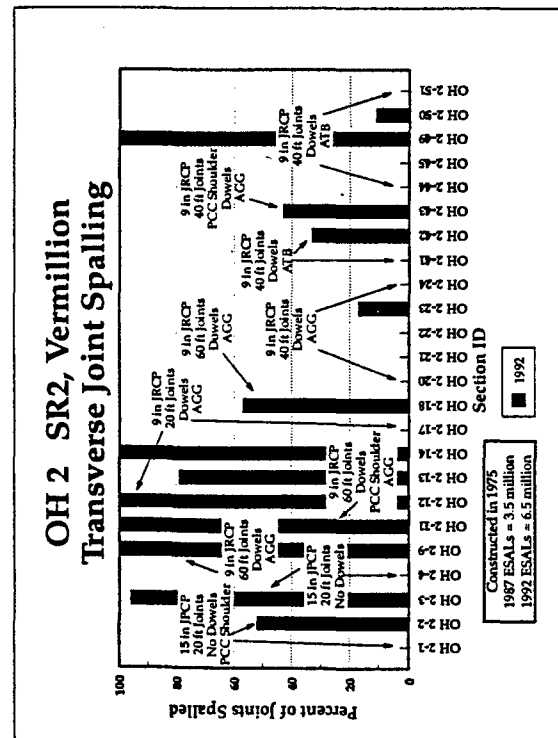
Figure 42. Performance summary of OH 2 sections, joint faulting and spalling.

Tables 45 and 46 summarize the performance of the jointed concrete pavement sections at OH 2. This information is also presented graphically in figures 42 through 44. The performance of the CRCP sections is summarized in table 47. Sections without faulting data represent those where the joints were spalled to bad to measure or those that were surveyed using PASCO.

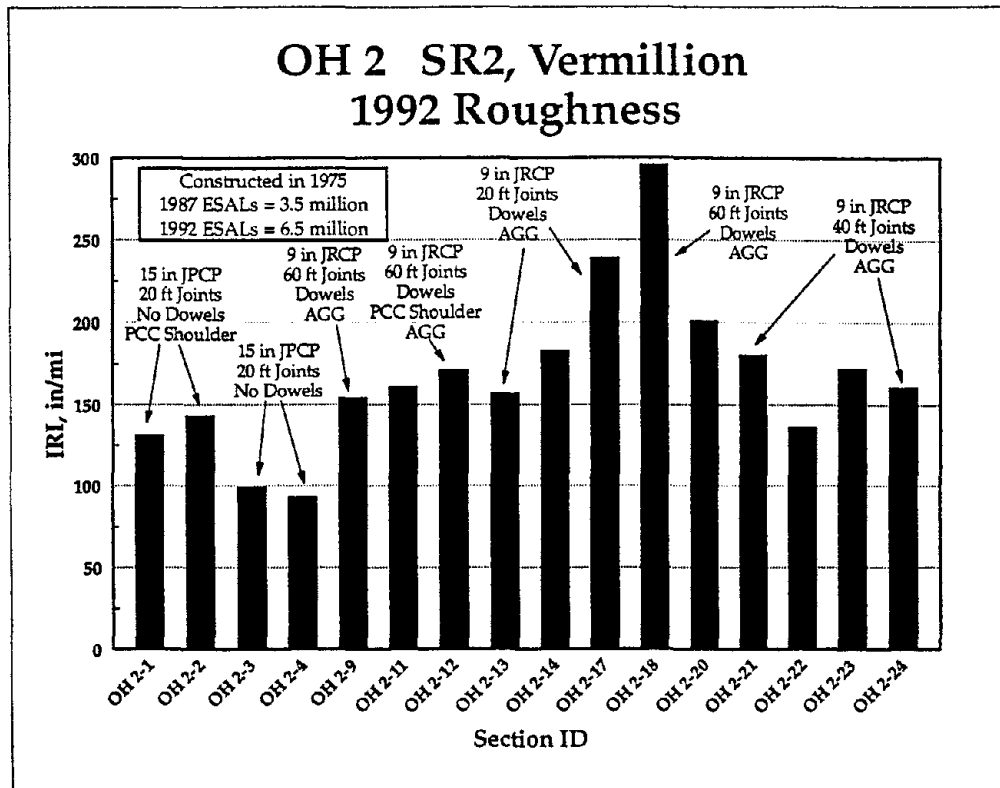
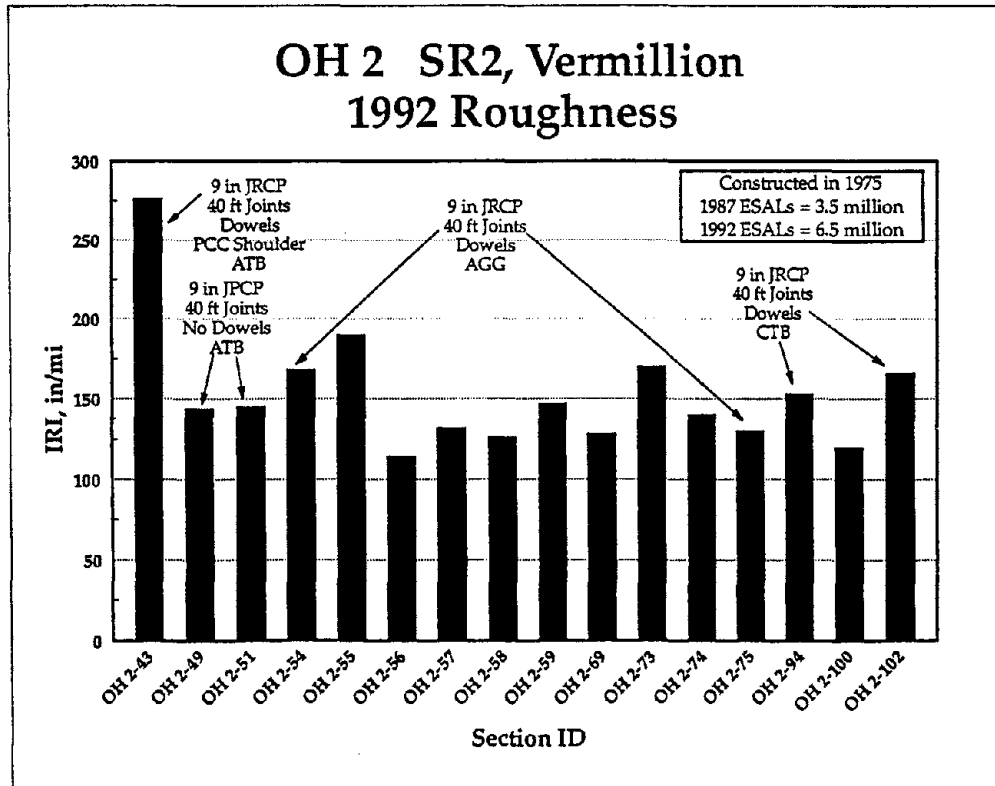
Figure 44. Roughness summary for OH 2 sections.

The roughness data for OH 2 sections are illustrated in figure 44. These sections are extensively deteriorated and very rough. If the IRI is much greater than about 100 in/mi (1.6 m/km), the ride quality on the roadway is generally poor. Most of

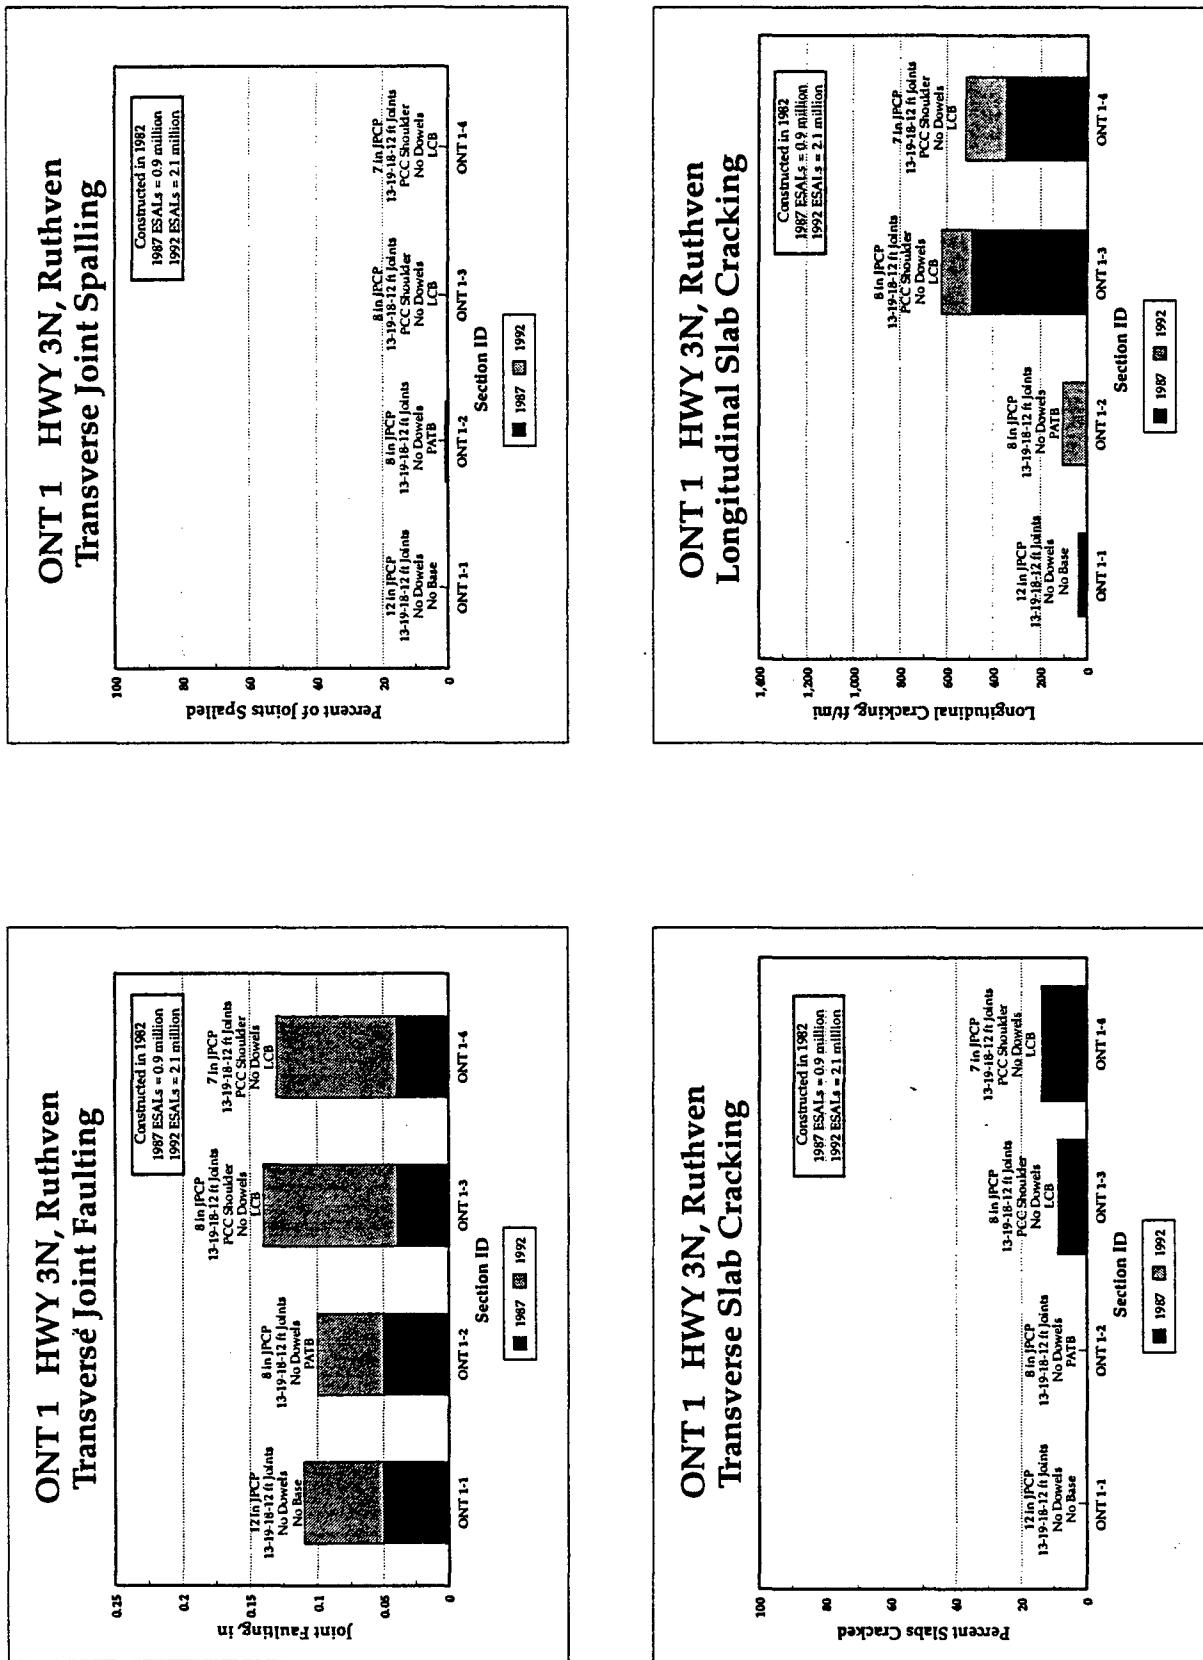
Figure 46. Performance summary for ONT 1 sections.

The performance of these sections is summarized in table 49 and presented graphically in figures 46 through 48. The only major difference in performance of the different sections (designs) on this project appears to be the presence of transverse cracking in those sections constructed on LCB. The differences in slab thickness did not appear to be a significant factor affecting performance. The LCB sections also represent the only sections that have tied concrete shoulders (2-ft [0.6-m] wide) at this project. Because the base type is also a significant factor affecting transverse cracking, a meaningful comparison of the effects of shoulder type on pavement performance is not possible with the ONT 1 sections.

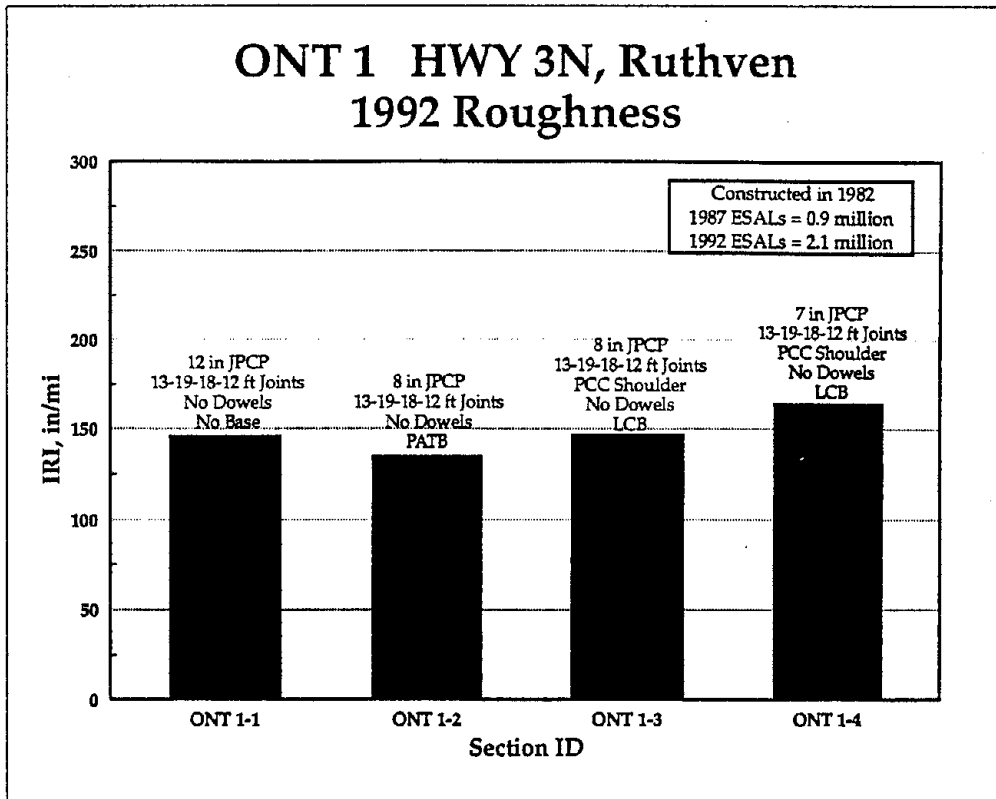
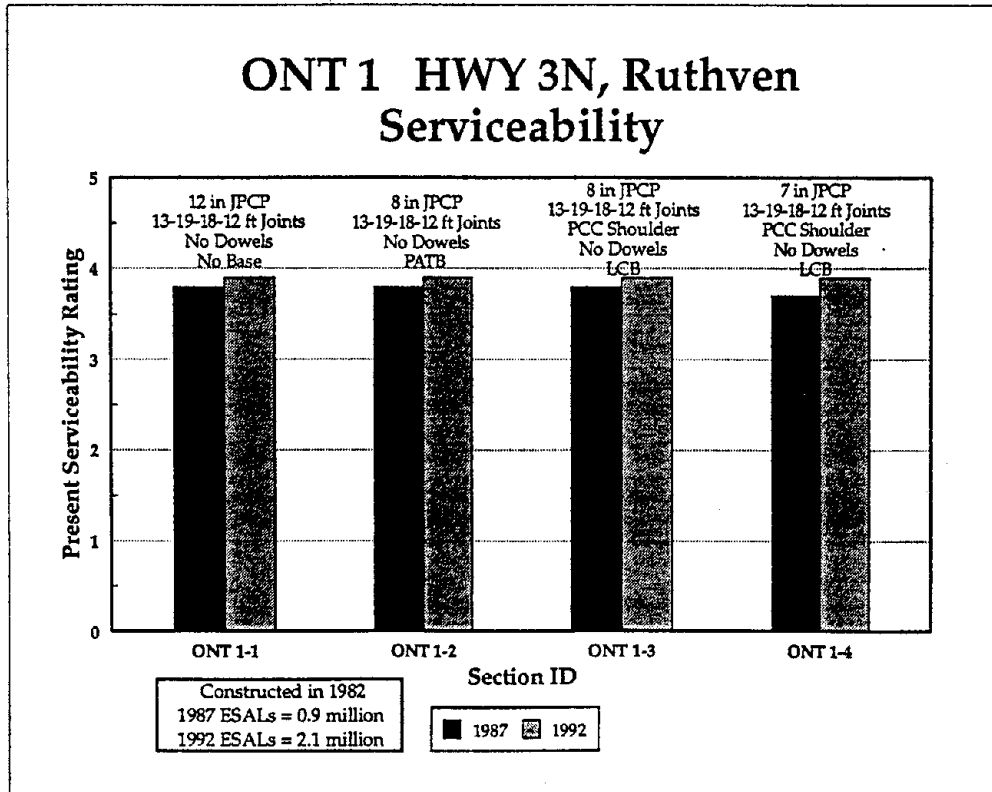
Figure 47. Roughness and serviceability summary for ONT 1 sections.

The roughness and present serviceability data for ONT 1 sections are shown in figure 47. As shown in this figure, both roughness and the perceived ride quality on all sections are similar. A fair amount of roughness was observed on these sections. The primary source of roughness in these sections appears to be joint faulting. Based on PSR, the ride quality over these sections does not appear to have deteriorated since 1987. The PSR for the ONT 1 sections are very high for the IRI values shown (average of about 150 in/mi [2.4 m/km]). The average PSR of 3.8 is typically associated with IRI values far less than 100 in/mi (1.6 m/km).

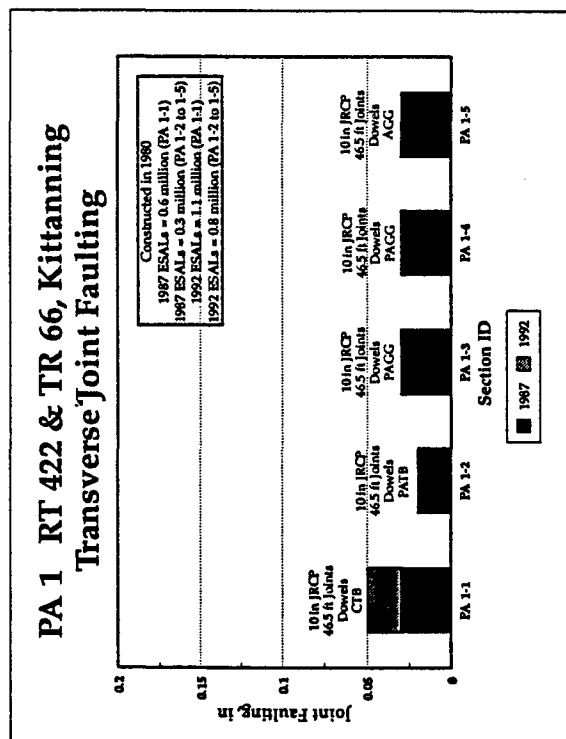
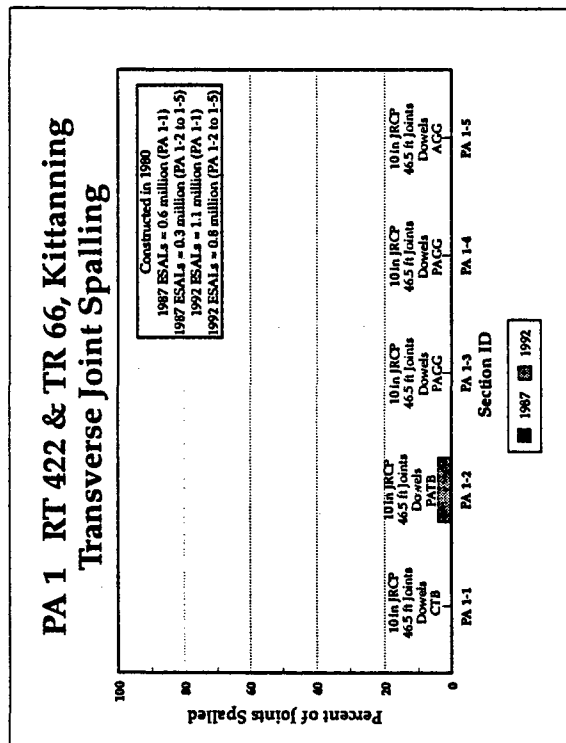
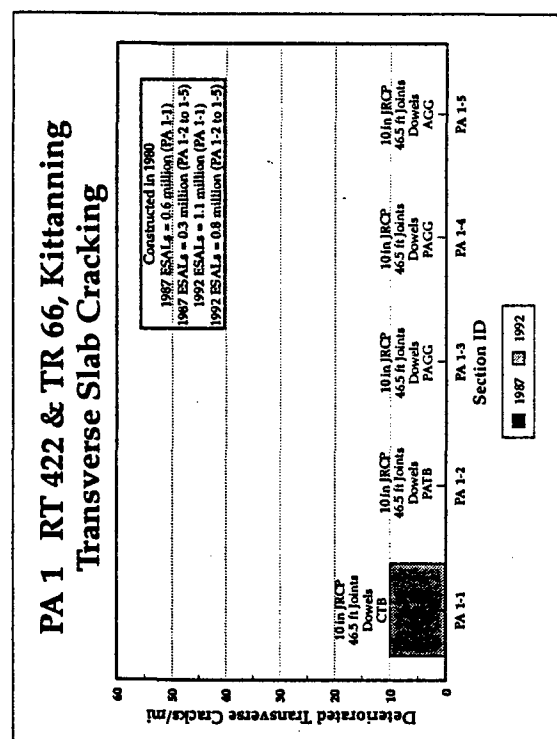
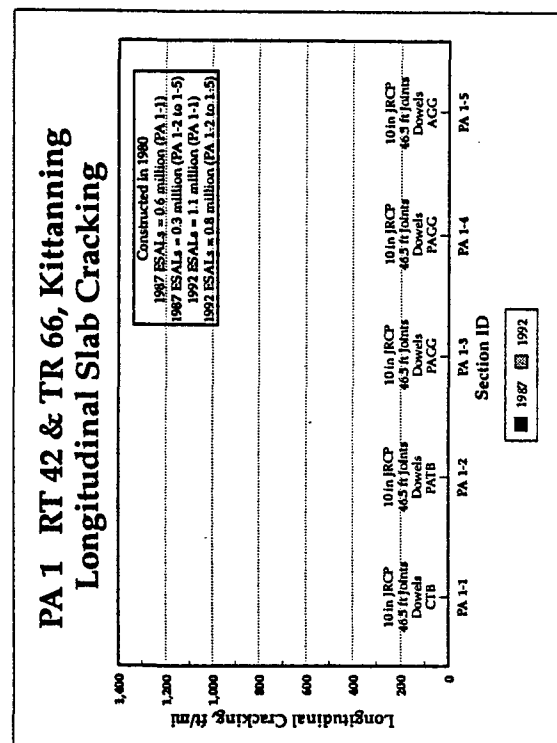
Figure 49. Performance summary for PA 1 sections.

A summary of the outer lane performance data for PA 1 is shown in table 52 and presented graphically in figures 49 through 51. The only significant difference in the performance of the different designs is the deterioration of transverse cracks in PA 1-1, the CTB section. This cracking may be expected since stiffer base leads to higher curling stresses in the slab. No section has an appreciable amount of faulting or spalling at the joints.

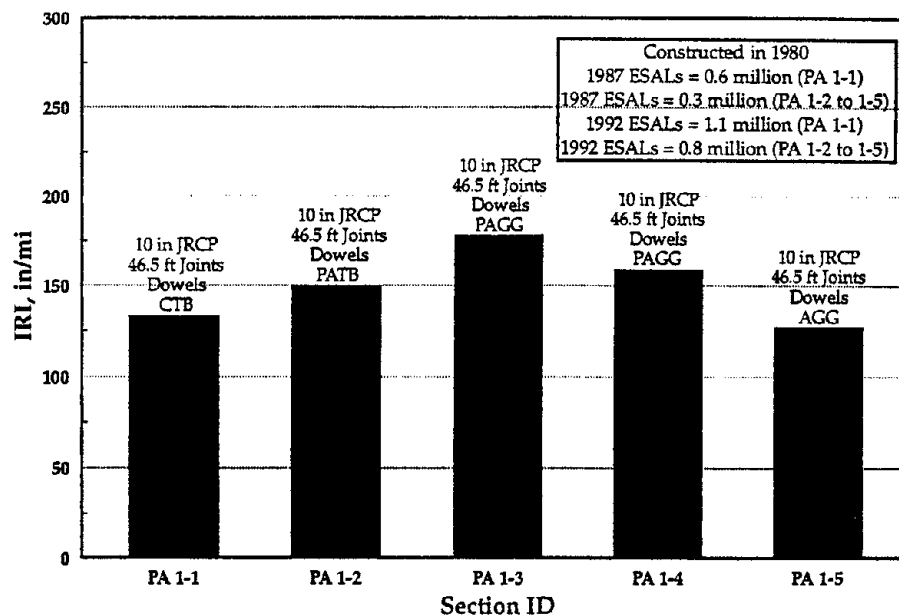
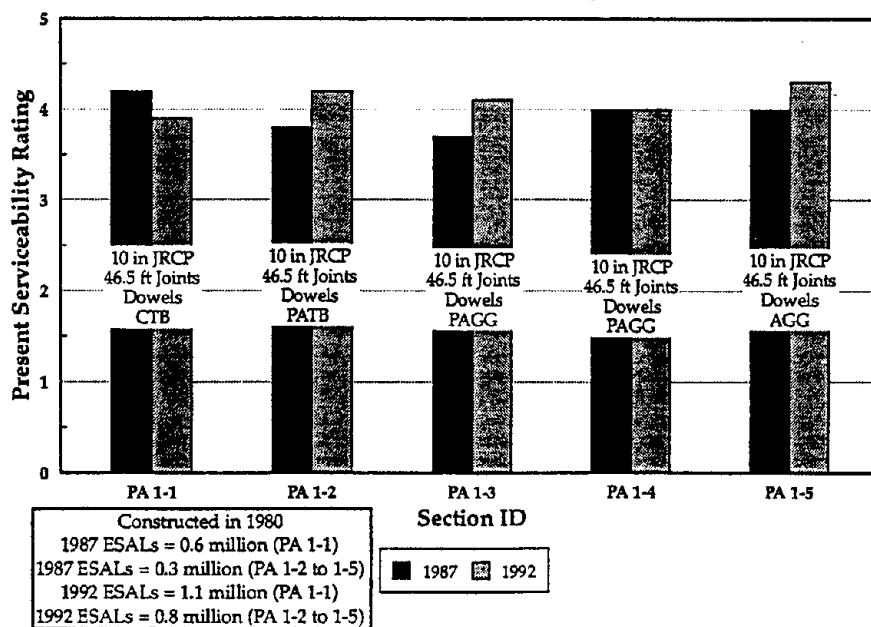
Figure 50. Roughness and serviceability for PA 1 sections.

Roughness and serviceability of PA 1 sections are presented in figure 50. The ride quality on PA 1 sections is very good and all sections have similar serviceability. PA 1-3 has slightly higher IRI than other sections and PA 1-5 is slightly lower. The deviation is relatively small, but the cause of the deviation is difficult to understand. The two sections have similar levels of faulting and exhibit no other distresses.
