Performance of Concrete Pavements

Volume I: Field Investigation

PUBLICATION NO. FHWA-RD-94-177

JULY 1997

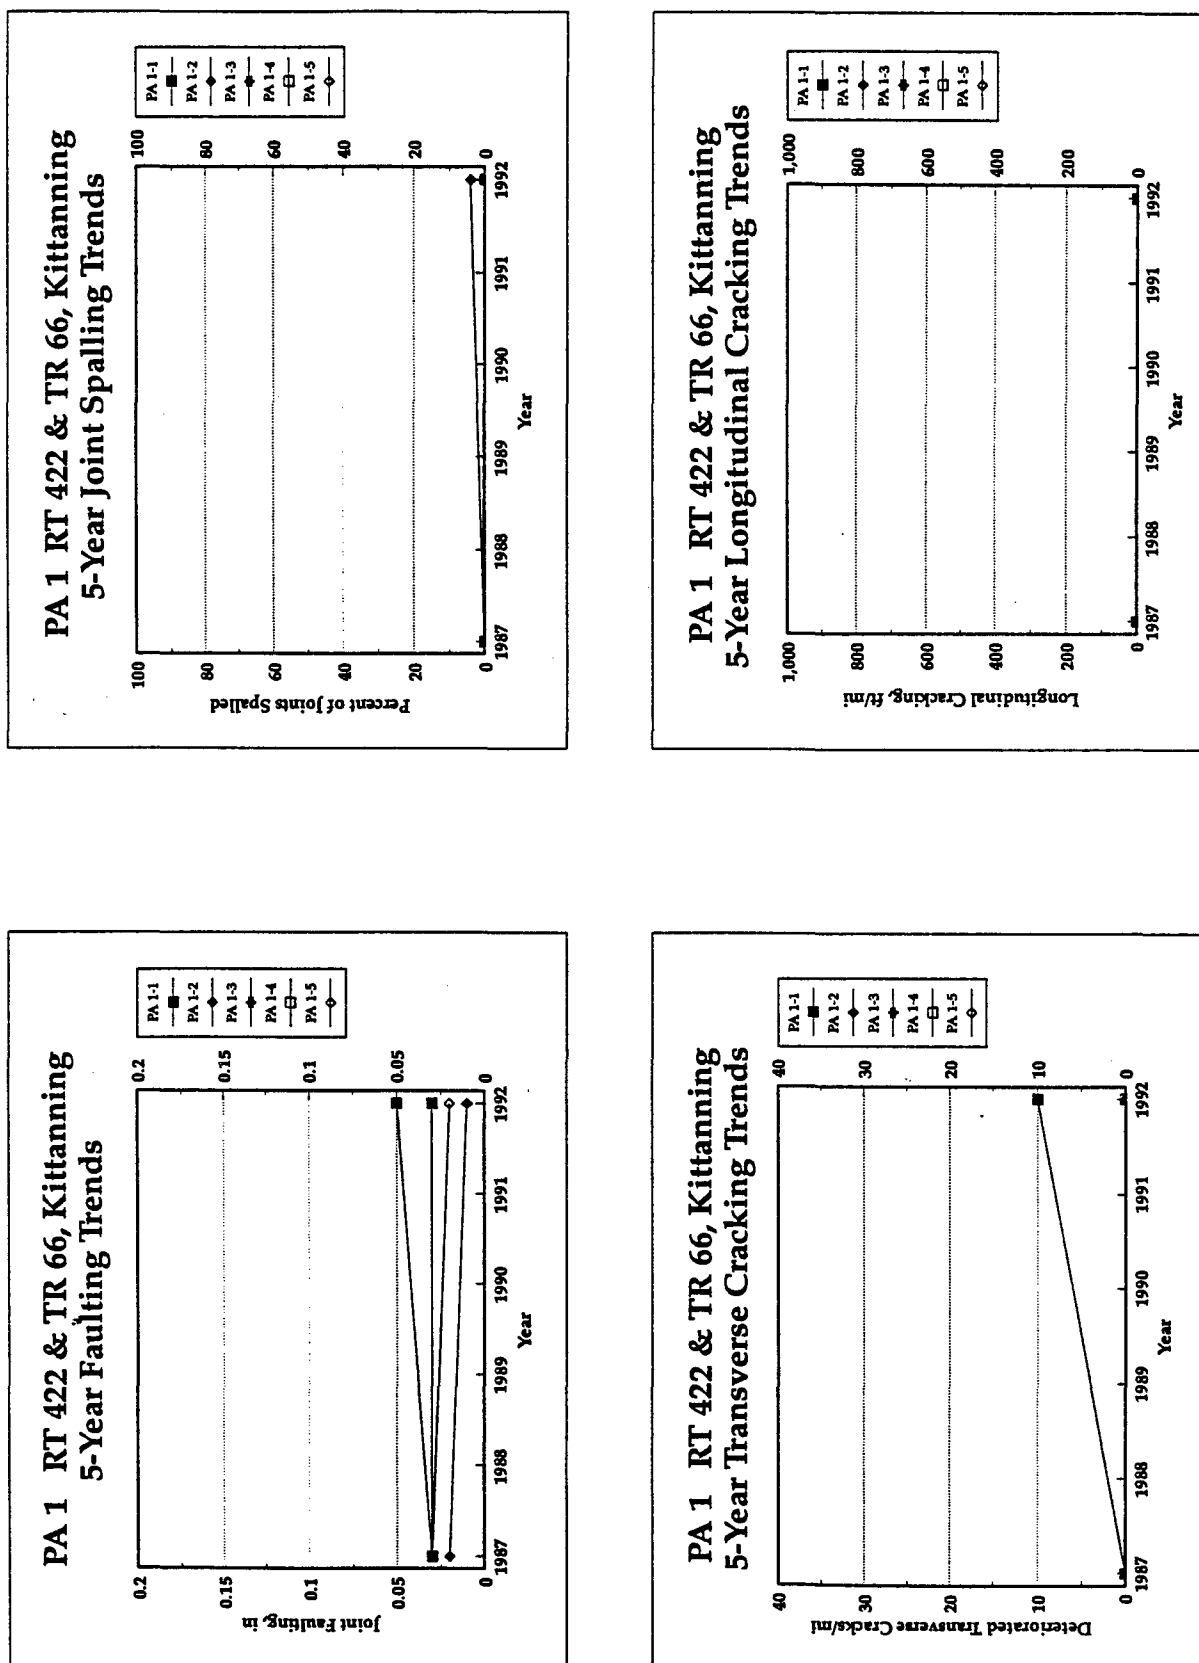
Figure 51. 5-year performance trends for PA 1 sections.

The 5-year performance trends of PA 1 sections is presented in figure 51. The only notable changes since 1987 are the slight increase in the amount of deteriorated transverse cracks and faulting in PA 1-1. PA 1-1 is constructed on a CTB, and is the only section with deteriorated transverse cracks. The amount of faulting in all sections is negligible (average of about 0.03 in [0.8 mm]) and faulting in PA 1-1 is also not significant (0.05 in [1.3 mm]), but while faulting in other sections remained the same since 1987, the faulting in PA 1-1 has roughly doubled. No other significant change was observed.

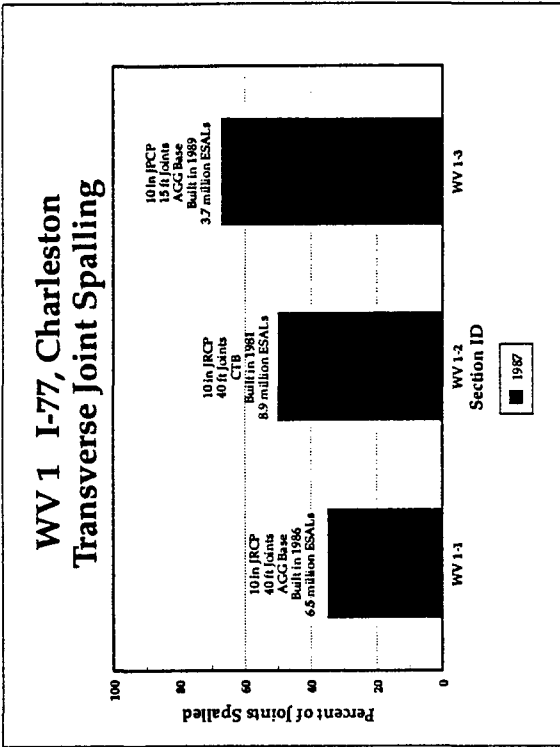
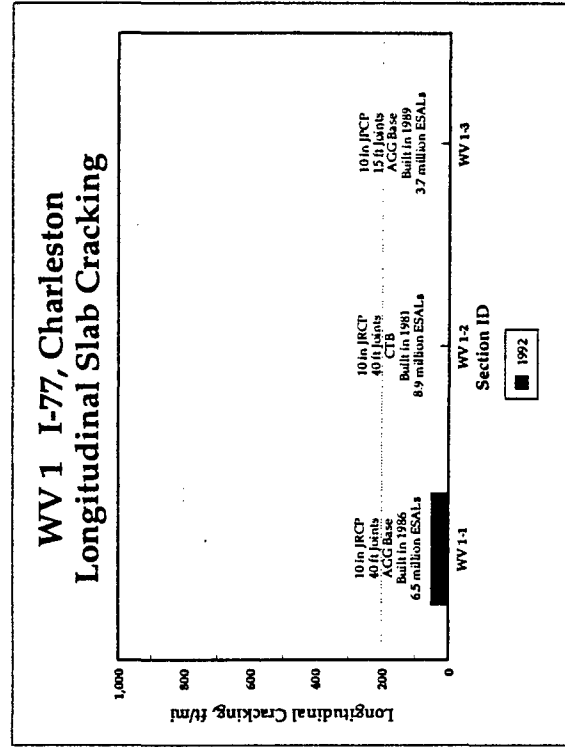
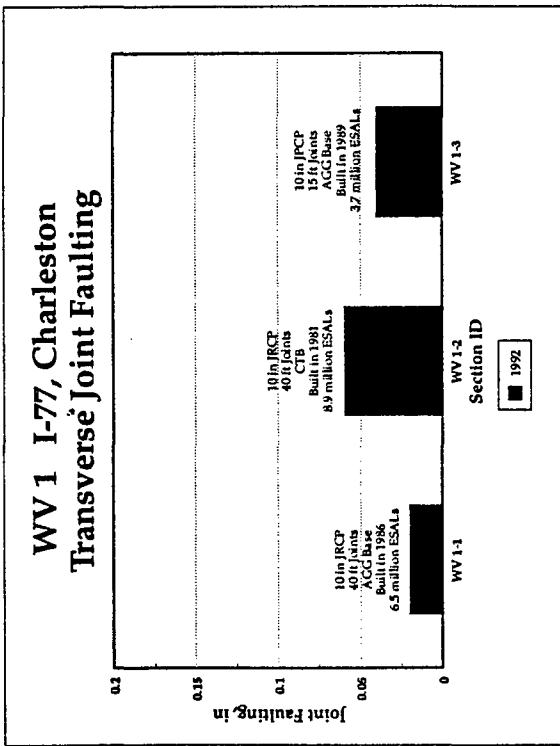
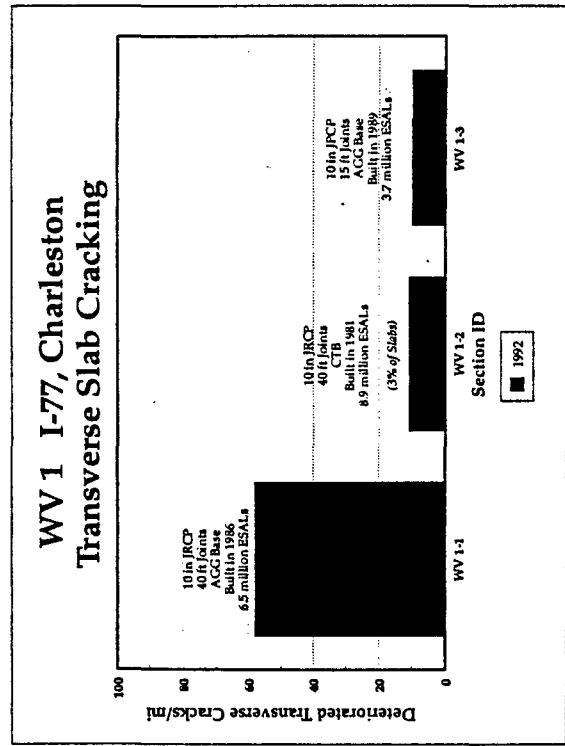
Figure 52. Performance summary for WV 1.

The performance data for these sections are summarized in table 53. Figure 52 presents that data in graphical format. The oldest section (WV 1-2), shows the most faulting of the three sections, although the level of faulting is not that substantial. WV 1-1 shows the most transverse slab cracking, with deteriorated transverse cracks found on nearly one-half of the slabs in the survey section. The small percentage of reinforcing steel (0.1 percent) evidently was unable to hold the transverse cracks tight and prevent them from deteriorating. However, the reason why the transverse cracks have not deteriorated as much on WV 1-2 (which is older than 1-1) is not clear.

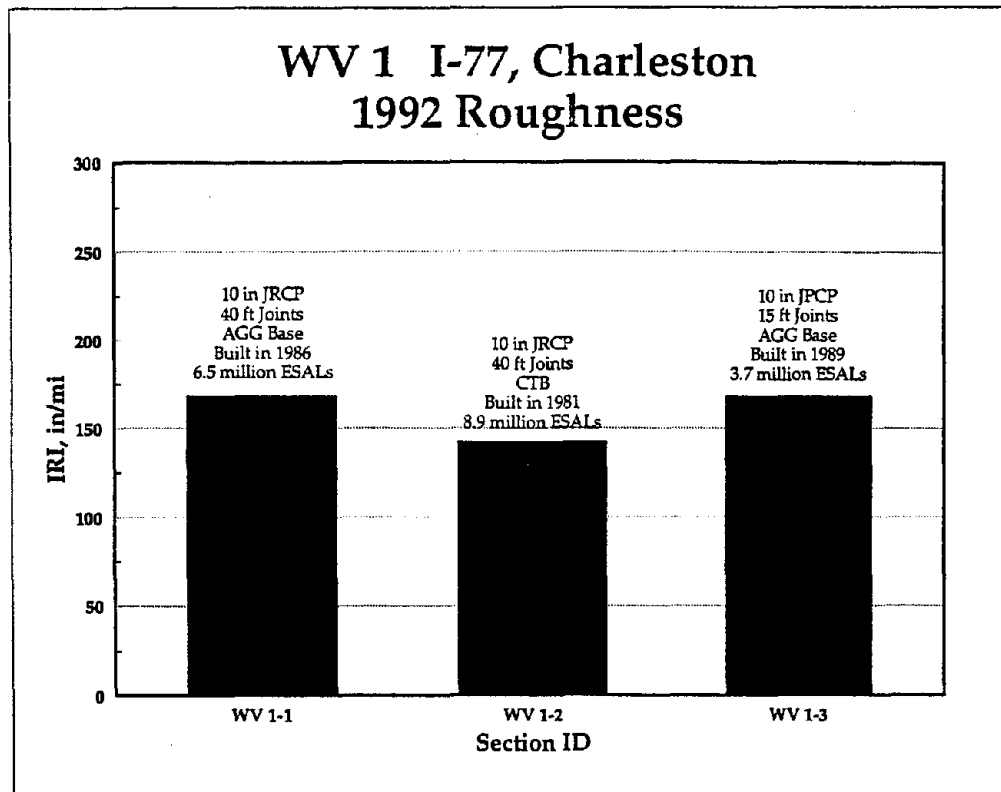
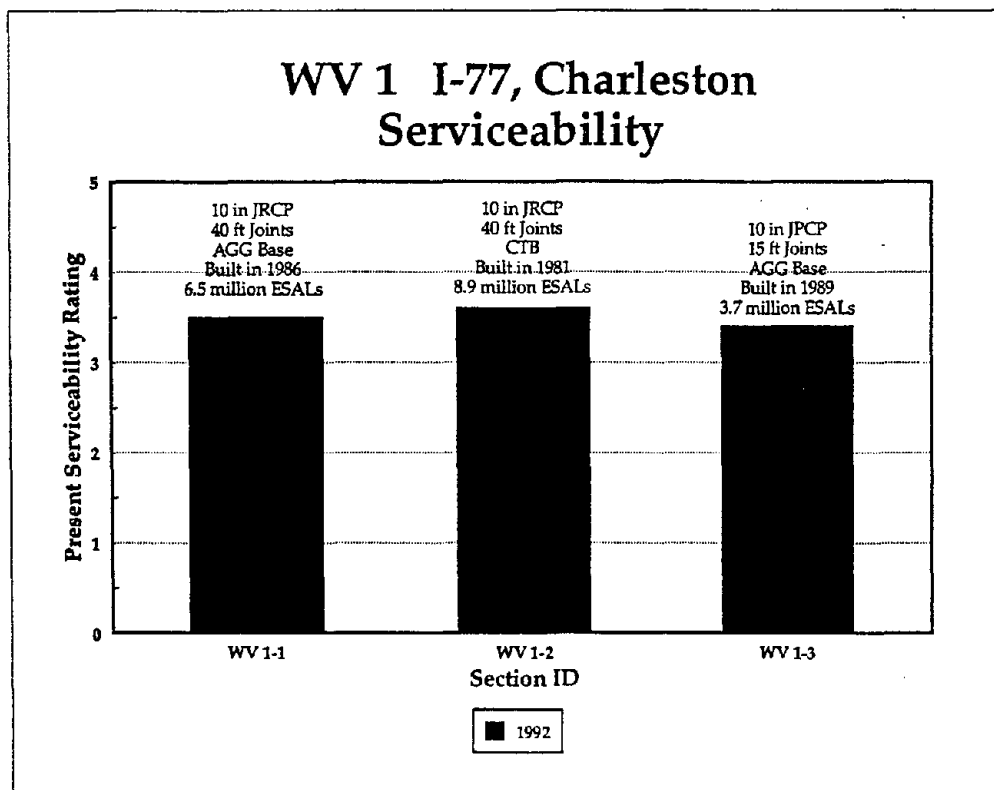
Figure 53. Roughness and serviceability for WV 1.

Roughness and serviceability data for the WV 1 sections are shown in figure 53. The roughness data indicate that section 1-2 is the smoothest riding pavement, with the two newer sections (1-1, 1-3) having the same roughness. These trends also appear in the serviceability data, with section 1-2 having a higher serviceability than the other two sections.

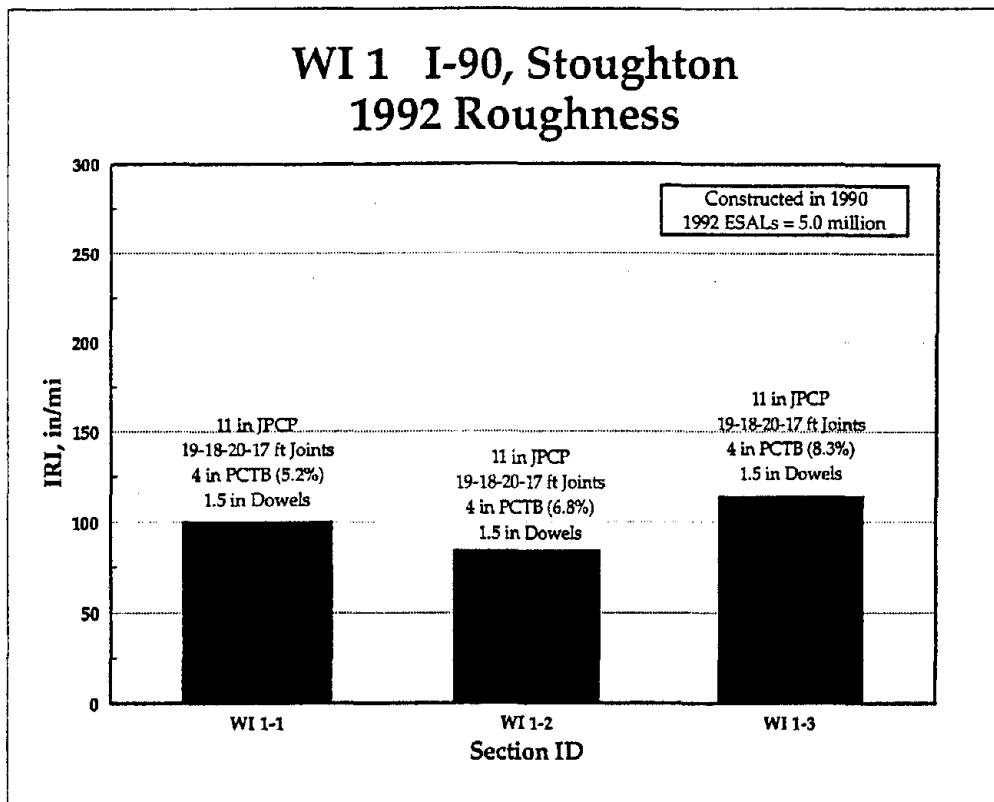
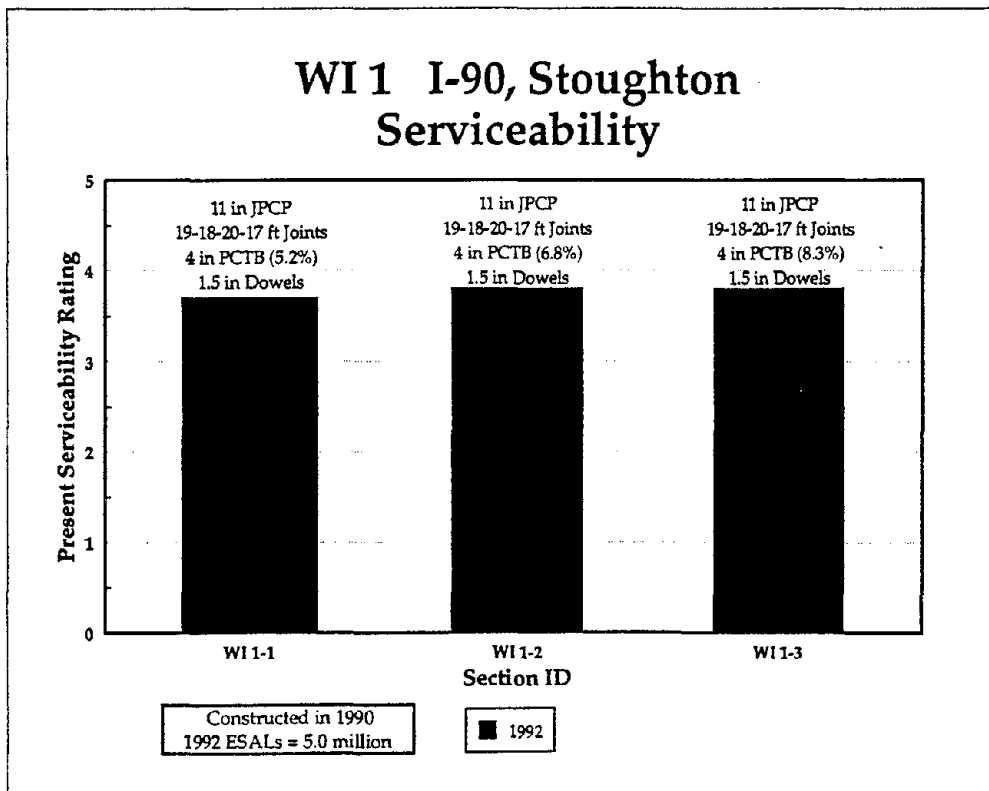
Figure 55. Roughness and serviceability for WI 1.

Figure 55 illustrates the roughness and serviceability data for the WI 1 sections. This information shows that all sections are very smooth, with only small differences in roughness. The serviceability data also indicate that each section is providing good serviceability.

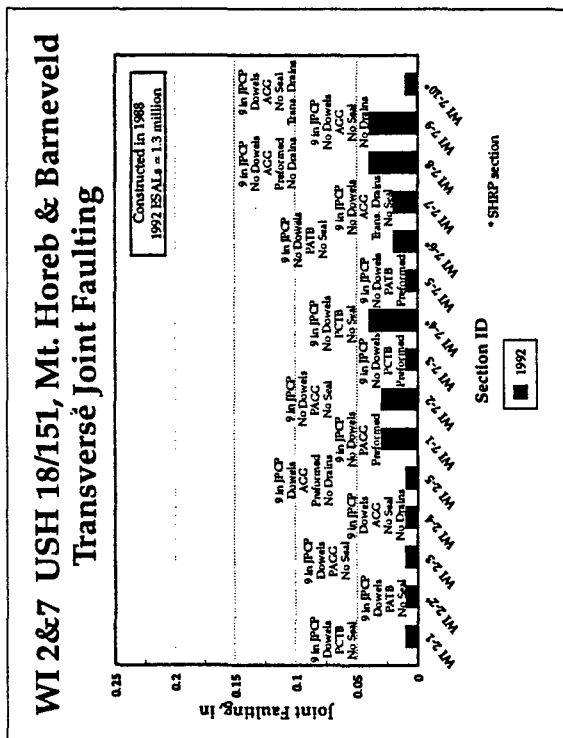
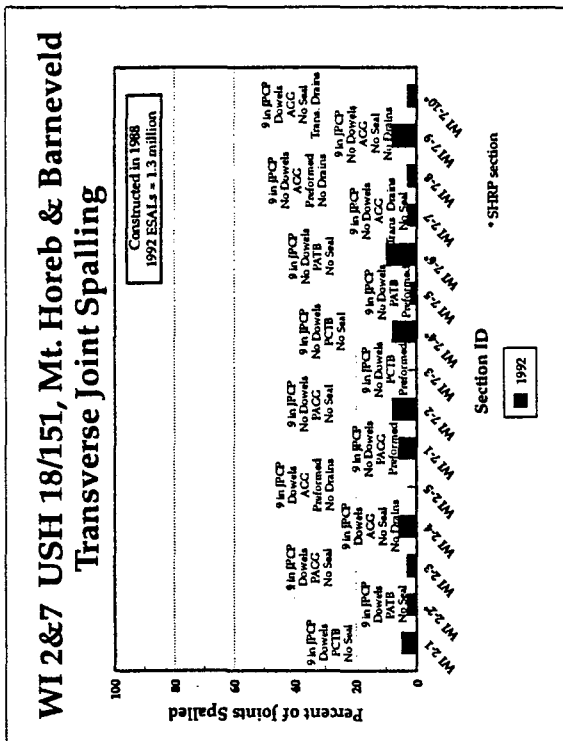
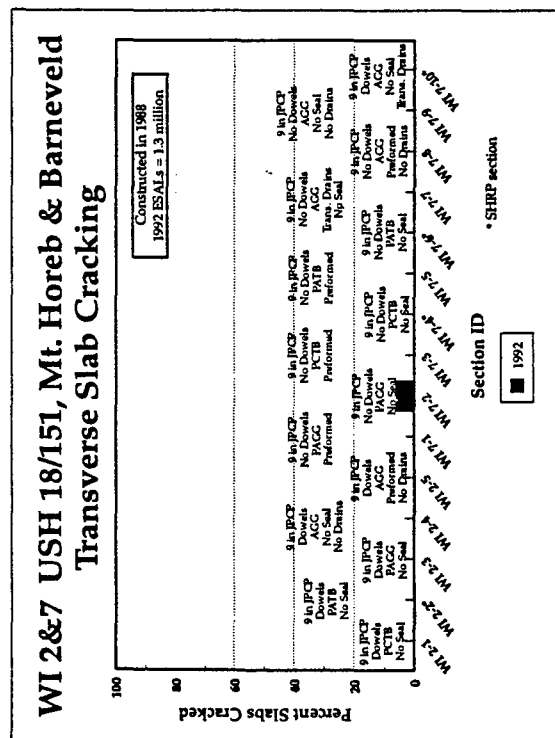
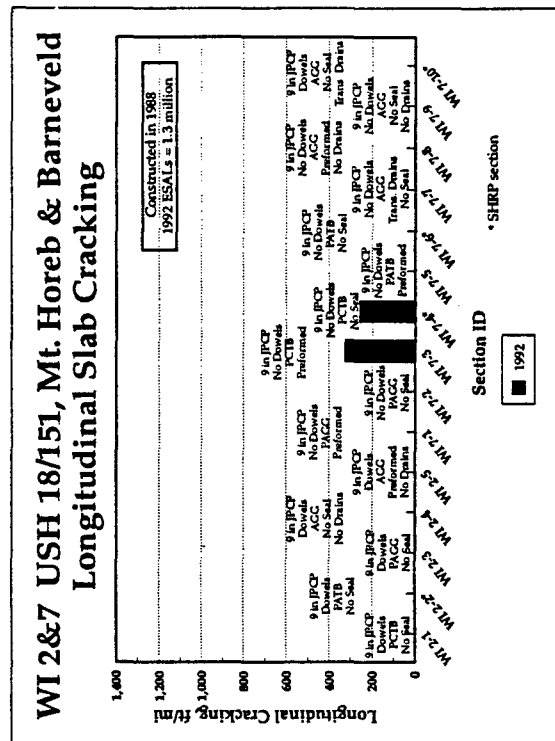
Figure 56. Performance summary for WI 2 and WI 7.

The performance data for the WI 2 and WI 7 experimental sections are presented in table 57 and in figure 56. An examination of this information indicates that these sections are performing very well after 4 years of service. Because of the small amount of distress that has developed, it is difficult to draw definitive conclusions regarding the relative performance of the section. For example, the faulting on the doweled sections is consistently lower than that of the nondoweled sections, although the difference is not significant. As another example, sections with preformed joint seals have less spalling than nonsealed sections, although again the difference is not significant. Finally, the PATB sections show less faulting than the PCTB or the PAGG, but this difference is not significant.

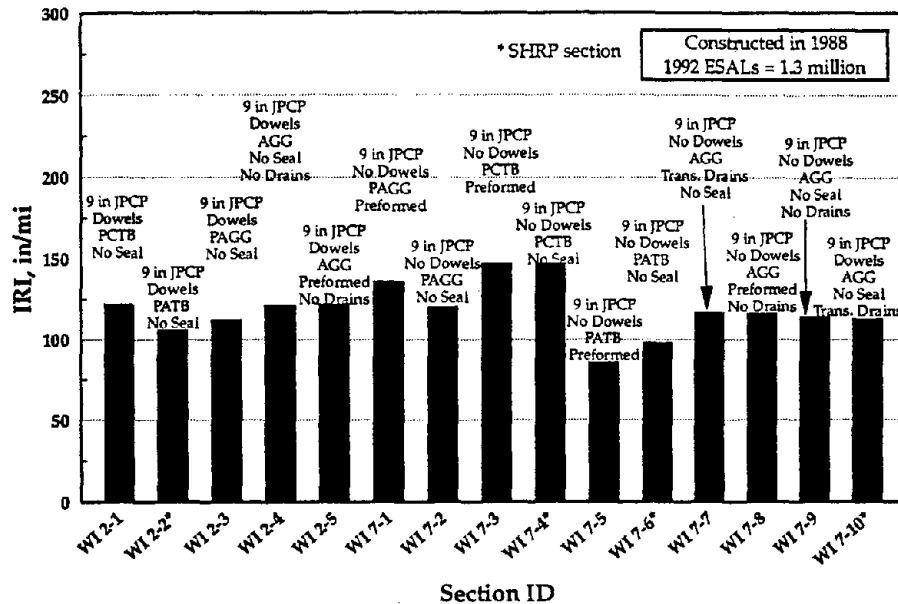
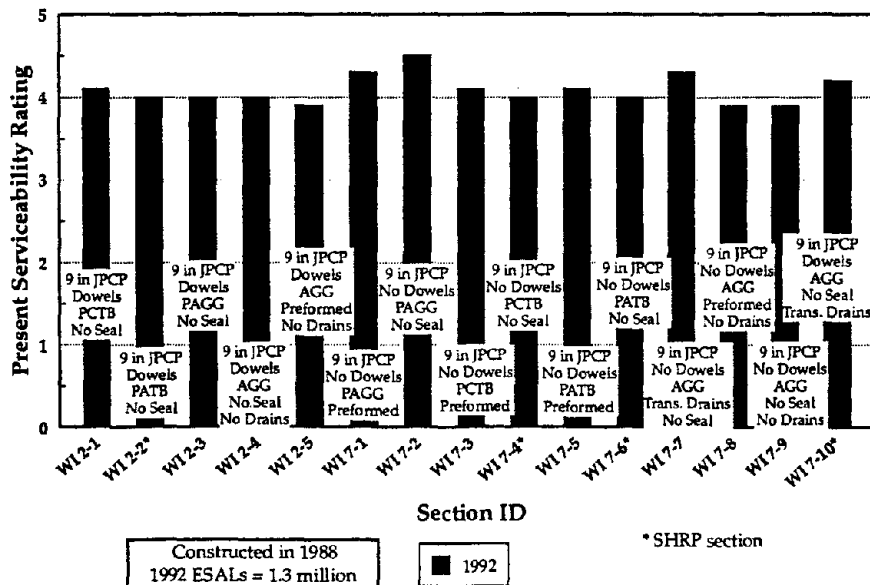
Figure 57. Roughness and serviceability for WI 2 and WI 7.

Figure 57 presents the roughness and serviceability data for the WI 2 and WI 7 sections. The roughness data for most of these sections are clustered relatively close together, with a few exceptions. For example, the smoothest sections on the project are WI 7-5 and WI 7-6, which are both constructed on PATB. This result is in contrast with sections 7-3 and 7-4, which are the two roughest sections on the project and are constructed on PCTB. By also considering section 7-1 (constructed on PAGG), these data may suggest that the PATB can be easily constructed and can provide a stable working platform for paving operations. Often, PAGG can be difficult to construct and may be unstable under construction traffic, exhibiting rutting or shoving. For this reason, some states prohibit hauling on permeable bases.

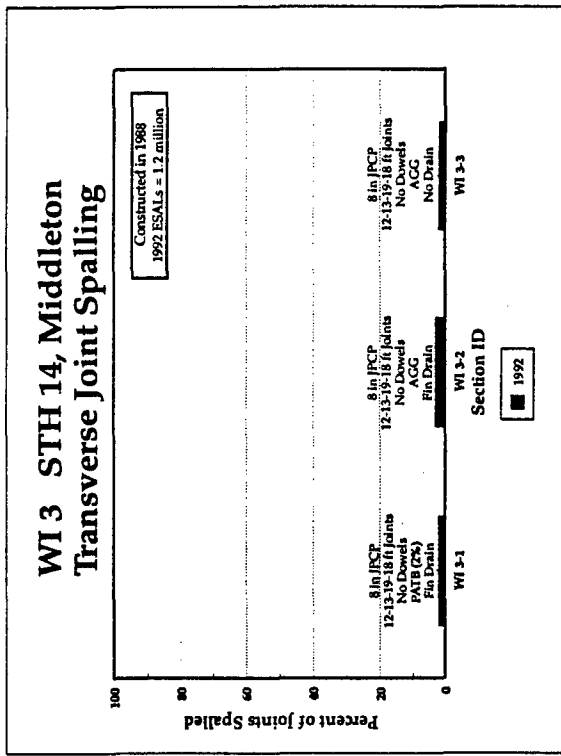
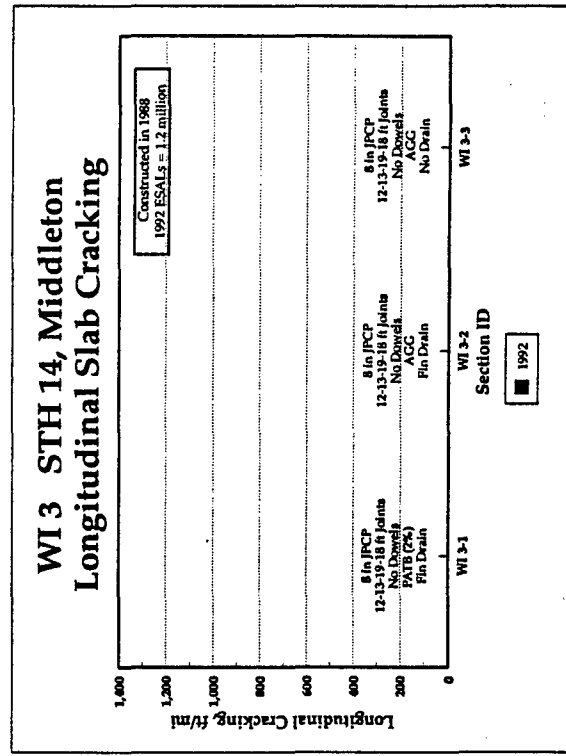
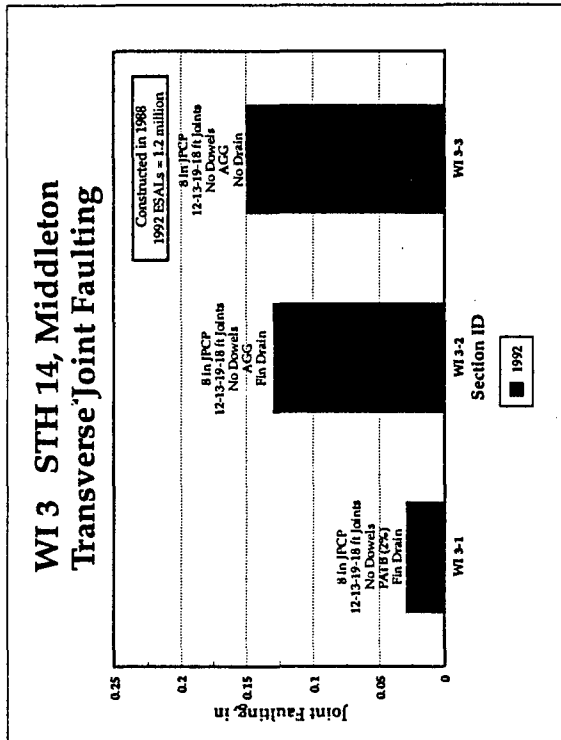
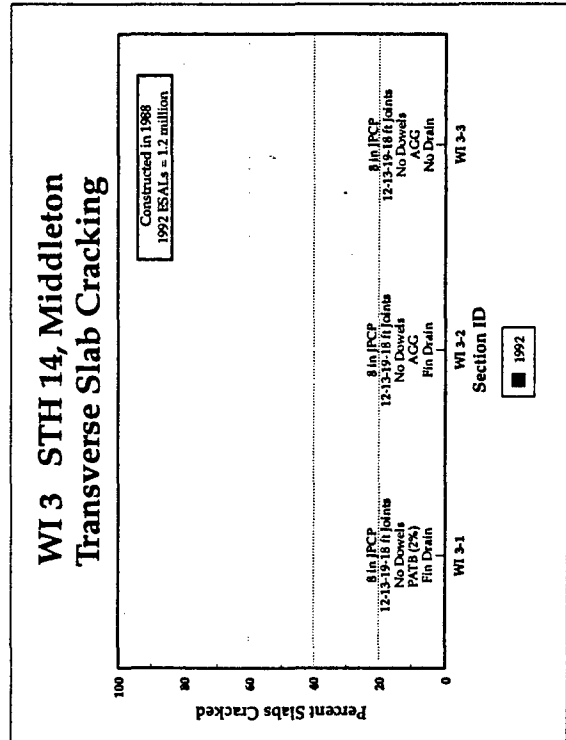
Figure 58. Performance summary for WI 3.

The performance data for this project are summarized in table 59. This information is portrayed in figure 58 in graphical format. With the exception of joint faulting, these sections are relatively free of distress.

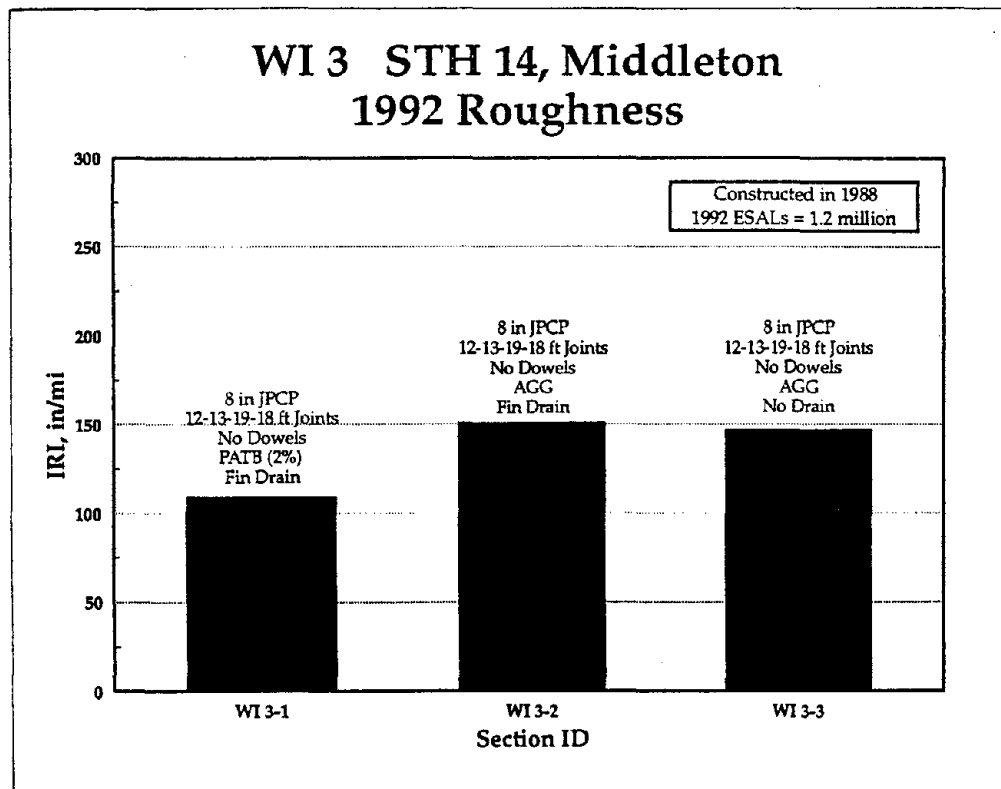
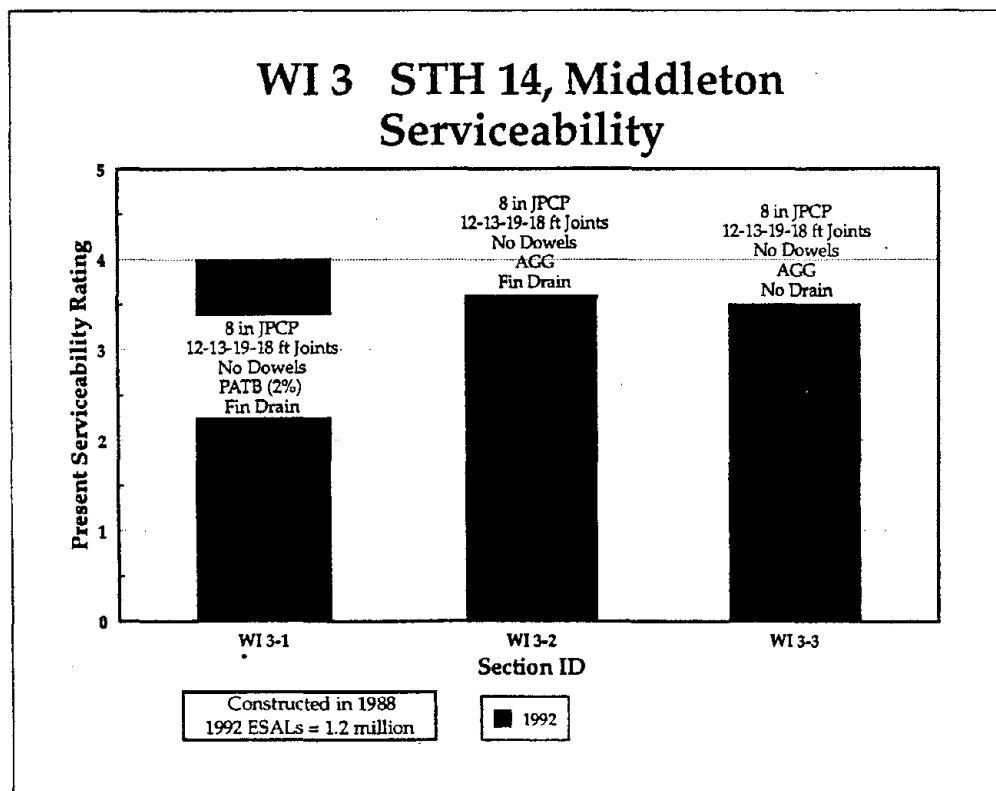
Figure 59. Roughness and serviceability for WI 3.

The roughness and serviceability data for the WI 3 sections are shown in figure 59. This information shows that, as expected, the section constructed on the permeable base is much smoother and has a higher serviceability rating than the other two sections. The critical levels of faulting exhibited by WI 3-2 and 3-3 no doubt contribute to the roughness recorded on those sections.

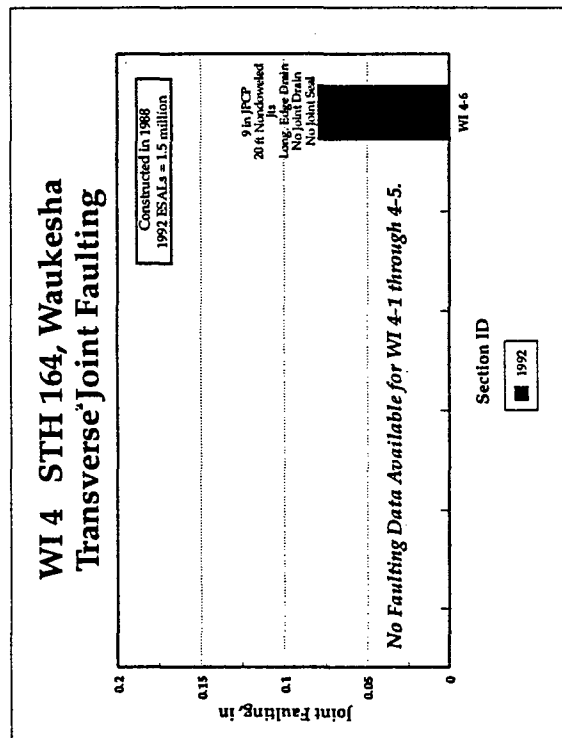
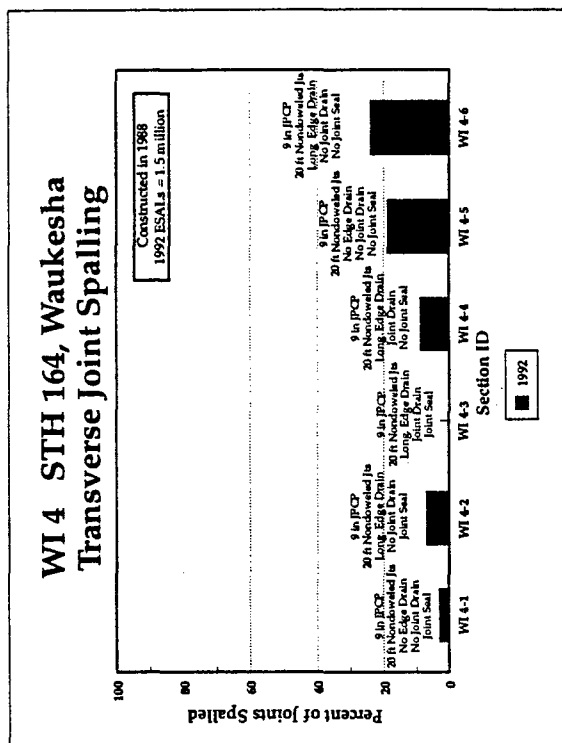
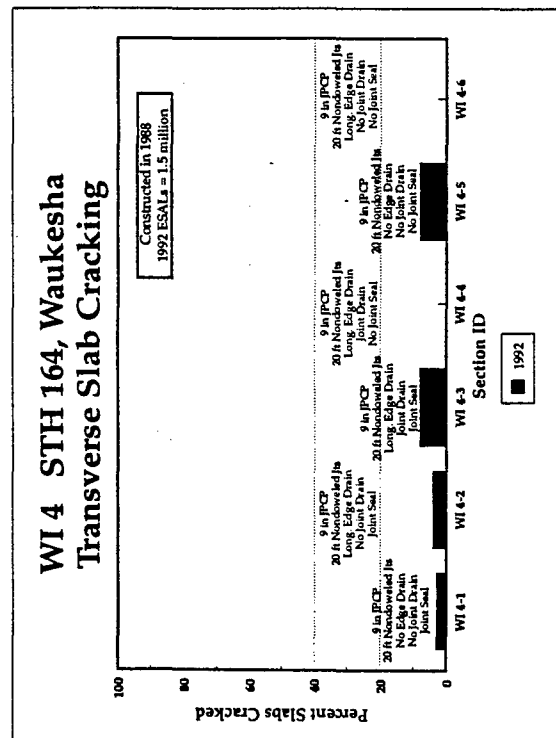
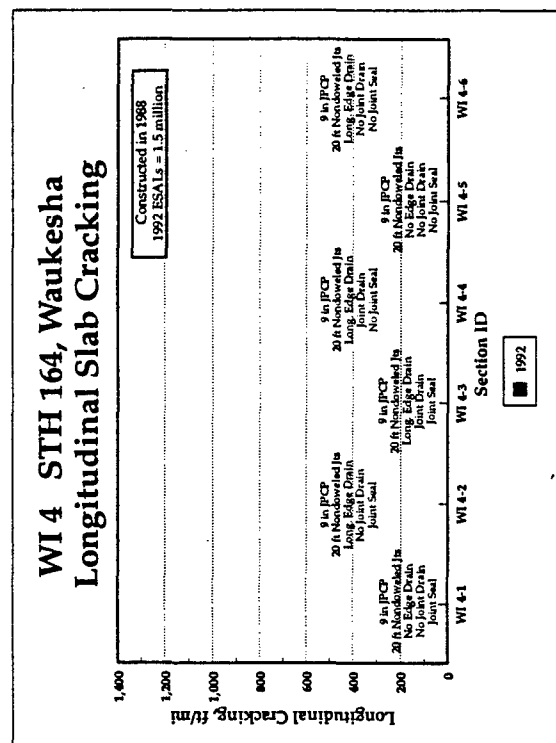
Figure 60. Performance summary for WI 4.

The available performance data for the WI 4 sections are provided in table 61 and displayed graphically in figure 60. The age of these sections (4 years) and the absence of faulting data for all but one section make the interpretation of the data difficult. The amount of faulting exhibited by WI 4-6 (0.08 in [2 mm]) is considered somewhat high for a pavement that is only 4 years old. When the faulting of section WI 4-6 is considered in conjunction with the faulting of WI 3-2, it appears to suggest that the presence of edge drains by themselves are not enough to ensure the reduction of faulting for nondoweled slabs.

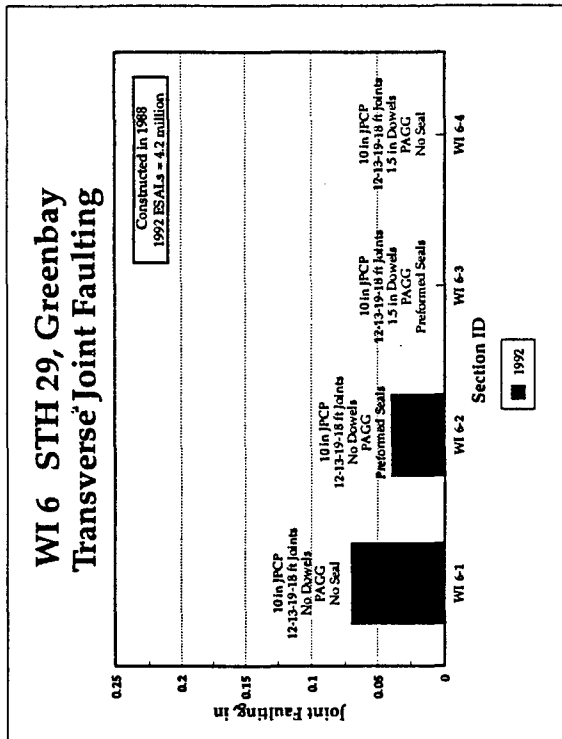
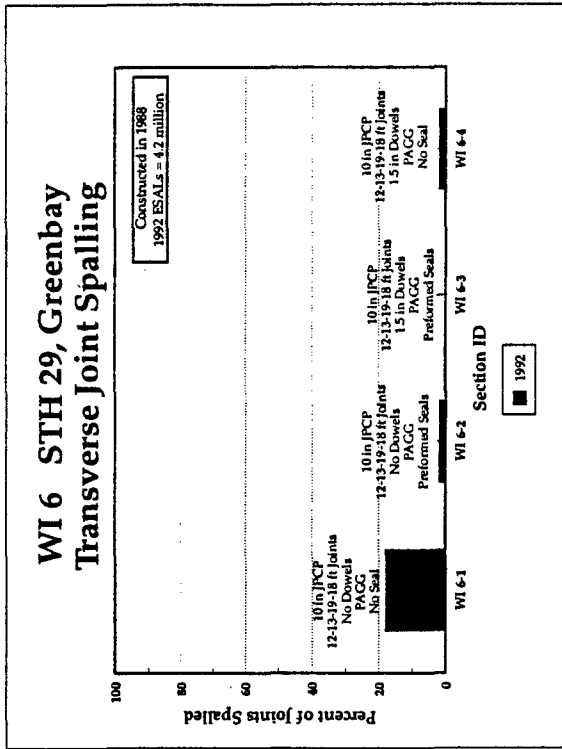
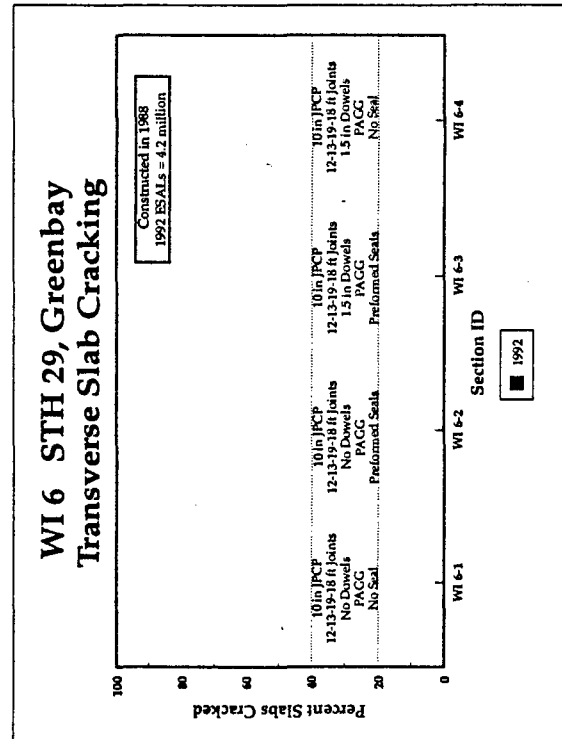
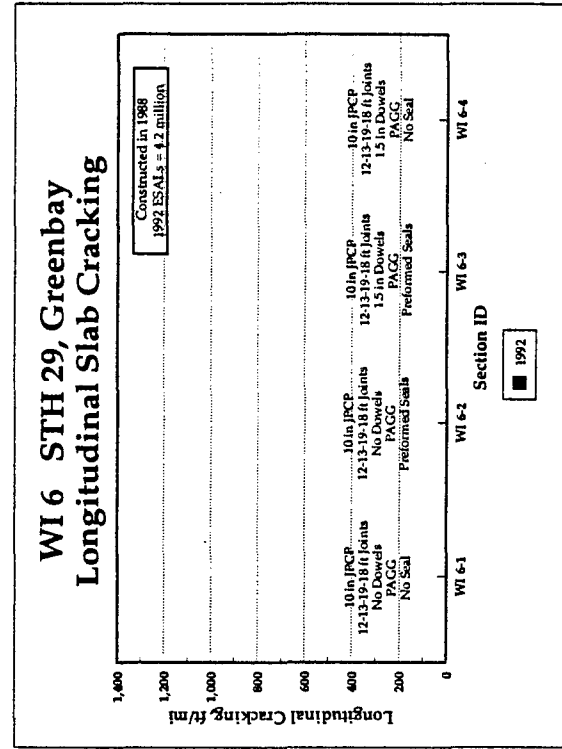
Figure 64. Performance summary for WI 6.

The performance data for these sections are given in table 65 and in figure 64. This information clearly shows the benefits of dowel bars in reducing joint faulting, even after only 4 years of service. The doweled sections are showing no faulting, whereas both of the nondoweled sections are exhibiting significant levels of faulting for a 4-year-old pavement.

The preformed compression seal is apparently working well, as the sections with sealed joints are displaying less joint spalling than the nonsealed joints. In particular, WI 6-1 is exhibiting a substantial amount of medium- and high-severity joint spalling. Although some sections are showing some faulting and spalling, no sections are displaying any transverse or longitudinal cracking.

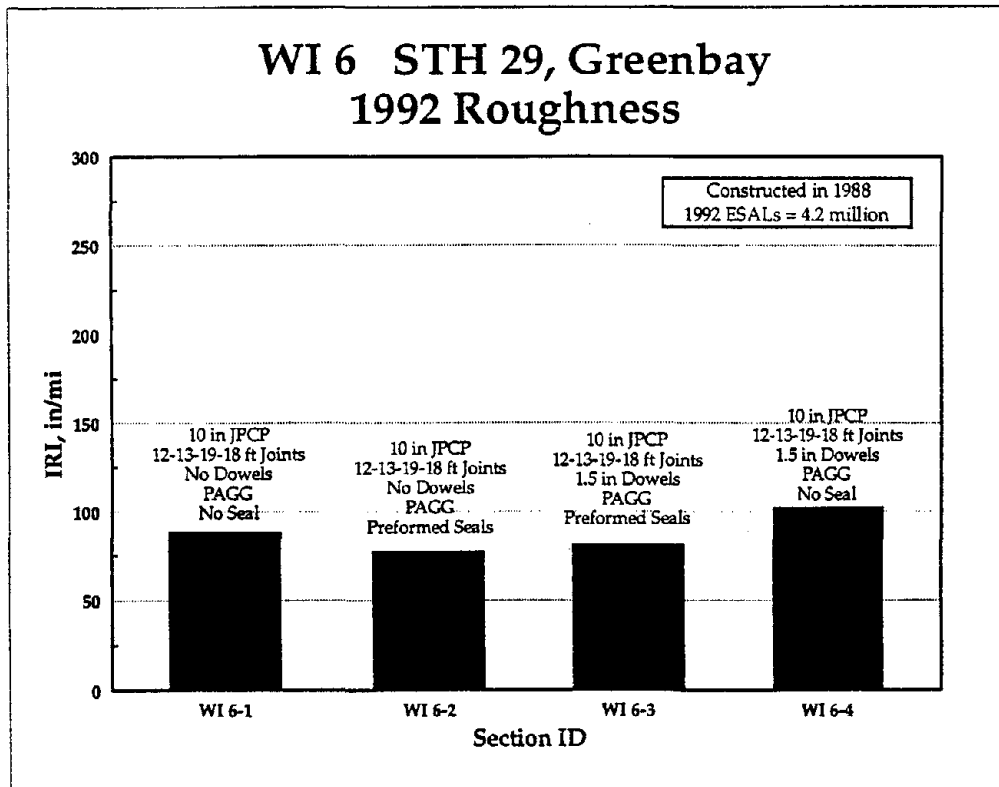
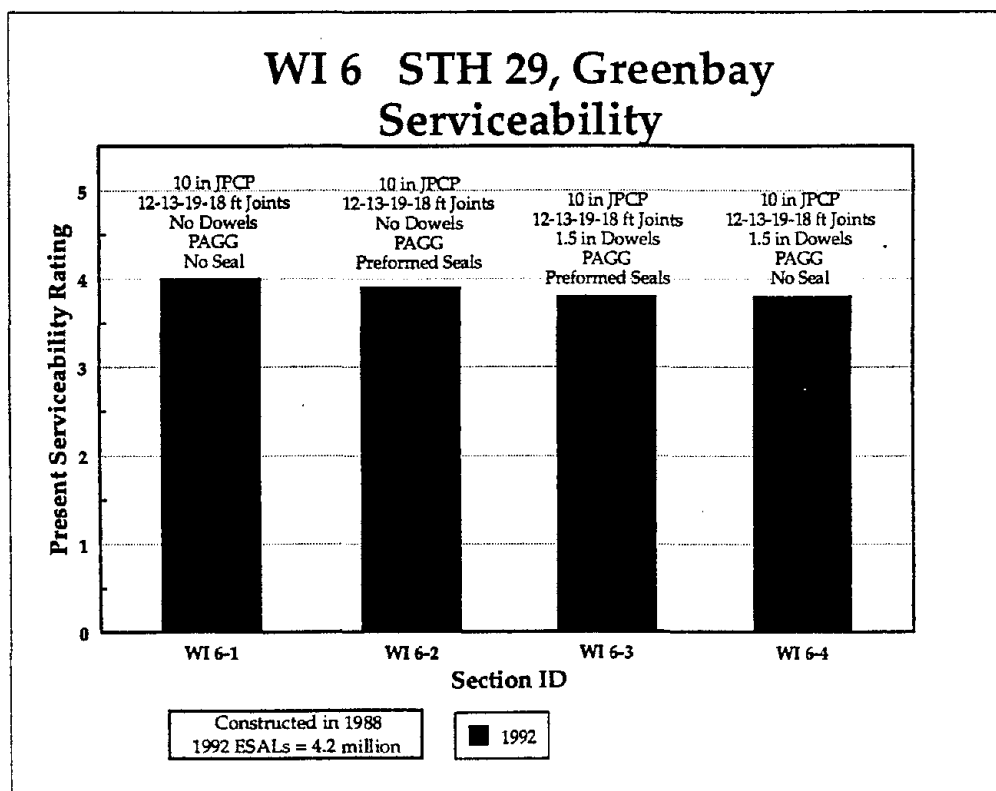
Figure 65. Roughness and serviceability for WI 6.

Figure 65 illustrates the roughness and serviceability data for these sections. The roughness data indicate that these sections are very smooth with little perceptible differences between pavement sections. The serviceability data also indicate the excellent rideability furnished by these sections.

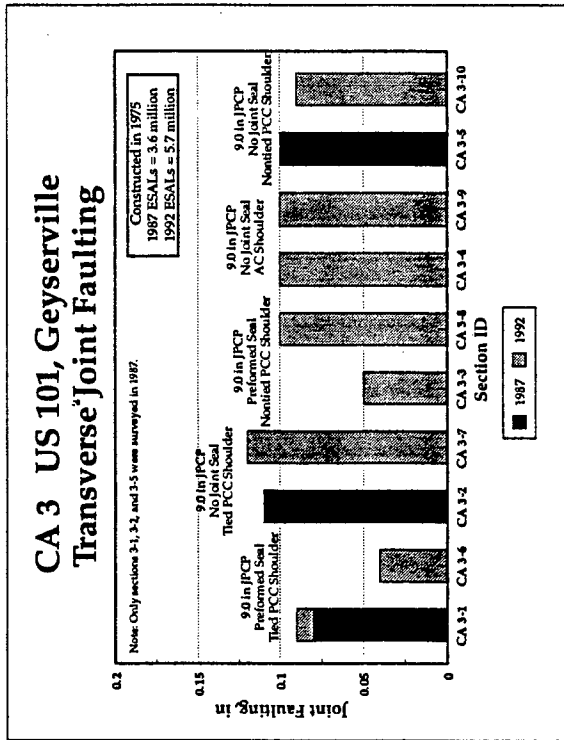
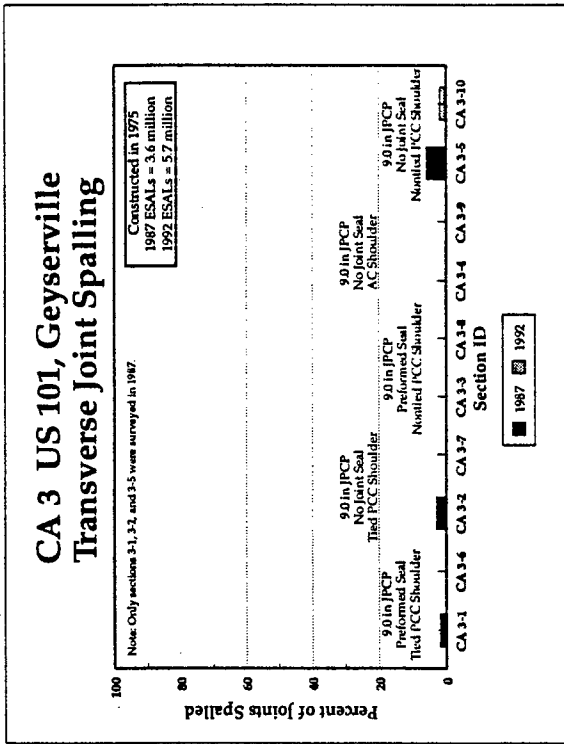
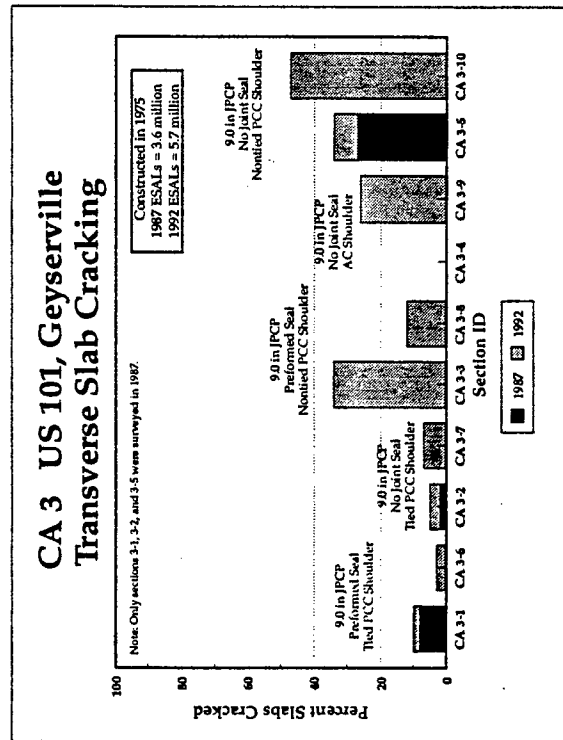
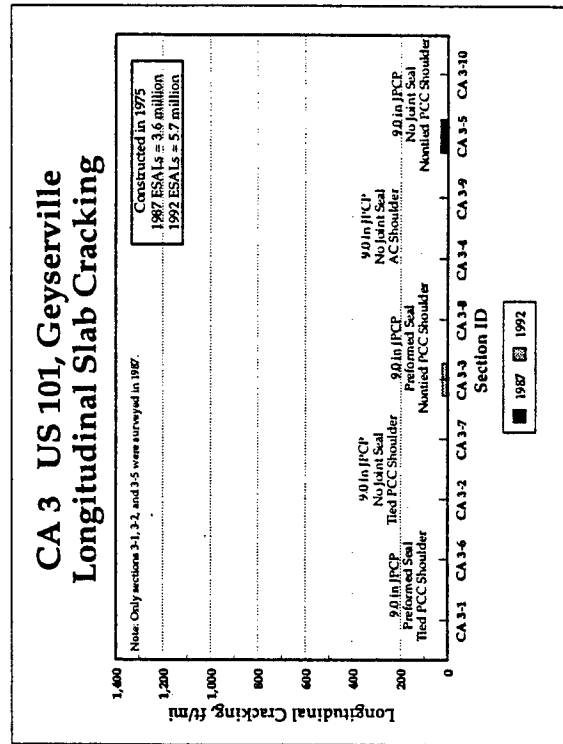
Figure 66. Performance summary for CA 3.

The performance of these sections is summarized in table 67 and in figure 66. The effect of joint sealing can be examined by comparing the performance of CA 3-1 and CA 3-6 with CA 3-2 and CA 3-7, and by comparing CA 3-3 and CA 3-8 with CA 3-5 and CA 3-10. For the first group of sections with a tied PCC shoulder, the sections that are sealed are performing better than those that are not sealed. They have lower levels of faulting and joint spalling, although the amount of joint spalling that has developed on the nonsealed sections is not significant. Transverse cracking is about the same for both groups of sections.

For the sections constructed with nontied PCC shoulders, the sealed sections show no spalling while the nonsealed exhibit a small quantity of spalled joints. The sealed sections also show less transverse cracking, although the faulting is about the same for the sealed and nonsealed sections.

Evaluating the effect of shoulder type revealed that sections with tied PCC shoulders have fewer transverse cracks than other shoulder types. The additional support provided to the slab by the tied shoulder apparently was effective in reducing the magnitude of the critical edge stress, thereby reducing the amount of transverse cracking. In addition, the tied shoulder appeared to have a slight effect in reducing joint faulting. The sections with AC shoulders exhibited fewer transverse cracks than the sections without tied PCC shoulders and about the same number of transverse cracks as the sections with tied PCC shoulders. This phenomenon is likely

related to the ineffective shoulder tie bar design system. However, the sections with AC shoulders had more faulting than the sections with tied PCC shoulders.
