Performance of Concrete Pavements

Volume I: Field Investigation

PUBLICATION NO. FHWA-RD-94-177

JULY 1997

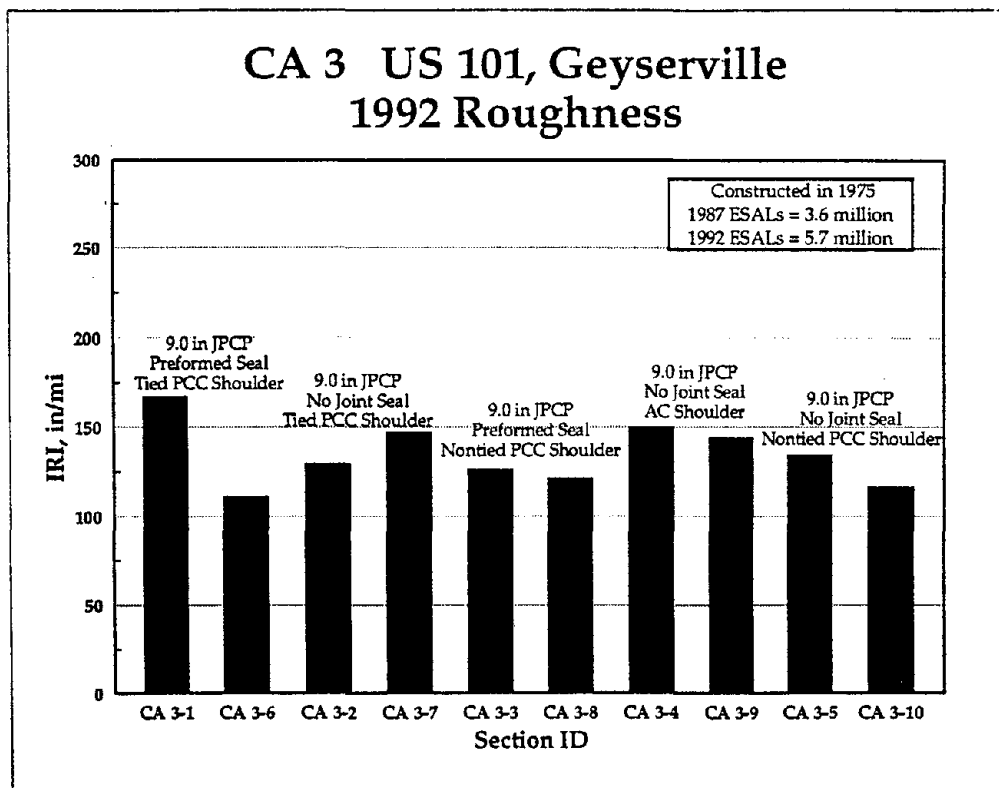
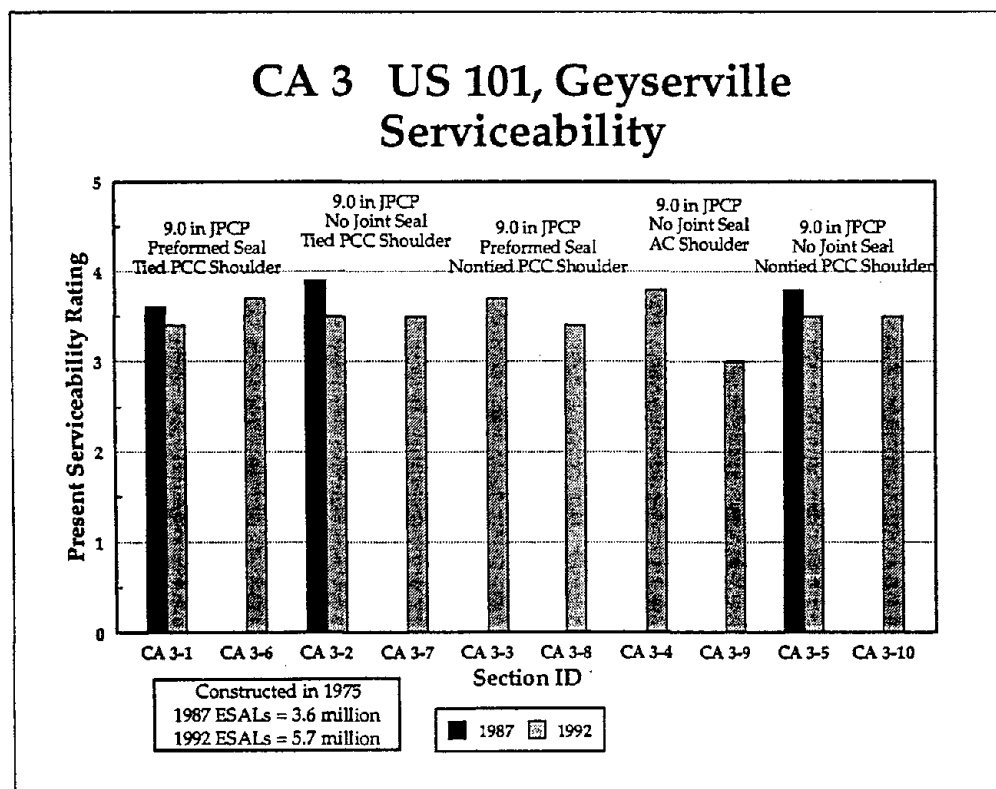
Figure 67. Roughness and serviceability for CA 3.

Figure 67 shows the roughness and serviceability data for the CA 3 sections. The roughness data show that the smoothest pavement is section 3-6, which contains sealed joints and a tied PCC shoulder. However, several of the sections with nontied PCC shoulders are also providing a smooth-riding surface. Overall, the roughest group of pavement sections are those constructed with AC shoulders. Similar observations are apparent from an examination of the serviceability data.

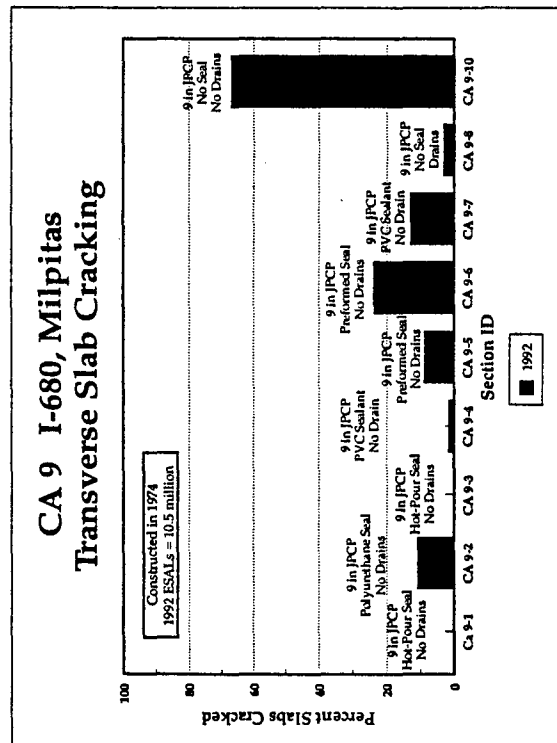
Figure 69. Performance summary for CA 9.

Table 69 and figure 69 present the performance data for the outer traffic lane of the CA 9 sections. The six sections for which faulting measurements are available are all exhibiting significant levels of faulting (0.10 to 0.15 in (2.5 to 3.8 mm), and high-severity pumping was noted on each section. The section exhibiting the least amount

Overall, some of the sealed sections are performing better than the control section, particularly in terms of transverse cracking. However, even after 18 years, it remains to be seen what effects the sealants will have on joint spalling.

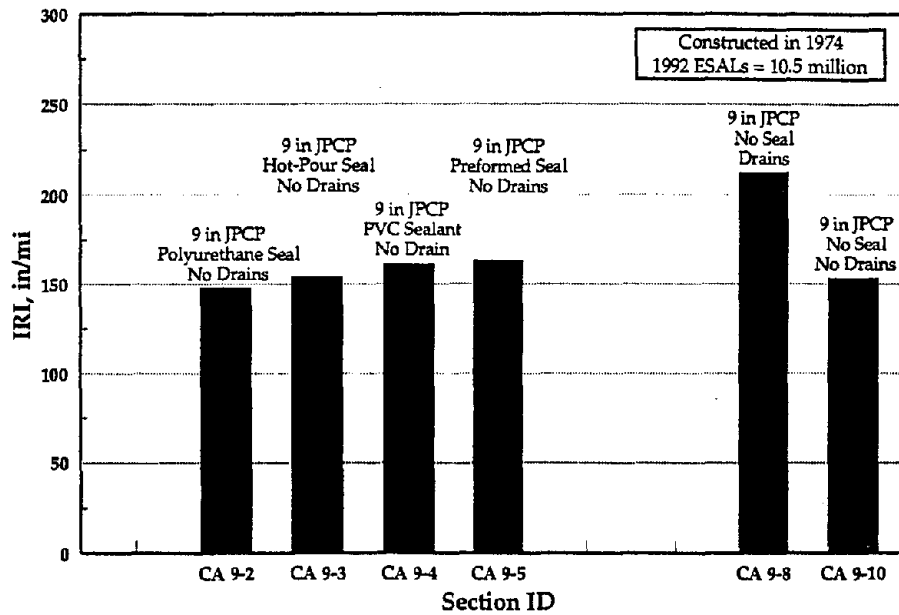
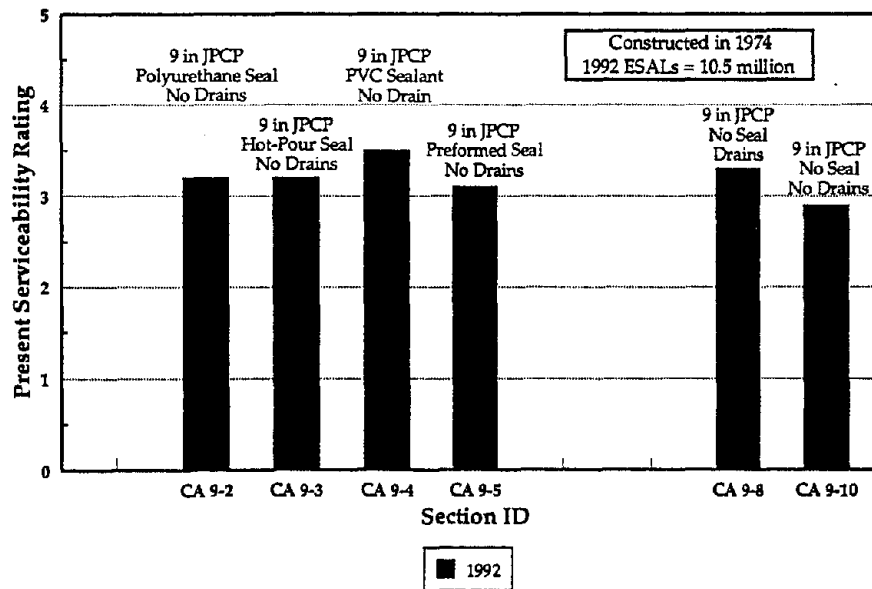
Figure 70. Roughness and serviceability for CA 9.

Figure 70 shows the roughness and serviceability data for the CA 9 sections. The roughest section is the one constructed with drains, which also had the greatest amount of faulting. The smoothest riding section is CA 9-2, which contains a polyurethane sealant. However, with the exception of the drained section, the roughness data for all of the sections are not significantly different. These same trends are shown by the serviceability data.

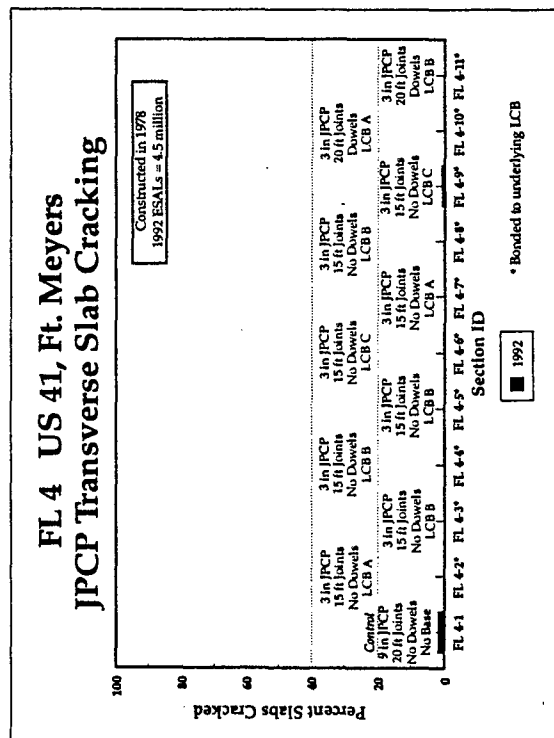
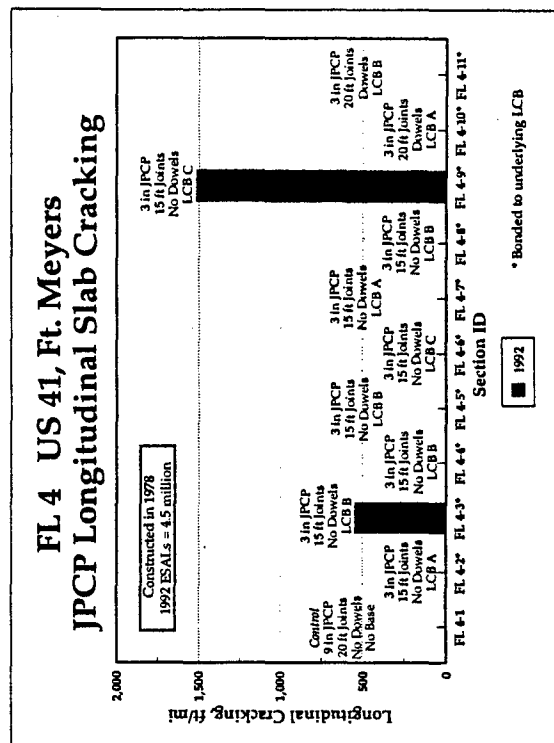
Figure 71. Performance summary for JPCP sections for FL 4.

Generally, the JPCP sections constructed on a higher strength LCB provided slightly better performance than those constructed on a lower strength LCB. The sections on higher strength LCB had slightly less faulting and cracking than the other sections. Nevertheless, the performance of one section constructed on the lowest strength LCB (FL 4-6) was comparable to the corresponding section constructed on the highest strength LCB (FL 4-2).

Sections constructed on stabilized subgrades (FL 4-2 through 4-6) appear to be performing better than those on cement-treated subgrades (FL 4-7 through 4-9), although this effect is confounded by joint orientation. Sections constructed on stabilized subgrades exhibit lower levels of faulting and cracking than those constructed on the cement-treated subgrade. However, the skewed joint design also may be contributing to the lower faulting observed on the stabilized sections.

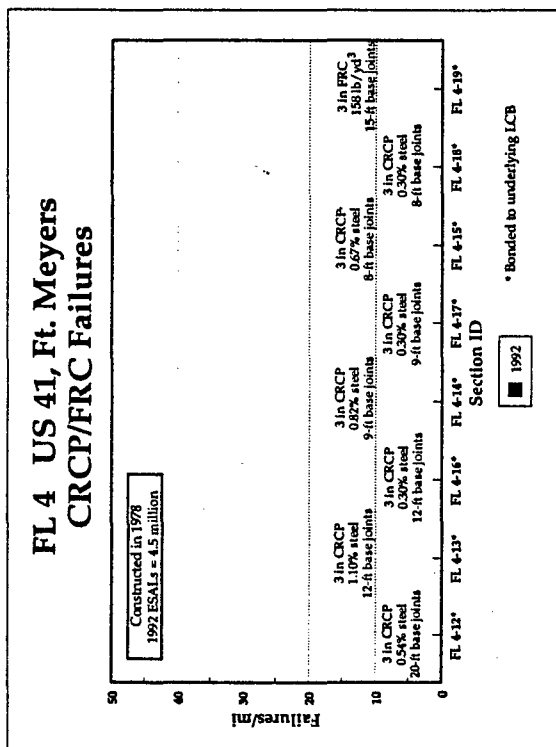
Figure 72. Performance summary for CRCP/FRC sections for FL 4.

Figure 72 shows that the CRCP sections with the smallest amount of reinforcing steel (FL 4-16, 4-17, and 4-18) all show the greatest amount of deteriorated transverse cracking, much higher than any of the other CRCP sections. The FRC section also exhibits more deteriorated transverse cracking than the other sections. The section with only 0.54 percent reinforcement shows the least amount of deteriorated transverse cracking; the sections with 0.67 percent, 0.82 percent, and 1.10 percent steel all exhibit about the same amount of deteriorated transverse cracking. The transverse cracking for these latter sections has exceeded the critical levels for continuously reinforced concrete pavements.

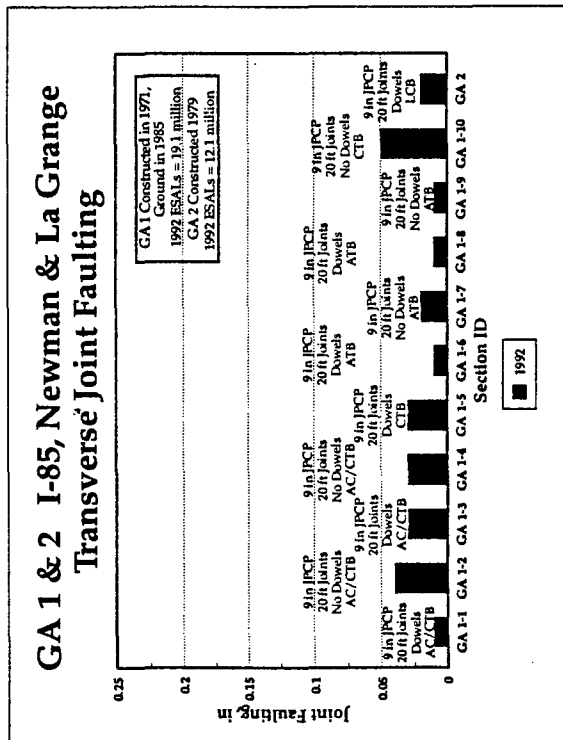
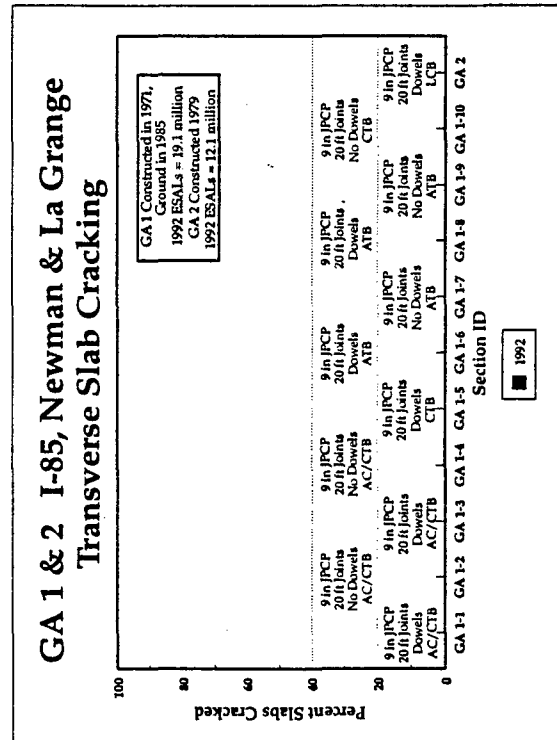
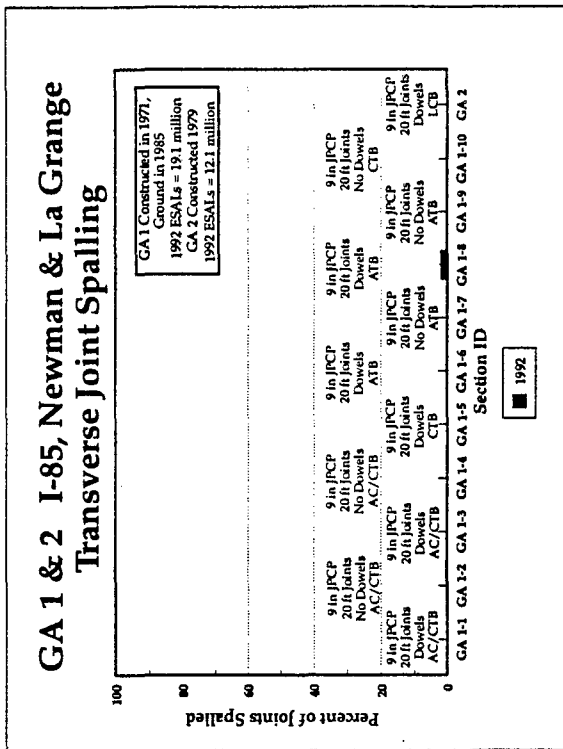
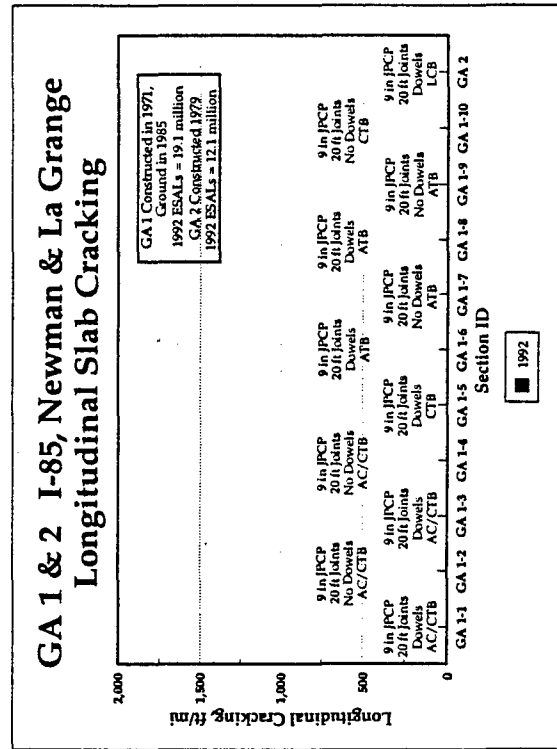
Figure 74. Performance summary for GA 1 and GA 2.

A summary of the outer lane performance data for these sections is shown in table 75. This performance data is displayed graphically in figure 74. The performance data indicate that all sections are in excellent condition. None of the sections display any transverse or longitudinal cracking, faulting levels are minimal (recall that the GA 1 sections were ground in 1985), and a small amount of joint spalling is present on only one section.

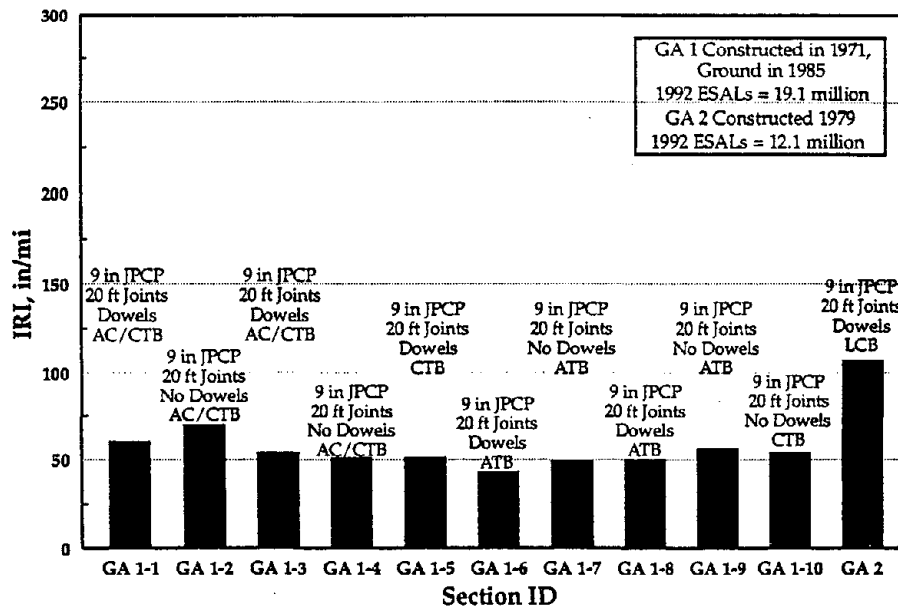
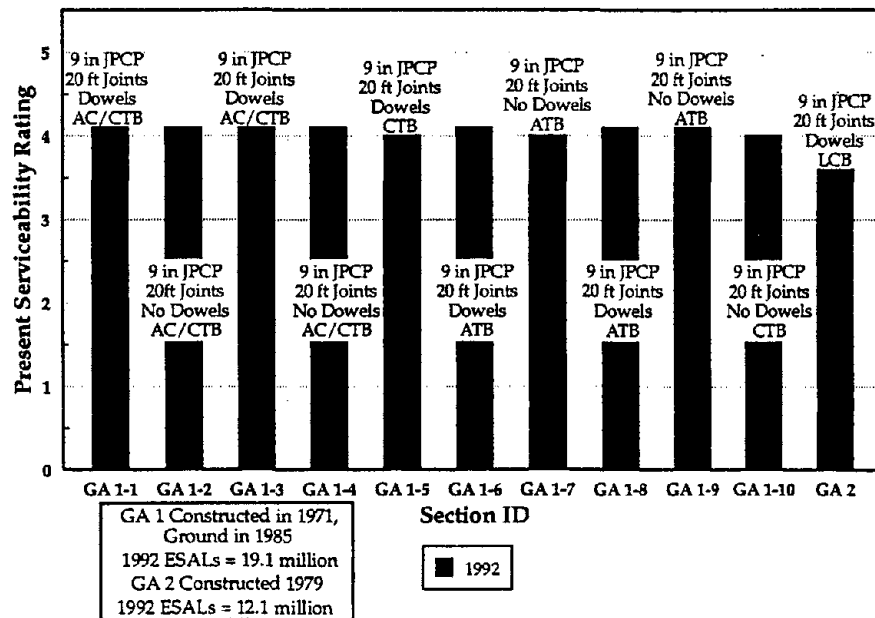
Figure 75. Roughness and serviceability for GA 1 and GA 2.

The roughness and serviceability data for the GA 1 and GA 2 sections are presented in figure 75. All GA 1 sections are extremely smooth, even though it has been 7 years since they had been diamond ground. Because of the low roughness levels, no trends in the smoothness of different designs are apparent.

Figure 75 shows that GA 2, which was constructed in 1977 and has not been diamond ground, is rougher than the GA 1 sections. However, its overall roughness level is still quite acceptable.

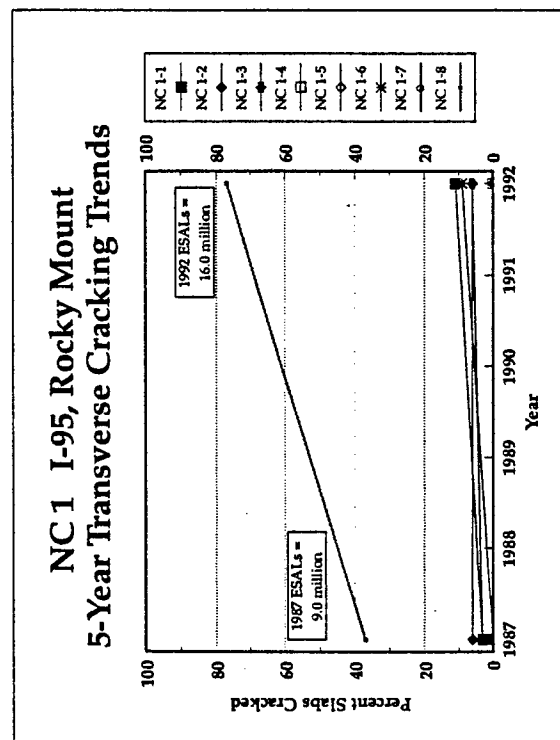
Figure 78. 5-year performance trends for NC 1.

The 5-year performance trends for the NC 1 sections are shown in figure 78. This figure shows that joint faulting and joint spalling have not changed significantly since the 1987 survey. NC 1-8 shows a marked increase in transverse slab cracking, while the other sections show only a small increase, if any.
