RENOLD

Troubleshooter

INTRODUCTION

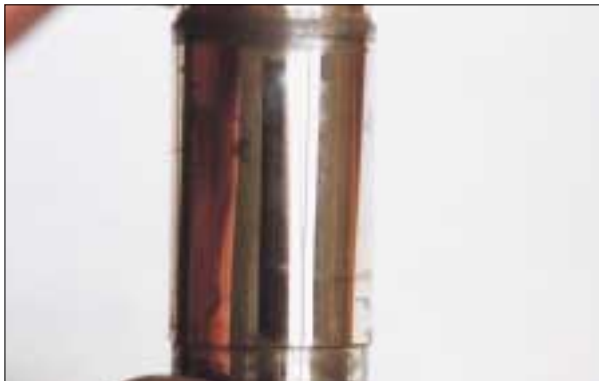
Figure 11

FIGURE 11	MODE OF FAILURE - NONE
-----------	------------------------

APPLICATION	107,000 <i>N</i> breaking load hollow pin.
FAILURE MODE	None.
DIAGNOSIS	A correctly lubricated component.
SOLUTION
