RE: Mitchell Park Horticultural Conservatory
Structural Condition Study

MITCHELL PARK DOMES

INTRODUCTION

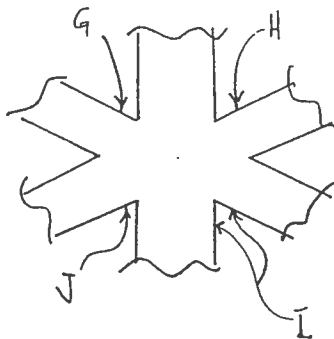
Good continuity exists btwn pt A and pts B, C, D, & E.

Continuity does not exist between pt A & pt F.

Continuity does exist btwn pt A and pts G ~ J (Locations of exposed rebars).

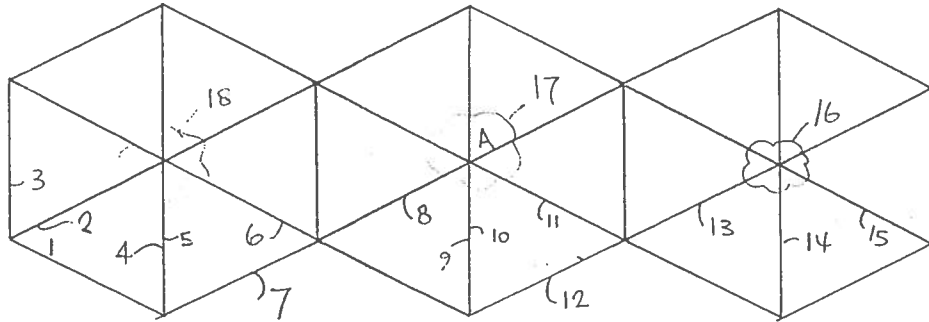
TROPICAL DOME

1/2 CELL POTENTIAL READINGS (RELATIVE TO COPPER-COPPER SULFATE ELECTRODE)

1 @ 0.101 V	8 @ 0.104 V	15 @ 0.020 V
2 @ 0.151 V	9 @ 0.154 V	16 @ 0.115 V
3 @ 0.102 V	10 @ 0.098 V	17 @ 0.080 V
4 @ 0.071 V	11 @ 0.083 V	18 @ 0.089 V
5 @ 0.102 V	12 @ 0.137 V	
6 @ 0.090 V	13 @ 0.012 V	
7 @ 0.151 V	14 @ 0.123 V

POINT A LOCATED TWO PANELS SOUTH OF EW PANEL

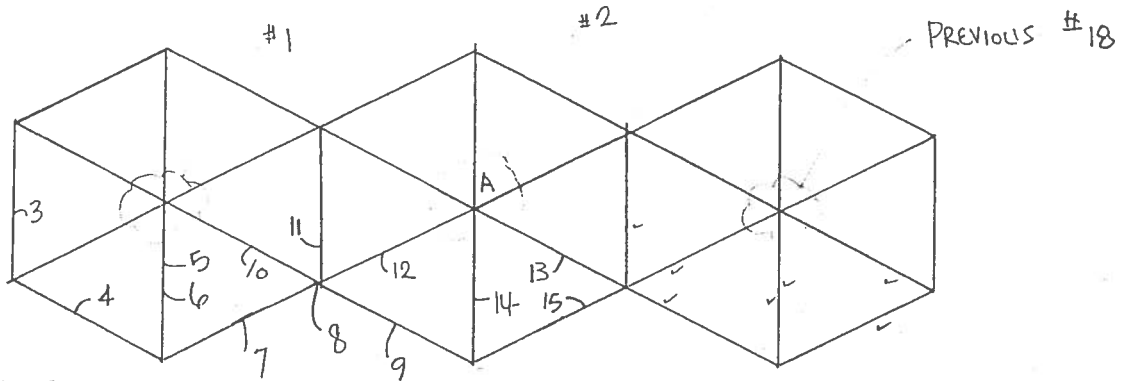
1/2 CELL POTENTIALS

1e 0.195V

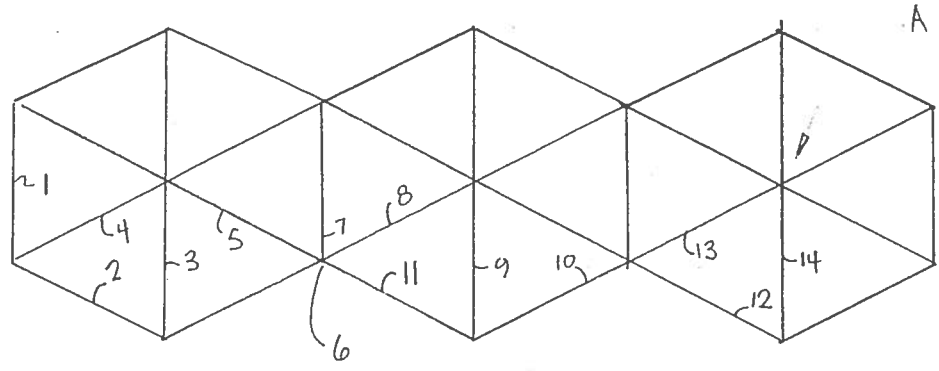
1/2 CELL TESTS

REBAR CONNECTION @ PT "A"

1/2 CELL POTENTIAL TESTING

(RELATIVE TO COPPER - COPPER SULFATE ELECTRODE)
