**Milwaukee County  
Mitchell Park Horticultural Conservatory  
"The Domes"**

**Show Dome Facade Study  
and  
Lower Level Facade Study**

**October 10, 2008**

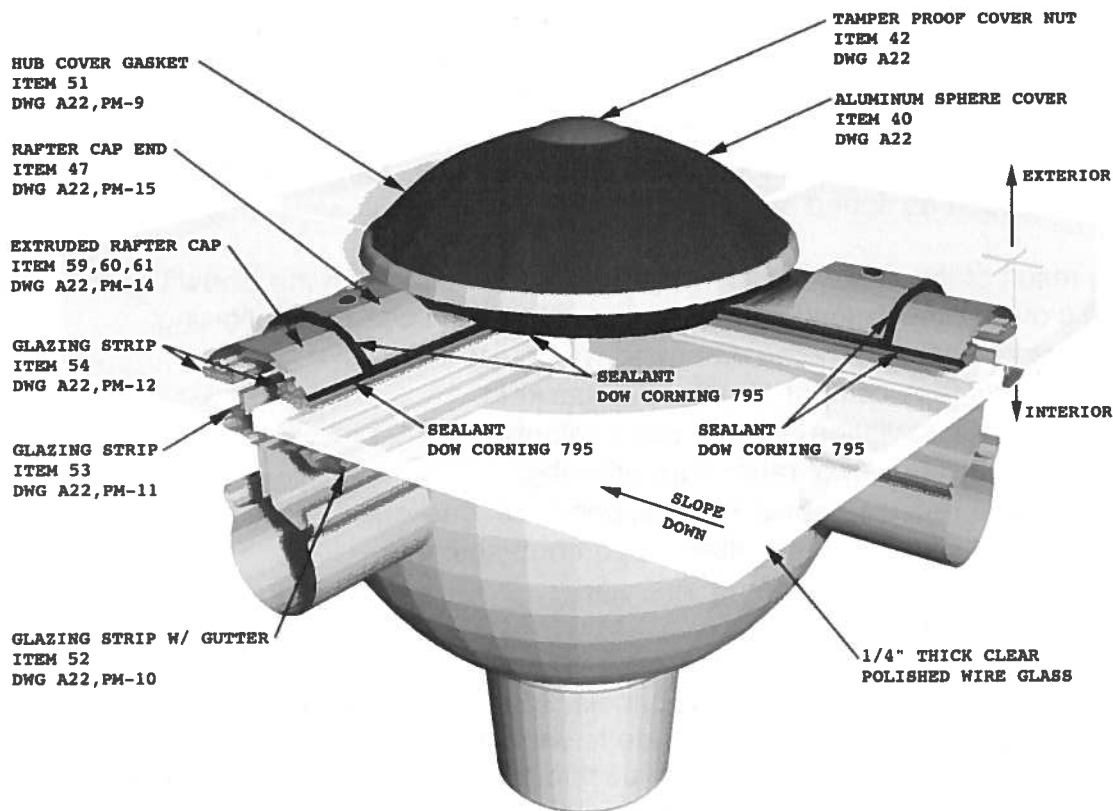
Figure 1: Isometric View of Typical Façade Hub Assembly

As discussed earlier and as shown in Figure 1, the aluminum framing system consists of stainless steel connection posts, aluminum spherical hubs, aluminum façade rafters, rubber glazing strips, wire glass, aluminum rafter caps and aluminum hub covers. In general the aluminum framing system is in good condition, with the exception of old gaskets and a malfunctioning drainage system, described later.

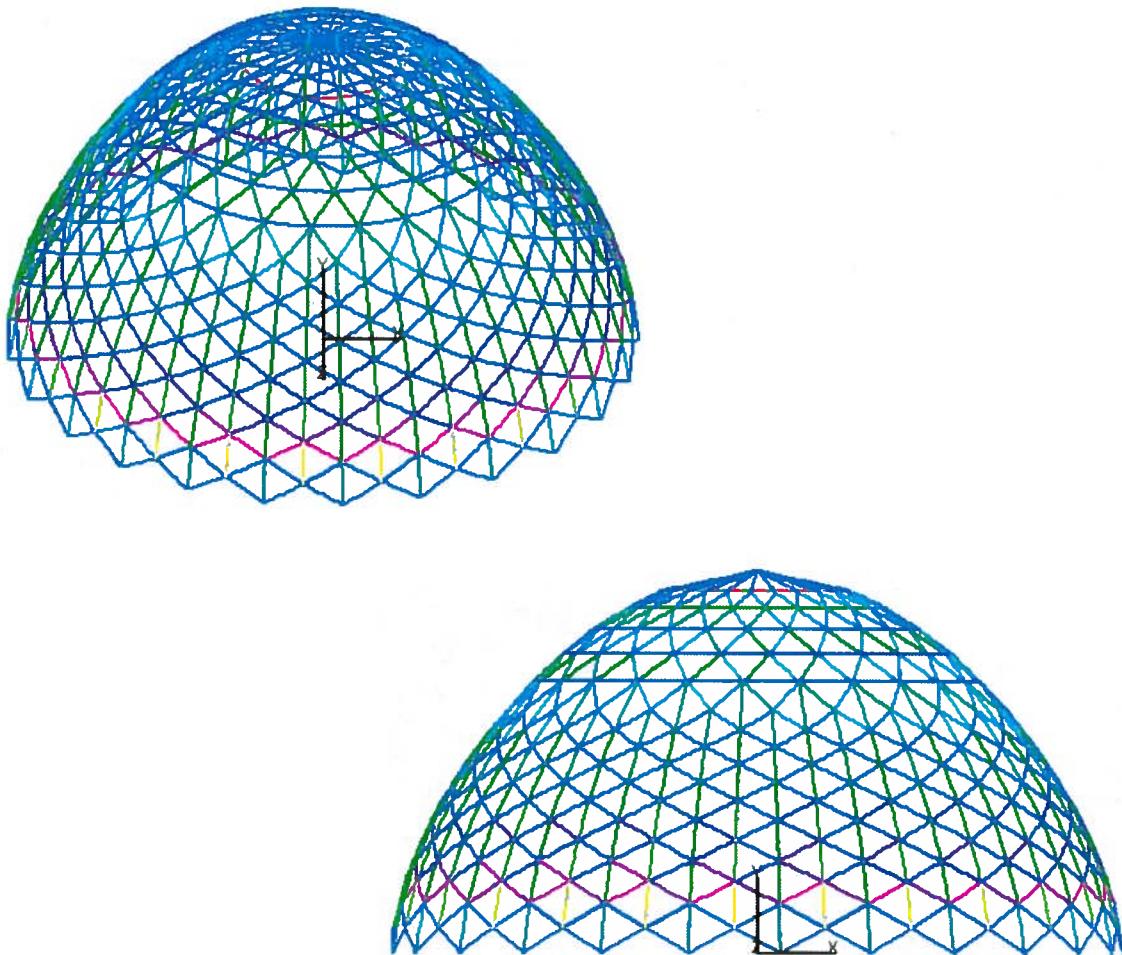
**Figure 4:** Structural Analysis Model of the Show Dome Concrete Frame (representing varying levels of tension and compression forces in concrete members under dead plus live loads, magenta = tension and blue = compression)

loads, and wind loads. The dead loads included the weight of the concrete, the weight of the glass, the weight of the aluminum framing which supports the glass, the weight of the aluminum framing at the apex which supports the mechanical equipment, and the weight of the mechanical equipment itself. The snow load was determined by using the American Society of Civil Engineers (ASCE) Standard 7-2005, Minimum Design Loads for Buildings and Other Structures. There were two separate snow loading requirements: balanced and unbalanced. The wind load was determined from ASCE 7-2005, as well.

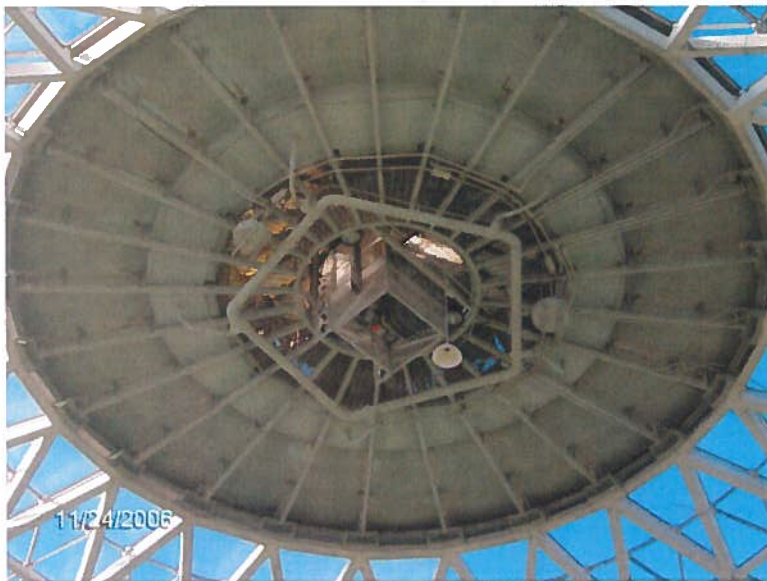
**Figure 7:** Underside of Show Dome Apex

The apex is constructed of aluminum framing components, including I-beam sections, plates, grating, and pipe. All of the framing appeared to be in good condition. The exterior of the apex is enclosed with frosted wire glass and aluminum sheets. There are forty-nine (49) glass panels and one (1) aluminum access hatch. Fifteen (15) glass panels were observed to be cracked; most of the cracks had been previously sealed with a surface applied sealant. See Figure 8. (The locations of the cracked glass panels at the apex are shown on Exhibit SD-6 in Appendix A).

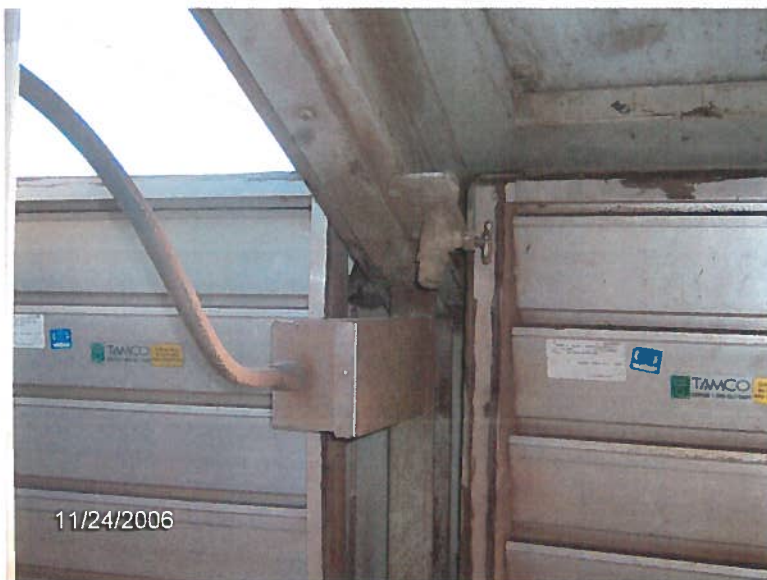
**Figure 10:** Drainage System Flushing Valve at Apex Louvers

Adjacent to the top corner of each motorized damper, there exists a gate valve with a male garden hose fitting as shown in Figure 10. Flexible rubber hoses, are connected to one end of each valve, and extend down adjacent to each rafter towards the aluminum façade hubs at the perimeter of the apex. (Existing building drawings indicated that a stainless steel hose coupling was to be installed at each upper level hub. This connection is not visible). It is assumed that these valves, hoses and connections were meant to allow for periodic flushing of the aluminum façade drainage system. It is unknown if this has ever been completed. It is also unknown if flushing water can reach the apex of the dome without auxiliary pumping equipment.
