14/09/  
2015.templet\_na\_inv

COMPANY: IPS  
INSPECTED BY: N Joubert  
DATE OF INSPECTION: 14/09/2015  
PREPARED FOR: Temples Nantwich

Agent: Temples (Nantwich)  
Property Type: Four Bedroom – Detached  
Prepared & Inspected By: IPS (NJ)  
Inspection Type: Inventory & Schedule of Condition  
Weather Conditions: Sunshine & Clouds  
Tenant Details: Goldbeck Construction Ltd  
Tenancy Start Date: 15th September 2015  
Landlord: Temples (Nantwich) Ltd

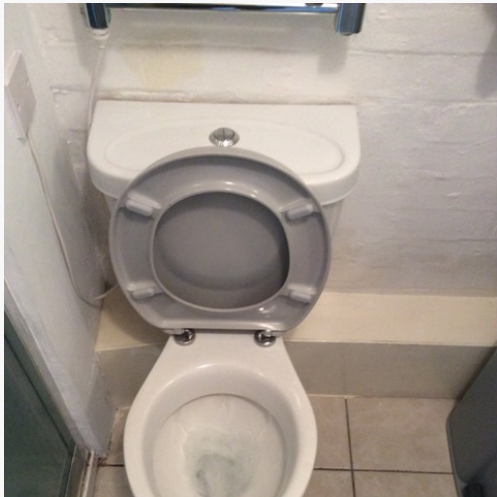
Including one white low level WC with matching cistern, chrome dual flush button and grey toilet seat and lid. The WC and fittings are clean and in good condition overall.

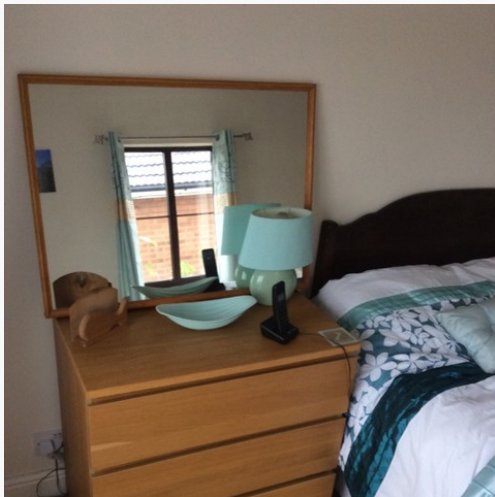
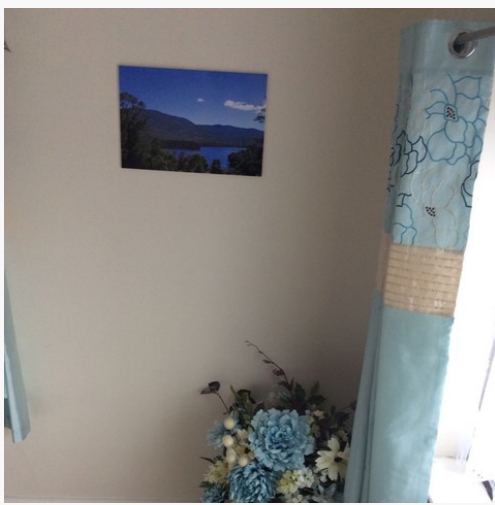
One three drawer unit with matching mirror  
 One decorative pale blue ceramic bowl  
 One pale blue ceramic bedside lamp with light shade  
 One household telephone with docking station  
 One blue glass vase with blue artificial flowers  
 One decorative wall art  
 One double bed with mattress and matching bedding  
 One varnished wooden chair—showing signs of wear  
 Wooden decorative shelving units with ceramic ornaments

The bed needs dressing, as per the ingoing inventory (T)

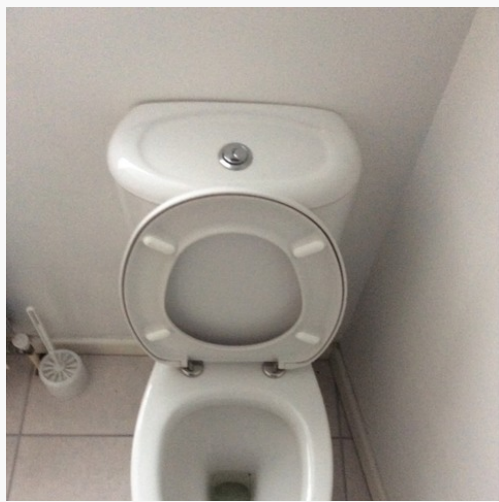
Including one white low level WC with matching cistern, chrome dual flush button and white toilet seat and lid. The WC and fittings are clean and in good condition overall.

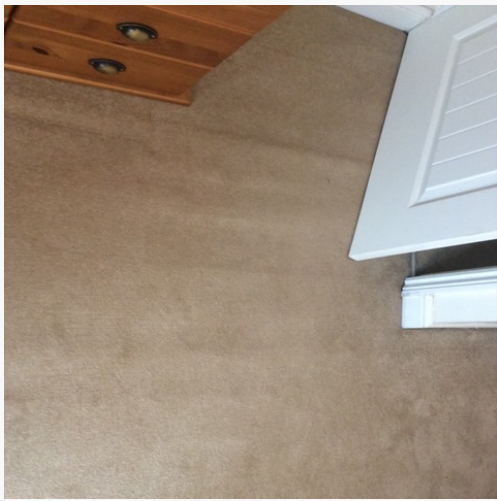
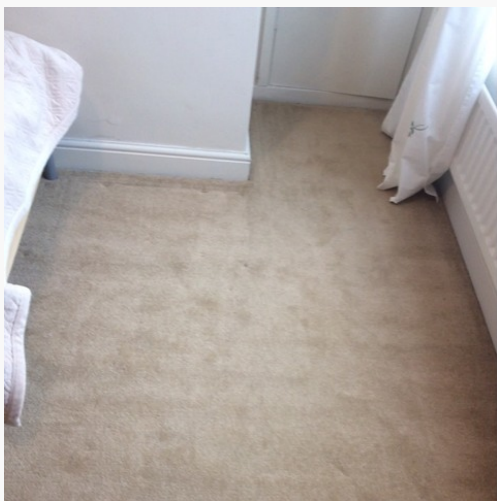
Light brown fitted bedroom carpet.  
The fitted carpet is in good condition overall, but is showing light signs of wear to central and high traffic walkways.  
Carpet creasing is visible.  
Furniture indentations are present.  
The carpet skirting board edges are discoloured and dusty.

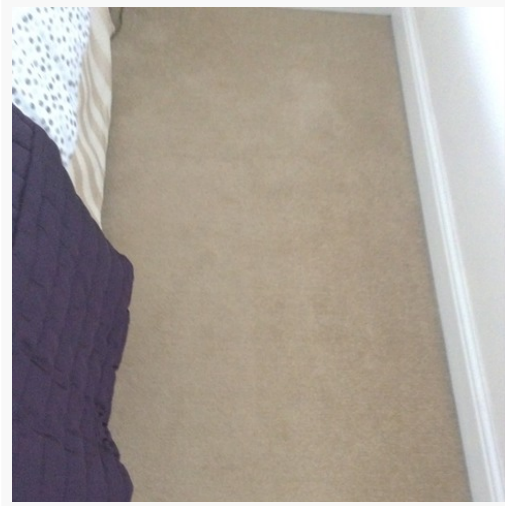
Vacuuming is required under and around furnishings (T)  
One stain now present to the carpet (T)

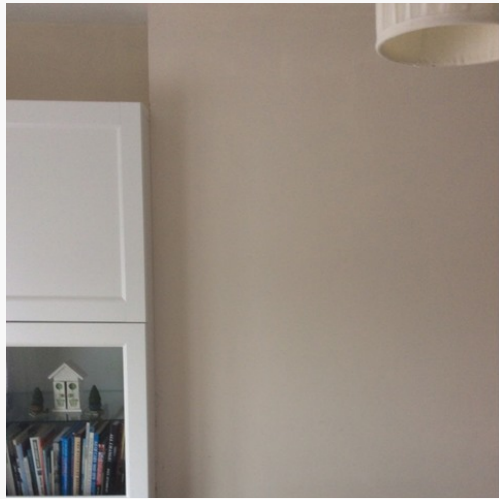
Dust is visible to skirting board surfaces (T)

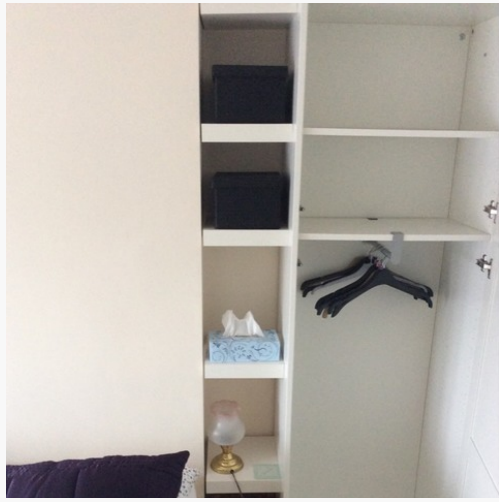
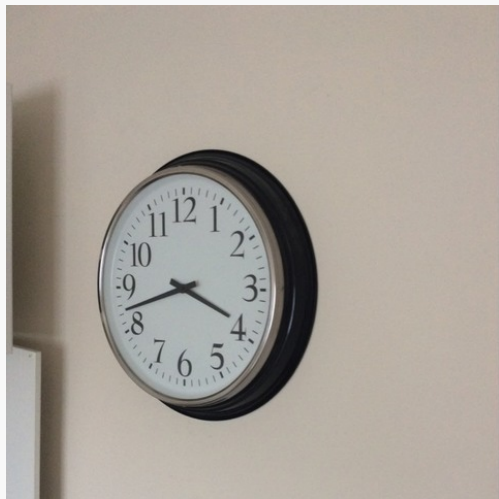
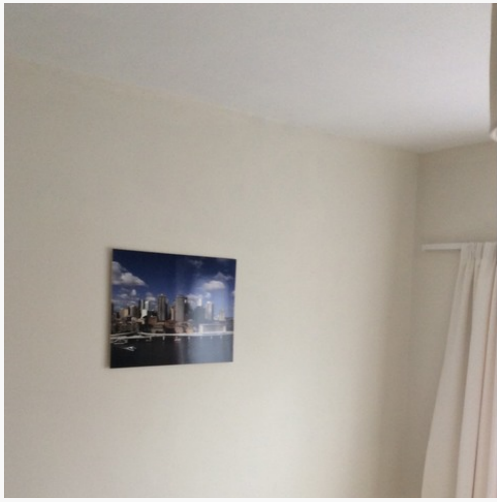
Bedside lamp is damaged (T).
