CONSERVATION OF THE WAZIR KHAN MOSQUE LAHORE

PRELIMINARY REPORT ON CONDITION AND RISK ASSESSMENT

AGA KHAN TRUST FOR CULTURE AGA KHAN CULTURAL SERVICE - PAKISTAN

PART II: DOCUMENTATION AND DAMAGE ANALYSIS

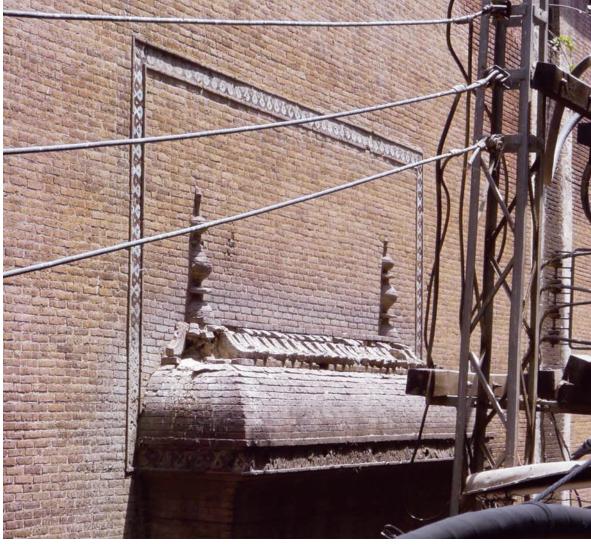
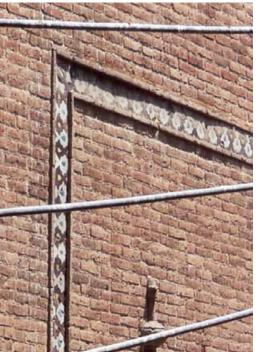
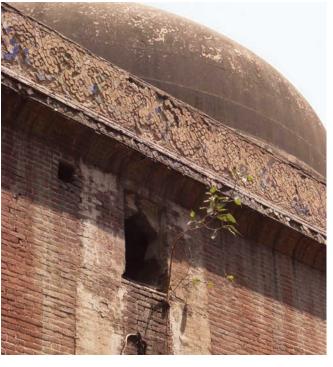
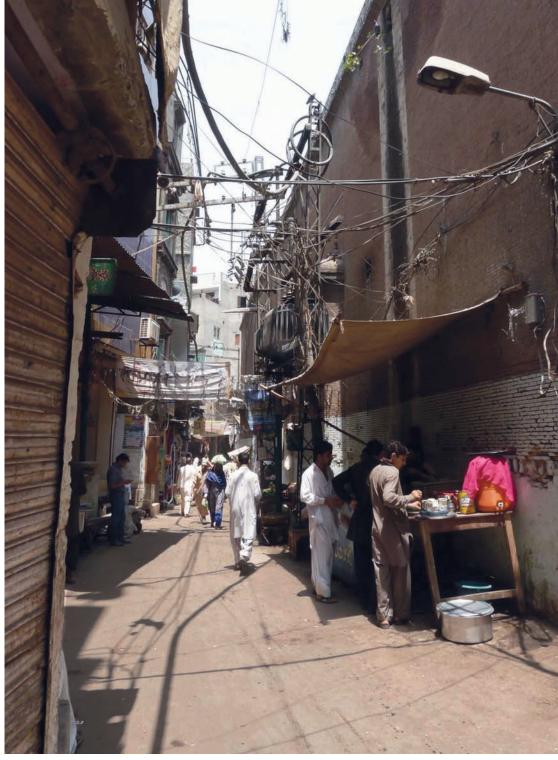
Above: There are no structures abutting the western façade of the mosque, with the exception of the south-western corner where a residential building is using the mosque's walls for support. The remaining western façade is fully accessible from the gali immediately adjacent, which is occupied only by street hawkers, mobile food trolleys, and a conspicuous electricity transformer.

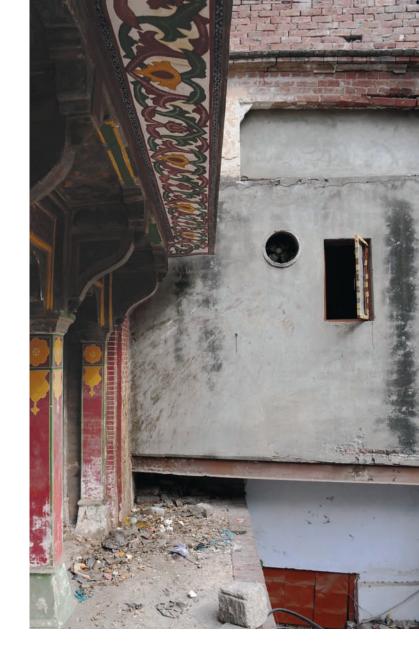
Above: The same house on the south-western corner as seen from its western side. A heavy steel girder has been inserted directly into the fabric of the pavilion at Level 2 of the Calligraphers' Bazaar.

Additionally, the occupants of the house are disposing of their household waste on the roof of the mosque. By the pattern of marks on the wall, it would seem that they throw their waste out of the open window, with little regard for sanitation, and without considering what happens to the rubbish in the long term.

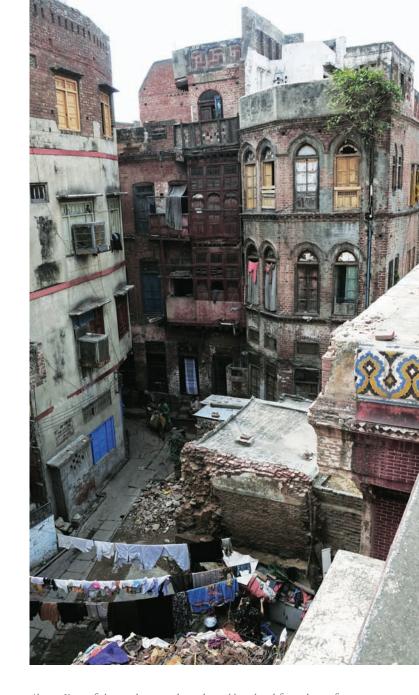
Above: View of the southern residential neighbourhood from the roof of the Calligraphers' Bazaar. Housing quality is poor, and solid waste management is minimal. The 3-storeyed building to the right of the photograph is built on the footprint of the original Persian well which supplied water to the mosque through the southern pavilion.

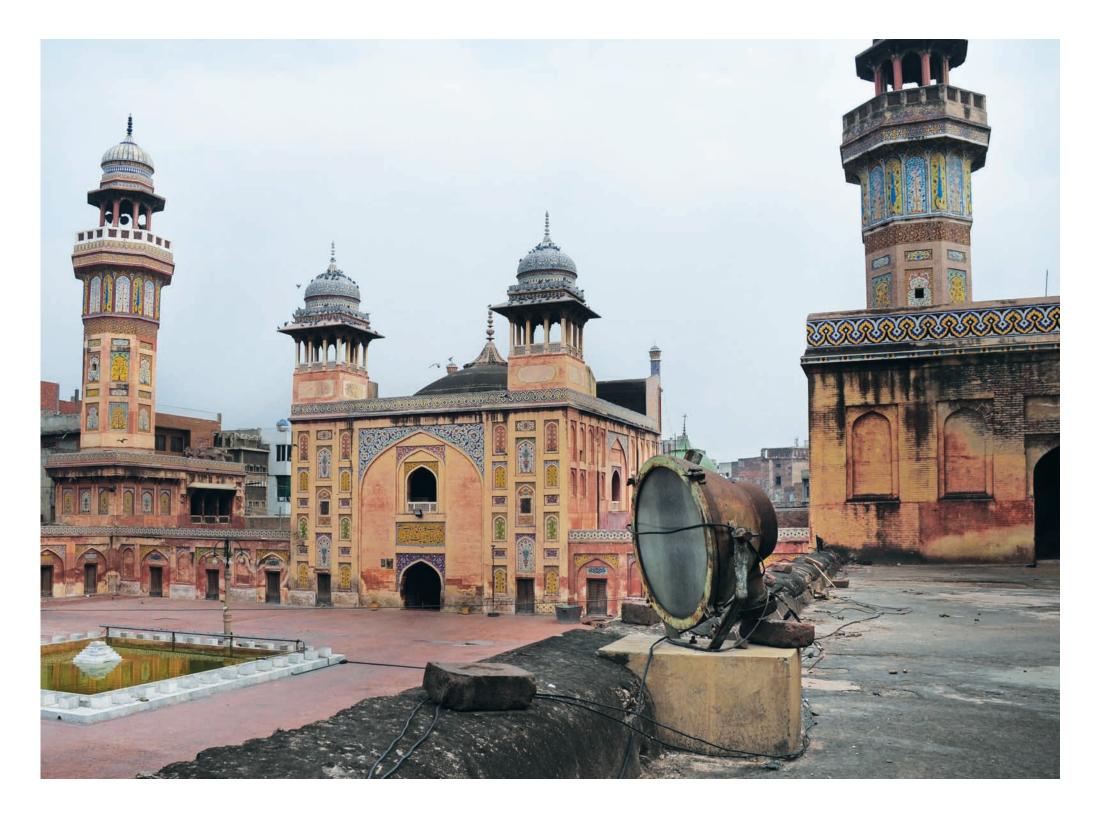
Opposite: View of the entire south side of the mosque. Water tanks are visible on the eastern side of the pavilion, while the houses on the western side of the pavilion are abutting the southern wall and to some extent are encroaching upon the roof of the hujras.

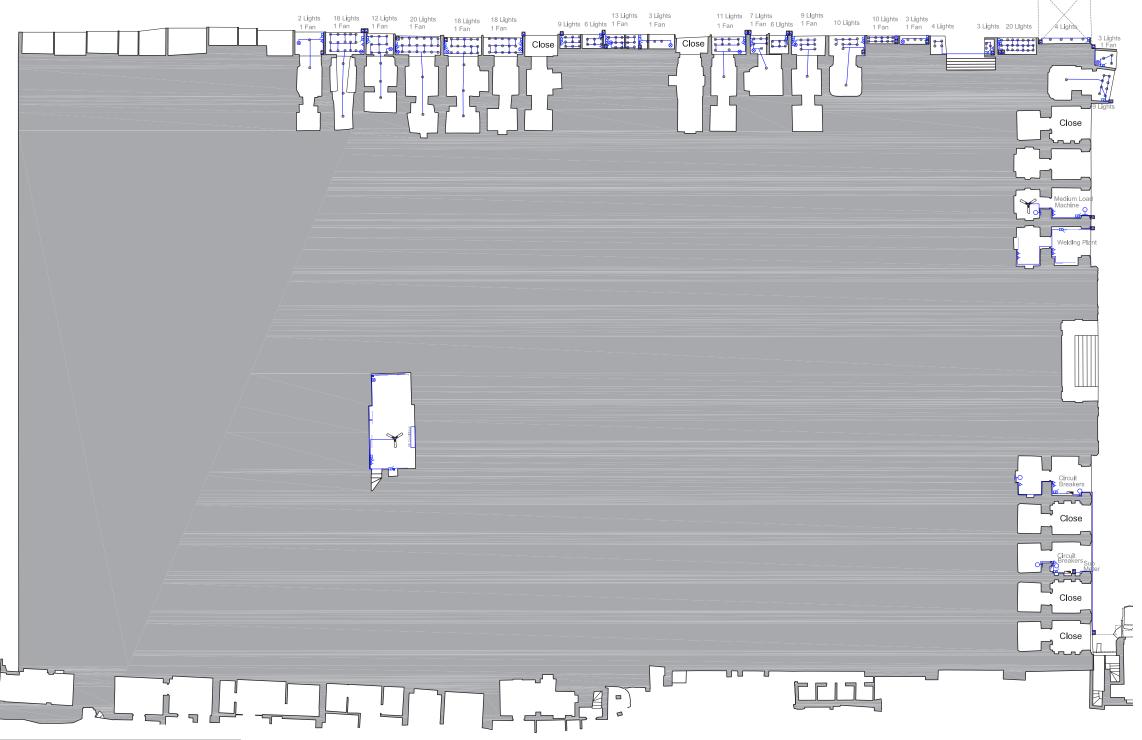
EXISTING ELECTRIFICATION (LEVEL 0) 0 2

- 1. There are dangerous open connections of live wires
- 2. Insulation of electrical wires are damaged at a number of places
- 3. High risk for short circuiting & fire
- 4. No water proofing of electrical installations located in the open
- 5. Most of the sockets are damaged

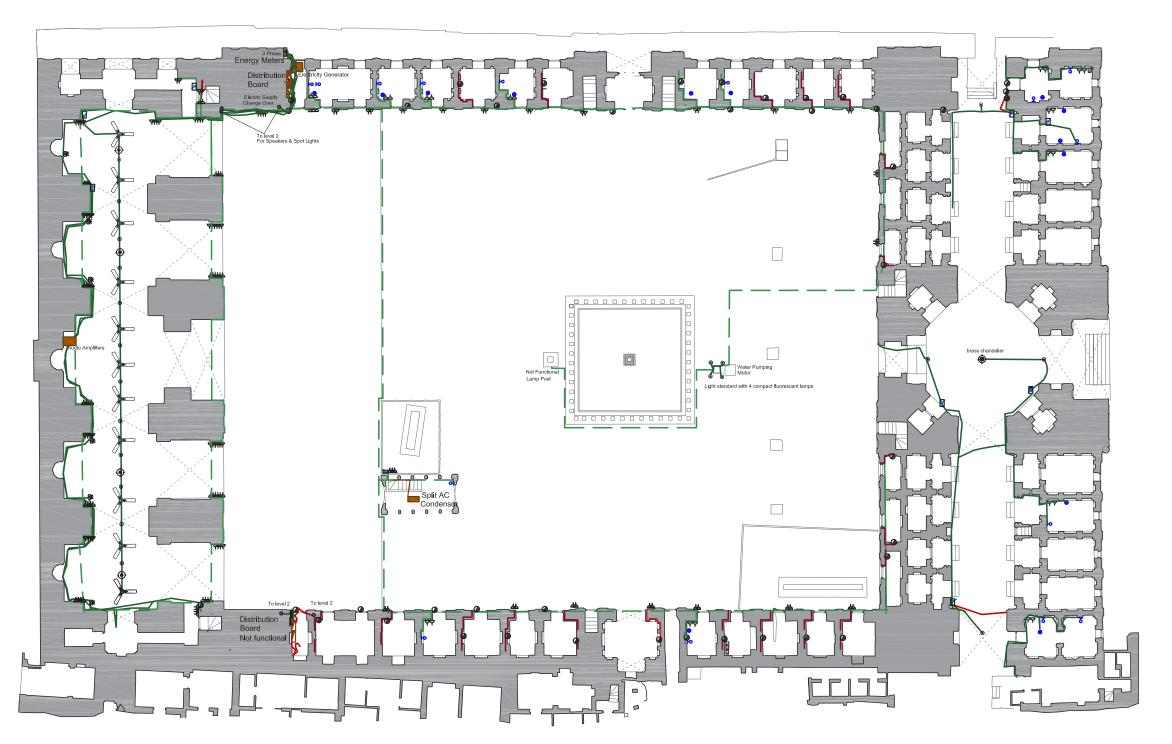
- 1. There are dangerous open connections of live wires
- 2. Insulation of electrical wires are damaged at a number of places
- 3. High risk for short circuiting & fire
- $4.\ \mbox{No}$ water proofing of electrical installations located in the open
- 5. Most of the sockets are damaged

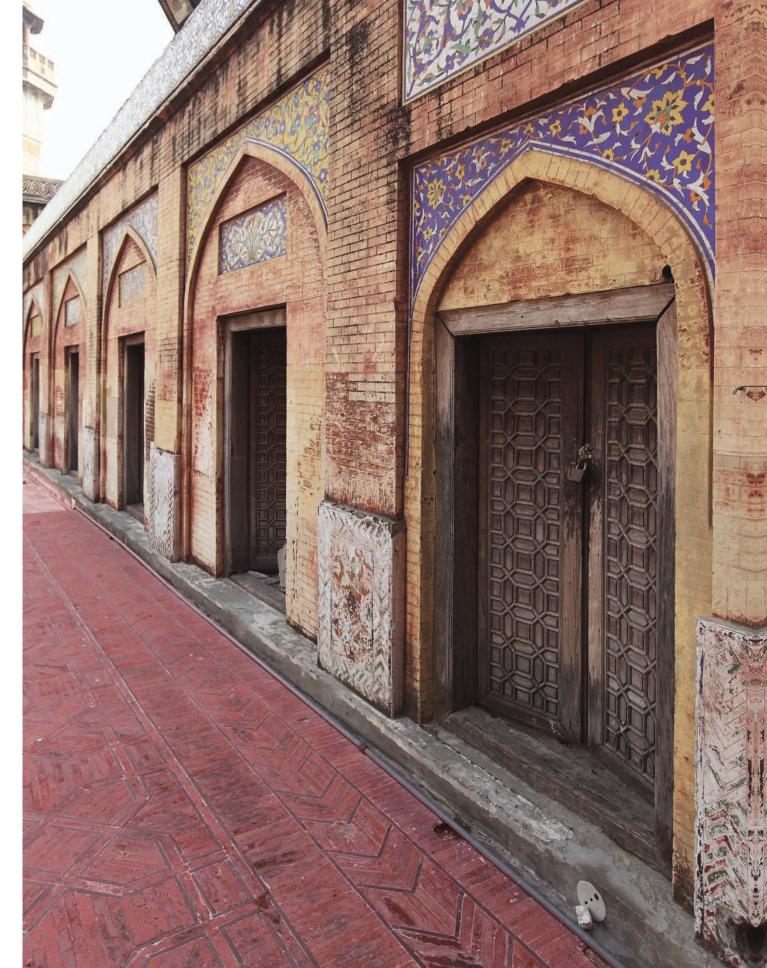
Gas pipe running along the southern row of hujras, supplying the prayer chamber.

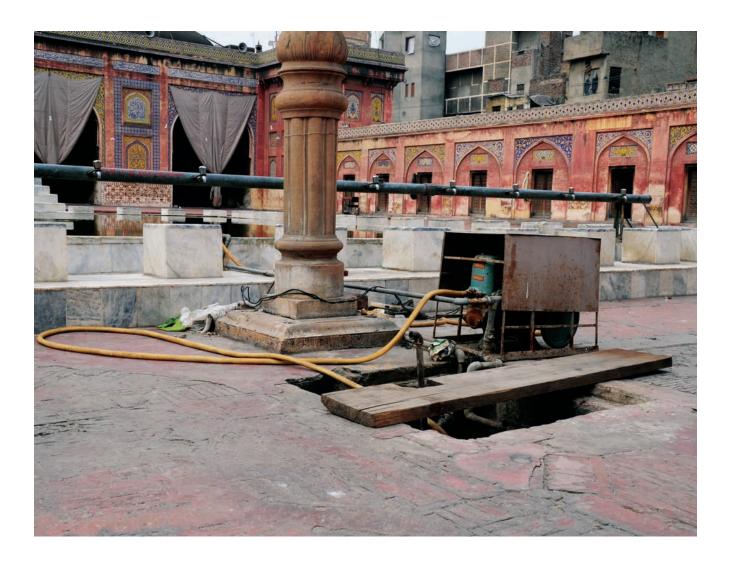
Above: Water supply pump positioned on the east side of the ablution pool - one of the first things visitors are confronted with on entering the courtyard from the

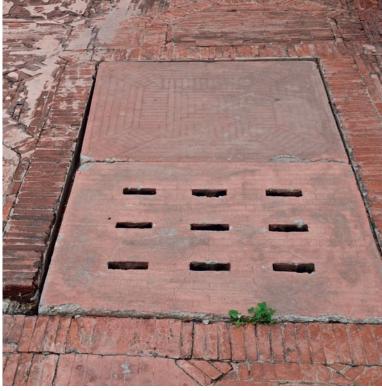
Top: Drainage grate at the level of the courtyard. Above: Cover is lifted to expose drain and water supply pipes.

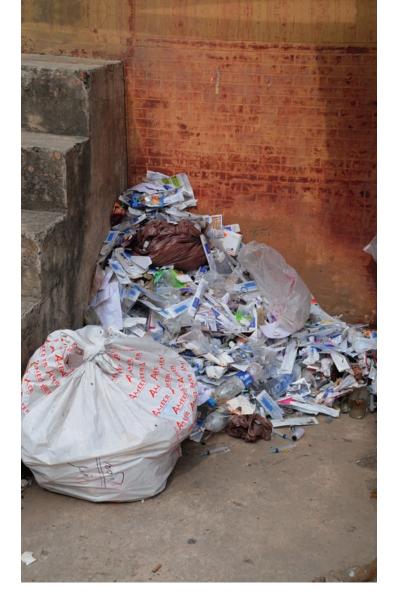
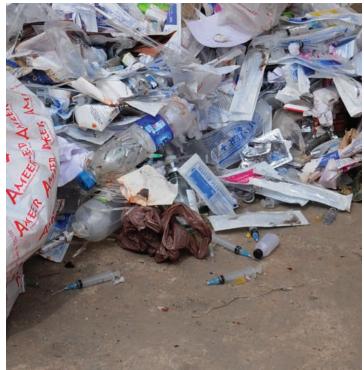
Far Right: The height of wall damage corresponds to the height of the pedestal fans being stored. In this instance, it is a small room on the southern side of the prayer chamber.

Right: Medical waste being stored on the roof of the Calligraphers' Bazaar.

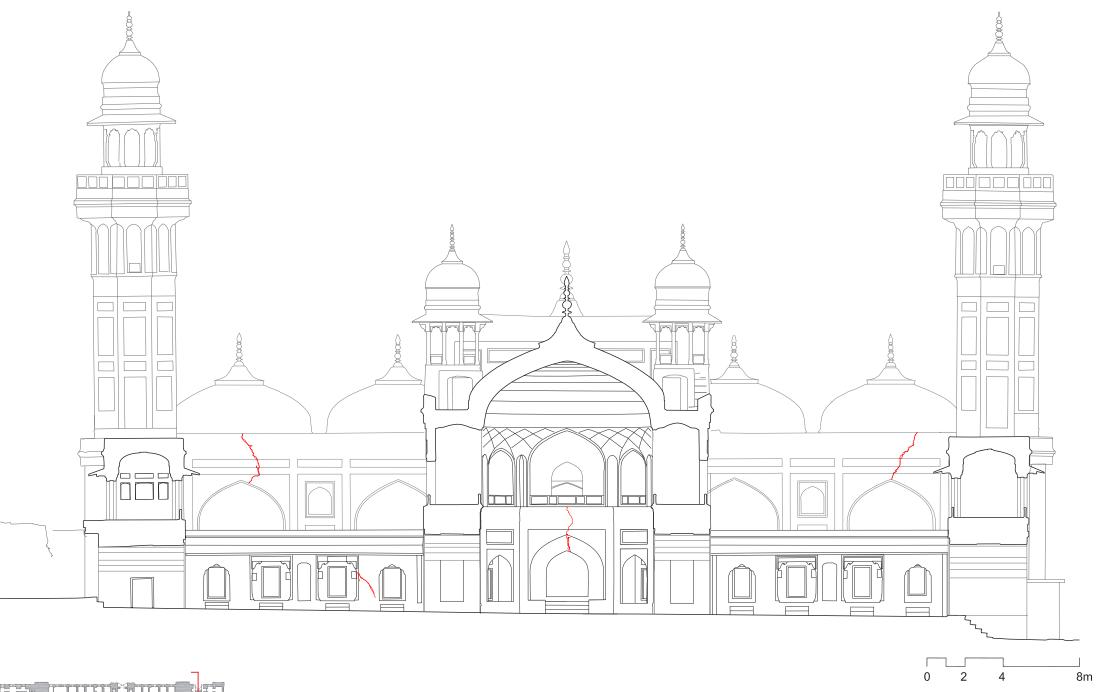
CRACK DOCUMENTATION IN THE CALLIGRAPHERS' BAZAAR

The existing cracks in the critical areas of the mosque have been identified and monitored periodically with the help of total station theodolite measurements and Vernier digital callipers. The outward leaning of the western minars, which were recorded precisely, has produced some major cracks in the apex of the northern and southern arches of the main chamber. Major cracks were identified in six locations in the prayer chamber of the mosque and each location was later equipped with a group of three stainless steel studs in a triangular formation. A detailed monitoring scheme has been set in place where the distance between each stud is recorded with the help of callipers and which can be periodically compared with recordings done at a later stage.

The roof of the pavilion at the centre of the southern array of hujras shows a large crack, probably due to the precarious condition of its southern wall.

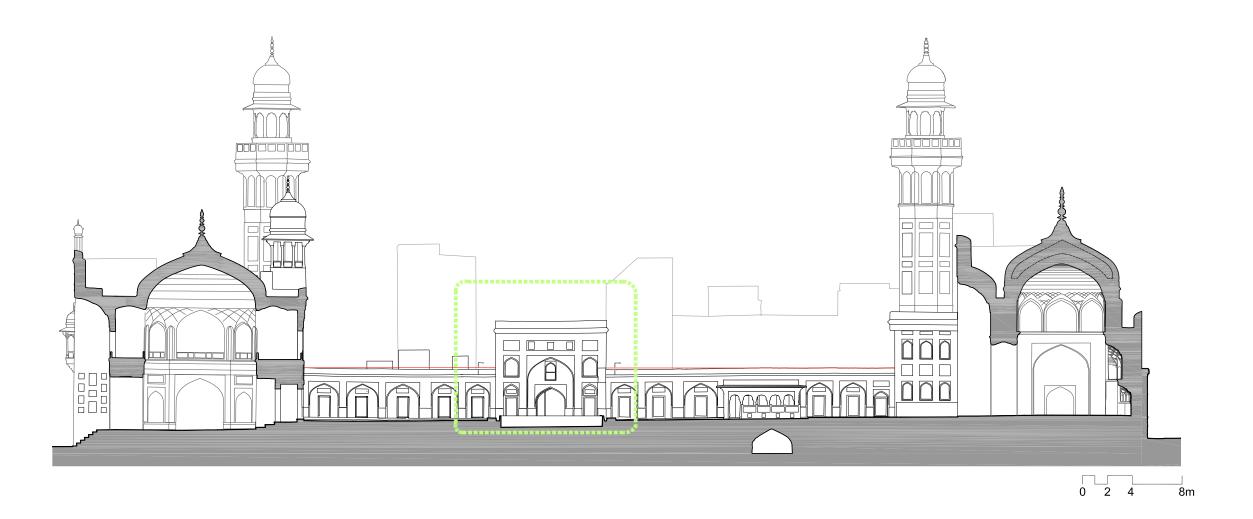
SUBSIDENCE IN THE SOUTHERN ROW OF HUJRAS

Opposite page: detail of the southern hujras and the southern central pavilion. Note the subsidence experienced on this side. The two wings of the hujras on the south side of the courtyard have subsided as shown with respect to the central pavilion. Subsidence is shown in millimetres with reference to a horizontal line (in red) drawn from the point where the parapets end against the base of the south-east and south-west minars.

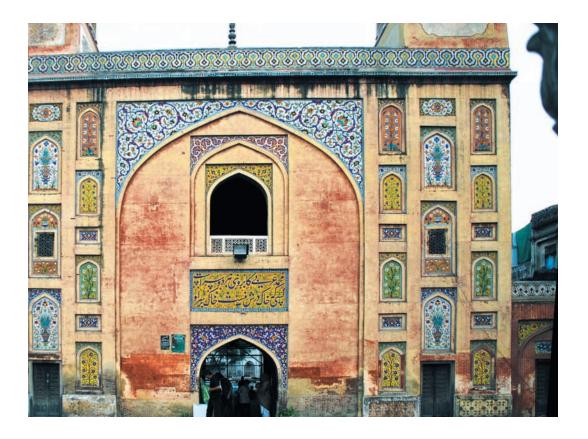
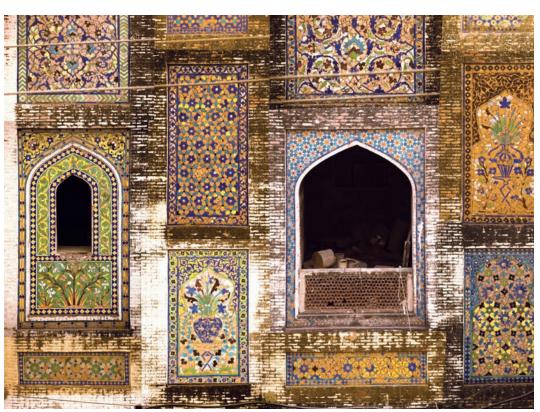
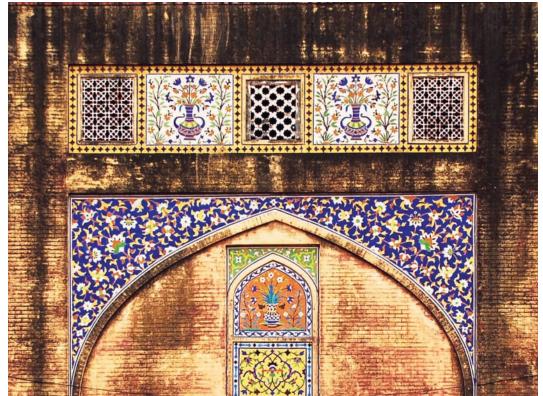
DISCOLOURATION

Three examples of discolouration, biological deposits and dust on various surfaces of the exterior.

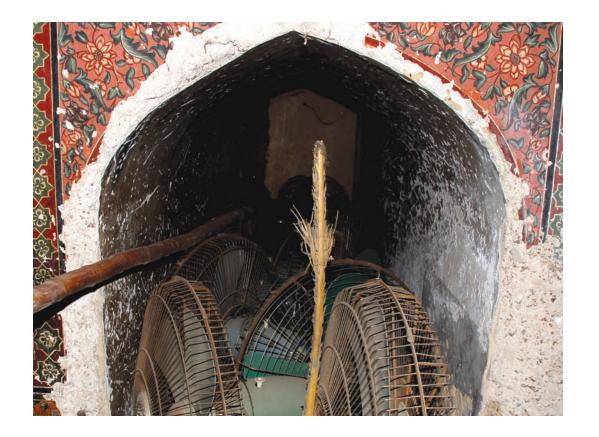
Top left: Damage caused to the historic fresco work by careless and insensitive moving about of electric fans.

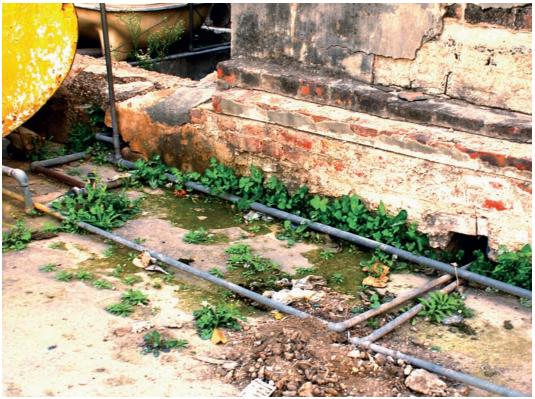
Top right: Installation of leaking water tanks on the roofs of the southern hujras.

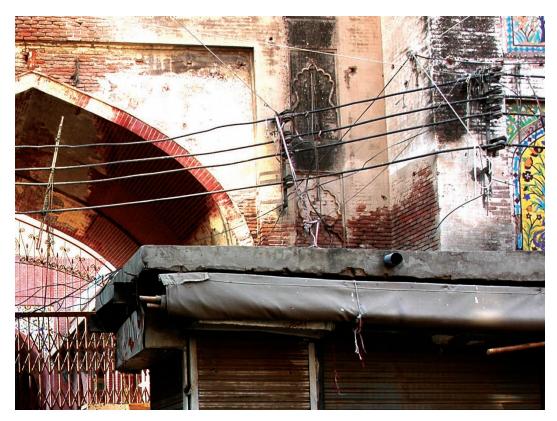
$Bottom\ left:\ In sensitive\ installation\ of\ electric\ distribution\ cables\ on\ the\ historic\ monument.$

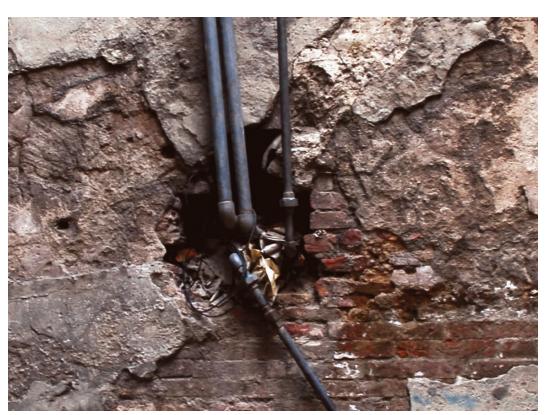
Bottom right: Insertion of water/gas pipes into the historic walls.

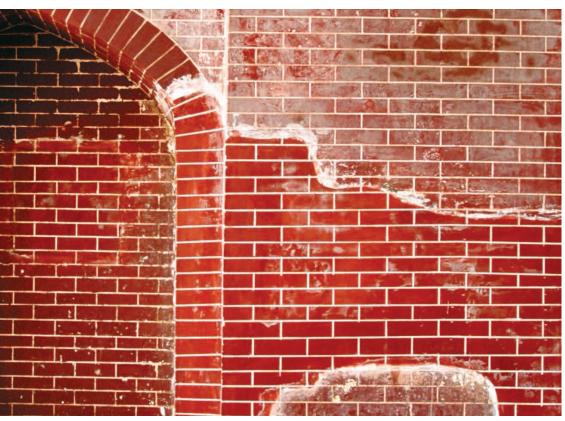
Top: Efflorescence in the dome of the entrance dewrhi caused by rain water penetration through the structure.

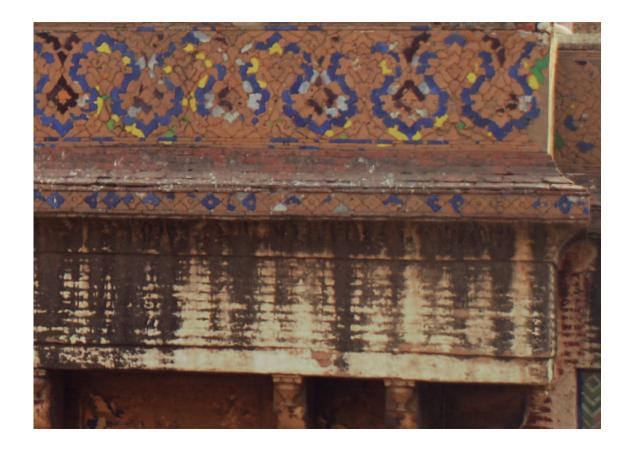
Bottom: Efflorescence caused by the drying of render and the leeching of salts contained in inappropriate mortar.

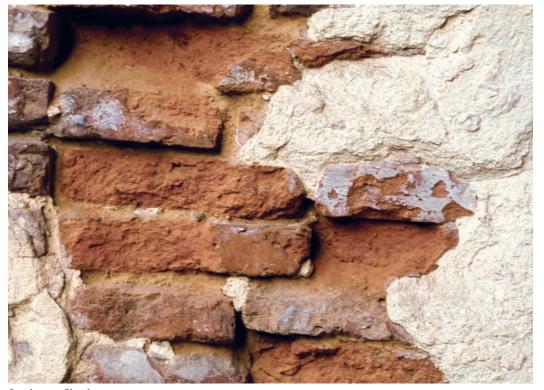
Powdering of brick.

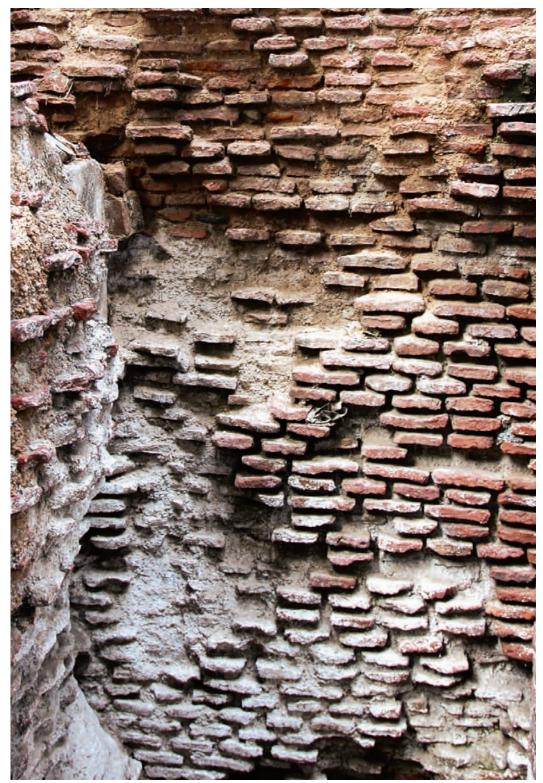
Sanding of mortar.

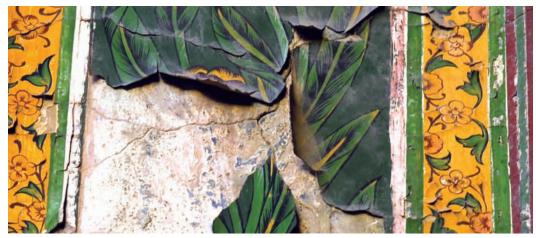
Peeling of upper coat of paint surface in the northern axial pavilion.

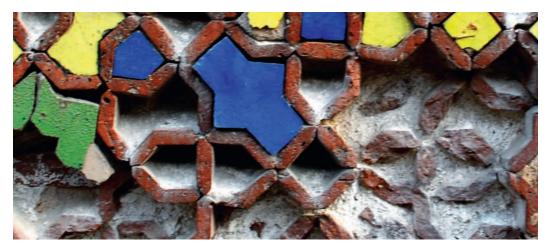
The main reason for this could be ascribed to the loss of bond between the tile and the mortar bed in which it is embedded. This in turn is caused by the lack of an effective seal between the glazed tile and the surrounding terracotta elements which allow rain water to penetrate into the mortar, causing chemical changes in the mortar over the long term, eventually leading to loss of cohesion and detachment of the tile. An added factor is the fact that the terracotta lattice work is relatively more porous than the glazed tile, and water interacting with salt ions can be retained for longer periods.

Breakout of tile embedded in unglazed terracotta lattice.

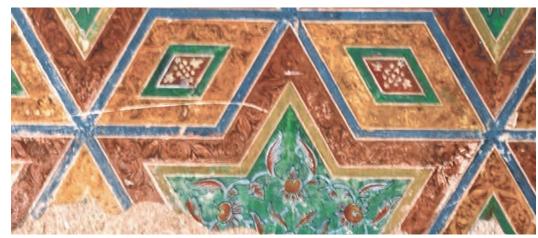
Peeling of the upper coat of surface render in the prayer chamber.

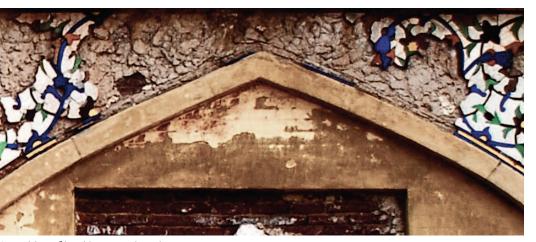
Partial loss of bond between tile and mortar.

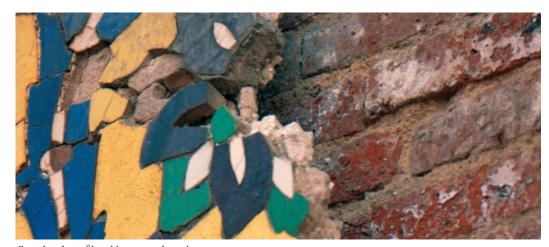
Complete loss of bond between tile and mortar.

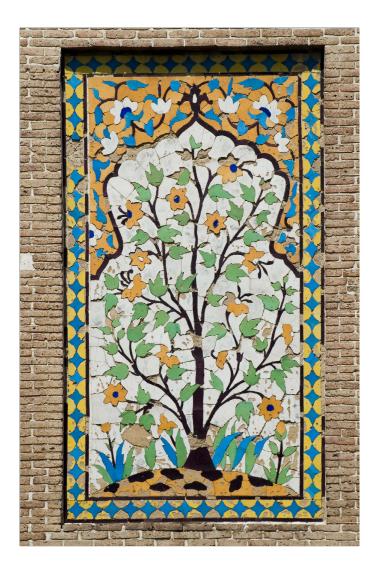
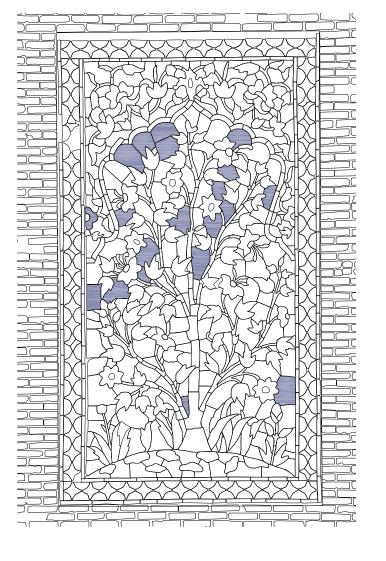
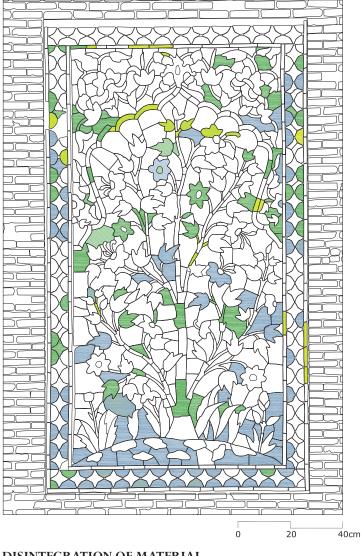
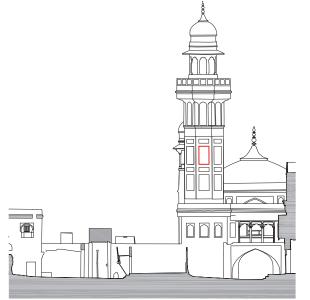
This arboreal and geometric south facing glazed tile panel on the south-eastern minar displays instances of discoloration of glaze, exfoliation of glaze from the terracotta body, complete loss of glaze from terracotta and spalling of tile body.

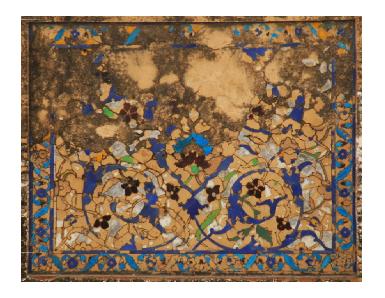
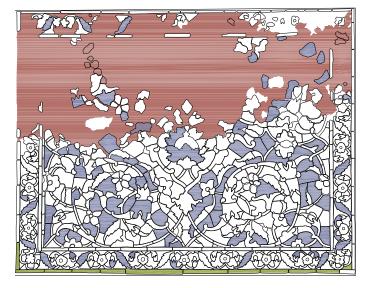
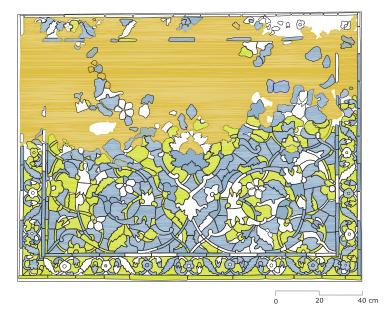
DOCUMENTATION OF SURFACE CHANGES AND TILE DISINTEGRATION OF A PANEL ON THE NORTHERN FAÇADE OF THE PRAYER CHAMBER

This floral/geometric glazed tile panel on the north façade of the prayer chamber, is located above Kotwali Bazaar. It displays instances of discoloration of glaze, deposits, complete loss of tiles and base mortar, exfoliation of glaze from the terracotta body, complete loss of glaze from terracotta and spalling of tile body.

The incipient changes described as surface changes give rise to more significant damage to the tile revetments, described under five categories that in fact represent gradual transformation of the glazed tile surface until the occurrence of the complete loss of the tile and its mortar under-bed. The earliest aspects of these changes, the exfoliation of the glaze, creates an age-value that could be the factor constraining us from aggressive "conservation" interventions. Pitting and spalling of the terracotta body under the glaze represents the first serious area of intervention, opening up the loci of significant scales of intervention. These could involve completion of the lost parts of a panel. Such reconstruction may or may not be carried out using tiles that attempt to recreate the complete panel, This could well involve tile glazed a specific tone of colour or even blank glazed tiles to distinguish the 17th century work from contemporary work, even if the evidence for a reconstruction exists. Tile panels that are detached from the base masonry could be re-anchored to the latter using appropriate grouts.

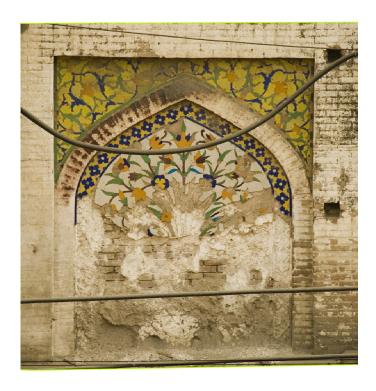
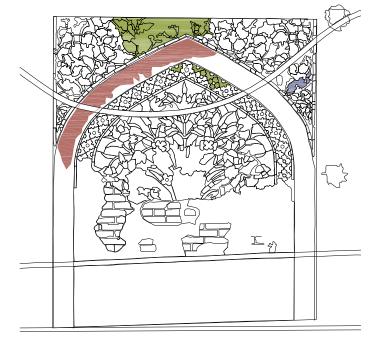
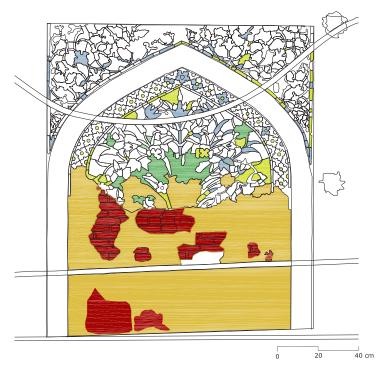
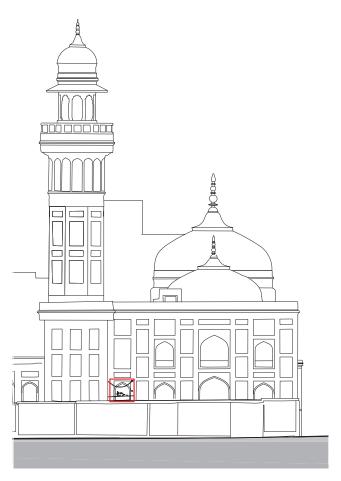
DOCUMENTATION OF SURFACE CHANGES AND TILE DISINTEGRATION ON THE NORTHERN FAÇADE OF THE PRAYER CHAMBER

This arboreal glazed tile panel on the north façade of the prayer chamber, is located directly above the roofs of the shops on Level 0 and thus has suffered from the damages associated with Kotwali Bazaar. It displays instances of deposits, complete loss of tiles and base mortar, exfoliation of glaze from the terracotta body, complete loss of glaze from terracotta and spalling of tile body.

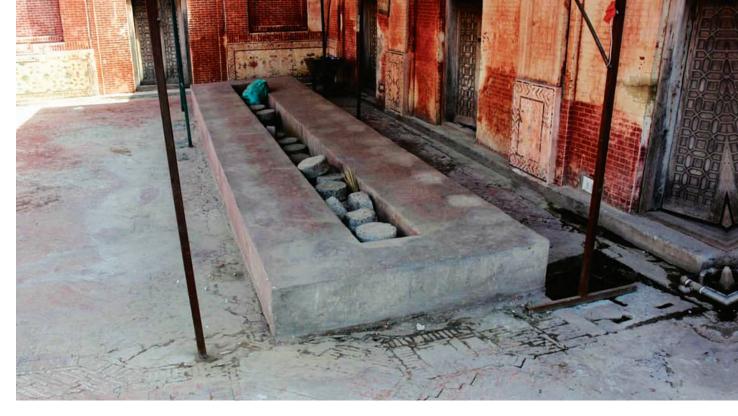
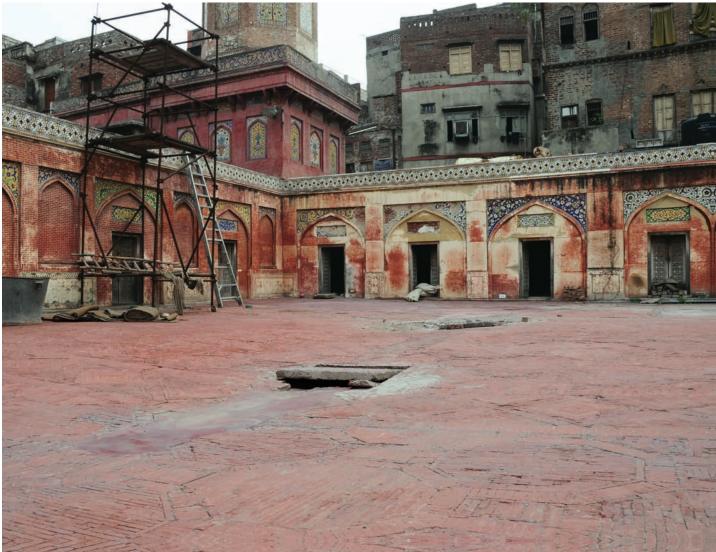
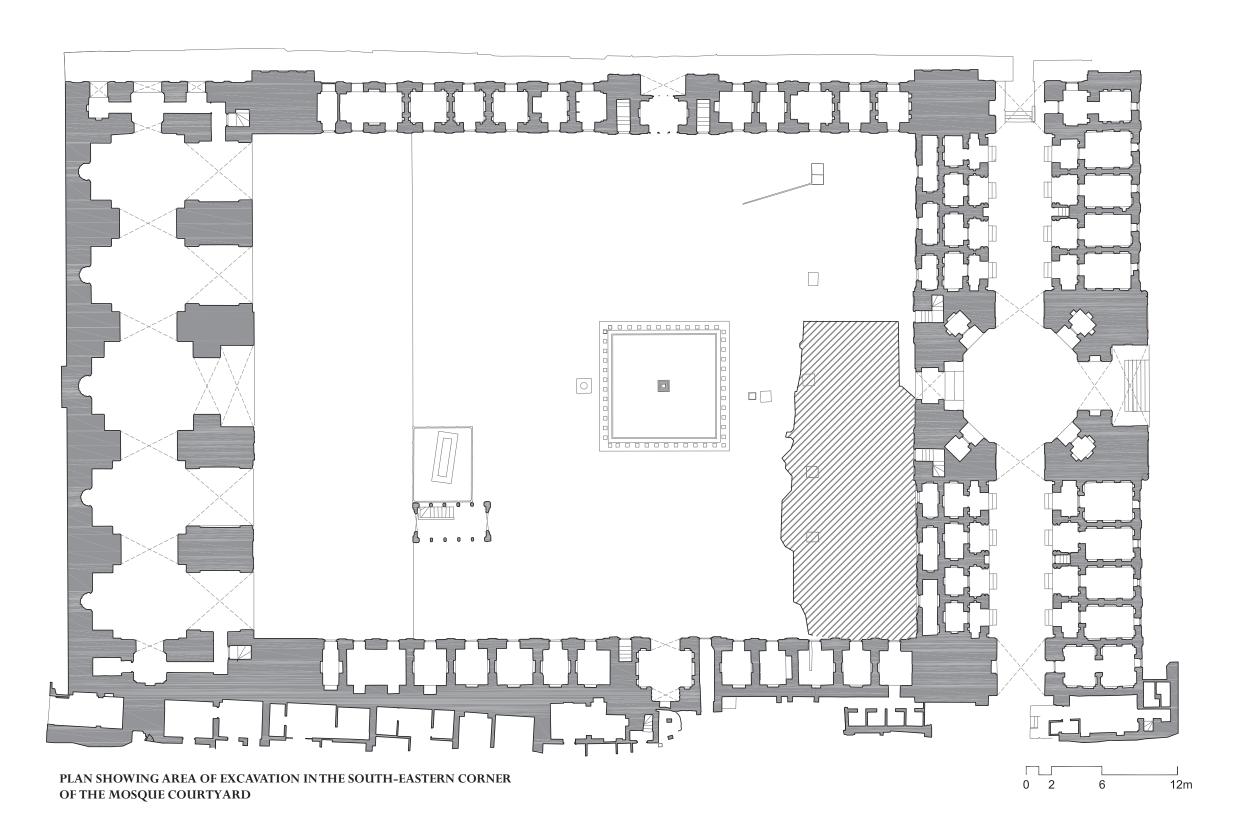
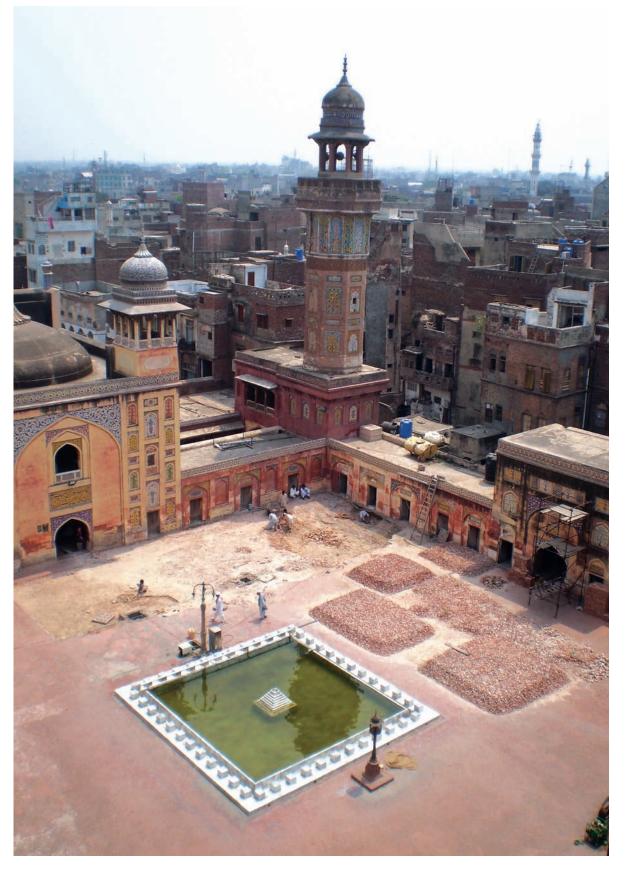
View from the north-west minar of the excavation work in the south-east corner of the courtyard.

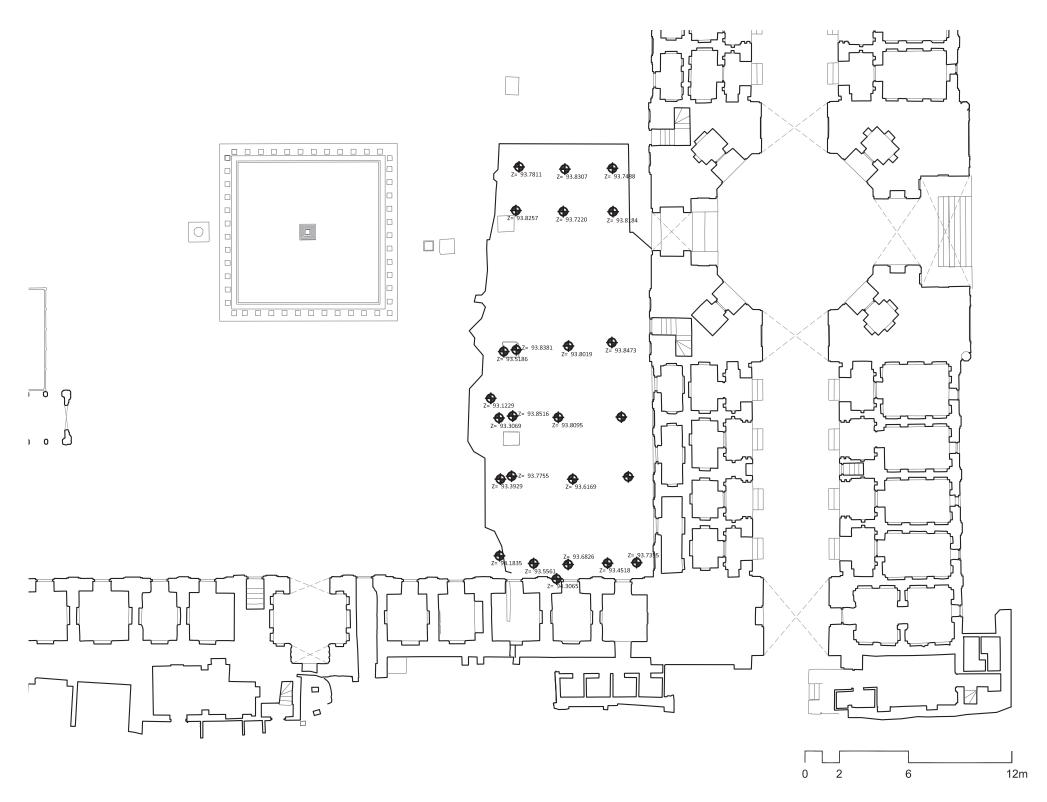
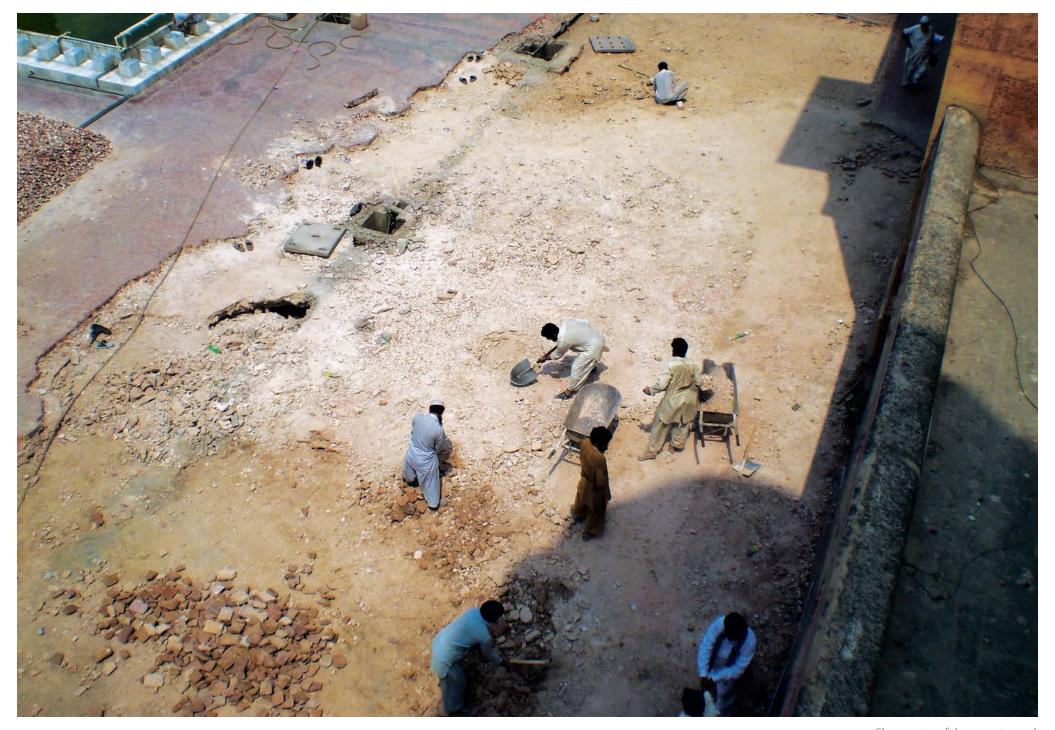
Close-up view of the excavation work.
