**Connaught Point**  
**ENVELOPE MAINTENANCE REVIEW #3**

**Produced by PBEM Ltd.**

**Feb 1, 2007**

Strata Plan LMS 265  
2288 West 12ave,  
Vancouver, B.C

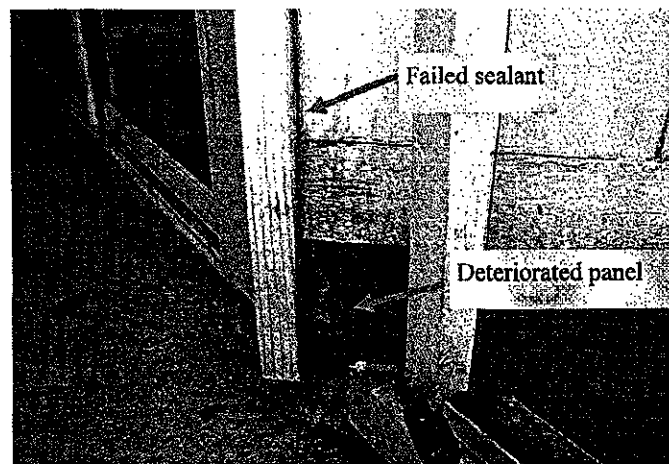
Photo V11: Unit 309 North

Deteriorated panel

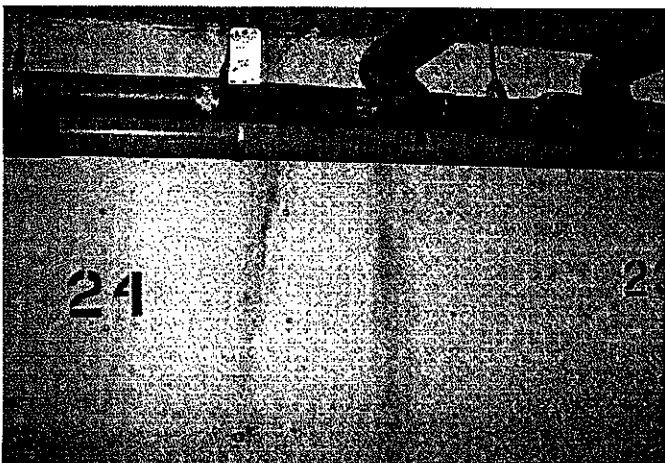
Photo P5: Stall 24 below exhaust grill
