## **Depreciation Report/Reserve Fund Study**

### **Aquarius Strata Corporation LMS 3903**

Tower A – 1199 Marinaside, Vancouver, BC  
Tower B – 198 Aquarius Mews, Vancouver, BC  
Tower C – 189 Davie Street, Vancouver, BC  
Tower M – 1111 Marinaside, Vancouver, BC

Report No. 5105557.00

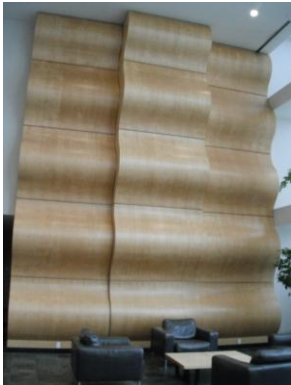
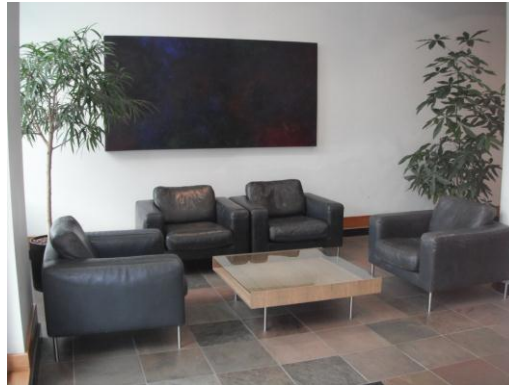
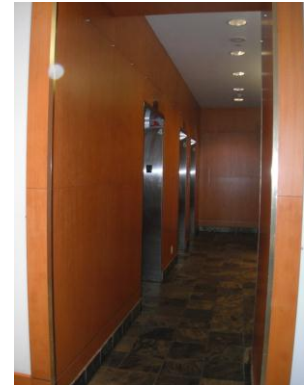
The main entrance/elevator lobbies are finished with tile flooring, painted gypsum wallboard, and decorative wood panels. Various pieces of furniture and artwork are provided. We assume the finishes to be original to the buildings.

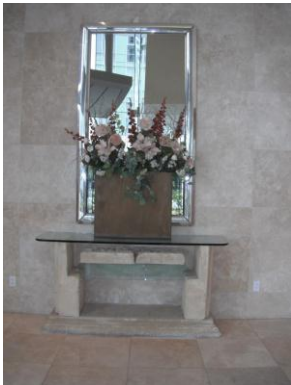
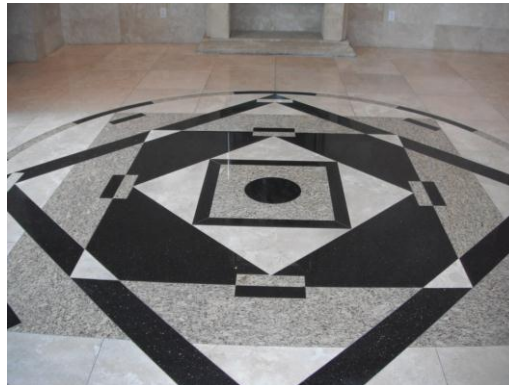
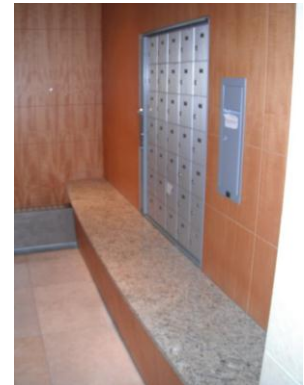
The main entrance/elevator lobbies are finished with marble tile flooring. At a small area in front of the fireplace the flooring is carpet. The majority of wall finishes are marble tiles. The walls around the mail boxes and elevators are finished with wood panels. Various pieces of furniture and artwork are provided.

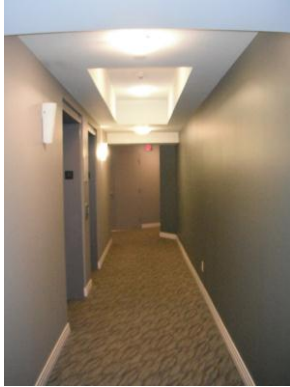
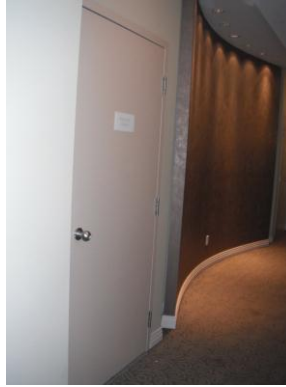
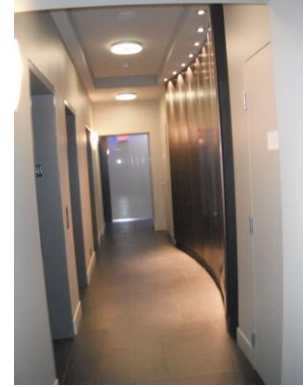
The flooring in the corridors is carpet and the walls are painted drywall throughout. The suite entrance doors are solid core wood framed doors.

The corridor finishes at the penthouse levels are the same as the rest of the floors, except that the wall in front of the elevator door is covered with wallpaper or stone.

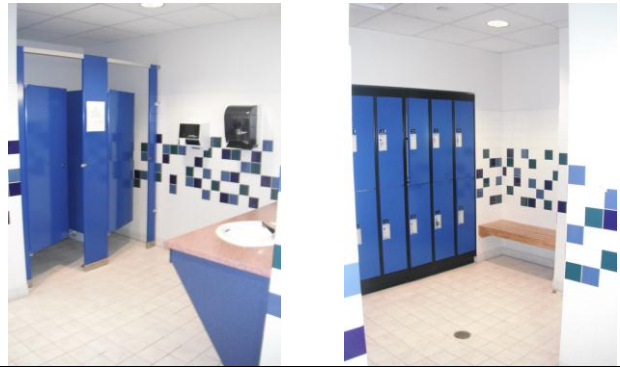
There are two washrooms and two changing rooms next to the pool area. The washrooms and changing rooms flooring and wall finishes are tiles. Each washroom is equipped with 6 toilets and two sinks. The changing rooms are equipped with a bench and lockers.

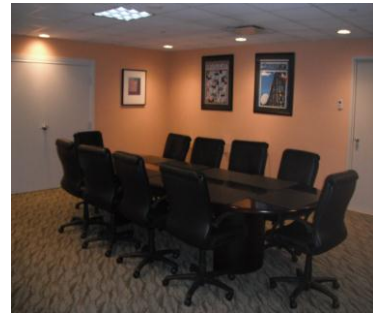
There is a conference room in the complex. The floor is carpeted; the walls and ceiling are painted. Various pieces of furniture and artwork are provided.

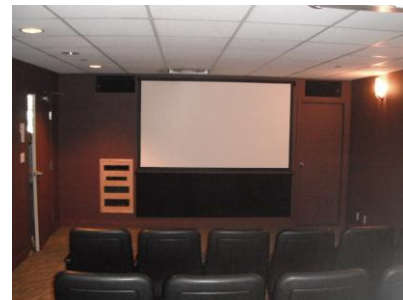
The complex has a theatre, which sits 20 people. The walls are finished with wallpaper. The floor is carpeted.

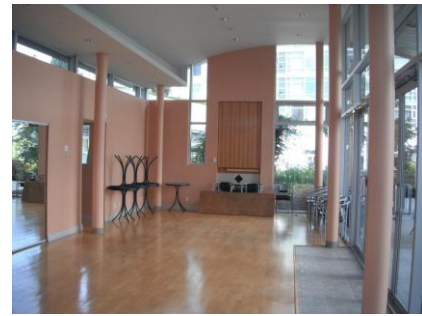
The complex has a yoga room which is located at the podium level. The walls are painted and the flooring finishes are wood. There is also a small kitchen and washroom inside the yoga room. Various pieces of furniture and appliances (TV, microwave, refrigerator etc.) are provided.

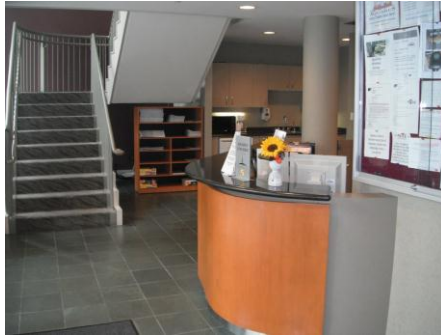
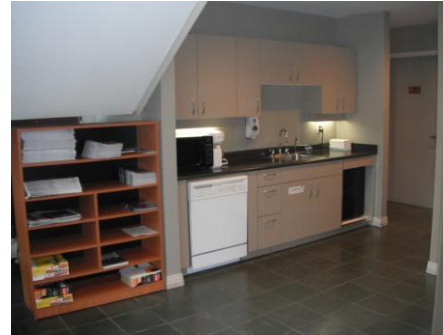
There is a concierge office in the complex. The office area includes a small kitchen and two washrooms. The floors are finished with tile and the walls are painted. Various pieces of furniture and appliances/electronics (coffeemaker, microwave, refrigerator, dishwasher and computer) are provided.

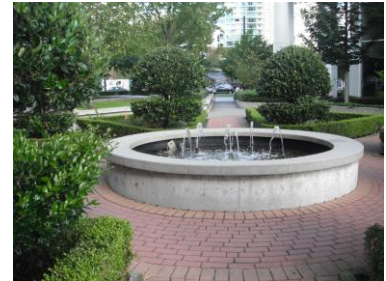
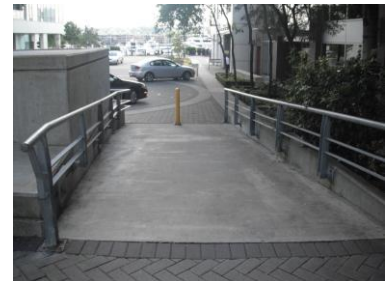
- Brick and concrete walkways in the courtyard.
- Concrete stairwells with handrails at the courtyard and podium.
- Concrete planters and benches

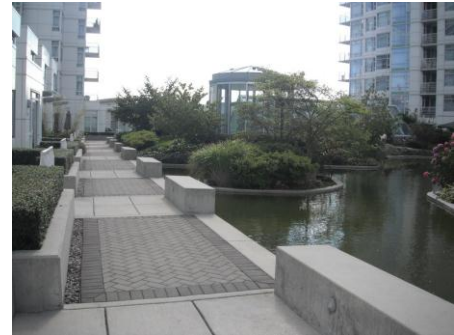
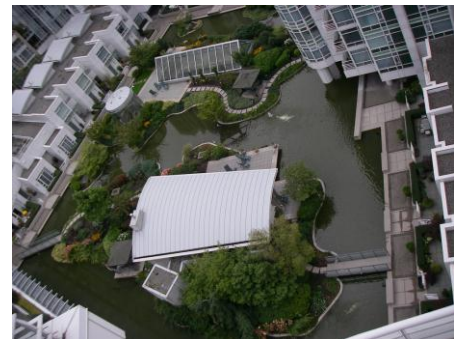
The podium is located in the middle of the complex at level 5. The podium has a variety of garden furniture and fixtures, including canopies, benches, tables and chairs. Metal guardrails are provided at walkways over the water.

Typically the soft landscaping is included in maintenance and does not appear as a line item for the reserve fund study. However, when it is time to replace the podium membrane (Item B10) the landscaping (hard and soft) should be replaced.
