## PARKING GARAGE CONDITION EVALUATION

1330 BURRARD STREET  
1333 HORNBY STREET  
950 DRAKE STREET  
VANCOUVER, BC

PREPARED FOR:  
THE OWNERS, STRATA VR 1182, 1183 AND 1184  
C/O ASCENT REAL ESTATE MANAGEMENT CORPORATION  
2176 WILLINGDON AVENUE  
BURNABY, B.C. V5C 5Z9

205VR012A.R1  
SEPTEMBER 30, 2005

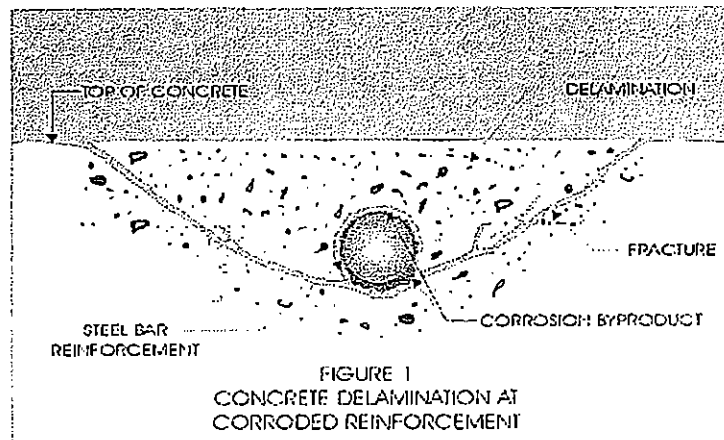
Steel chains are dragged over the surface of the slab to detect delaminations (see Figure 1). Delaminations sound hollow. They are marked and the area measured to determine the present extent of physical damage. The results obtained must be carefully interpreted. Delaminations on the underside of slabs or on vertical surfaces are generally identified by visual inspection and sounding with a hammer in local areas. This process is only approximate.
