REPORT

**Building Envelope Condition  
Assessment – The Sonesta**

1989 Dunbar Street  
Vancouver, British Columbia

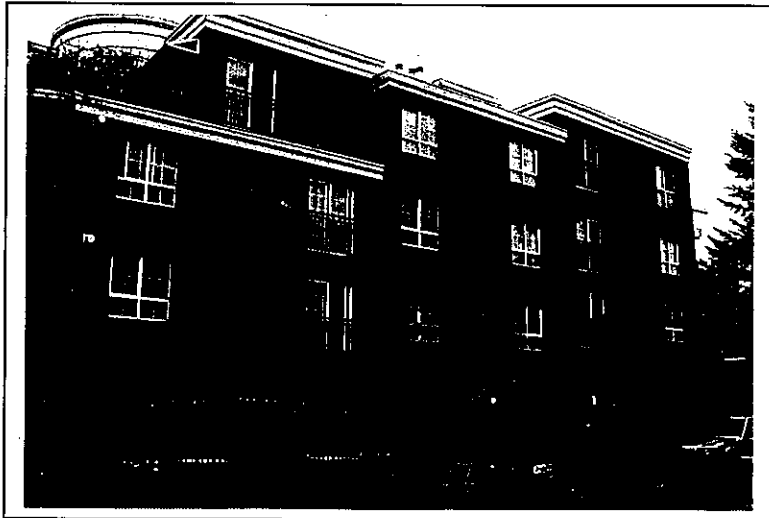
### Photo 2

| Location | East elevation (Dunbar) |
| Building Element | General building configuration |

**Description:** Commercial unit and residential entrance at ground floor and residential units on above floors. The exterior walls are not protected by roof overhang, except for the ground floor commercial units.
