## PERFORMANCE ASSESSMENT REVIEW

<sup>3</sup>  
Delano Centre  
3024 West 4th Avenue, Vancouver, BC

**Project:** Delano Centre, 3023 West 4th Avenue, Vancouver

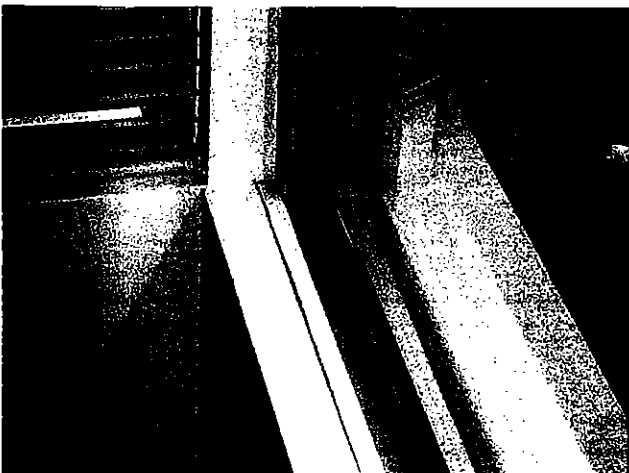
- 2.4 Windows** - See photos 1, 4, 5, 9, 11, 12, 12, 14, 18, 19, 24, 26, 27  
Windows were inspected from the exterior and from the interiors of Suites 409, 406 and 401. No signs of leaks, staining or damage from rain ingress or condensation were observed. Circular windows in exit stairs were also found to be free of leaks or condensation.

5. Window sill at corner - Suite 409

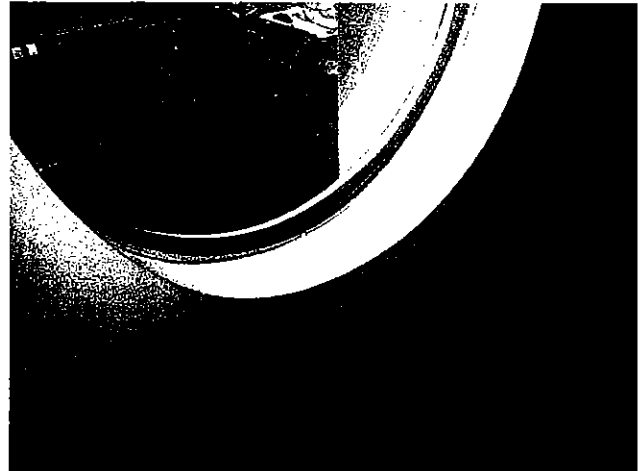
26. Circular window at exit stair - interior

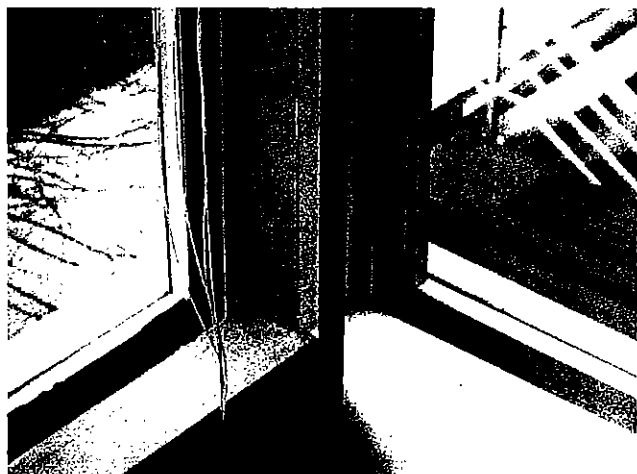
The walls and window frames appear dry with no indication of retained moisture.

5. Corner of windows - Apartment 306

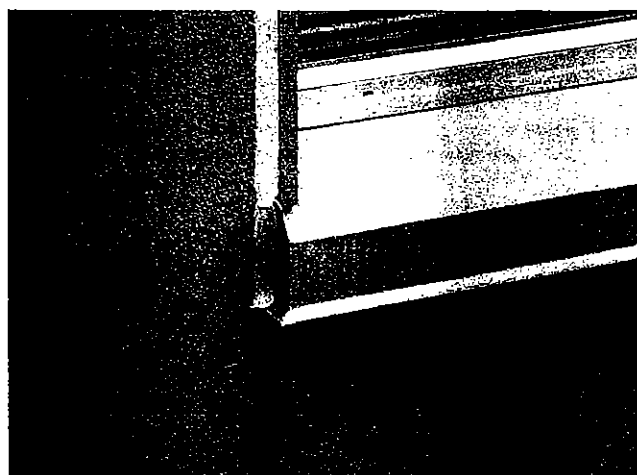
Sealant installed at junctions of stucco cladding and trims, frames and flashings is well adhered with no signs of bulging, cracking or delamination and, although primarily aesthetic, appears to be performing as intended. At one location there is sealant delamination at a stucco control joint immediately under the main roof parapet cap flashing at the east end of the roof.

7. Sealant at window trim well adhered

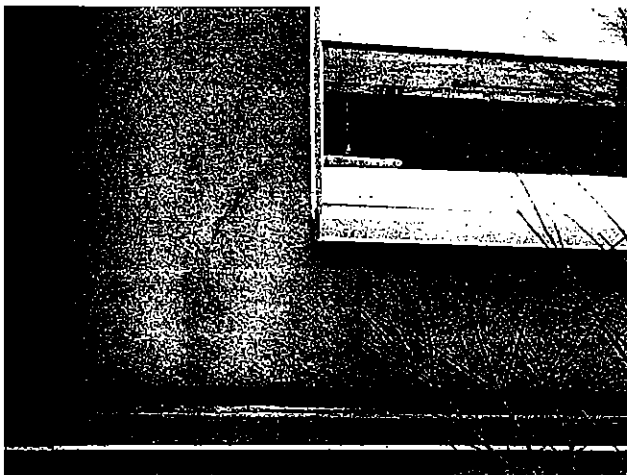
Repairs have been made to previously reported cracks in stucco cladding. Further cracks were observed from the roof on the upper walls on the south side of the building. These hairline cracks are not of immediate concern. The wall assemblies are well protected with the rainscreen cavity.

15. Previous stucco repair

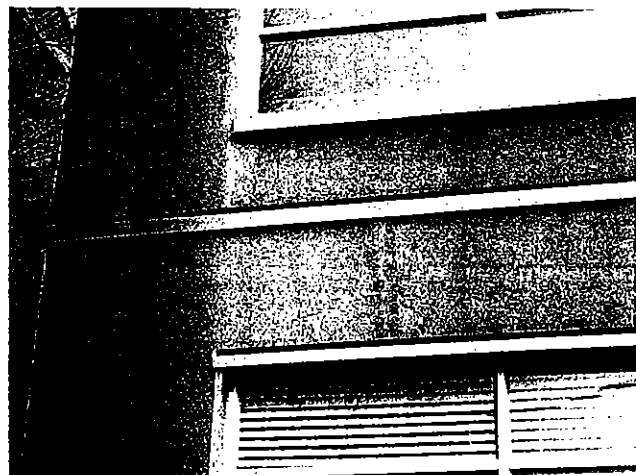
16. Previous stucco repairs
