**BPG Inspection, LLC**

Client(s): Sorge  
Inspection Date: 9/30/2026  
Inspector: Mark Kirkland ,

## SECTION I. KEY FINDINGS

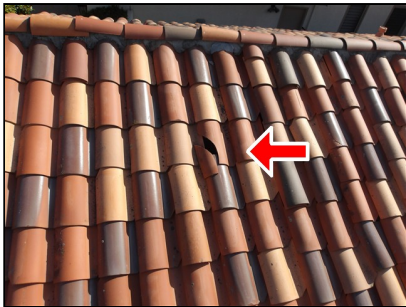
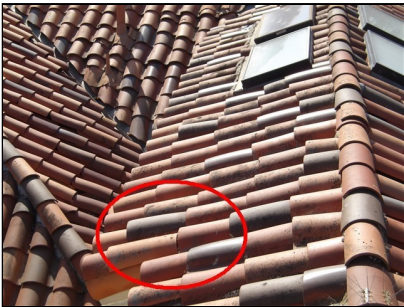
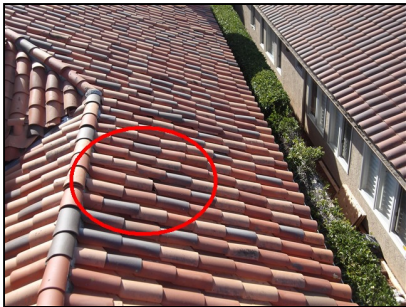
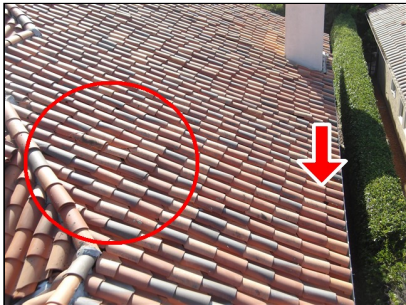
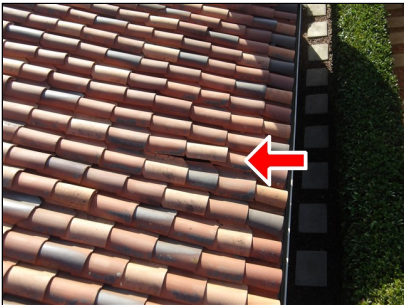
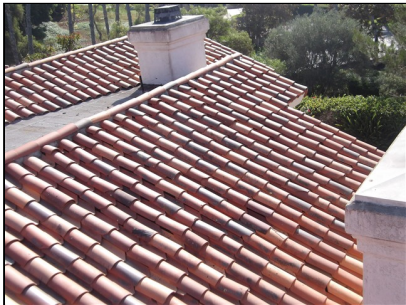
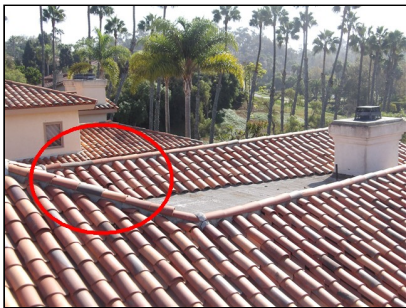
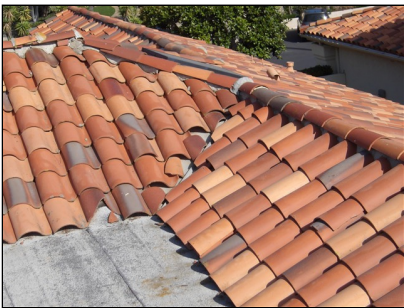
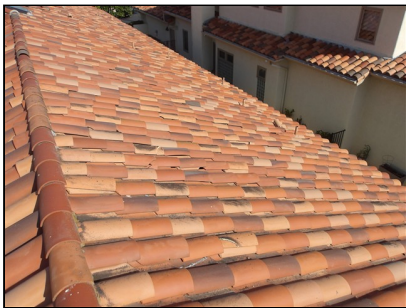
- ❌ 5. Roof tiles were noted to be cracked, damaged, or displaced. Further evaluation and repairs/replacement is needed. Since inspectors do not walk on concrete/clay/composite roof tiles, there could be additional tile defects. Have the roofing technician who corrects this/these reported conditions, check the rest of the roof.

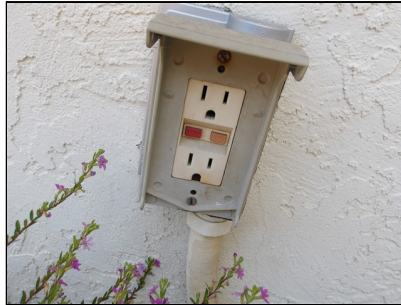
- ❌ 10. The outside outlet cover at the rear of the home is damaged/missing and needs repaired or replaced.

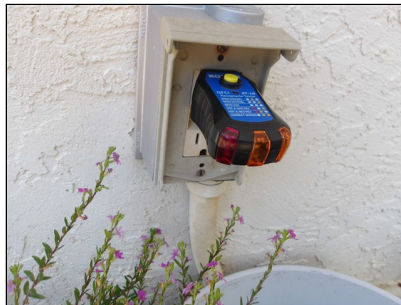
- ❌ 11. One or more exterior outlets at the rear of the home did not work or there is no power to outlet. A qualified electrician should make any needed corrections.

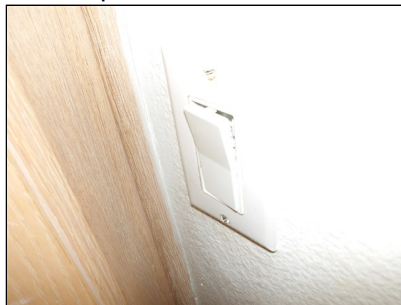
- ❌ 12. Several switches are loose at multiple locations in the home. One was even taped down so it wouldn't come on. A qualified electrician should make any needed repairs.

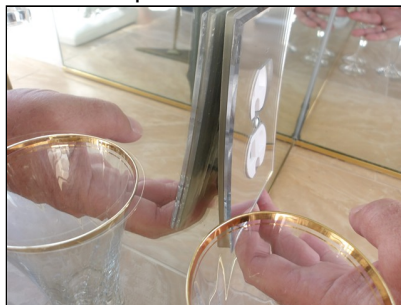
- ❌ 13. One receptacle is loose in the wall at bar area. A qualified electrician should make any needed repairs.

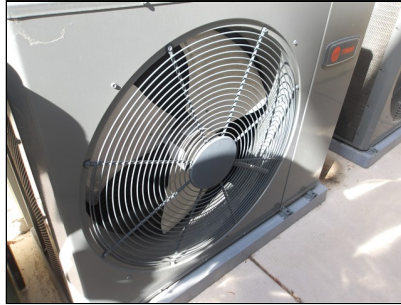
- ✘ 14. The compressor did not respond to normal user controls for the main living area of the house. Non-functioning compressors may be the result of some simple mechanical or electrical problem easily fixed, or may involve the expense of complete replacement of the unit(s). A qualified technician should evaluate the compressor and make repairs or modifications as necessary.

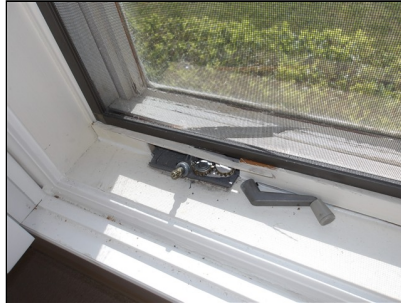
- ✘ 15. Several windows do not operate smoothly, are difficult to latch or are in need of adjustment. Several windows are missing hardware or stuck and not operational. All poorly or non-operating windows and their associated hardware should be cleaned, lubricated, and adjusted for smoother operation. Where needed, essential hardware, such as operator cranks, sash balances and latches should be replaced with compatible components.

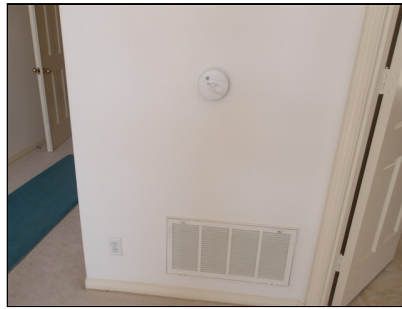
- ✘ 18. The smoke detector is too low on the wall at the master bedroom. A qualified technician should repair or replace as needed.

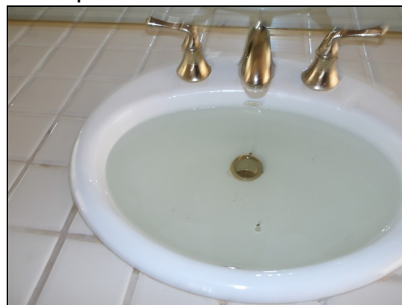
- ❌ 20. The wash basin(s) in the master bathroom drain stop is damaged and stuck down. Resulting in the sink not being able to drain. A qualified technician should repair the wash basin as needed.

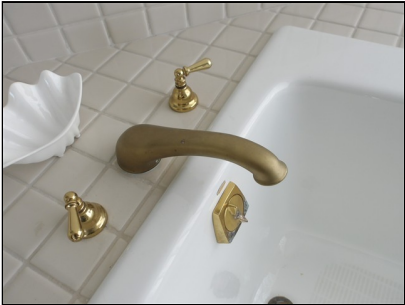
- ❌ 21. The hot and cold water was shut off or not functional at the bathtub in the master bathroom. The seller may have details as to why it's off. A plumber should perform repairs as needed.

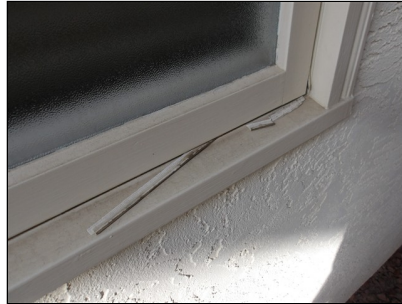
- 41. Several window gaskets/seals are damaged or deteriorated at multiple locations. A licensed contractor and/or specialist should perform repairs.

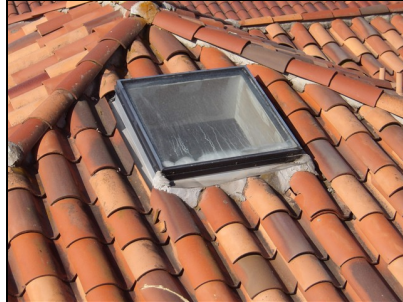
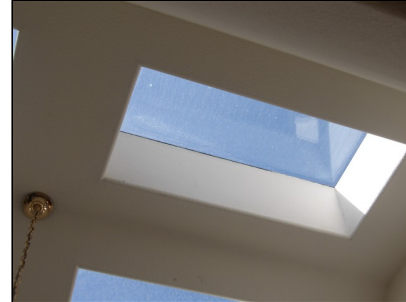
48. There is condensation in the skylight lens. No external deficiencies were noted.

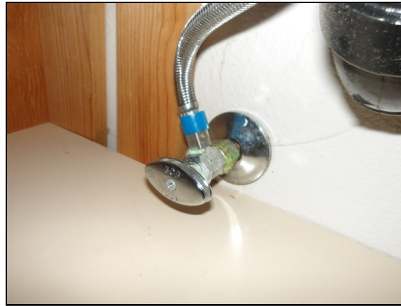
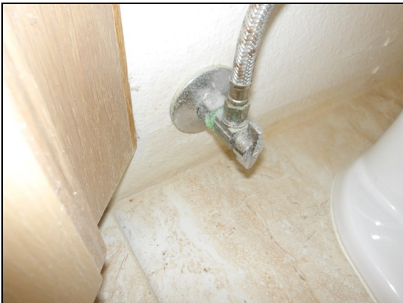
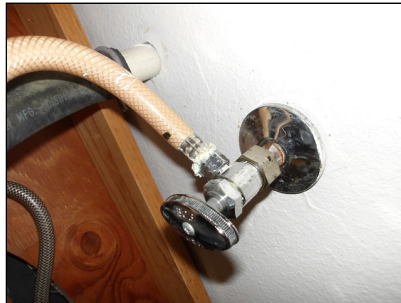
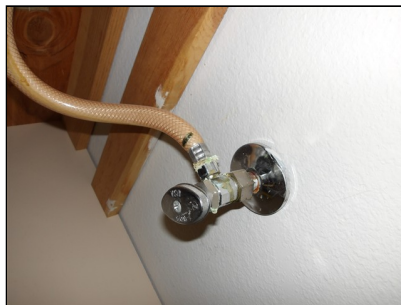
53. There is surface corrosion in the visible supply and/or waste piping at several valves, fixture and drains in the home. We observed no signs of active leaks at the time of the inspection but leaks can develop anytime without warning. All valves and fixtures should be evaluated during your final walk through and before close of escrow to verify that no new leaks have developed.
- This piping should be evaluated for leaks on a regular basis and repaired by a qualified technician when necessary.

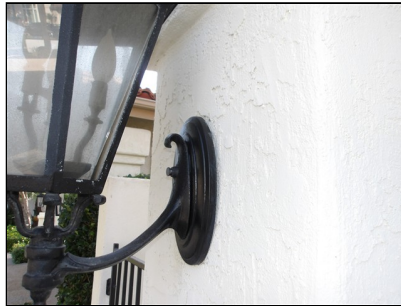
58. One or more light fixtures are loose and/or not sealed at the exterior walls. A qualified licensed electrician should make any needed corrections.

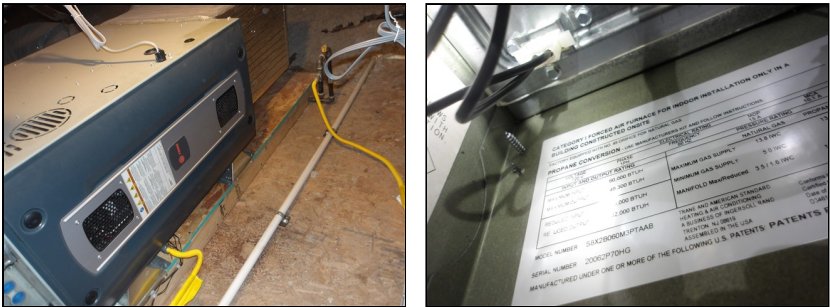
60. We believe the heaters are dated 2020 but observed several different serial numbers on the units. We recommend having the home owner verify the ages. You can also contact the manufacturer to confirm ages.

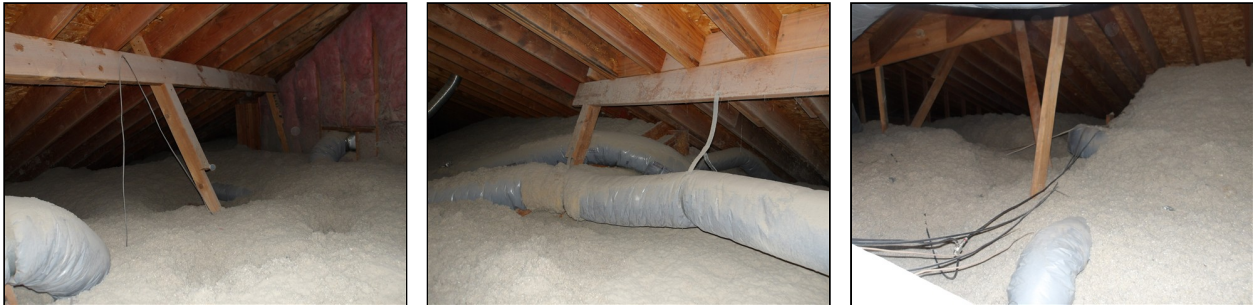
61. We could not access one or more attic areas due to one or all of: no access, low headroom, vaulted ceilings, insulation concealing the rafters, duct work, temperature, unsafe conditions, storage, etc. Further evaluation is advised if the client has concerns about these areas.

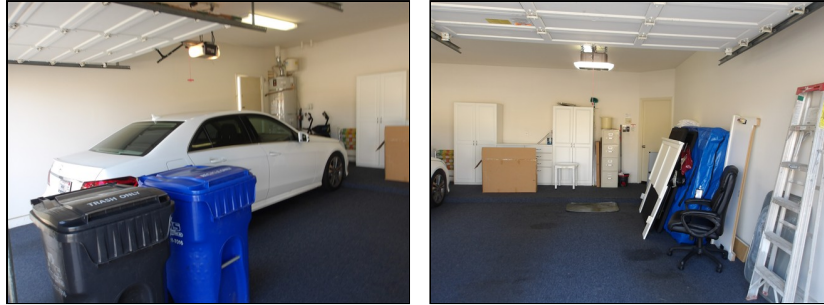
64. The presence of personal items limited access to the garage at the time of this inspection.  
- A "walk through" is recommended when the areas is cleared and accessible, prior to the close of escrow.

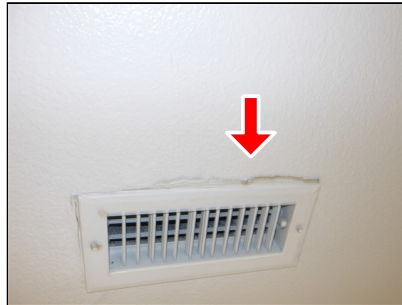
66. Paint is peeling from the half bathroom ceiling near the register. This could indicate improper painting technique or excess moisture. A qualified technician could make repairs or modifications as necessary.

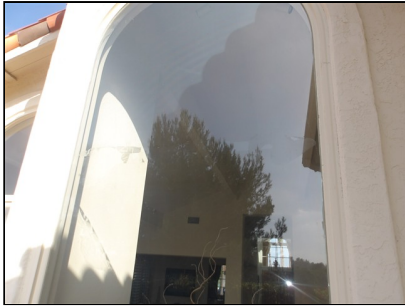
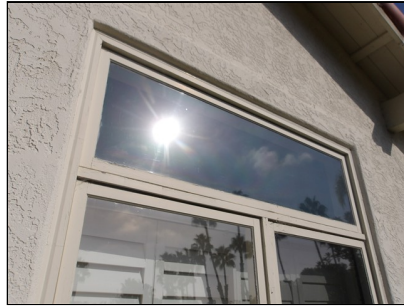
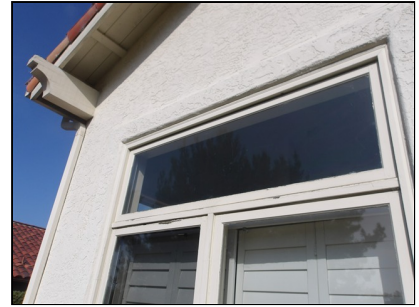
68. Several windows and glass doors have a film on them that is peeling or deteriorated. It makes it blurry to look out the glass. A licensed contractor and/or specialist should repair glass as needed.

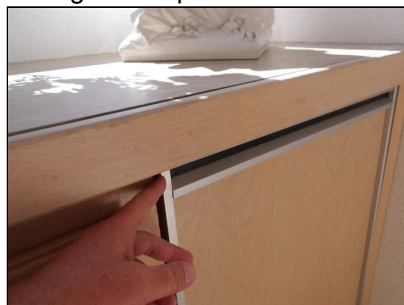
72. The refrigerator at the wet bar area is hard to open because the top trim board for the counter blocks access. A qualified technician should modify so the refrigerator opens.

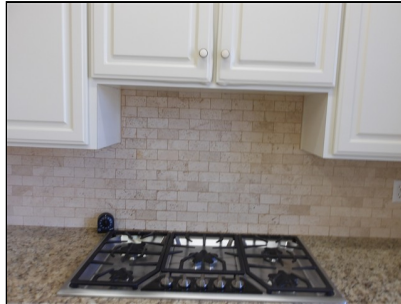
- 75. There is no power ventilation system over the cooking appliance.
  - Consider installing a ventilation system. A qualified technician should do the job.

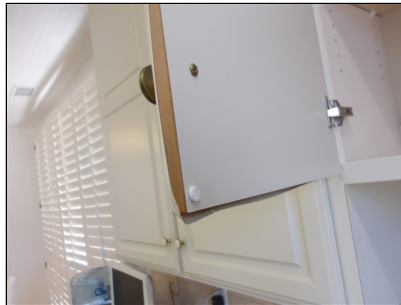
- 76. Several cabinet doors are coming apart and peeling. A qualified technician should make any necessary repairs or replace components as needed.

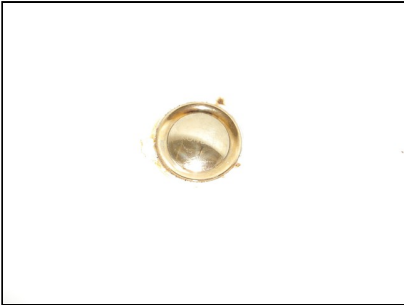
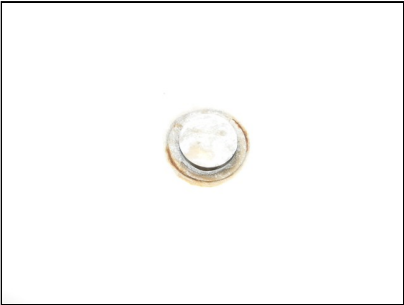
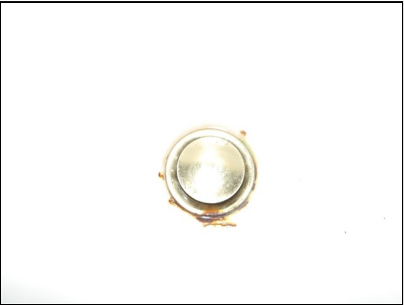
- 78. Several wash basin(s) in the bathrooms are rusted and deteriorated at several areas. A qualified technician should repair or replace the wash basin as needed.

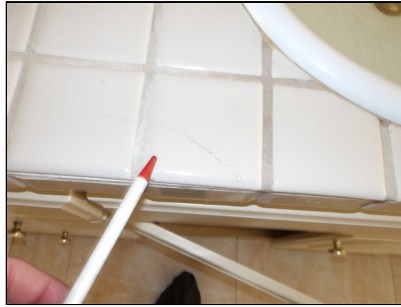
83. The vanity countertop to the master bathroom is cracked. A qualified technician should perform necessary repairs.

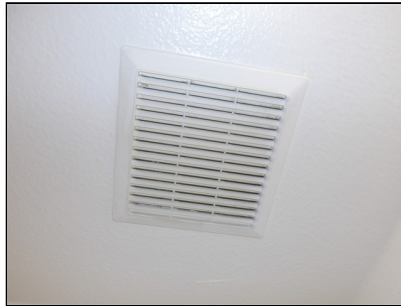
84. The ceiling fan does not work at the laundry room. The room does have a window. Repair or replacement is needed. A qualified licensed electrician should make any needed repairs.
