**Cranor Inspection Services, LLC**

# Inspection Report

**8939 Cardiff Rd, Richmond, VA 23236**

Yr Blt:1987 Sq Ft: 3180

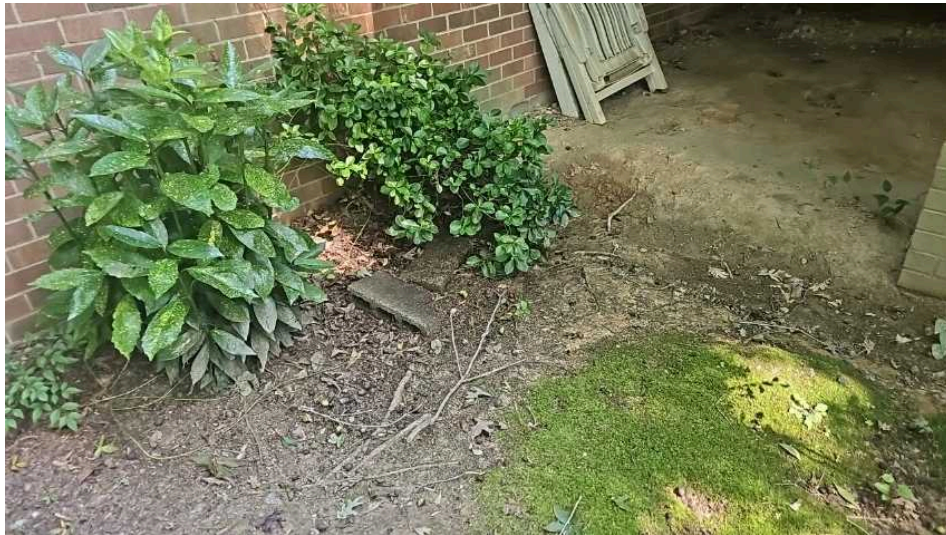
Sunken area on rear near porch

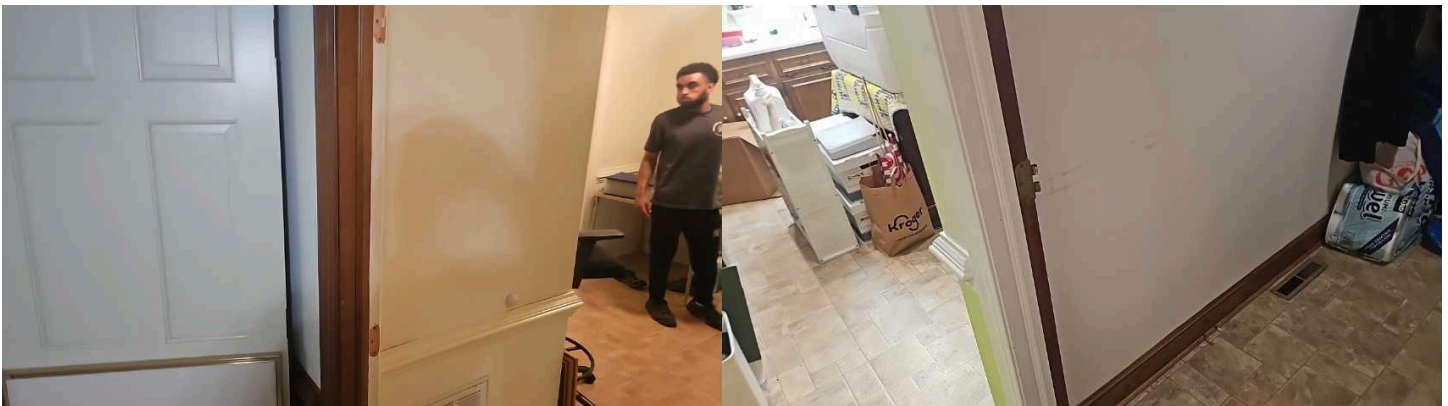
Door removed between den and foyer

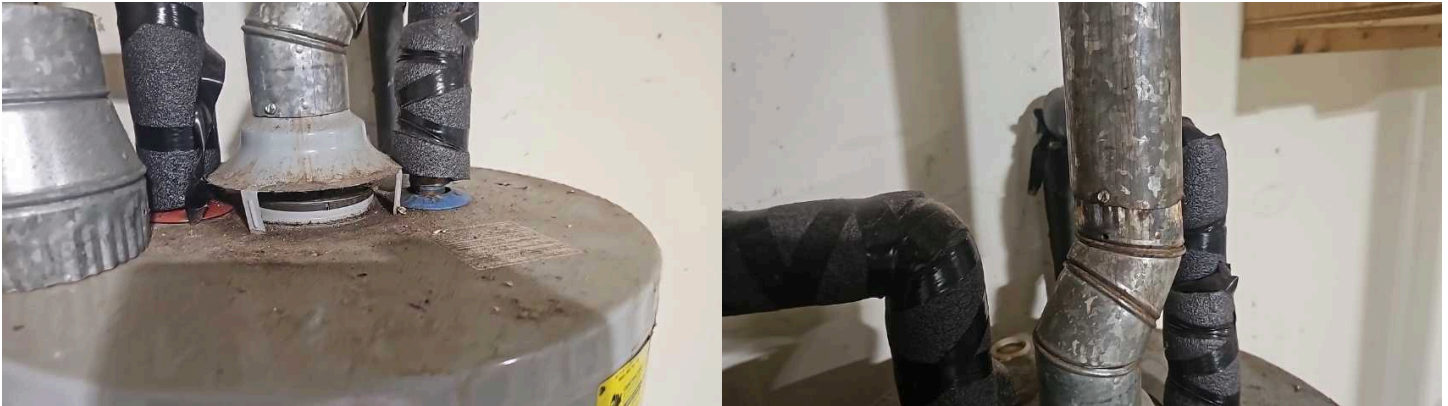
Flue pipe not secured properly

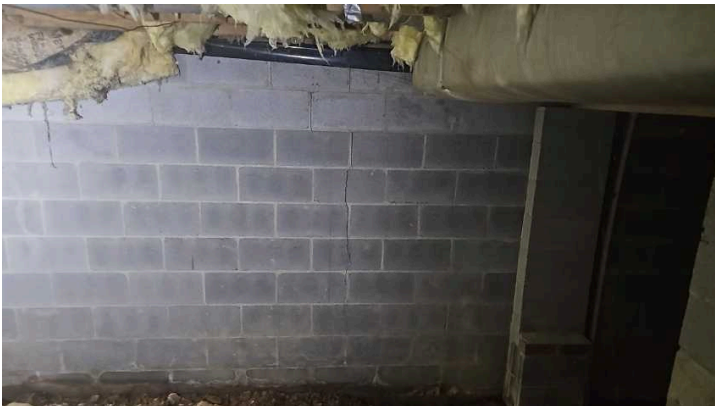
**2.1. There is unusual vertical cracking in the foundation on far left. Also see garage comments. Recommend having foundation evaluated by licensed qualified engineer and/or licensed qualified foundation repair contractor and have corrected as necessary.**

Unusual cracking in foundation on far left

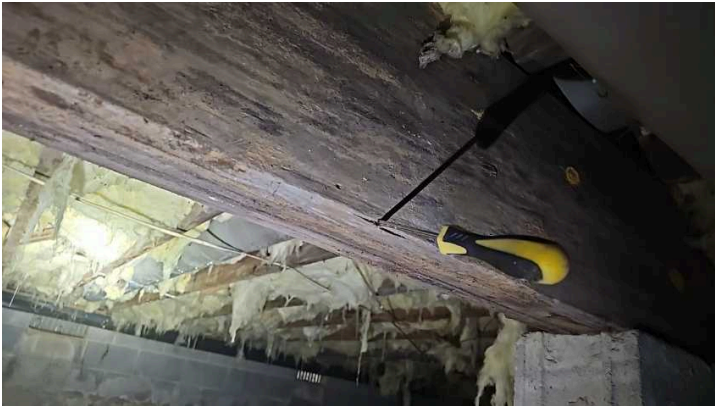
Page 44 Item: 3	Crawl Space Floor Structure	<b>3.1. The floor structure including the main support beam and joists have moisture related damage (rot). The floor structure is covered with a dark fungal like growth. Recommend having floor structure evaluated and repaired by a licensed contractor.</b>
Page 45 Item: 4	Crawl Space Ventilation, Moisture Control & Conditions	<b>4.1. The crawl space shows indications of chronic wet conditions and there is a visible surface discoloration or a suspected fungal like growth, such as mold or wood destroying fungi, on the floor structure. Fungal growth is the result of a water or high humidity problem. Addressing and alleviating the high humidity and wet conditions is critical in preventing the continuing development of the fungal growth. Fungal growth can result in deterioration of the floor structure, and in some cases affect indoor air quality. There is obvious damage on the wood floor structure. There are mushrooms growing in the crawl space. Recommend having evaluated and corrected as necessary by a qualified moisture control specialist.</b>

Black fungal like growth and rot on floor structure

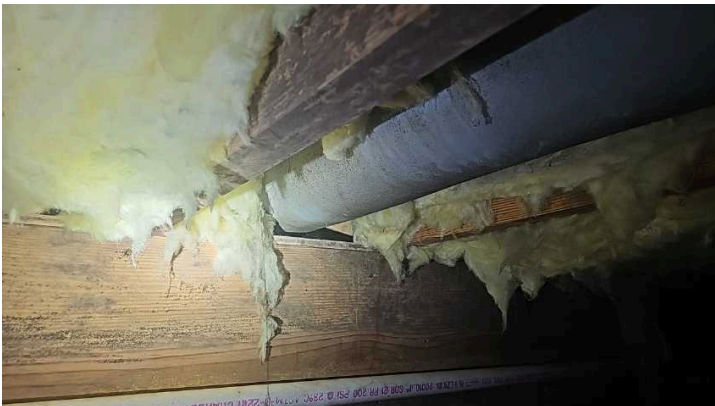
**4.1. The crawl space shows indications of chronic wet conditions and there is a visible surface discoloration or a suspected fungal like growth, such as mold or wood destroying fungi, on the floor structure. Fungal growth is the result of a water or high humidity problem. Addressing and alleviating the high humidity and wet conditions is critical in preventing the continuing development of the fungal growth. Fungal growth can result in deterioration of the floor structure, and in some cases affect indoor air quality. There is obvious damage on the wood floor structure. There are mushrooms growing in the crawl space. Recommend having evaluated and corrected as necessary by a qualified moisture control specialist.**

Fungal like growth on floor structure

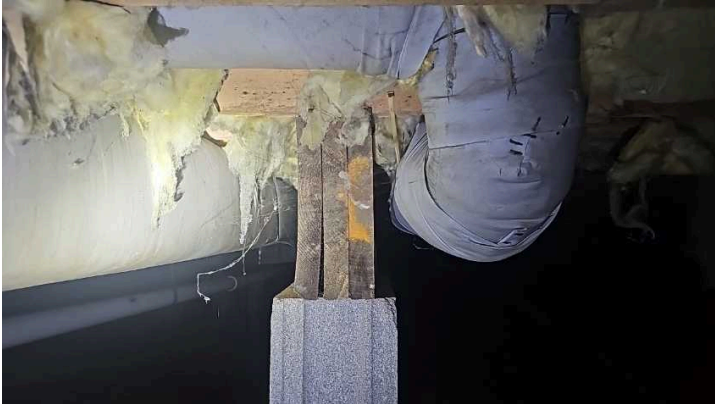
Fungal like growth on floor structure

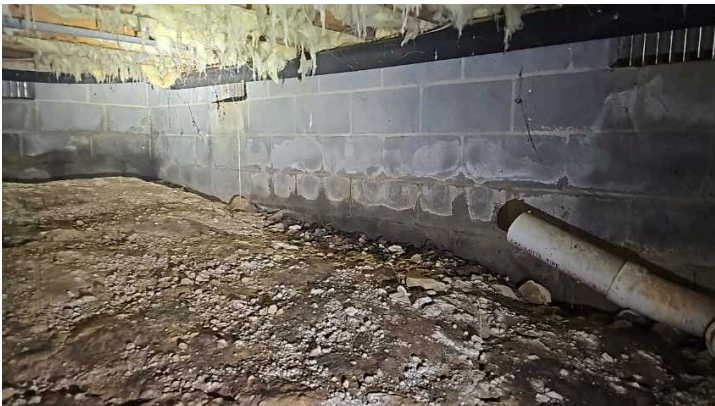
Wet foundation adjacent to the concrete apron on front
