## Roof Inspection Report

5793 Independence St.  
Arvada, CO 80002

March 4, 2019

Section: 1  
Roof System: Modified GTA  
Size: 1300 Sqft  
Inspection Date: March 1, 2019

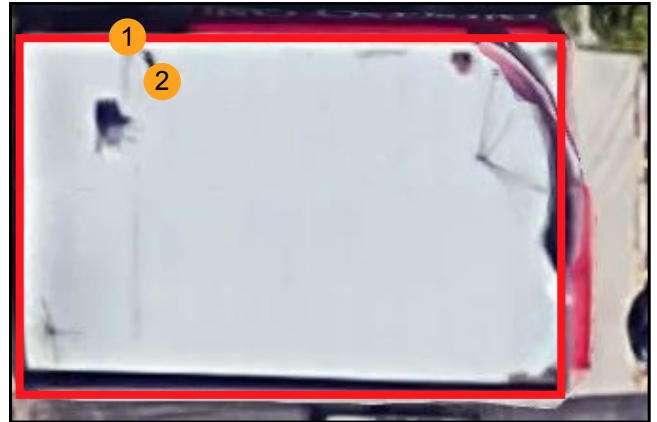
**Deficiency #1** Remedial

Missing Pitch Pocket.

Monitor or perform repairs to increase its longevity.

Install per manufacture specification once a new roof system is installed.

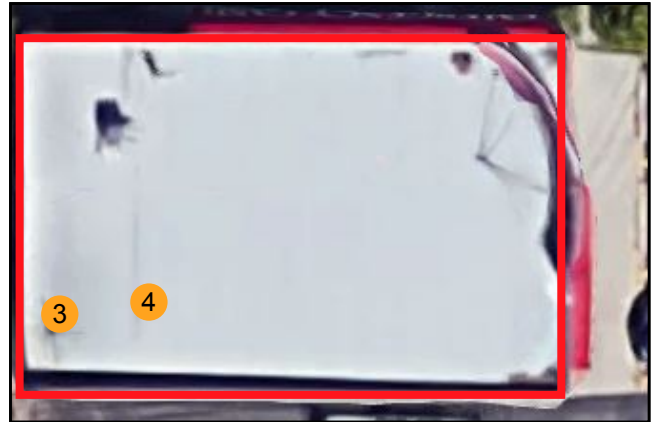
**Deficiency #3** Emergency

Displaced / Cracked Sealants

Perform a 3 coarse repair to mitigate any leaking into the underlying substrates.

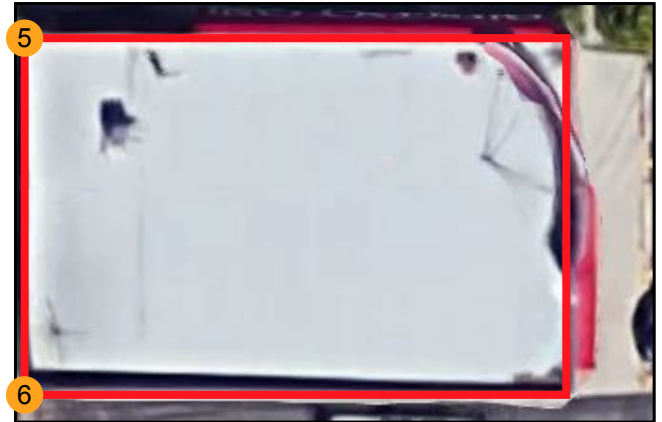
**Deficiency #5** Emergency

Missing Termination

Install termination bar and sealants per manufactures specifications.

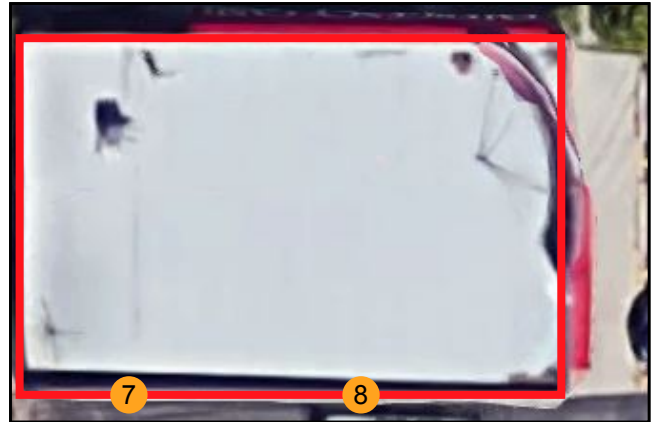
**Deficiency #7** Emergency

Displaced / Cracked Sealants

Perform a 3 coarse repair to mitigate any leaking into wall flashing and the underlying substrates.

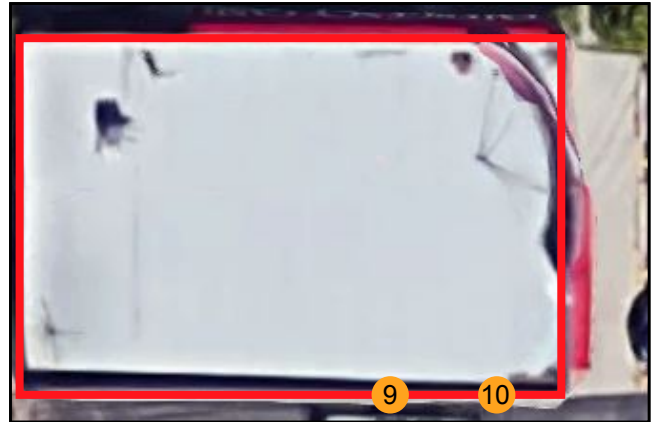
**Deficiency #9** Emergency

Missing Termination

Install termination bar and sealants per manufactures specifications.

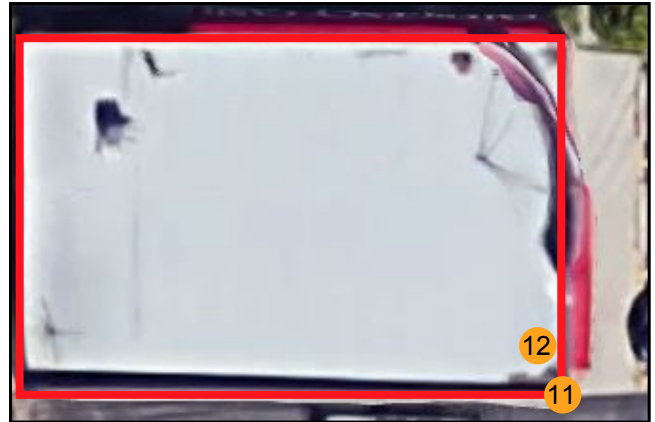
**Deficiency #11** Emergency

Displaced / Cracked Sealants

Perform a 3 coarse repair to mitigate any leaking into wall flashing and the underlying substrates.

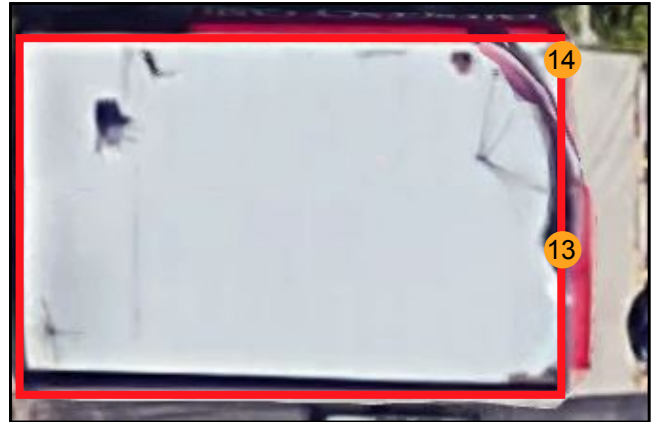
**Deficiency #13** Emergency

Displaced / Cracked Sealants

Perform a 3 coarse repair to mitigate any leaking into wall flashing and the underlying substrates.

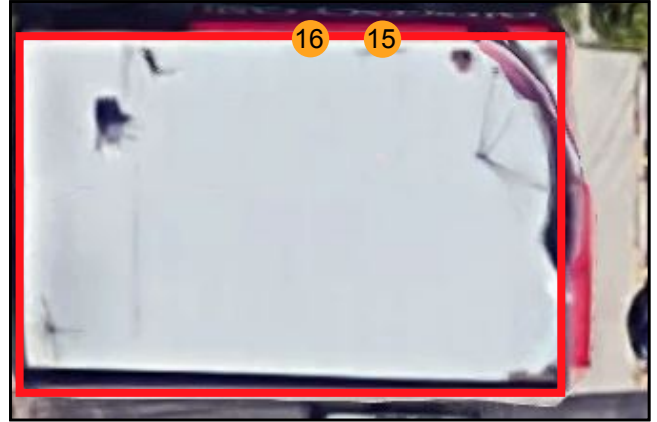
**Deficiency #15** Emergency

Open Base Flashings

Perform a 3 coarse repair to mitigate any leaking into wall flashing and the underlying substrates.

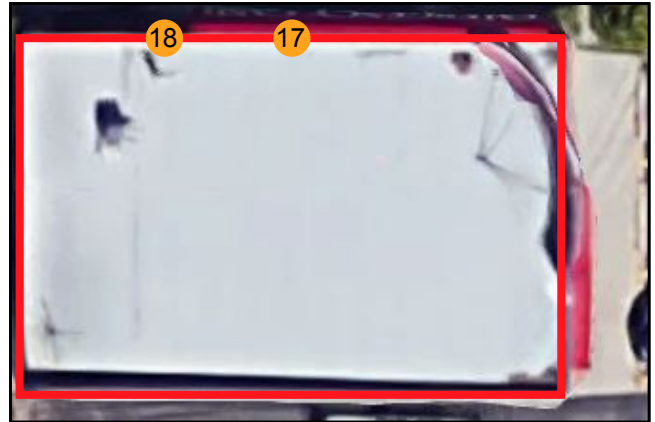
**Deficiency #17** Emergency

Open Base Flashings

Perform a 3 coarse repair to mitigate any leaking into wall flashing and the underlying substrates.

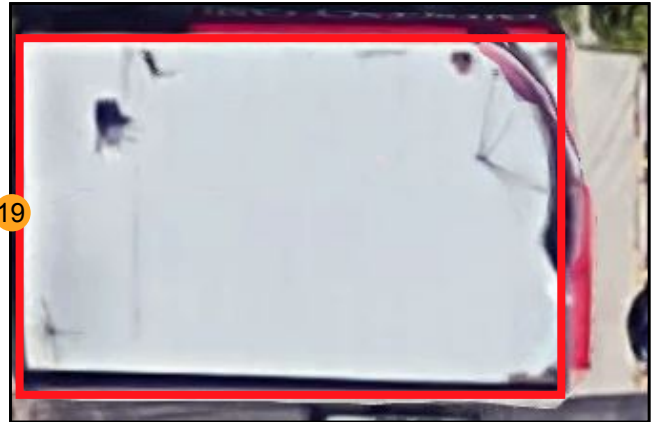
**Deficiency #19** Emergency

LF  
Debris In Drainage
