Train Collisions and Derailments (in Maryland)

Douglas Hunt*, Wayde Yeager, Katelyn Hamilton, Jonathan Assurian, Nathan Olen

Outline

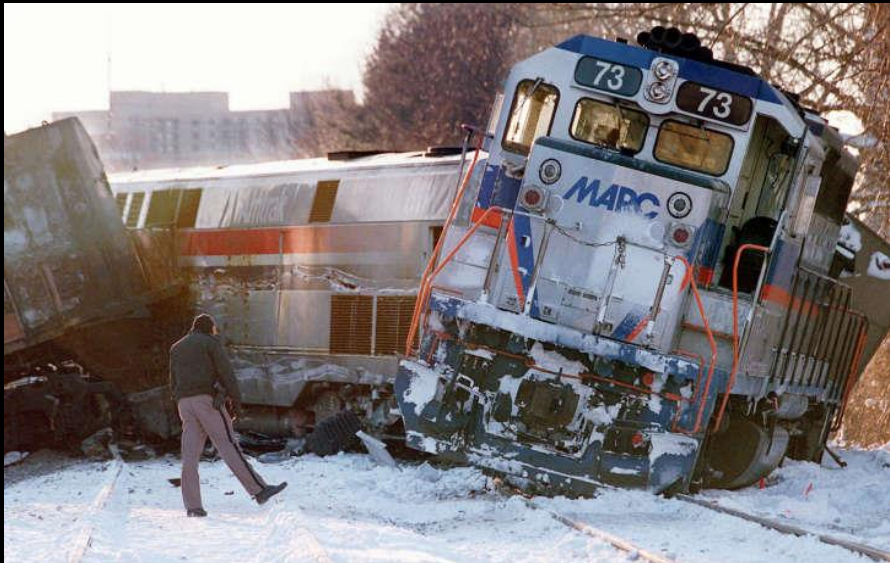
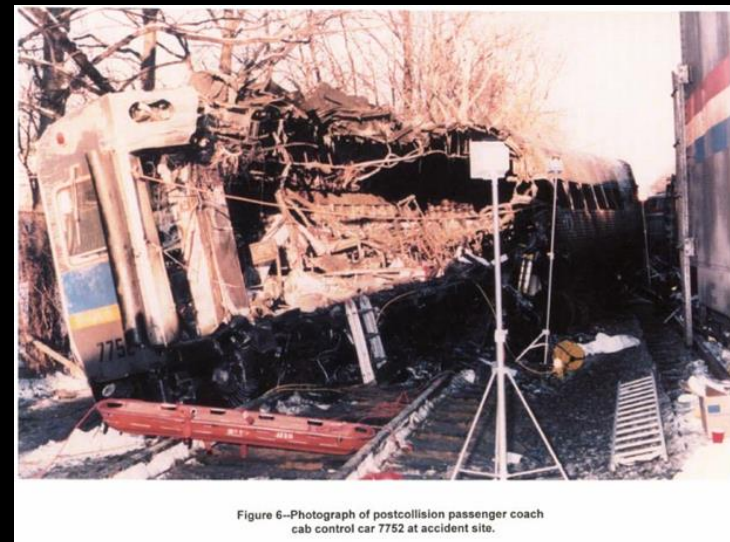
- February 16, 1996 two trains collided near Silver Spring, Maryland.
- The trains involved were a Maryland Rail Commuter (MARC) train and a National Railroad Passenger Corporation (AMTRAK) passenger train.
- The collision resulted in numerous deaths, injuries and \$7.5 million in damages.

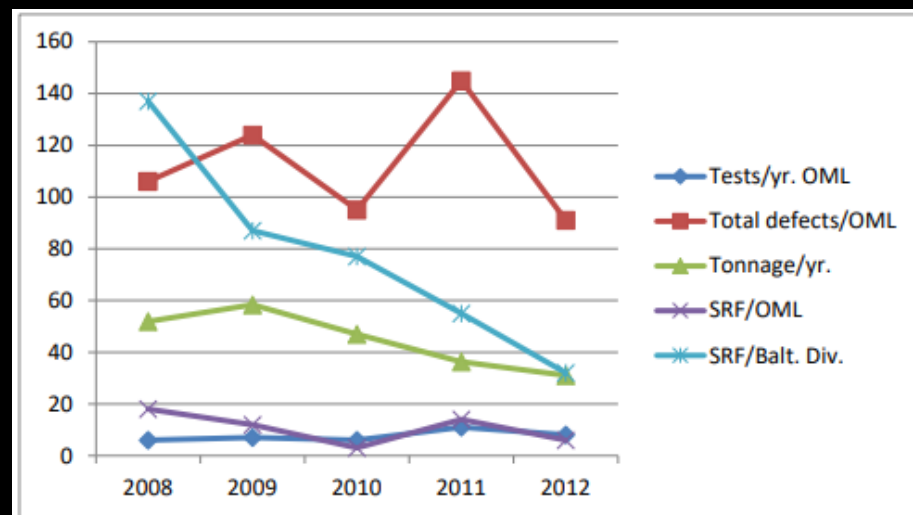
- The FRA operated the Automated Track Inspection Program over the OML Subdivision on July 17, 2012. The FRA data showed no recorded defects for that test, including in the vicinity of the derailment.
- CSXT was aware of the history of rail defects on the OML Subdivision and of the increase in tonnage due to a rise in coal traffic over the previous years.
- CSXT retained a consulting firm to recommend the ultrasonic rail detection intervals. It was recommended CSXT test the OML Subdivision every 30 days.

Year	Test Cycles	Total Defects OML	Transverse Detail Defects OML	Transverse Detail Defects in Curves	Service Rail Failures OML	Service Rail Failures Baltimore Division	MGT Annual Tonnage
2007							44.34
2008	6	106	57	28	18	137	51.91
2009	7	124	86	48	12	87	58.36
2010	6	95	67	44	3	77	47.00
2011	11	145	86	51	14	55	36.23
2012	8	91	44	21	6	32	31.02

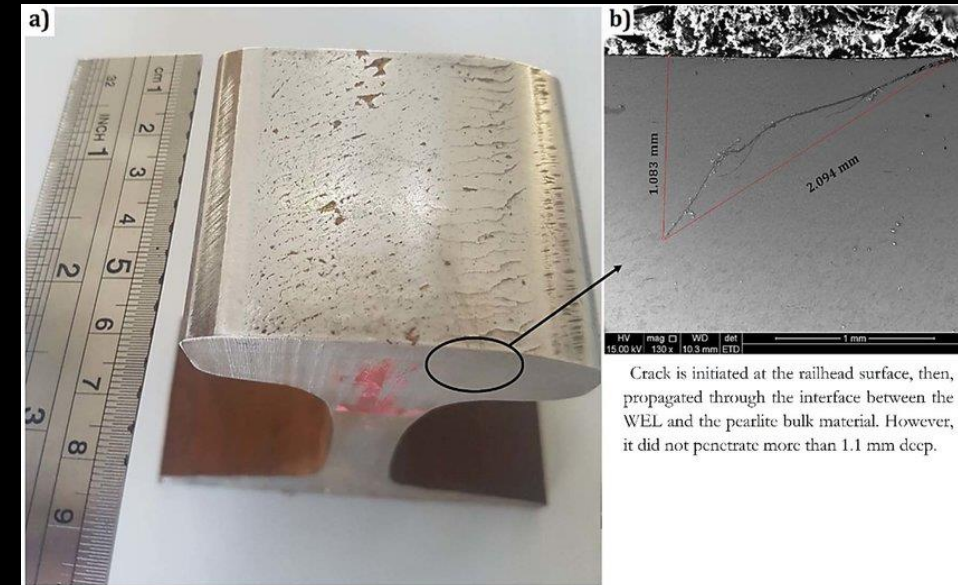
- At the point of derailment, the rail fractured due to a detail fracture that initiated from the head checks, patterns indicate that the primary fracture occurred at one of the ends of rail piece.
- Material properties did not appear to be a significant factor in the failure.
- NTSB investigators determined that the defect extended across just 24 percent of the remaining head area, compared to other cases where it extended from 70 to 80 percent of the remaining head area

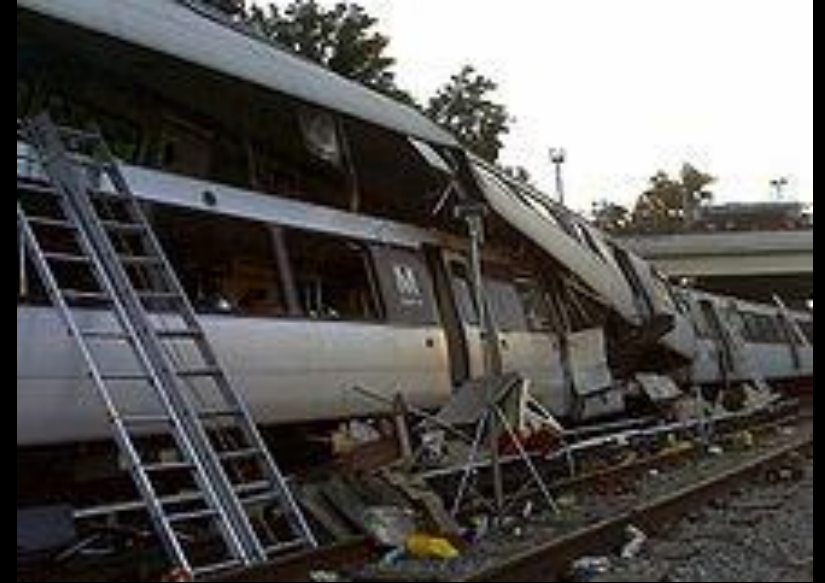
- Train on train collision, June 22 2009
- A moving train collided with a stopped train
- 8 passengers killed
- 80 injured
- Deadliest crash in history of the Washington Metro

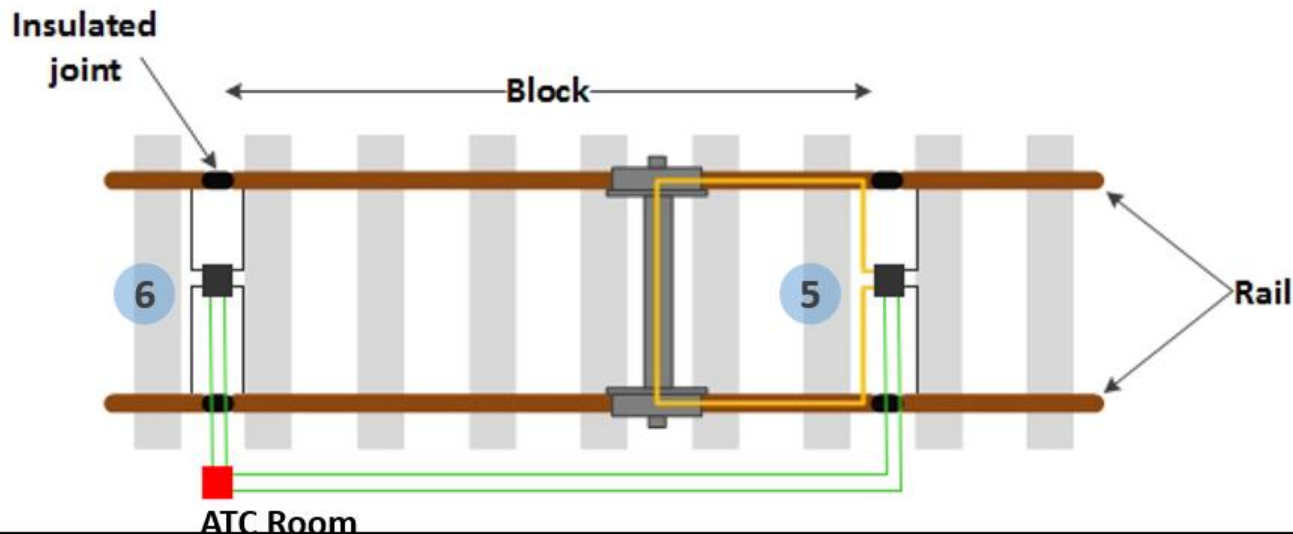
Metro's Train Circuit

- Each block has a relay on both ends
- The bonds are split between the blocks, acting as a transmitter (5) for the first block and receiver (6) for the second
- If the transmitter and receiver have a complete circuit, then the block is considered unoccupied
- When circuit is broken the block is considered occupied, sending a signal to the Automatic Train Control (ATC)
- ATC can control the speed of these trains
