Hurlbutt Elementary School

HURLBUTT ELEMENTARY SCHOOL - FACILITY CONDITIONS ANALYSIS

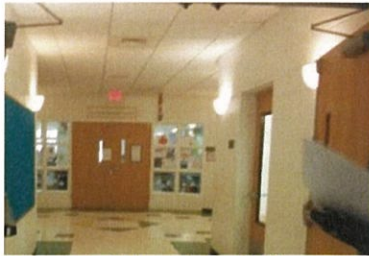
Figure 4: Center House hallway

The interior of the building is well maintained based on the existing conditions and existing systems. A visual inspection of the walls, floor and ceiling were reviewed during the building walkthrough. The interior walls are a variety of concrete masonry units or block (CMU), plaster and sheetrock. Each House has its 'own interior identity. Paint color begins to designate each house making it easy for children to find their way around the school. Center House consists of painted white 8x8 concrete block. East House appears to consist mostly of plaster. The lower portion of interior walls are painted yellow. However, the cafeteria is painted with blue accents. South House too is plaster but with green accent paint. North House consists mostly of standard concrete block interior walls. It was noted in the basement along the stair the paint is significantly peeling and water infiltration is present. There were also some cracks noted in the CMU of the gymnasium. A few areas throughout the entire facility could use some touch up paint but most appear to be in reasonable condition. Ceramic tile at the toilet rooms are in fairly good condition.

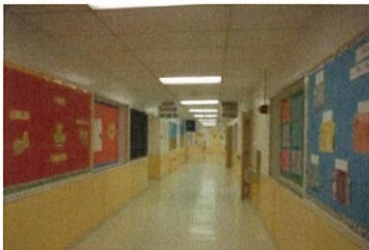
Figure 6: South House hallway

The majority of the ceilings are acoustical ceiling tiles. Some are 2x2 and some are 2x4. They all appear to be in fair condition. However South House cafeteria has a spline ceiling and some tiles are missing leaving glue dabs exposed.

The majority of the flooring throughout the facility consist of 12x12 VCT tiles. Most appear to be in good condition with some areas of cracking. Most notably the tiles in the South House cafeteria are bubbling and therefore appear to have problems adhering to the slab. The kitchen in East House has 9x9 tiles which usually indicate asbestos containing materials. The quarry tile in the South House kitchen appear to be in good shape. The rubber

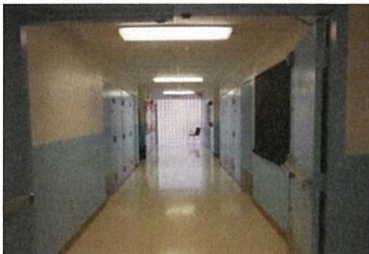
Figure 7: North House hallway

baseboards are in fair condition with some areas beginning to wear. The sheet flooring in the North House gymnasium looks fair although it was indicated that its beginning to bubble. Overall the interior walls, floor and ceiling are in good condition.

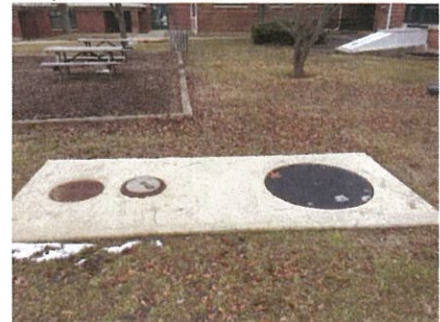
The 4000 gallon UST serving the Central Area was installed in 1998, was last tested in 2009, and is due for replacement in 2018.

The 6000 gallon UST serving the South Wing was installed in 1988, was last tested in 2009, and is due for replacement in 2018.

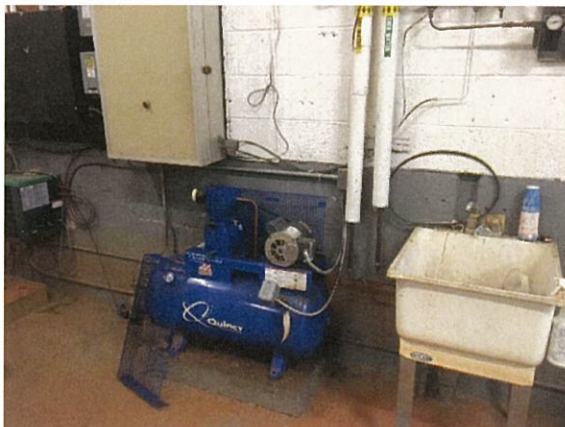
Except for the Central Area renovated in 2000, Automatic Temperature Control is provided by a pneumatic control system. Controls Compressors are located in the Boiler rooms. The compressors appear to be in good condition, but the pneumatic controls are obsolete and unable to optimize building efficiency. It is recommended that the pneumatic controls be replaced with electric/electronic controls and that the systems be integrated into the existing Alerton Building Management System (BMS) currently serving the Central Area.

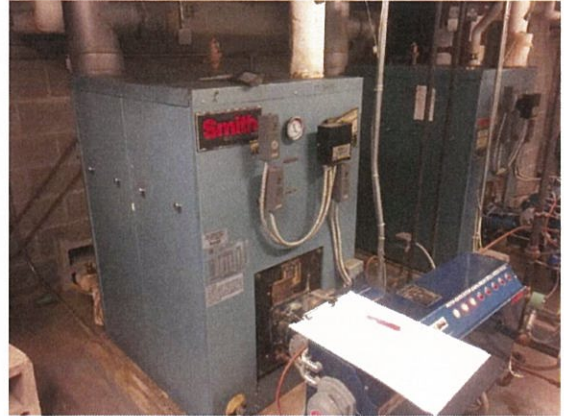
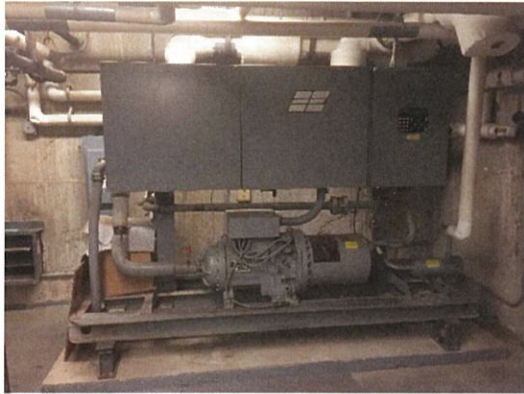
Heating for the Central Area is provided by two Smith model 19-W-6 Boilers with Power-Flame dual fuel burners capable of firing #2 Fuel Oil or Natural Gas. The Boilers are believed to have been installed as part of the 1997 renovation and appear to have been well maintained, likely having a minimum of 10 years useful life remaining. Hot Water Pumps appear to be in serviceable condition but are showing some surface rust. Boiler Room floor was dry at the time of our visit however, there are signs of previous leakage including the noted rusting of the pumps. Two combustion air openings have been provided which meet the requirements of the Mechanical Code.

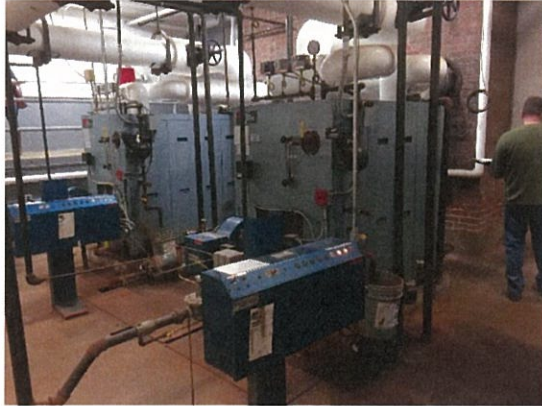
East House

The East Wing is served by two Smith model 28HE-S-08 Steam Boilers with Power-Flame dual fuel burners capable of firing #2 Fuel Oil or Natural Gas. The Boiler Room is neat and well organized and the Boilers, Boiler Fed Unit and related piping and equipment in the Boiler Room appear to be well maintained and in good condition, likely having a remaining useful life of 10 years or more. Combustion air is provided by a louver which is ducted down to within 12 inches of the floor. A second louver appears to have been closed off and the provisions for combustion air do not appear to be compliant with the code.

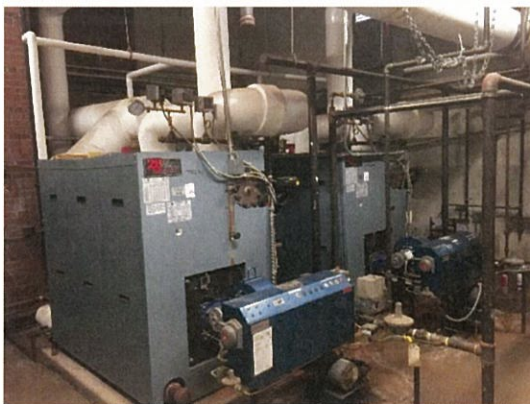
South House

Heating for the West Wing and Senior Center is provided by two Smith model 28HE-S-08 Steam Boilers with Power-Flame dual fuel burners capable of firing #2 Fuel Oil or Natural Gas. The Boiler Room is neat and well organized and the Boilers appear to be well maintained, in good condition, likely having a remaining useful life of 10 years or more. Boiler Room piping and equipment appears to be in mostly good condition except for the Boiler Feed Unit which is badly corroded from leakage and appears to be at the end of its useful life. The leak appears to have been repaired and the life of the unit may be extended by performing maintenance including cleaning and painting.

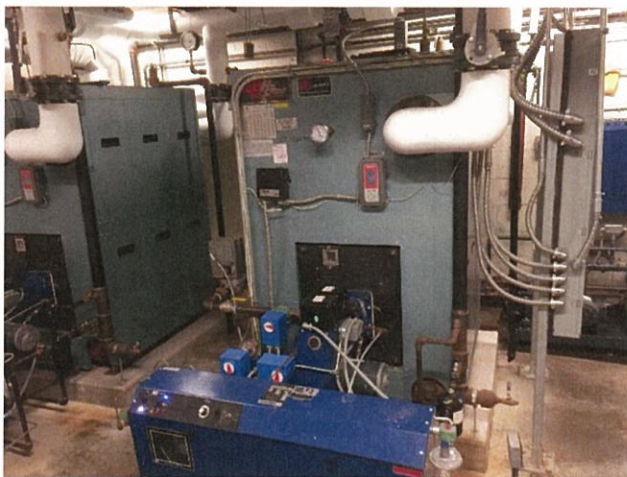
North House

Heating for the North Wing is provided by two Smith model 28HE-W-05 Water Boilers with Power-Flame dual fuel burners capable of firing #2 Fuel Oil or Natural Gas. The Boiler Room appears to have been renovated within the last 10 years. The Boilers, Hot Water Pumps and related piping and equipment in the Boiler Room appear to be well maintained and in good condition, likely having a remaining useful life of 15 to 20 years. Combustion air is provided by a door louver which appears to be adequately sized for the input of the boilers but is slightly damaged.

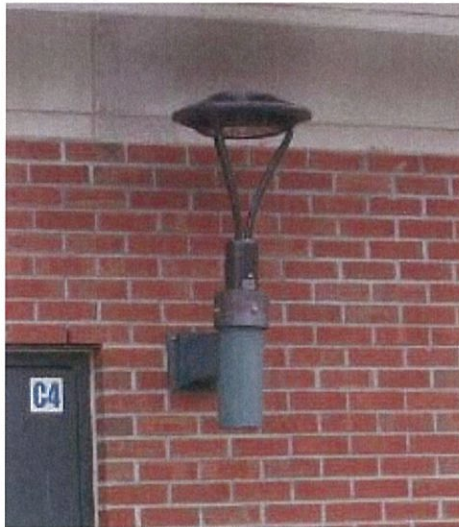
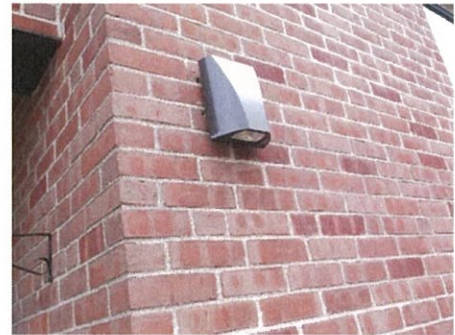
The existing luminaires throughout the exterior consist of new building mounted post top LED fixtures, wall mounted full cutoff LED sconce fixtures, surface mounted canopy light fixtures and pole mounted post top and "shoe box" LED fixtures. The pole mounted "shoe box" fixtures are installed only in the parking area of the senior center on new matching square poles. The building mounted and pole mounted post top LED fixtures are mounted to the existing pole and building mounted arms. The fixtures are all in good condition and should not need to be replaced or upgraded. The lights were not on at the time of the walk through since it was late morning early afternoon, so their operation could not be verified. Without a

photometric report with all the existing normal & emergency exterior fixtures, we cannot determine if the code required light levels are met. Also, it does not appear that all exterior egress doors have an emergency fixture and/or second normal fixture, so that failure of a fixture will not leave the area without light.

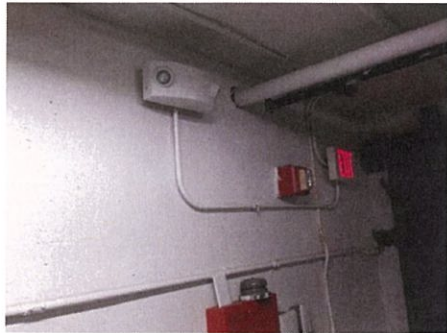
There are existing emergency lights throughout the buildings, we are not sure the design meets the code and should be reviewed with the AHJ. There are old central DC battery systems in multiple buildings with “dead light” incandescent fixtures which we were told are no longer operational. These systems should be removed to avoid confusion on whether these lights or this system is not working. There are self-contained twin head emergency light fixtures in some of the utility areas, these fixtures appear to be in good operating condition. We were not able to test all fixtures at the time of our walk through. The

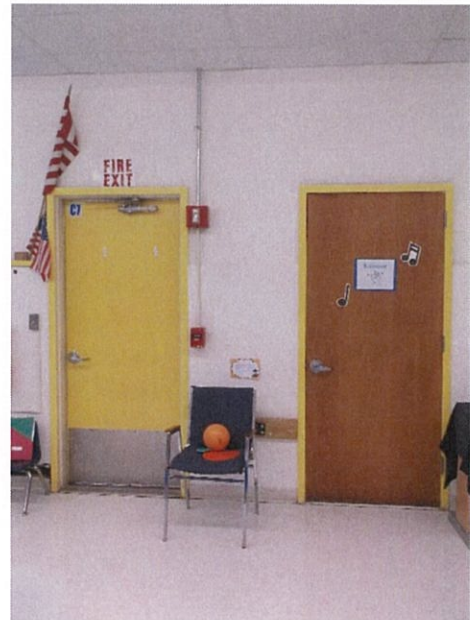
school’s electrical distribution is backed up by a diesel generator which is also used to provide emergency lighting throughout. The current code does not allow a single transfer switch to serve both emergency and standby loads from the same switch. The standby loads (ie: HVAC equipment, kitchen refrigeration, misc. power, etc.) should be moved to a second transfer switch. Another concern is the requirement for failure of a single fixture, lamp and/or source will not leave an area in darkness. The current generator distribution is designed where a single point of failure could leave an area, and/or a building without any lighting. Also, it does not appear the generator has the same load capacity as the normal service, providing the potential for the generator to overload on startup and not start and then have no emergency lighting in any of the buildings. This should be reviewed with the AHJ.

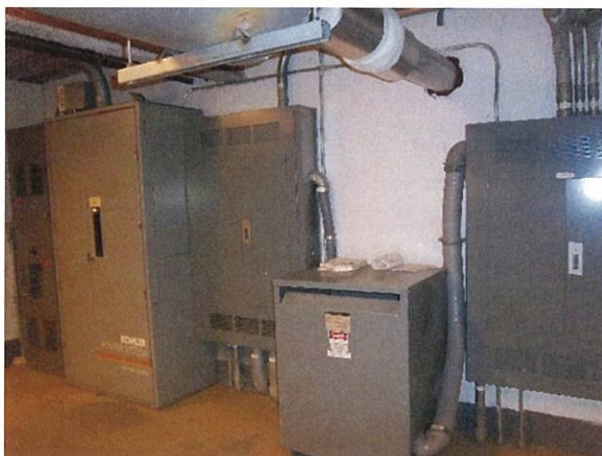
The existing electrical service originates from a pad mounted utility transformer located to the east side of the Central House. From the utility transformer, the secondary feeder runs underground to a 1200 amp, 480Y/277V – 3 phase service rated switch. The service switch intern feeds a generator transfer switch, we could not determine the size of the transfer switch but assume it is 1200 amps. The transfer switch feeds a distribution panel “MDP-1”, this panel feeds the four houses (Central, North, East & South/Senior Center) via a 150 KVA transformer located in each house. Also in this room is a 265 KW diesel generator and day tank that feeds the standby side of the transfer switch.

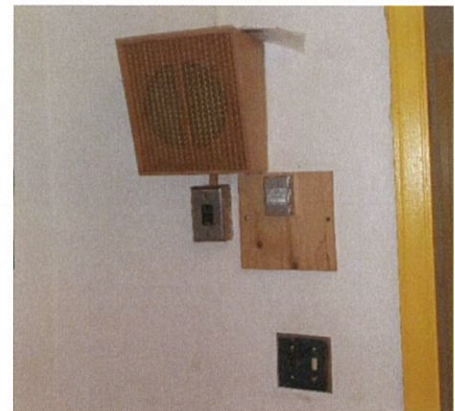
The existing data outlets are located throughout in the classrooms and the Administration Offices. There is a network cabinet (Multicom-2000) in the main office with the Franklin Time System master clock, CD & DVD player. There are wall mounted phones in all the classrooms, along with a wall mounted clocks and speakers. There are speakers in all the hallways and utility rooms. Some of the classrooms in the East House have older wall mounted speakers that should be upgraded to a newer ceiling mounted speaker. There are desk phones in the Offices of Central House.

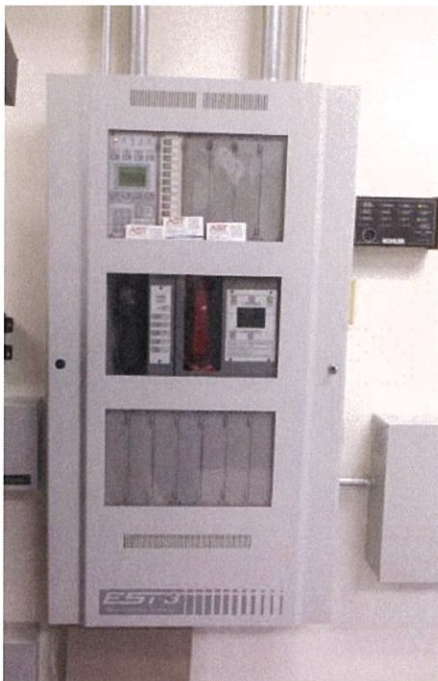
The existing fire alarm system is an addressable Edwards (EST3) system, with the control panel located in the main office. There are additional power panels and transponders located in the other houses. There are manual pull stations at the egress doors along with audio/visual devices throughout the complex. There appears to be a voice evacuation system, we could not determine if it is throughout the entire school or only in the assembly spaces. The devices throughout appear to be in good operating condition.
