Weston High School

WESTON SCHOOLS FACILITIES FEASIBILITY STUDY

WESTON HIGH SCHOOL - FACILITY CONDITIONS ANALYSIS

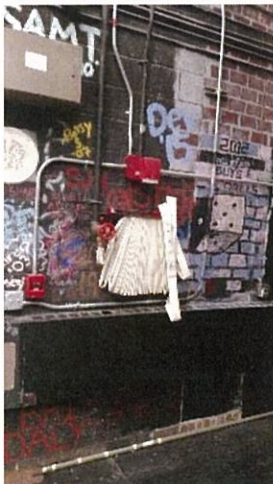
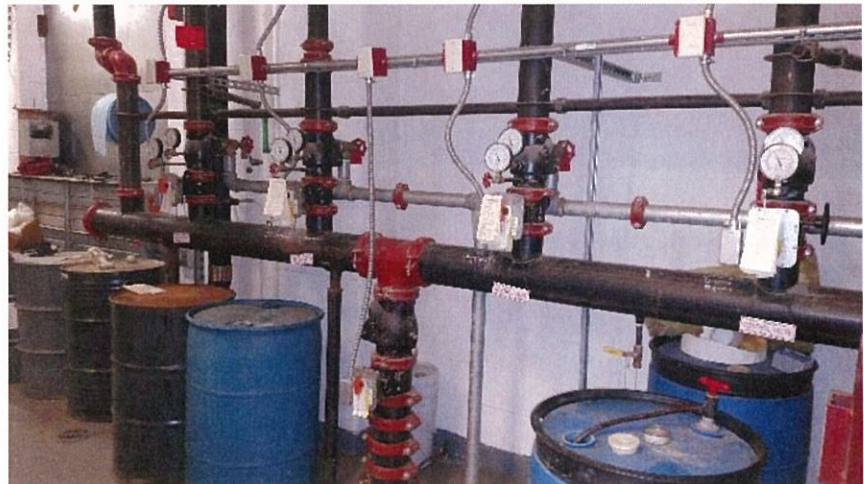
The facility is fully sprinklered. The sprinkler piping and components appear to be in good condition. There is a check valve and flow switch on the supply. This feeds 5 alarm valve risers that provide multi-zoned sprinkler coverage for the building. This main is fed from a pump house on the campus that serves multiple buildings. It is not known if the stage platform is wood-framed, as there was no visible way to access the area below the stage. Due to this, it is unknown if sprinkler protection has been provided under the stage or if it is required due to the type of construction materials used. The stage has been provided with standpipes. Overall, the sprinkler system for the school appears to be in good condition.

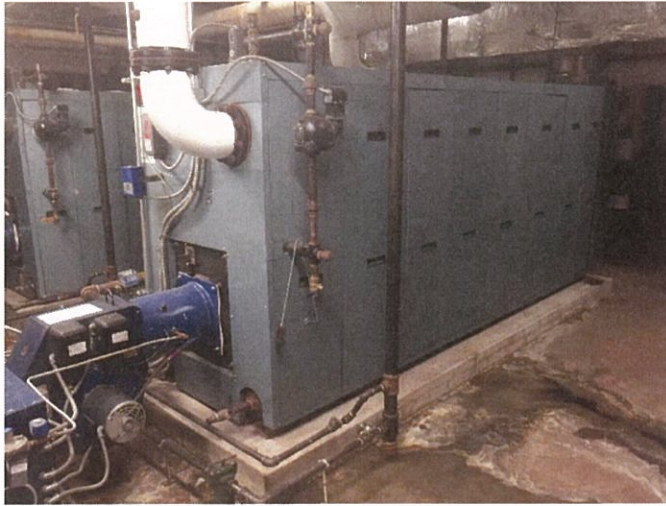
Heat for the facility is provided by two separate Hot Water Boiler Plants. The 1968 portion is served by two Smith Model 28HE-W-18 Boilers installed in 2011. The boilers are fitted with Power-Flame dual fuel burners. The Boilers appear to be well maintained and in good condition with likely 25 to 30 years of useful life remaining. The Hot Water Pumps, system valves and accessories appear to date back to the original 1968 construction. The pumps should be considered near the end of useful life but appear to be serviceable and may remain in service with continued Maintenance. Recommend planning for eventual replacement. Provision for combustion air appears adequate.

Water was observed on the floor of the Boiler Room which is reported by maintenance staff to be seepage through the walls rather than leakage from equipment. No equipment leakage was observed.

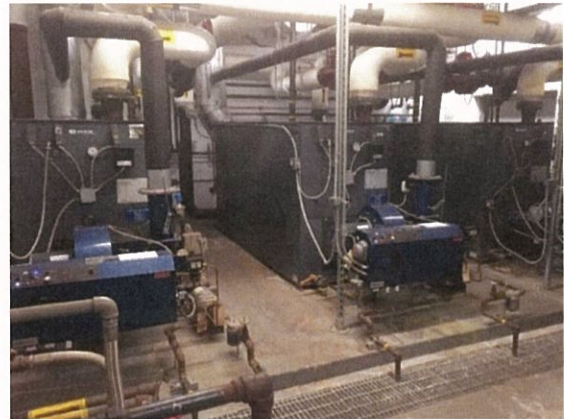
The 2005 addition is served by three Weil-McLain model 1488 Hot Water Boilers equipped with Power Flame Dual Fuel Burners. The Boilers appear to be well maintained and in good condition with likely 20 to 25 years of useful life remaining. Provision for combustion air appears adequate.

Since Boiler life can be affected by poor water quality and inconsistent maintenance, it is recommended that the boiler water be periodically tested. Regular preventive maintenance should be performed to maximize the service life of Boilers and related equipment.

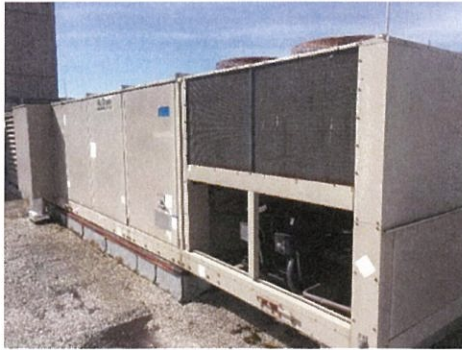
Packaged Rooftop Air Conditioning Units installed as part of the 2005 project serve interior spaces and the 2005 Additions. The units appear to be in good condition with 10 to 15 years of useful life likely remaining.

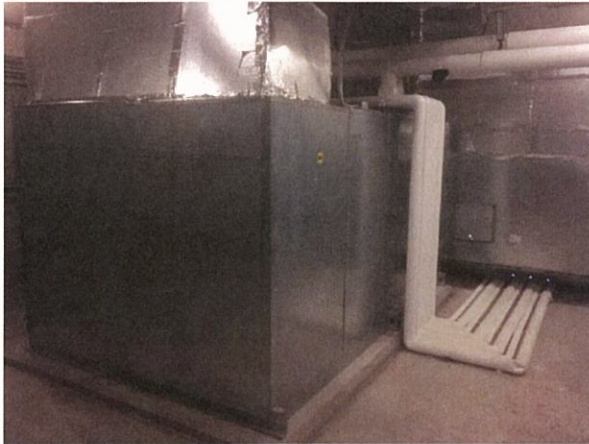
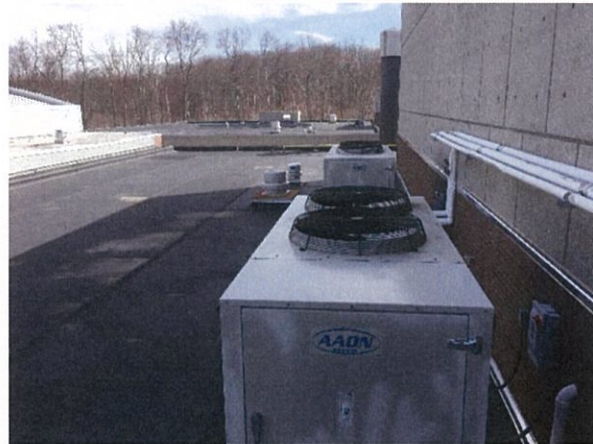
The Auditorium is served by an Air Handling Unit located in the Mezzanine Mechanical Room with a pair of roof mounted Condensing Units. The Unit was installed as part of the 2005 renovations and appears to be in good condition with 10 to 15 years of useful life remaining.

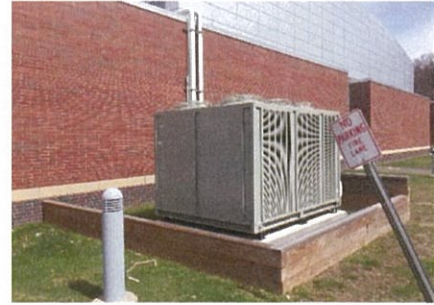
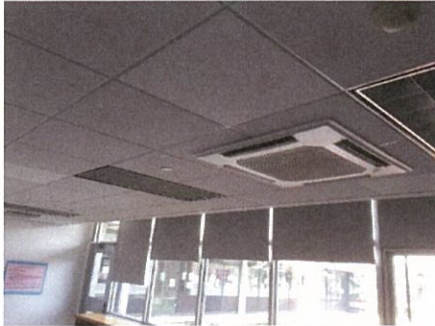
The New Gymnasium is served by a roof mounted Air Handling Unit installed at the time of construction in 2005. A 60 Ton Chiller was added to serve the Gym Air Handling Unit in 2015. The Air Handling Unit is in good condition with 15 to 20 years of useful life remaining. The chiller likely has 25 or more years of useful life remaining.

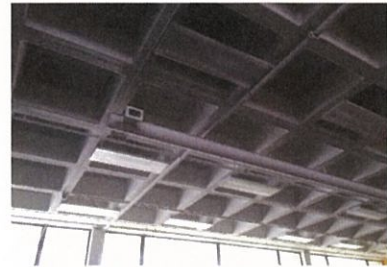
The Weight Room and Dance Studio are served by a Packaged Rooftop Unit serving other spaces of the Athletic Department. The Weight Room and Dance Studio are at the end of the duct run, the supply duct appears to be small for the space and ventilation of the spaces is not adequate. Recommend installing a unit dedicated to the Weight Room and Dance Studio.

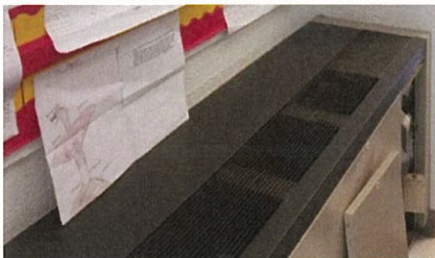
Classrooms B-6 thru B-9 of the 2005 B-Wing addition are served by a Packaged Rooftop Air Conditioning Unit. The Classrooms have large north facing windows and there have been complaints of poor heating in those spaces. Recommend further investigation and possible installation of supplemental heating.

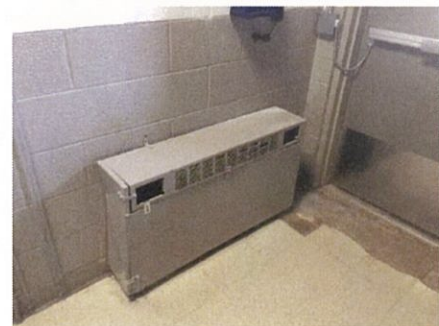
The original Finned Tube Radiation, Unit Heaters and Convectors installed in 1968 are near end of useful life. The enclosures are aged with some damage and the heating elements are likely providing diminished heating capacity having exceeded their useful life expectancy. Recommend planning for replacement as part of any major HVAC improvements.

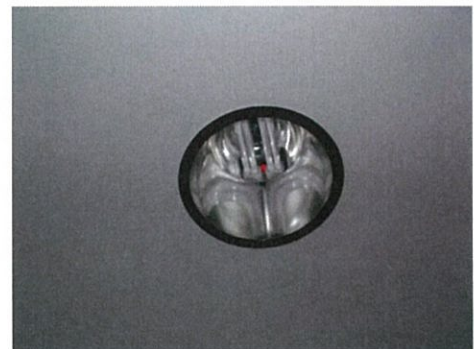
determine the extent of the existing battery emergency lighting system, to determine if it meets the current code required light levels. This should be reviewed further, to determine if any area requires more emergency fixtures or replacement of units not operating. There are remote mounted normally off single & twin head emergency fixtures and exit signs in the Main Courtyard, some of these fixtures appear to be broken and are hanging by their wires. We could not determine if all the exit signs are working and it do not appear that the emergency light fixtures will provide the current code required light levels to properly exit the courtyard. Additional emergency light fixtures

should be installed to meet the current code requirements. The two smaller courtyards did not have emergency lights or exits signs in them, these should be added in order for the area to meet code and continued to be used by students and staff. We were not able to determine if there are enough normal or emergency fixtures to properly illuminate all the egress paths from the building to meet the current code.

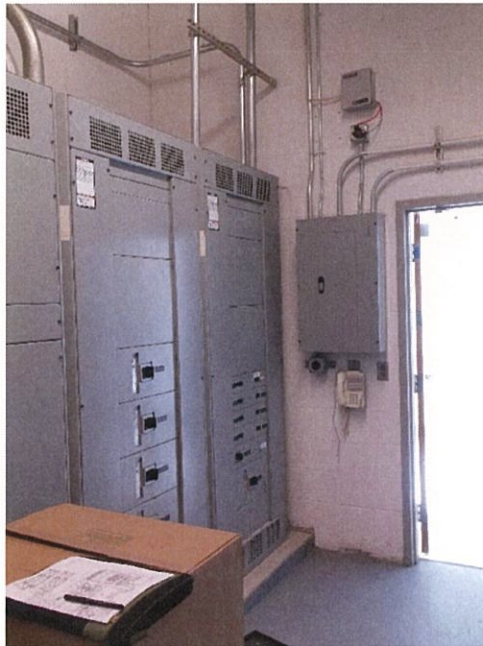
The existing electrical service originates from a pad mounted utility transformer located to the south side of the building. From the utility transformer, the secondary feeder runs underground to a 3000 amp, 480Y/277V – 3 phase service rated switch in the Main Electric Room. The service switch intern feeds two distribution sections. The distribution sections of the switchboard feed panels throughout the building in local electrical closets and directly in rooms, in addition to back feeding the old 2000 amp, 480Y/277V – 3phase switchboard in the old main electric room on the north side of the building.

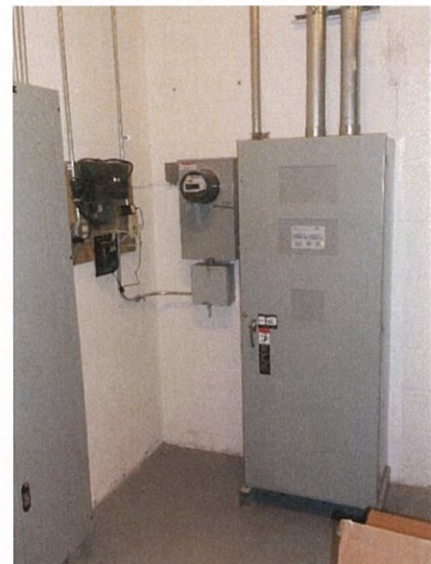
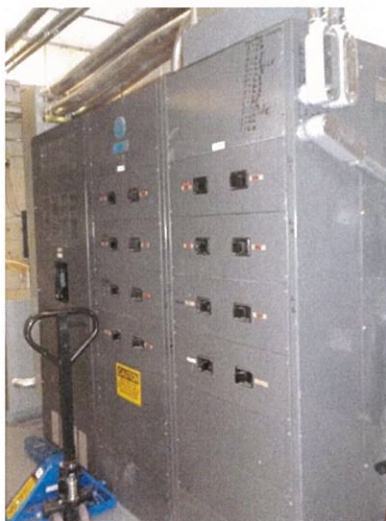
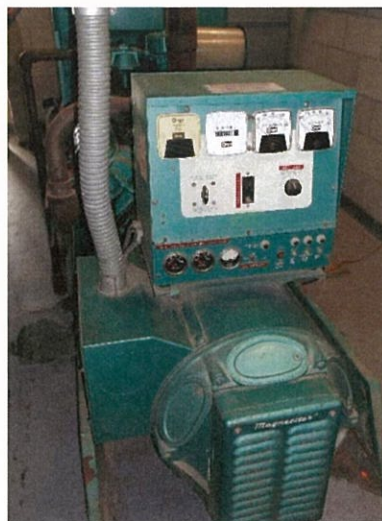
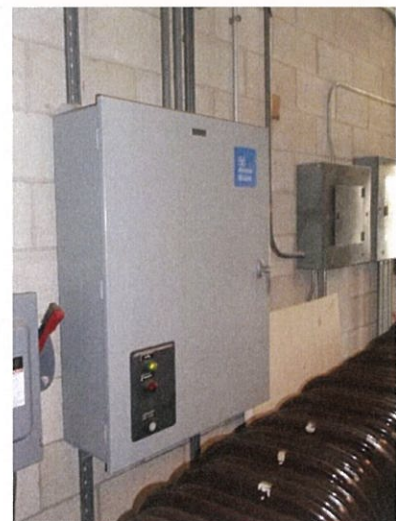
There are two generators, the newest is a 500 KW diesel generator by Caterpillar with base mounted fuel tank located outside of the south side main electric room. The generator has a single output breaker (800 amps) feeding a single automatic transfer switch in the main electric room (south side). The second generator is older and located inside the building near the loading dock on the north side of the building in a room adjacent to the old main electric room. The generator is a 85 KW natural gas unit by Onan with a single output breaker that serves two automatic transfer switches in the room with the generator. The newer transfer switch feeds a 480V disconnect switch and then a 30 KVA step down transformer and then a 208V disconnect switch. The older transfer switch also feeds a step-down transformer then a disconnect switch. The two generator panels serve some interior lighting, exterior lighting,

paging system, security system, fire alarm system, kitchen refrigeration, misc. power and some HVAC equipment (heating). The main electrical equipment and panels from the old distribution (north side of building) are nearing the end of its useful life and will need to be replaced in the future, also the location of the existing 2000-amp switchboard does not meet current code. This room only has one door in or out of the room, which would require double the working clearances in front of the equipment or an unobstructed path to the door which it does not have. When the equipment is going to be replaced, careful planning and coordination will be required to locate the new equipment and be code compliant.

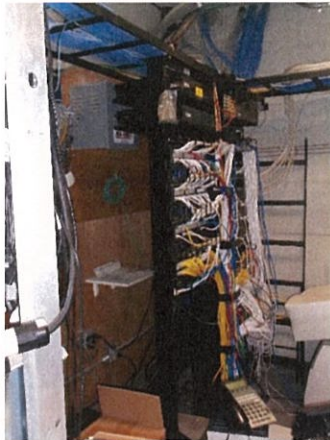
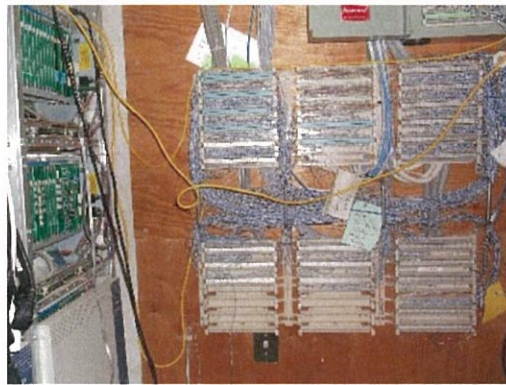
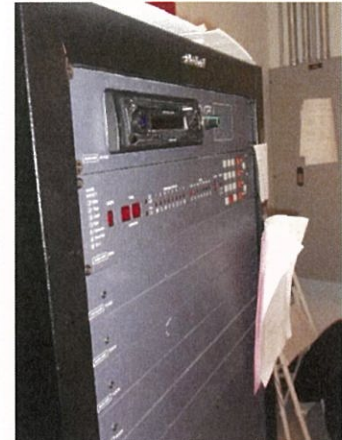
The existing telephone system demark is in the Data Room located near the loading dock on the north side of the building. There is an open rack, an enclosed cabinet and multiple telephone punch down blocks in the room. There are two other Data closets, one adjacent to the main electric room on the south side of the building and another in the Main Office area. The Rauland master clock headend equipment, and amplifier & cassette deck along with Sonitrol security panels are in the Data closet by the Main Office. The existing data outlets throughout the school are recessed mounted. There are desk mounted phones in all the classrooms, along with a wall mounted clocks and recessed ceiling speakers. There are a few rooms with wall mounted phones like the Gymnasium. There are speakers in all the hallways and utility rooms. There are desk phones in all the Offices. All equipment appears to be operating properly. There are wireless access point devices installed throughout the school. |

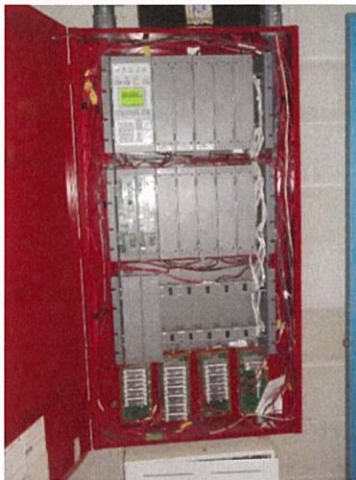
The existing fire alarm system is an addressable Edwards (EST3) system, with the control panel located in a room at the lower level Storage area by the elevator near the stair at the east side of the building. There is a remote alarm panel at the front entrance security desk along with multiple power supply panels (NAC panels) throughout.

There are three locations with remote alarm panels with emergency phones, both Gymnasiums and the Cafeteria. There are manual pull stations at all egress doors and in the Gymnasium. The pull stations in the Gym have “stopper” covers. There are audio/visual devices throughout the building including all the Classrooms, the Locker Rooms, the Gymnasiums and the Cafeteria. There are

carbon monoxide detectors in the mechanical rooms where there is fuel burning equipment. There are smoke detectors throughout the school, in the corridors, classrooms, stairs, etc. The devices throughout appear to be in good operating condition.

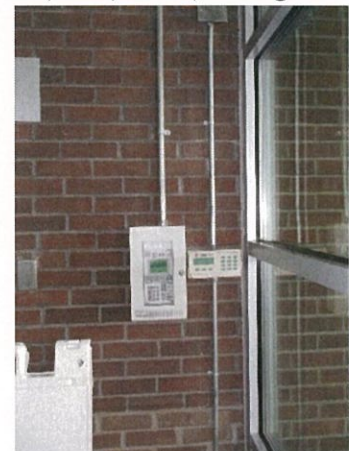
There is an existing security lock down system throughout the school, with emergency push button stations at the Main Office and Security Desk.

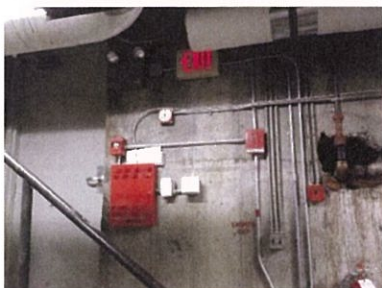
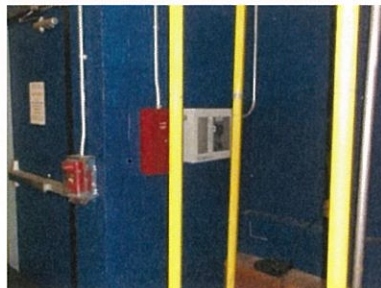
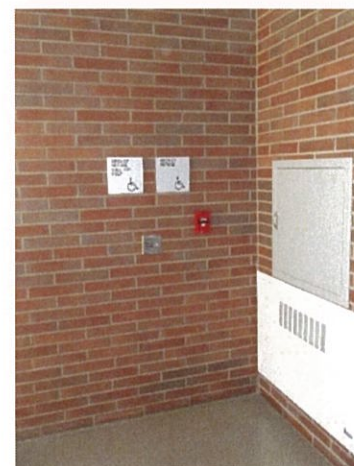
There is “area of rescue” system for the two stairs in the Science wing. In addition to the existing communication system, illuminated signs are required and need to be installed at each stair door.
