Weston Intermediate School

WESTON SCHOOLS - FACILITIES FEASIBILITY STUDY

WESTON INTERMEDIATE SCHOOL - FACILITY CONDITIONS ANALYSIS

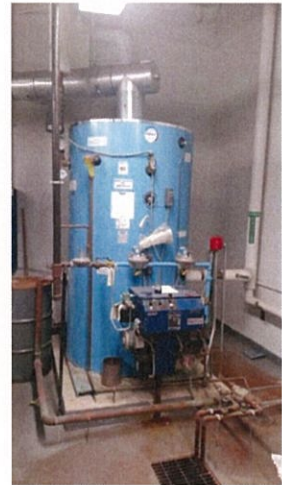
Domestic hot water is produced by a dual fuel-fired water heater having an input rating of 600,000 BTUH and a storage volume of 250 gallons. The system is approximately 10 years old. The system should have an average life expectancy of approximately 20-25 years and remaining life expectancy it about 10-15 years. To maximize service life, the Water Heater should be regularly serviced per the manufacturer's maintenance recommendations including, but not limited to, draining and flushing, testing relief valve, and inspecting/replacing anode. Refer to manufacturer's O&M literature. There is no recirculation pump for the hot water system. At the time of the visit there was an issue with the aquastat and it was disassembled and being repaired. This was causing an issue with controlling the water temperature and the outlet temperature from the master mixing valve was showing 140°F. This needs to be resolved due to the fact that people can get scalded with water temperatures that high to the fixtures.

Water temperature was designed to be maintained by the use of heat trace cable on the hot water piping. At the time of the site visit, the controllers for the heat trace system were off and we were told that they had been off for years. No one was able to tell us the reason they were off. They just knew that they had always been off since they worked there and that there are issues with having to wait an extended period of time to get hot water at the further area of the building. At an additional visit to the building with a manufacturer's representative for the company that manufactures the heat trace system, the units were powered up and the controllers were reprogrammed.

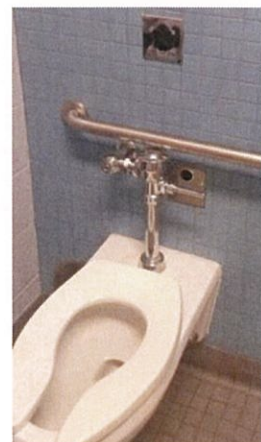
Plumbing fixtures for the building appear to be good condition. The urinals were originally installed with sensor flush valves. The valves are being replaced with manual flush valves to allow for operation when the power is out. The water closets are wall mounted and were originally installed with sensor flush valves. The valves are being replaced with manual flush valves to allow for operation when the power is out. The lavatories are a combination of wall hung single and multiple station wash basins originally installed with sensor faucets. The valves are being replaced with manual metered faucets to allow for operation when the power is out. Classroom sinks are stainless steel with single lever faucets or wrist blade handles depending on the location. The sinks in the art classrooms have solids interceptors on their drainage piping. The interceptors should be checked periodically and cleared of any solids that have been collected in them. Electric water coolers are provided throughout the building.

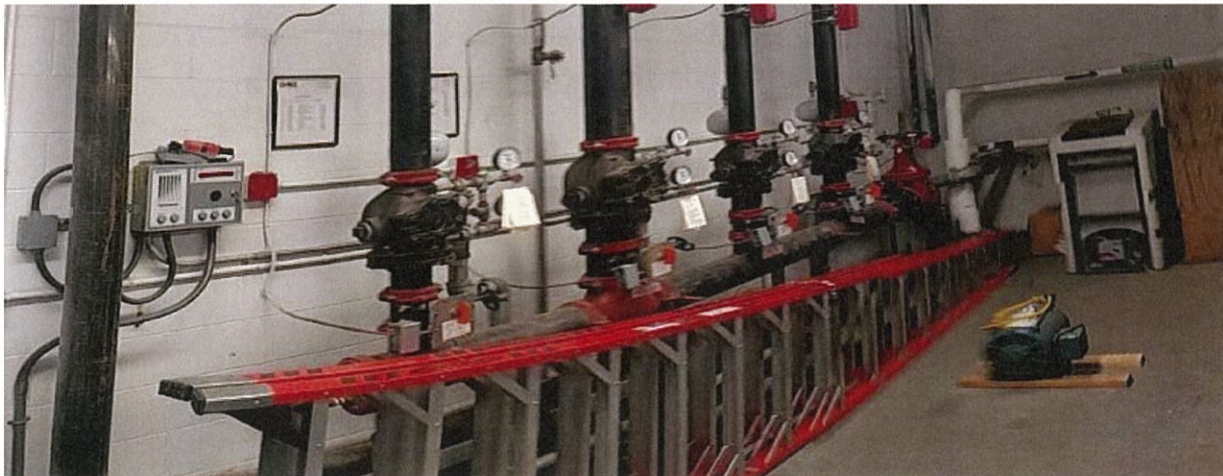
The facility is fully sprinklered. The sprinkler piping and components appear to be in good condition. There are isolation valves and flow switches on the supply. This feeds 4 alarm valve risers that provide multi-zoned sprinkler coverage for the building. This main is fed from a pump house on the campus that serves multiple buildings. It is not known if the stage platform is wood-framed, as there was no visible way to access the area below the stage. Due to this, it is unknown if sprinkler protection has been provided under the stage or if it is required due to the type of construction materials used. The stage has not been provided with standpipes and the stage is less than 1000 square feet so no fire protection standpipes are required. Overall, the sprinkler system for the school appears to be in good condition.

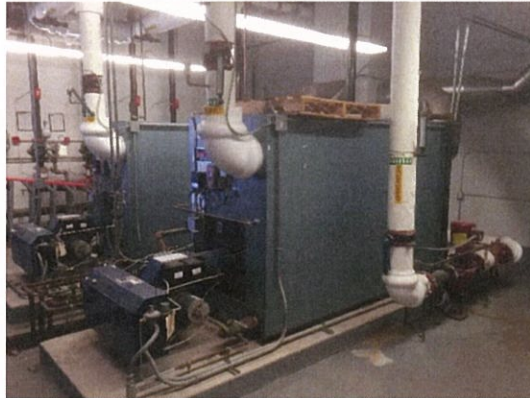
The HVAC systems, installed during original 2004 construction, are in generally good condition. At approximately 13 years old, most of the HVAC Equipment is at midlife with 10 to 15 years of useful life remaining. The Boilers and pumps likely have a remaining useful life of 20 years or more.

Heat for the school is provided by two Smith Model 28A Hot Water Boilers, each with a heating capacity of approximately 3200 MBH. The Boilers are equipped with Power-Flame Dual Fuel Burners which were firing on natural gas at the time of our visit. The Boilers appear to be in good condition and well maintained. The Boiler Room is neat and well organized. The equipment, piping and insulation all appear to be in good condition with no visible signs of leakage.

Since Boiler life can be affected by poor water quality and inconsistent maintenance, it is recommended that the boiler water be periodically tested. Regular preventive maintenance should be performed to maximize the service life of Boilers and related equipment.

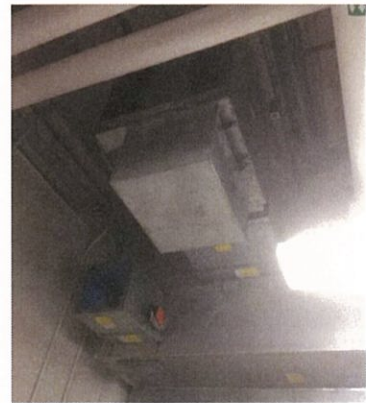
Combustion air is provided by a fan located in the Boiler Room which appears to be adequate and in good condition.

Draft Inducer is located at the top of the Chimney. Chimney height does not appear adequate to prevent flue gases from being introduced to the building through the rooftop air intakes under certain wind conditions. If odors of burning fuel are present within the building, the chimney height may be increased to address the situation. The Chimney and Draft Inducer should be cleaned and inspected as part of normal preventative maintenance.

M2	Chimney and Draft Inducer require regular service		2	Clean and Inspect chimney annually. Inspect and test Draft Inducer.	\$ 1,300	Annual Cost
M3	Combustion Air is provided by Fan in Boiler Room		2	Check for proper operation regularly. Replace drive belts, damper actuators and motors as required.	\$ 100	Annual Cost
M4	Two Chilliers should receive continued preventative maintenance		3	Perform Chiller service including testing of compressors, fans, controls and refrigerant charge, and cleaning heat exchangers.	\$ 2,400	Total annual cost for 2 Chilliers
M5	Hot Water and Chilled Water Pump life may be extended by regular service		3	Inspect and service pumps annually. Provide repairs as required.	\$ 1,600	Total annual Cost for 8 Pumps
M6	Air Handling Units require regular service		3	Replace filters and fan belts, lubricate bearings and damper linkages, check damper and valve operation, clean coils, condensate pans and drains.	\$ 3,500	Total annual Cost for 7 AHUs

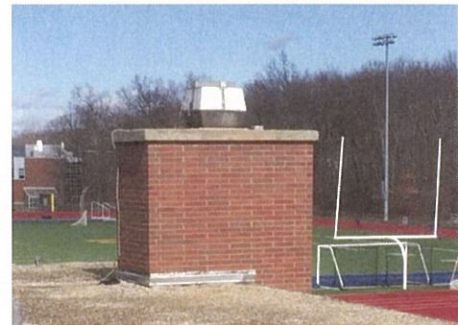
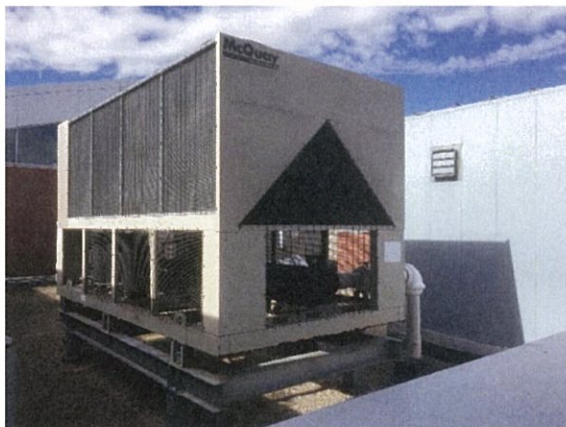
The School is fully Air Conditioned. Chilled Water is produced by two roof mounted Air Cooled Chillers with a combined cooling capacity of 325 Tons. The Chillers appear to be in good condition. Each Chiller is served by dedicated Chilled Water Pumps, located in Penthouse Pump Rooms which distribute Chilled Water to the Rooftop Air Handling Equipment.

Chillers should be serviced annually by an HVAC Service Company in accordance with the manufacturers' Operation & Maintenance requirements.

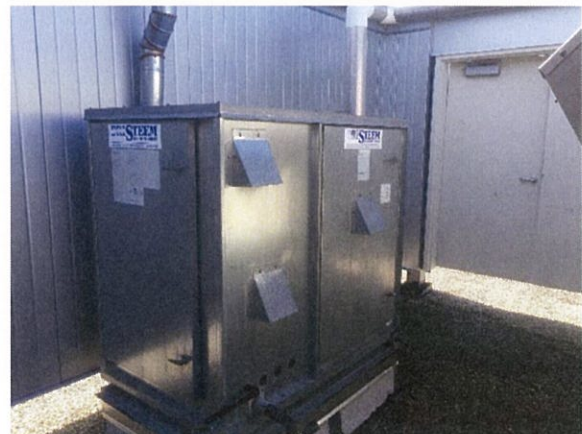
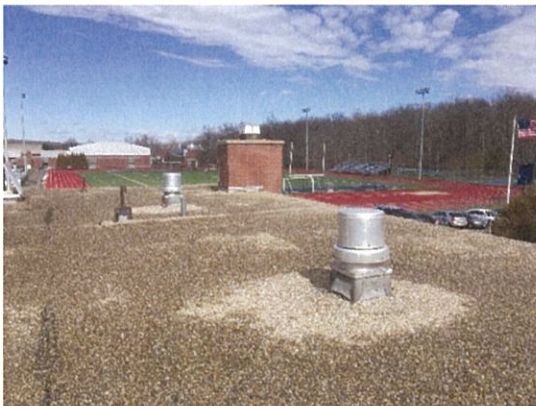
A gas fired Dri-Steem Humidifier is located on the roof and supplies steam for humidification to the adjacent rooftop Air Handling Unit. The unit is in good condition with 10 or more years of useful life remaining.

Toilet and general exhaust is provided by Rooftop Exhaust Fans. The fans appear to be running and in good condition. The fans should be regularly inspected for proper motor and damper operation. Belts, actuators and motors should be replaced as needed.

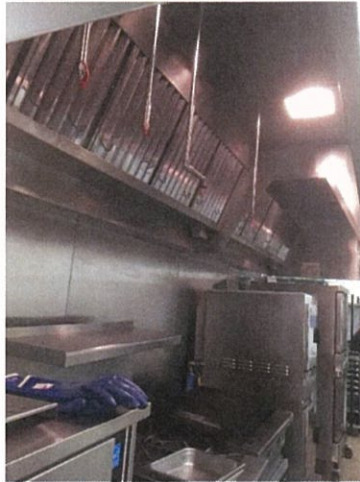
The Kitchen is furnished with a Grease Hood and roof mounted Grease Exhaust Fan. The hood is equipped with a chemical extinguishing system. The grease hood baffles, ductwork and fan should continue to be cleaned regularly.

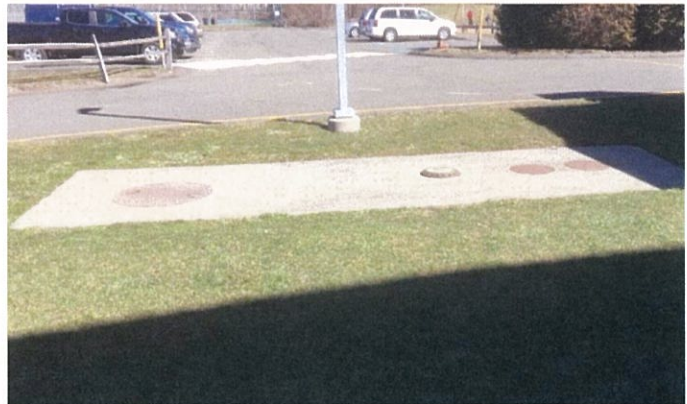
The Underground Fuel Storage Tank (UST) was installed in 2004 and is scheduled for removal in 2034. The Tank Inventory and Leak Detection System should be periodically checked for proper operation.

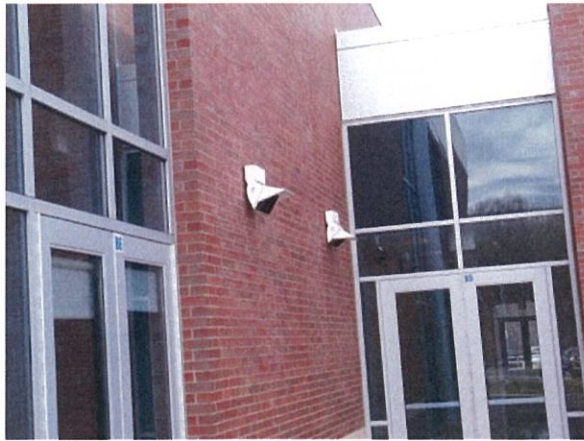
The existing luminaires throughout the exterior consist of recessed down light fixtures in the canopies. Building mounted white adjustable fluorescent fixtures with black louvers and a white shroud. The shroud is meant to provide the fixture with a full cutoff design to meet the code. The problem is the fixture can be adjusted where the fixture is no longer full cutoff. We propose these fixtures be replaced with new LED full cutoff fixtures; this will save energy and meet the code. The parking lot lighting is provided by pole mounted (approximately 20' high) LED low profile full cutoff fixtures. The pole mounted fixtures are all in good condition and should not need to be replaced or

upgraded. The lights were not on at the time of the walk through since it was late morning early afternoon, so their operation could not be verified. Without a photometric report with all the existing normal & emergency exterior fixtures, we cannot determine if the code required light levels are met. Also, we were not able to determine what fixtures are on the generator and which are not, to be able to determine if there are possible areas to could be without light upon loss of a single fixture or lamp. That would be a code violation and should be fixed immediately.

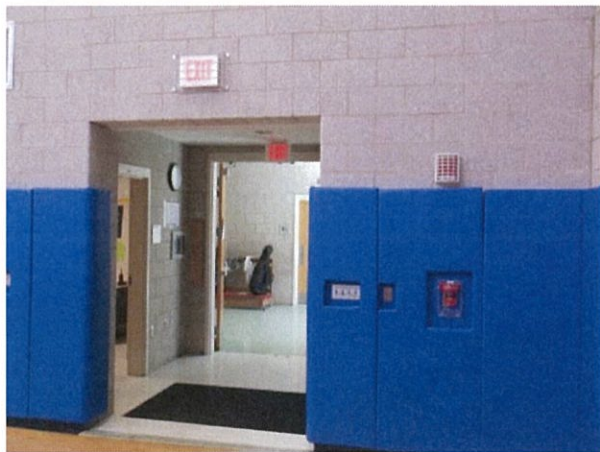
The existing emergency lighting is provided by general building light fixtures wired to the generator distribution system and a few battery powered (normally off) fixtures. The current code does not allow a single transfer switch to serve both emergency and standby loads from the same switch. The standby loads (ie: HVAC equipment, kitchen refrigeration, misc. power, etc.) should be moved to a second transfer switch. We were not able to determine the extent of lighting on the generator to determine if proper light levels are provided during an emergency condition to meet the current code. This should be reviewed further, to determine if any area requires more emergency

fixtures, in addition to providing a "pure" emergency system. There are three remote mounted "dead light" single head emergency fixtures in the Courtyard at the two egress doors and one near the Media Center (south-east corner). These fixtures are each fed from a battery inverter above the ceiling in the room adjacent to the fixture. We were not able to determine which exterior light fixtures are wired from the generator. This should be confirmed, because this is a possible code violation. The loss of a single lamp/fixture or source cannot leave an area without lighting. Thus, if there is only one exterior fixture serving an area and the lamp or circuit fails, the area will be without lighting. This would require a second exterior fixture be added in the same area wired on a different circuit (normal or emergency) than is currently feeding the existing fixture.

E2	It does not appear to be sufficient emergency lighting in the Courtyard for egress to meet the current code		2	Install new LED fixtures to provide current code required light levels for egress	\$5,000.00	
E3	Light levels are low and do not appear to meet egress requirements for the accessible access to the Stage/Platform		2	Replace existing fixtures with new higher output LED fixtures or add new LED fixtures in addition to the existing fixtures	\$5,000.00	
E4	Existing fluorescent, HID & incandescent fixtures throughout the school, appear fully operational but not very efficient		4	Replace all existing fluorescent, HID and incandescent fixtures with new energy efficient LED fixtures.	\$662,712.00	allowance
E5	A portion of the existing lightning protection system is damaged & partially removed		3	Replace damaged wire and reinstall existing lightning rods and cable after wall/parapet has been repaired.	\$2,500.00

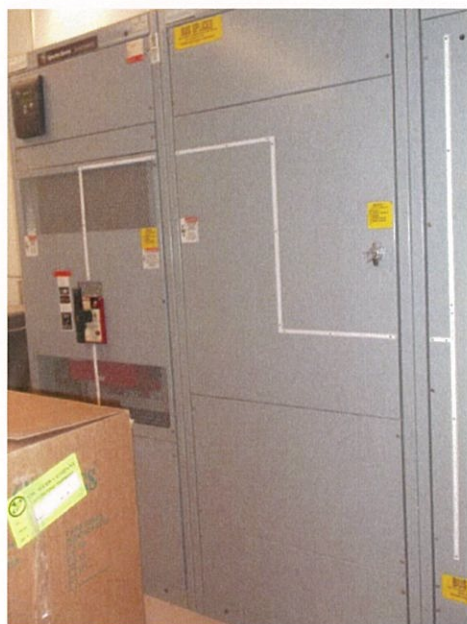
The existing electrical service originates from a pad mounted utility transformer located to the north-east side of the building. From the utility transformer, the secondary feeder runs underground to a 2500 amp, 480Y/277V – 3 phase service rated switch in the Main Electric Room. The service switch intern feeds a distribution section via bus splice section. The distribution section of the switchboard feeds panels in the Main Electric Room and throughout the building. There are seven other “normal” panels in the room (both 480/277V & 208/120V) along with three transformers. There is an automatic transfer switch fed from a 125 KW diesel generator outside next to the pad mounted utility transformer. The transfer switch feeds a 480/277V panel, step down transformer and a 208/120V panel. The two generator panels serve some interior lighting, exterior lighting, paging system, security system, fire alarm system, kitchen refrigeration, misc. power and some HVAC equipment (heating).

Electric Room is a Unison theater lighting control panel and an ETC emergency transfer switch also for the theater lighting. There are building supplies stored in this room, and although it appears working clearances are maintained in front of all electrical equipment, I believe there is a code violation. This room only has one door in or out of the room, which would require double the working clearances in front of the equipment or an unobstructed path to the door. With the supplies in the room, neither option is met.

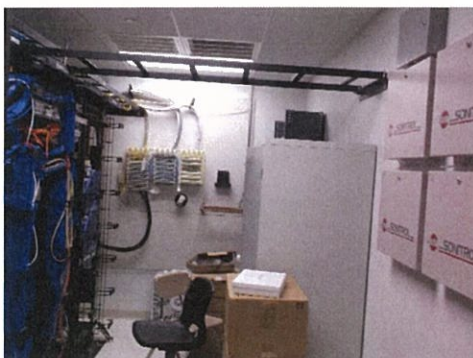
Voice / Data

The existing telephone system demark is in the Tel/Com. Room in front of the main electric room. There are tables and other items stored in the room, so we were not able to determine the condition of any the equipment. The main Data Closet is in the south-east corner of the Media Center, which has a network rack for data, punch down blocks for phones and security panels. There is a second Data Closet on the first floor across from the main stair at the front entrance. This room has the master clock headend equipment, a Rauland sound cabinet with a Bogen CD player & cassette deck. There are two hand held controllers to adjust the master clock system. There are two additional Data closets on the second

floor. The existing data outlets throughout the school are recessed mounted. There are desk mounted phones in all the classrooms, along with a wall mounted clocks and recessed ceiling speakers. There are a few rooms with wall mounted phones like the Gymnasium. There are speakers in all the hallways and utility rooms. There are desk phones in all the Offices. All equipment appears to be operating properly.

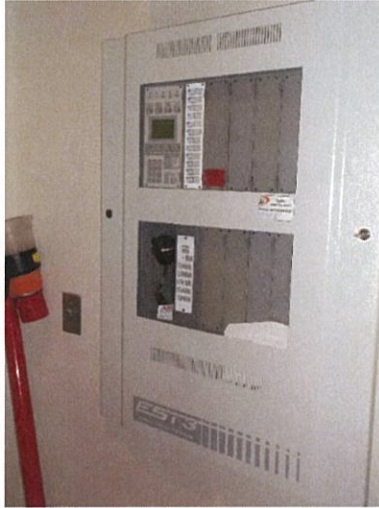
Fire Alarm

The existing fire alarm system is an addressable Edwards (EST3) system, with the control panel located in the corridor behind the Main Office and the batteries are on the wall in the room behind the control panel. There is a remote panel in the Cafeteria with voice capability and a second remote panel in the main lobby across from the elevator outside the Main Office. There are additional power panels located throughout the school. There are manual pull stations with “stopper” covers at the egress doors along with audio/visual devices throughout the complex. There are visual devices in all the Classrooms. There are carbon monoxide detectors in the mechanical room where there is fuel burning equipment. There are smoke detectors throughout the school, in the corridors, classrooms, stairs, etc. The system appears to have voice capabilities throughout the school and not just in the assembly spaces. The devices throughout appear to be in good operating condition.
