## Weston Middle School

# WESTON SCHOOL FACILITIES FEASIBILITY STUDY

## WESTON MIDDLE SCHOOL - FACILITY CONDITIONS ANALYSIS

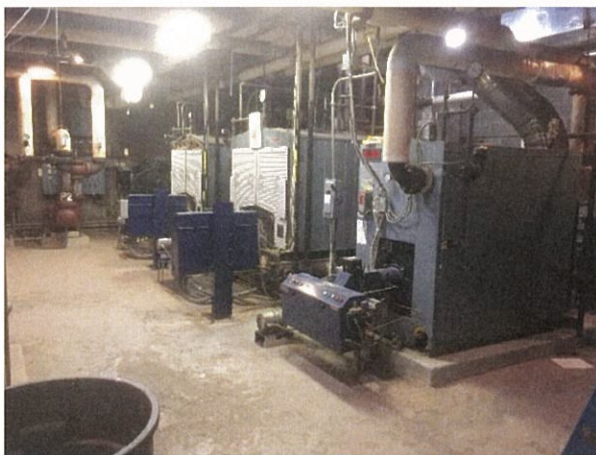
Heat for the facility is provided by two separate Hot Water Boiler Plants. The 1970 addition is served by the two original HB Smith 450 Mills Boilers which have been retrofit with Power-Flame dual fuel burners. The Boilers appear to be well maintained and in serviceable condition but at nearly 50 years old they are approaching the end of their useful life expectancy, are inefficient by current standards, and will become costlier to maintain. Hot Water Pumps and Fuel Oil Transfer Pump Set are at, or near, the end of their useful lives. Recommend planning for eventual replacement of Boilers, Pumps and related accessories and controls.

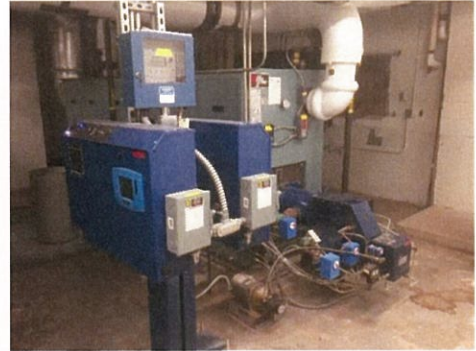
The 1960 Boiler Plant was renovated around 2010 at which time two Smith Model 28-HE-18 Dual Fuel Boilers were installed along with new Hot Water Pumps, Boiler Room Piping, Hydronic Accessories, and Fuel Oil Transfer Pump Set and piping. The Boilers and equipment appear to be in good condition with 20 to 30 years of useful life remaining. The equipment, piping and insulation all appear to be in good condition with no visible signs of leakage. Combustion air is provided by two roof mounted gravity vents ducted into the Boiler Room which appear to be adequate.

Since Boiler life can be affected by poor water quality and inconsistent maintenance, it is recommended that the boiler water be periodically tested. Regular preventive maintenance should be performed to maximize the service life of Boilers and related equipment.

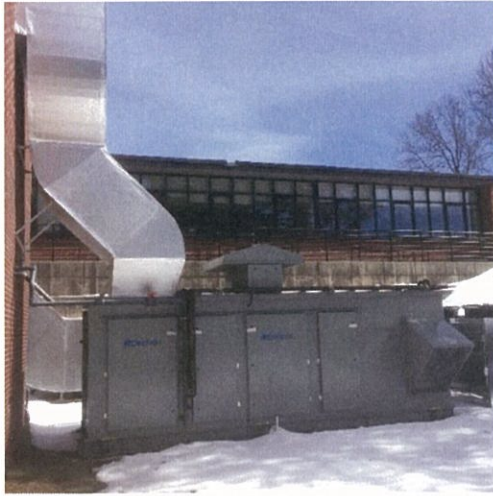
A new Pool Dehumidification System has been installed but final commissioning has not yet been completed. The system consists of a Dectron Dry-O-Tron unit located on grade and ducted into the Natatorium. Once online, the existing system serving the Natatorium will be abandoned and the new system will provide temperature and humidity control of the space.

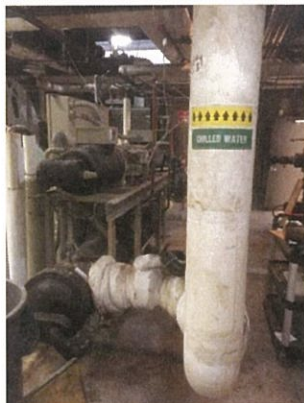
The Chiller supplies chilled Water to various Air Handling Units and Fan Coil Units serving the 1970 portion of the facility. The Chiller and Condensing Unit were manufactured in 2003, installed in 2004, and appear to be in serviceable condition with 10 to 15 years of useful life remaining. Chillers should be serviced annually by an HVAC Service Company in accordance with the manufacturer's Operation & Maintenance requirements.

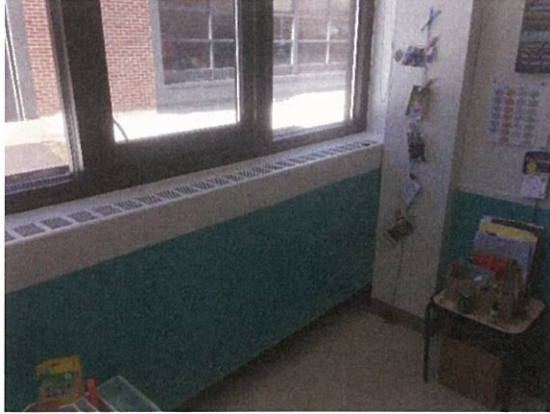
Perimeter Classrooms and miscellaneous spaces are served by Hot Water Fined Tube Radiation installed at the time of original construction. The enclosures are showing signs of age and the heating elements are likely providing diminished heating capacity having exceeded their useful life expectancy. Recommend planning for replacement as part of any major HVAC improvements.

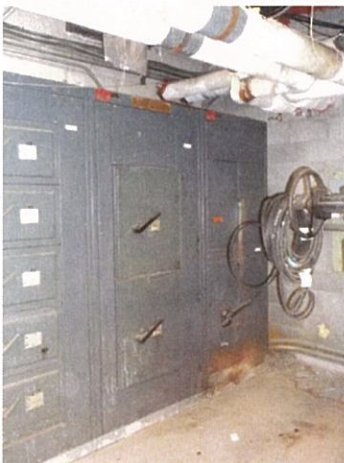
The existing electrical service originates from a pad mounted utility transformer located to the north-east side of the building. From the utility transformer, the secondary feeder runs underground to a 2500 amp, 480Y/277V - 3 phase service rated switch in the Boiler Room. The service switch intern feeds two distribution sections. The distribution sections of the switchboard feed panels throughout the building in local electrical closets and directly in rooms. There are two motor control centers in this room also, one “normal” and one “emergency” (both 480/277V). There is an Emergency Electric room adjacent to the Boiler room with an automatic transfer switch fed from a 275 KW diesel generator outside next to the pad mounted utility transformer. The transfer switch feeds a 480/277V panel, 150KVA step down transformer and a 208/120V panel. The two generator panels serve some interior lighting, exterior lighting, paging system, security system,

fire alarm system, kitchen refrigeration, misc. power and some HVAC equipment (heating). The main electrical equipment is older and nearing the end of its useful life and will need to be replaced in the near future, also the location of the equipment does not meet current code. This room only has one door in or out of the room, which would require double the working clearances in front of the equipment or an unobstructed path to the door which it does not have. When the equipment is going to be replaced, careful planning and coordination will be required to locate the new equipment and be code compliant.

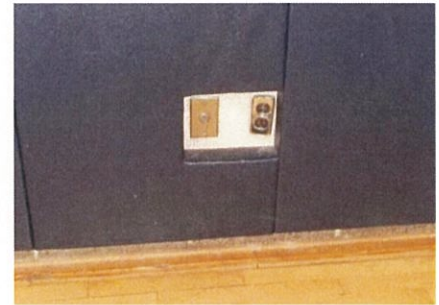
The existing power receptacles throughout the school are mostly recessed mounted duplex and quad receptacles with metal cover plates. There is some surface mounted raceway (wire mold) with surface mounted devices and some surface mounted conduit to surface mounted devices. The new Tech. Ed. Rooms have ceiling mounted cord reels with a duplex receptacle in a single gang box. There are also ceiling mounted cord reels with pre-ended duplex/quad receptacles mounted to them. The receptacles for the most part appear to be in good operating condition, there are a few locations that spotted that the devices should be replaced or remounted to the back box.
