FLYROCK **CAUSE & PREVENTION**

KURT GLEASON

RMS, LLC

BLASTING INCIDENT REVIEWS

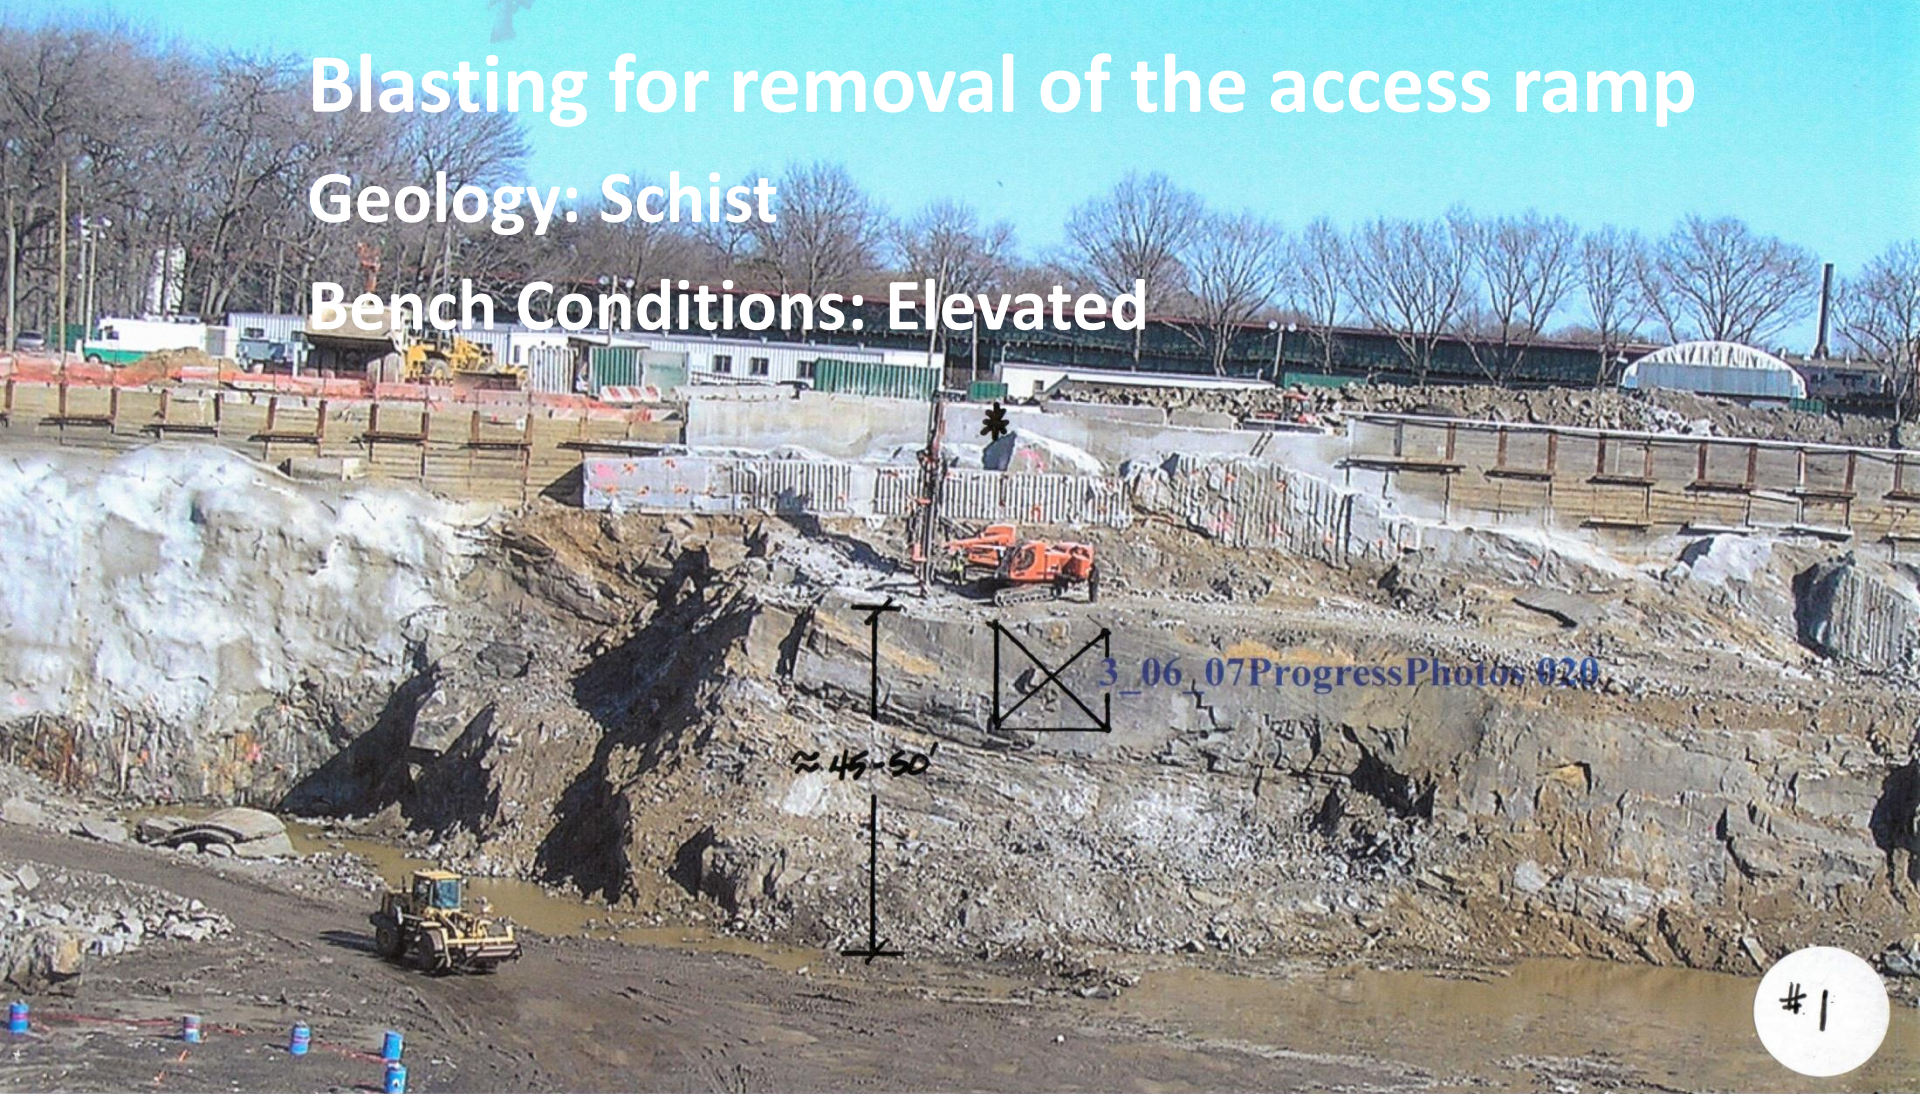
Croton WTP – 2007

Blasting for removal of the access ramp

Geology: Schist

Bench Conditions: Elevated

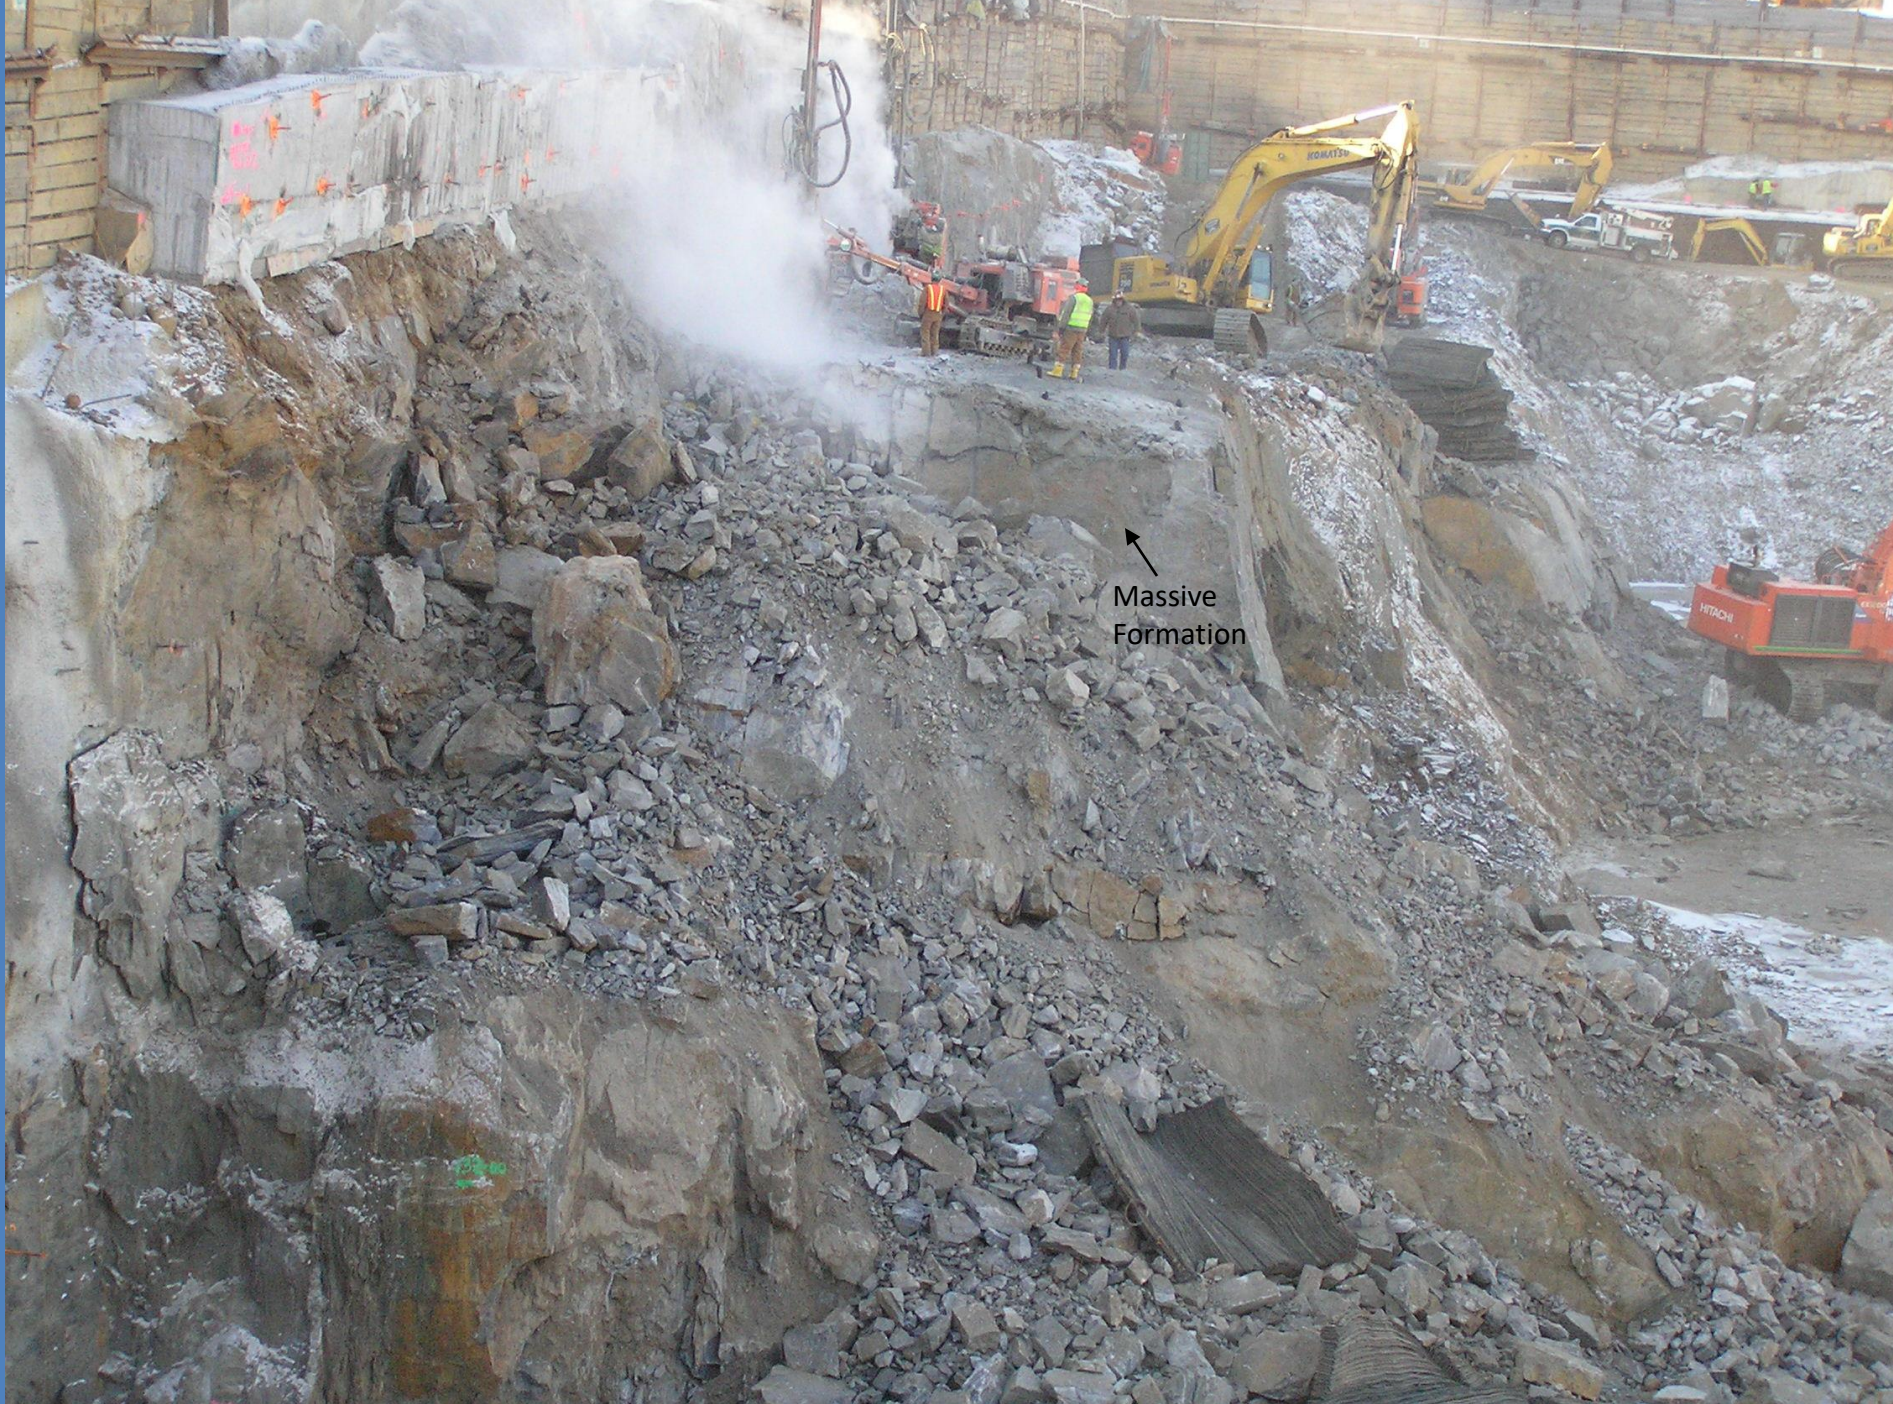
Massive
Formation

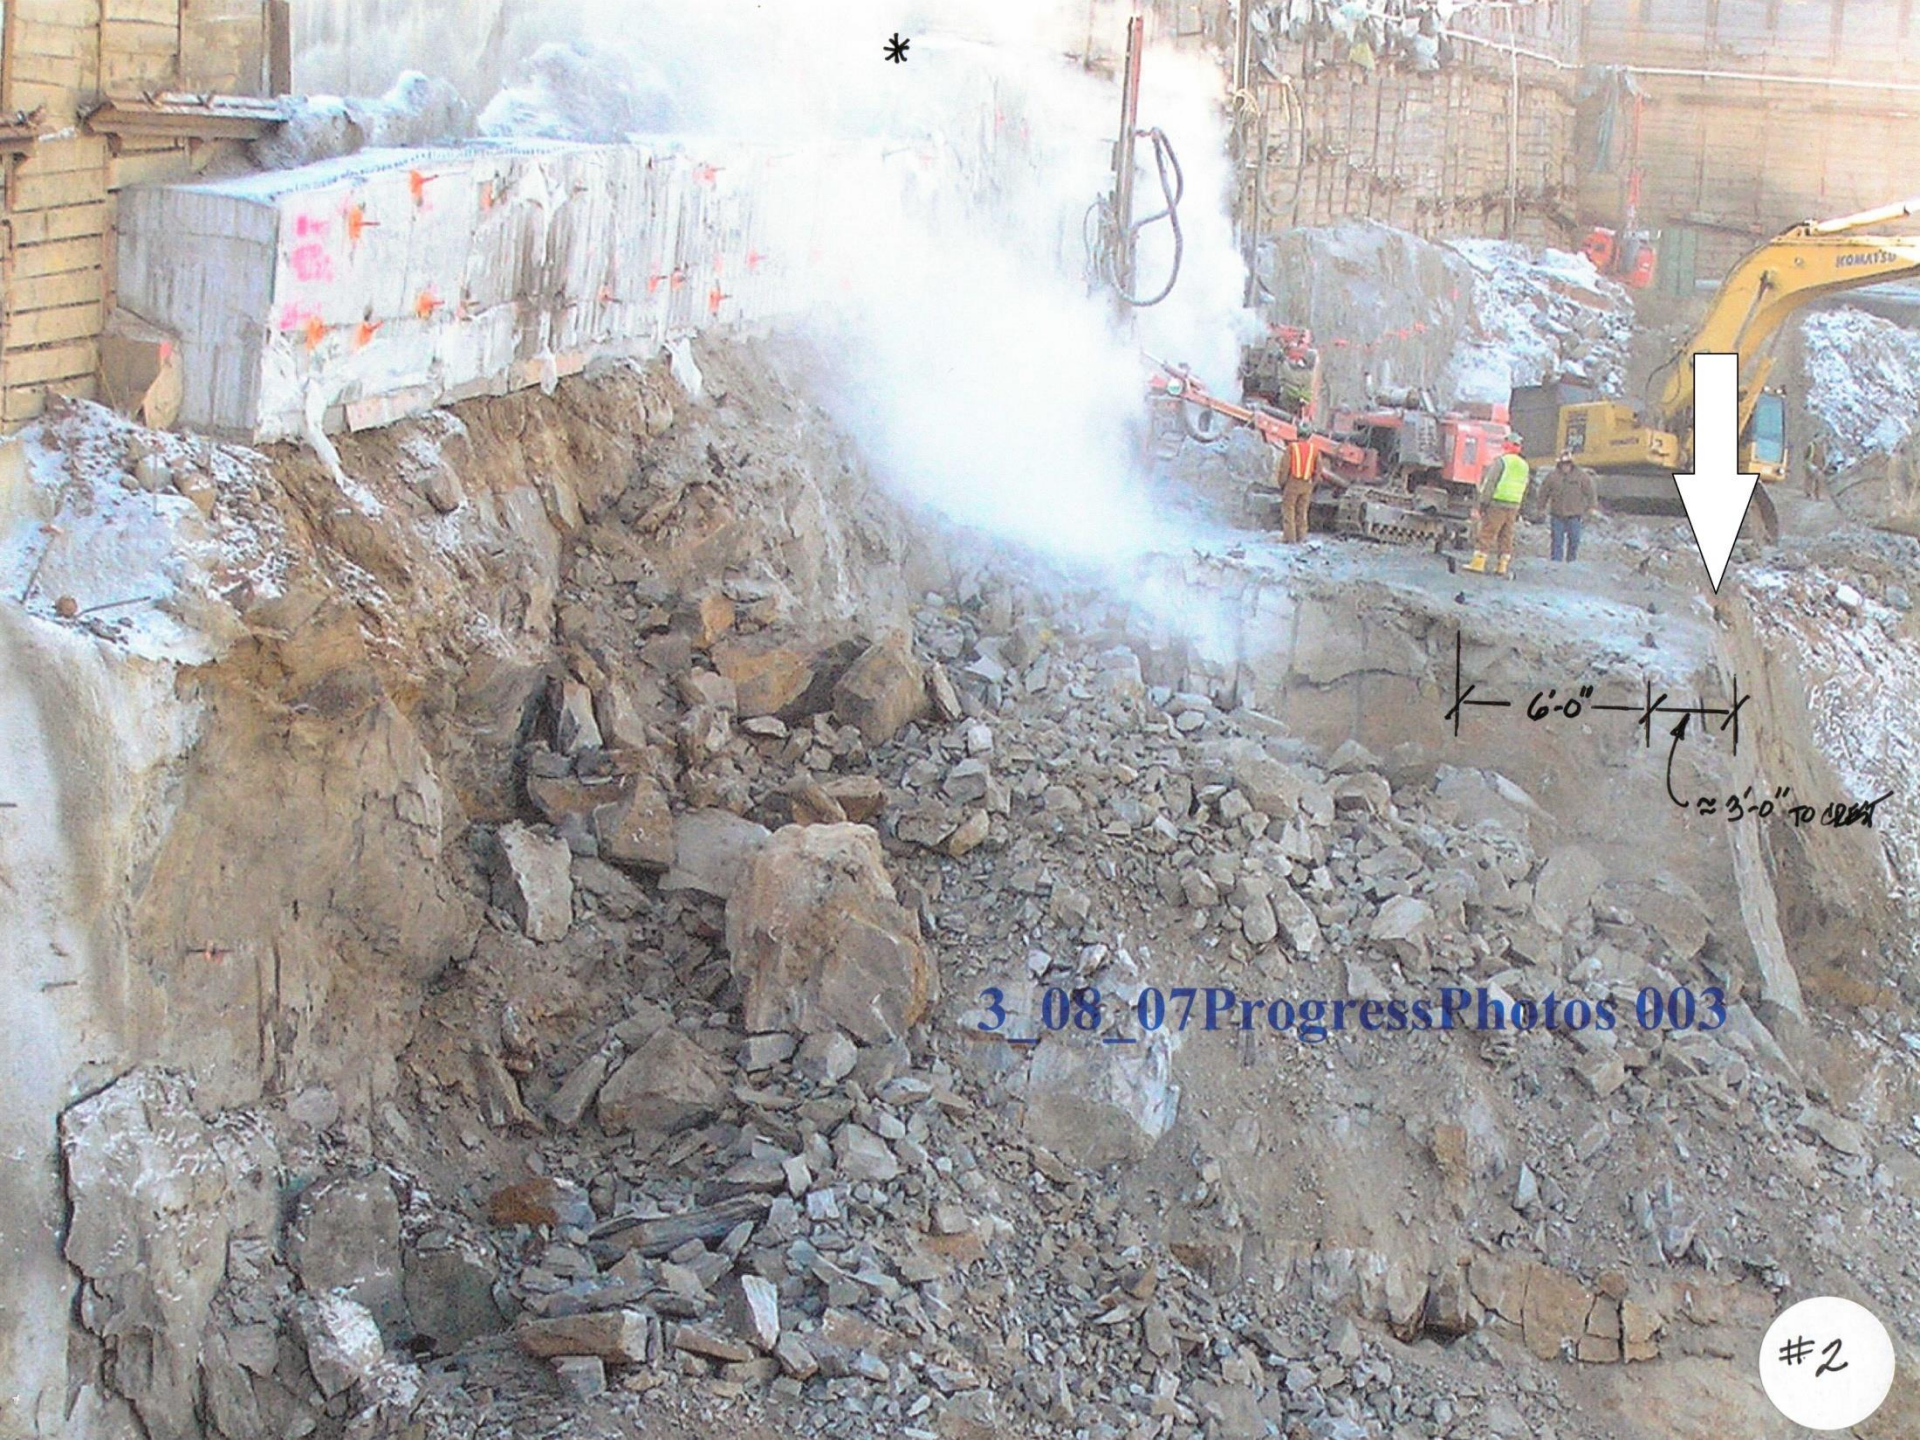
#2

- Abandonment of Blast Plan Recommendations
 - Remove all equipment and personnel from pit
 - Blaster positioned at top of ramp
- Original Blaster Replaced
 - Would not compromise his principles
 - Program advancing too slowly
- Schedule Issues
 - Expedite blasting by allowing equipment and personnel to remain in the pit during blasts.
- Utilization of non-blasting personnel for signaling
 - Labor Foreman for the rock anchor crew

Location of the blast

Location where
during the blast.

Approx. 325 feet

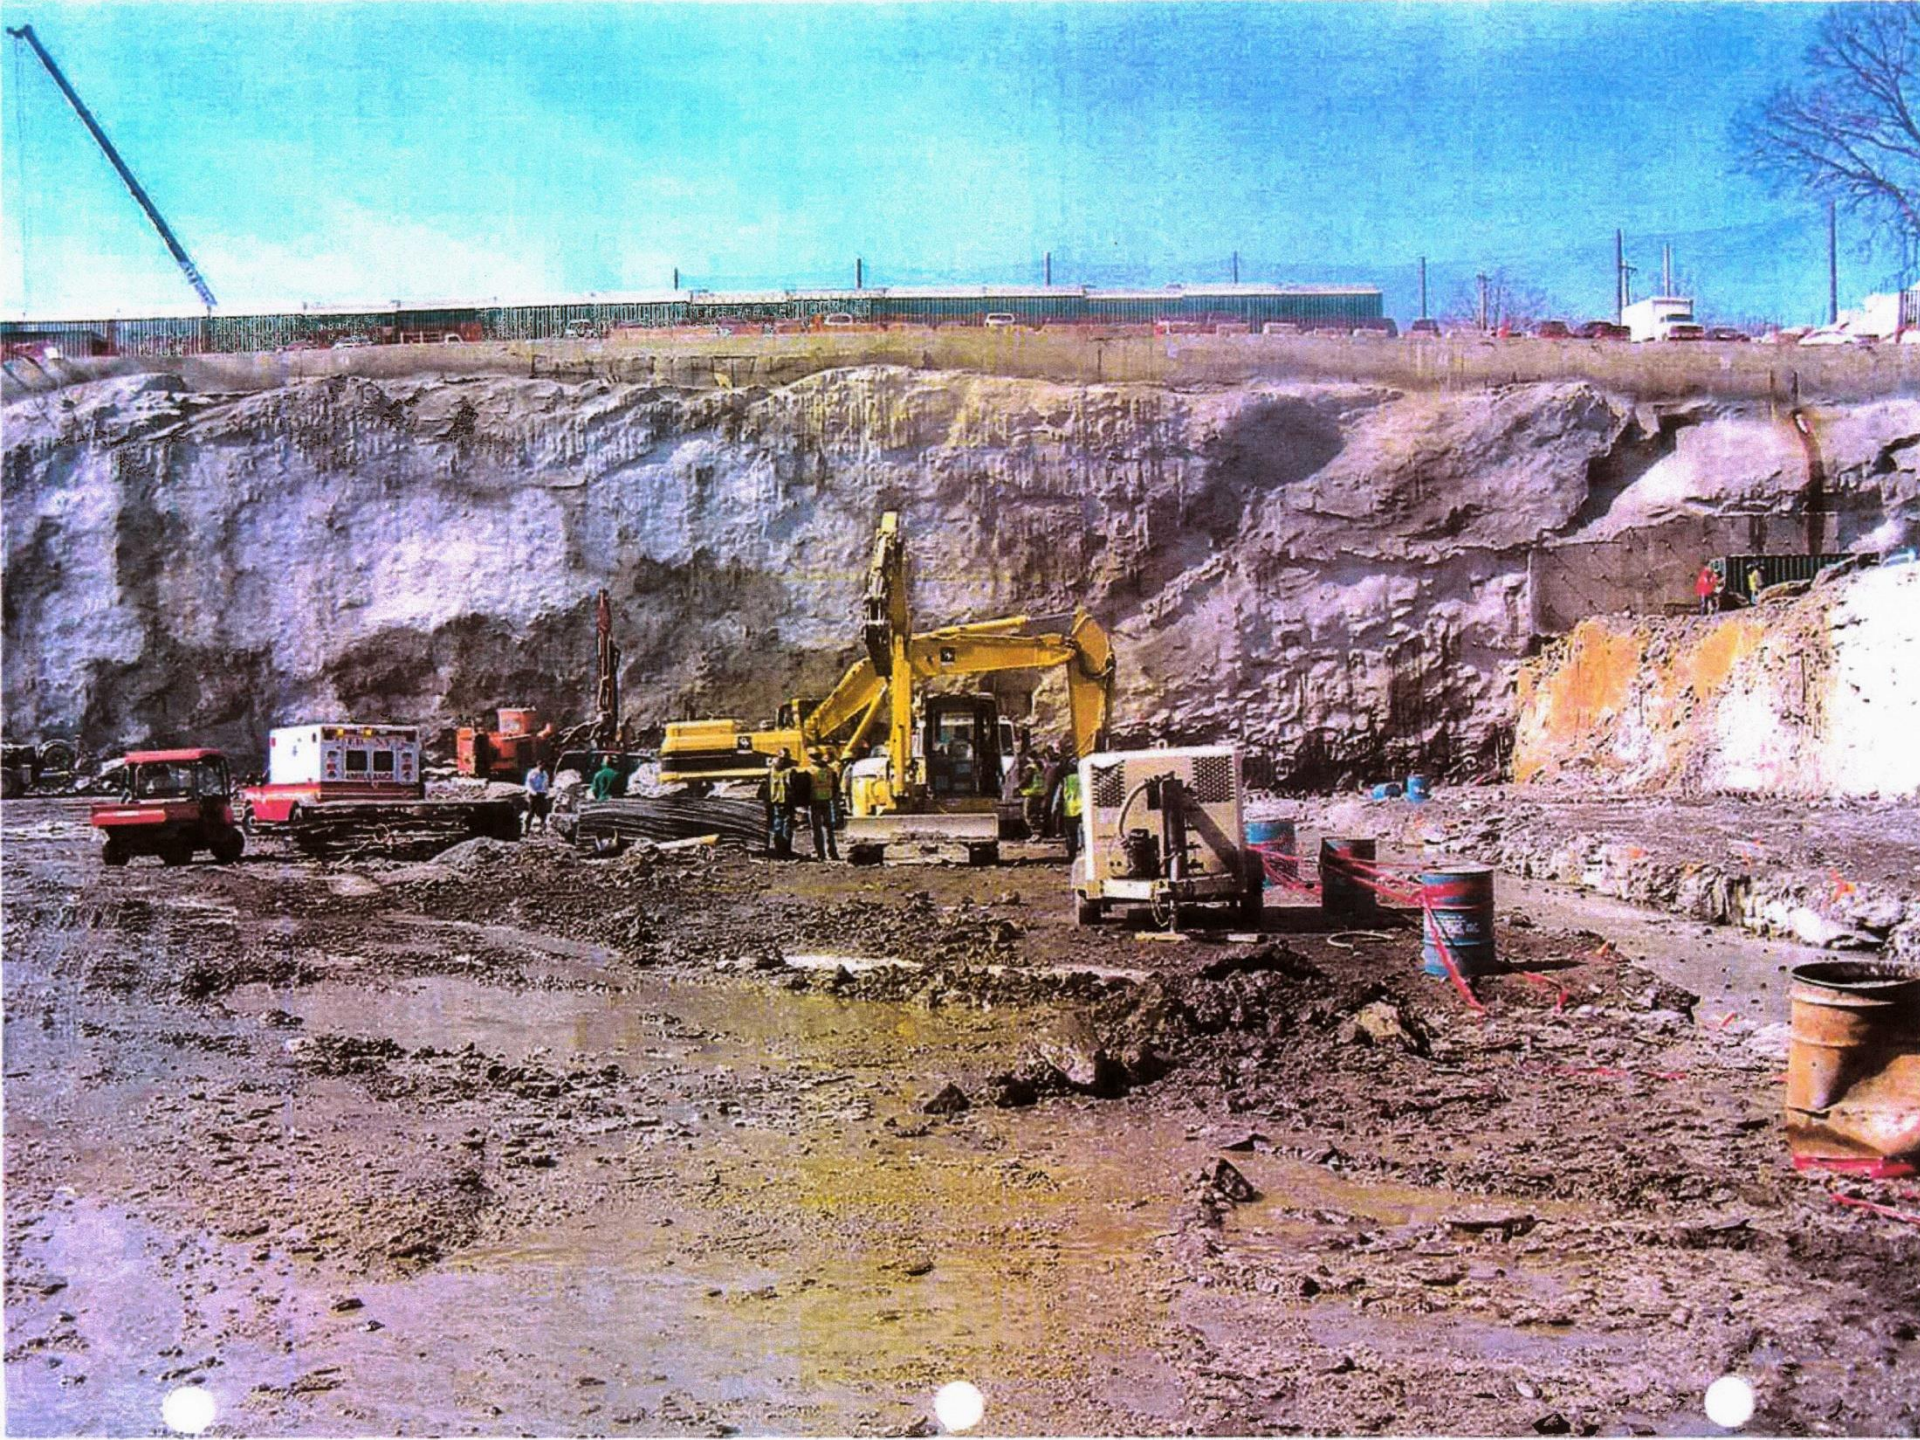
Mike was soundy Blast Hammer went to take ~~go~~ cover Blast
went off Fly Rock came toward Him and hit his back

Primary Cause (condition or act that caused the accident): Fly Rock

clear area totally

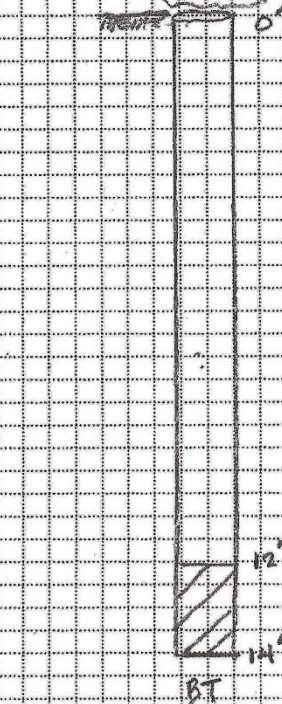
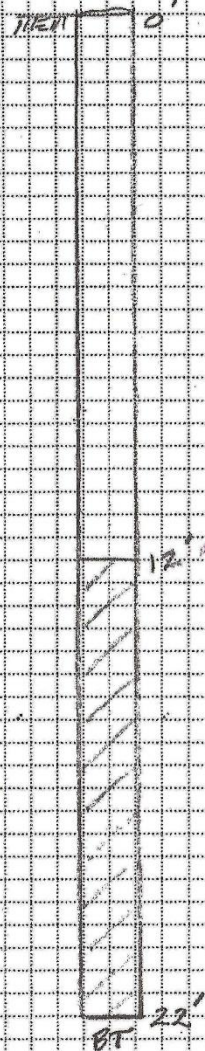
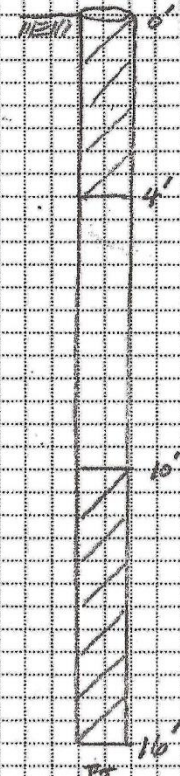
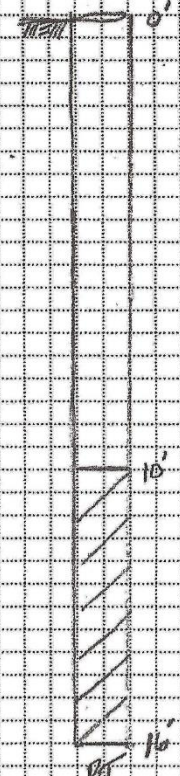
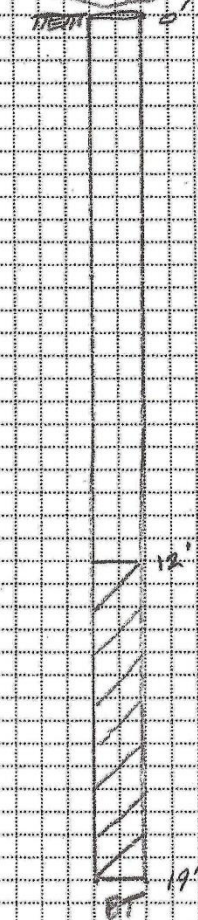
BOREHOLE PROFILE - Row # 14

32'-0" DRILLED DEPTH

TIMING: NOT LOADED

896ms

921ms

9146ms

NOT LOADED

996ms

1021ms

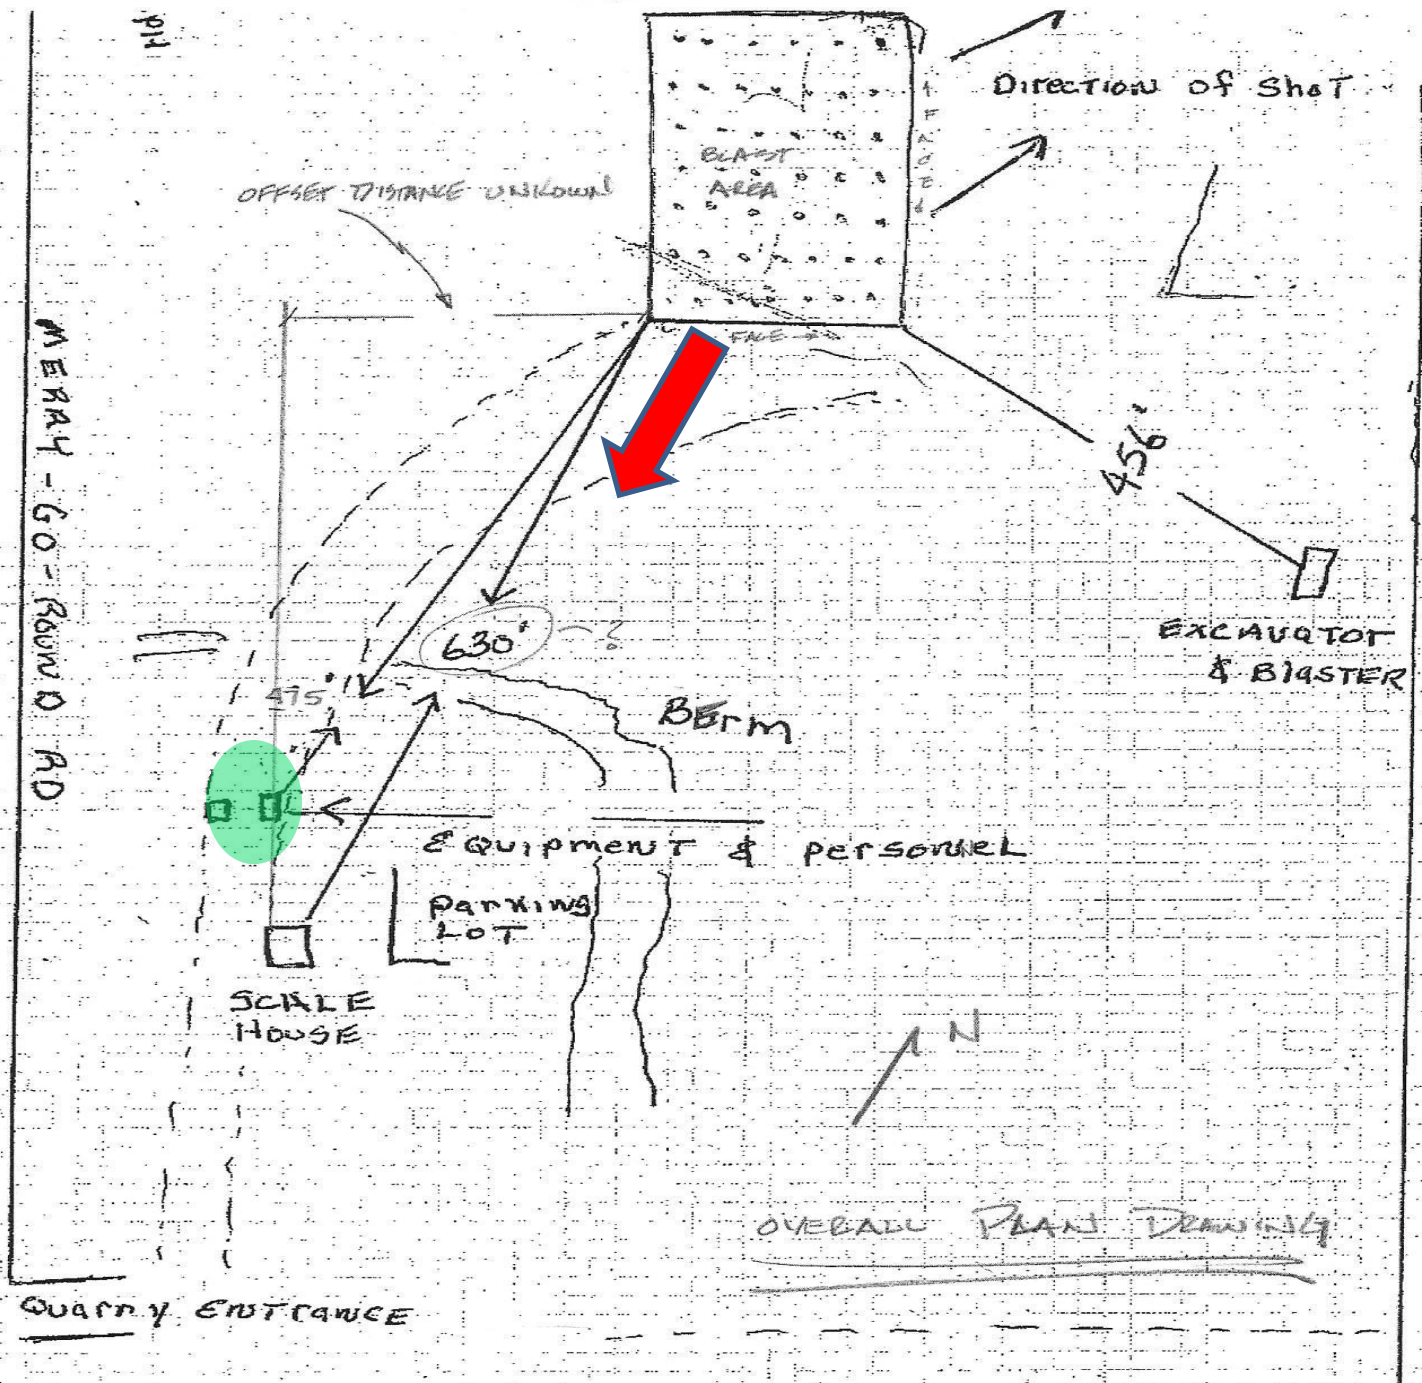
PRE-BLAST

- Site Safety Plan required personnel to be staged at entrance to quarry (+ 1,000' from blast)
 - Personnel were staged between the scale house and the blast less than 500' away
- Loaders, with operators in cab, staged at the scale house to block entrance to pit
- Personnel standing between and in front of loaders
- Third party dumps staged behind loaders

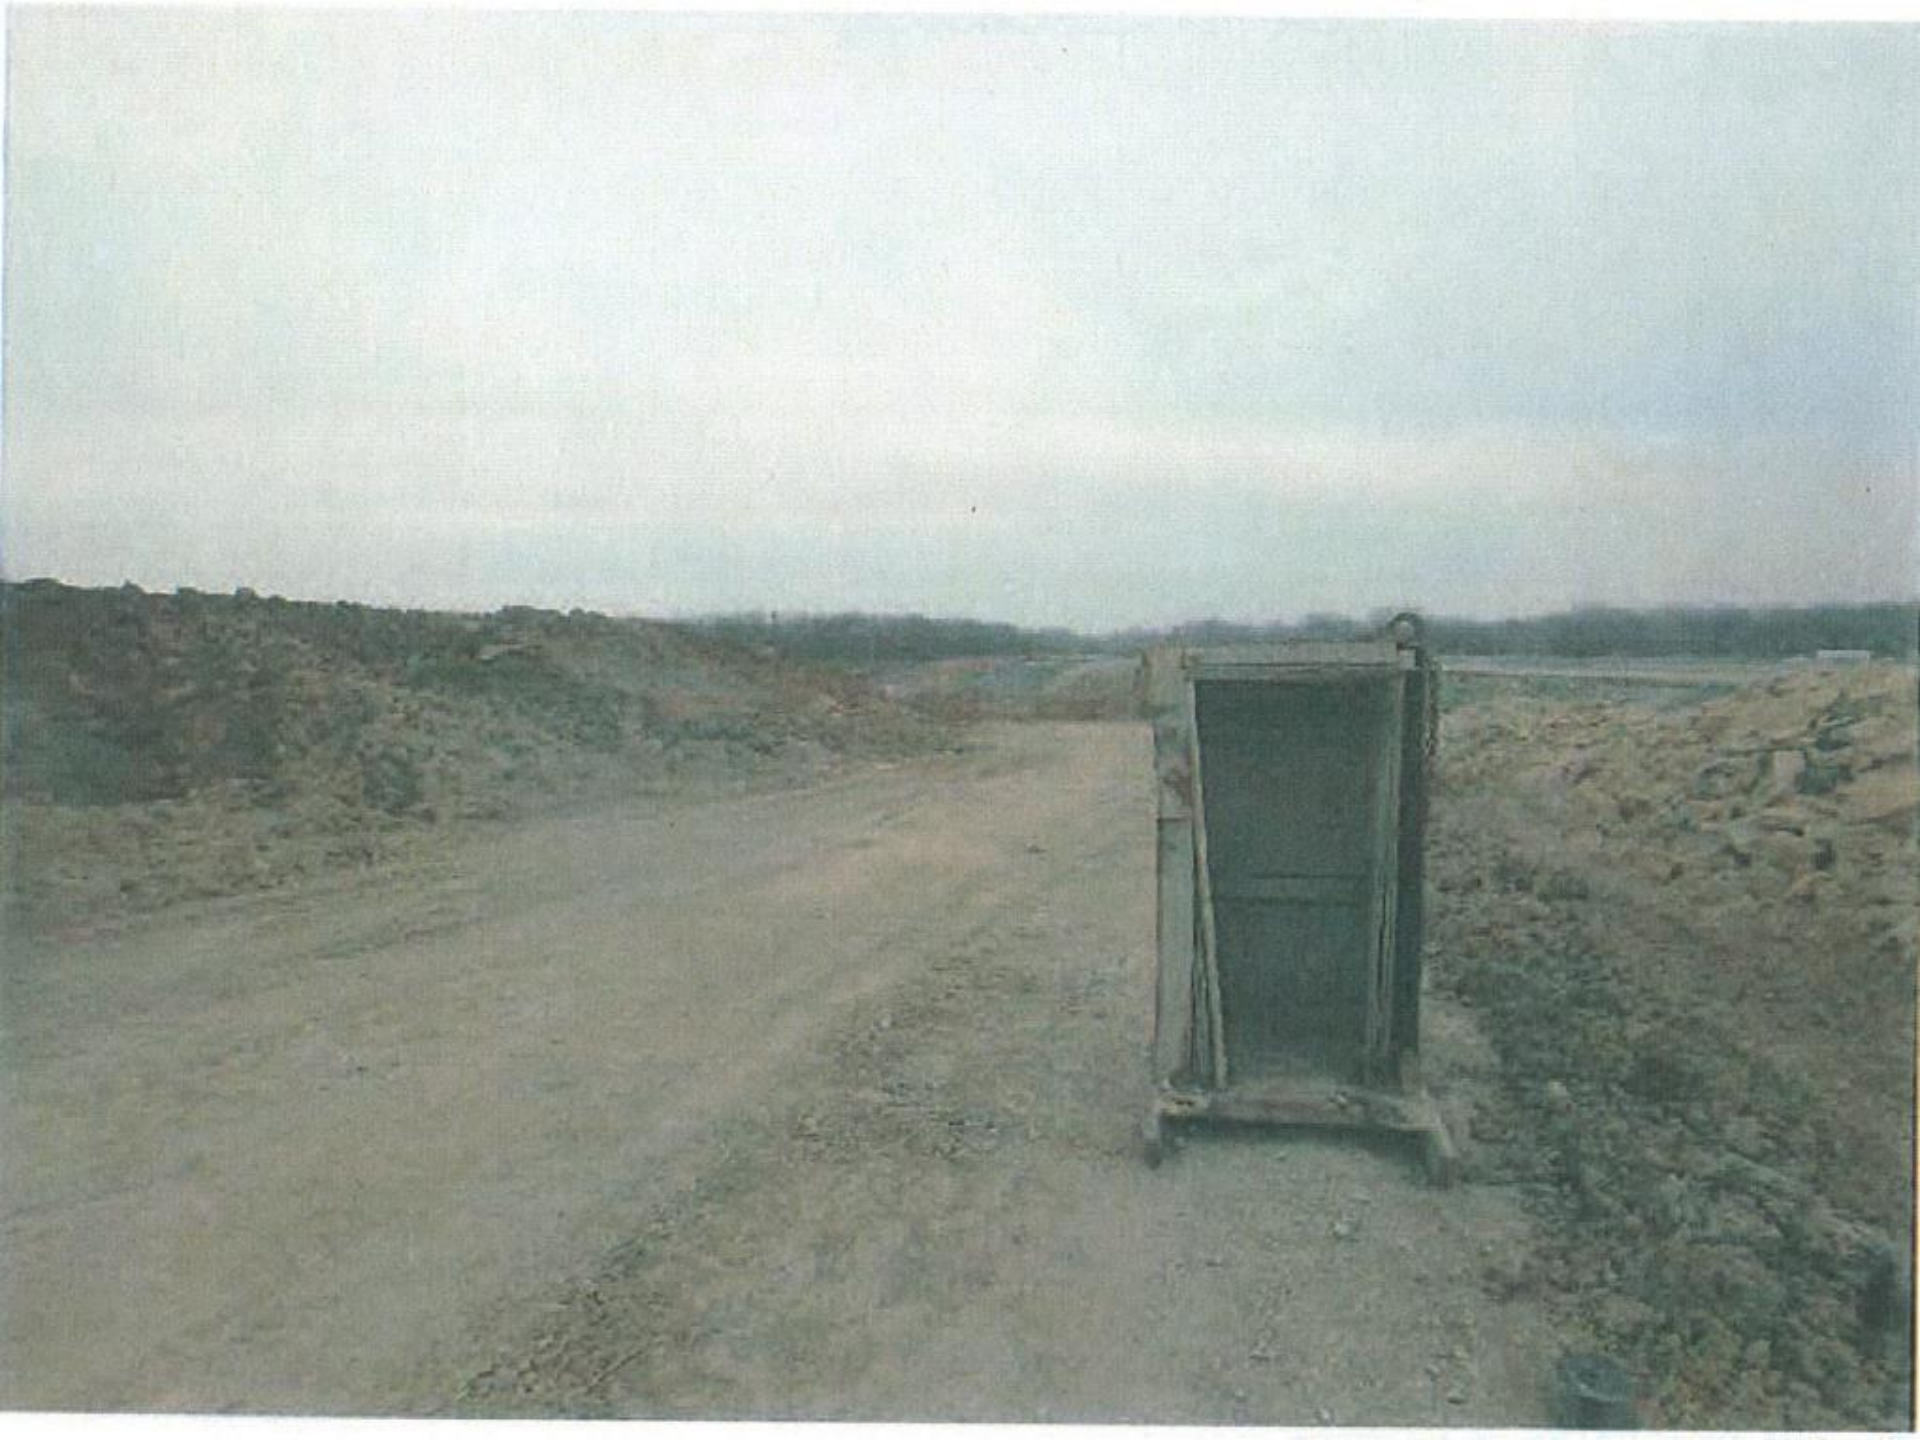
Location/Photo Description: over view of blast looking north to south

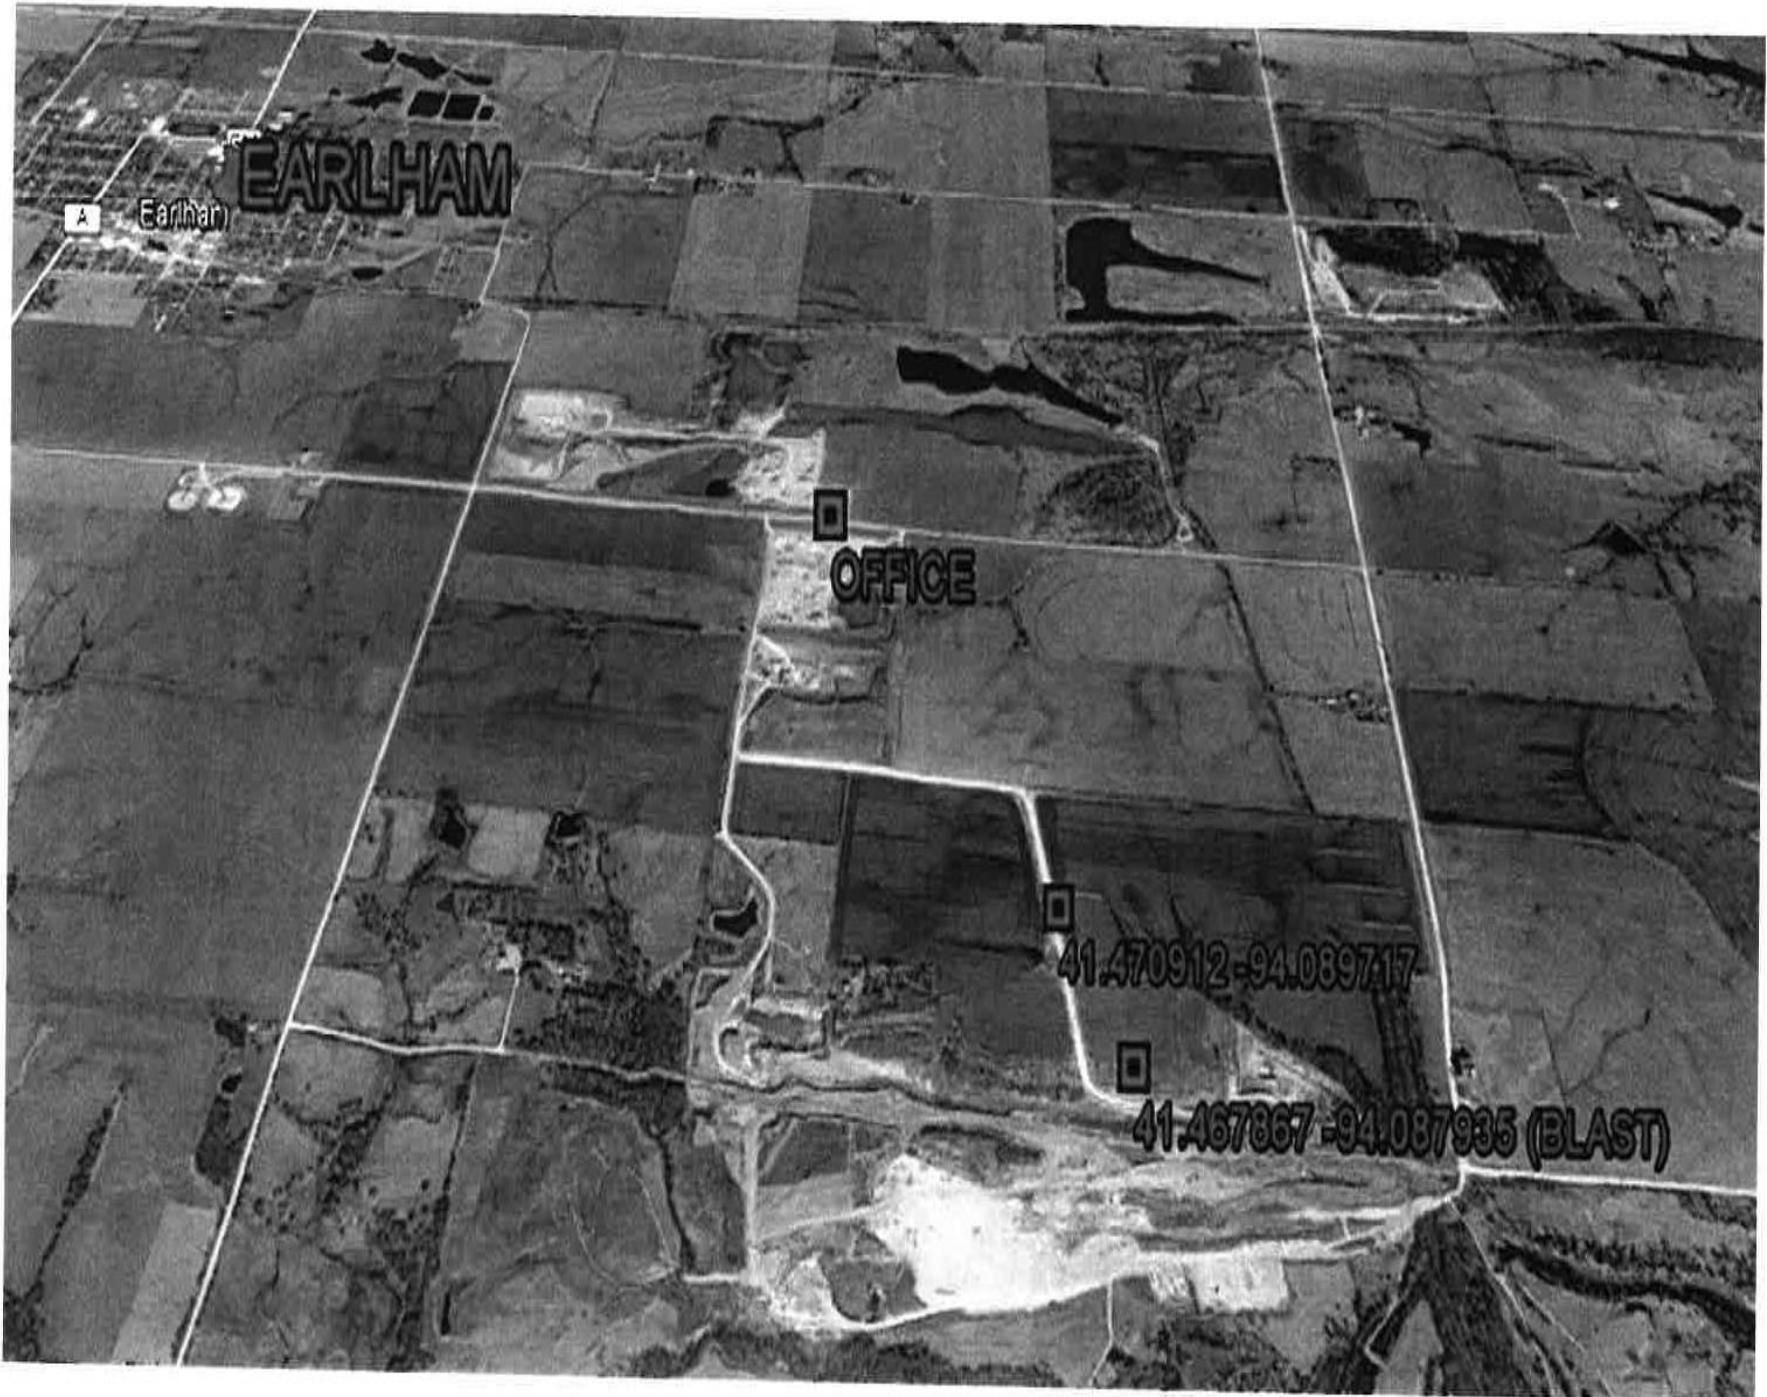
Fatalgram

METAL/NONMETAL MINE FATALITY – On March 22, 2016, a 42-year old lead man with 6 years of mining experience was fatally injured at a surface limestone mine when he was struck by fly rock from blasting operations. The lead man was parked in his pickup truck at a location to prevent others from accessing the blasting site. He was approximately 1,200 feet from the blast area.

- Review and follow site specific blast plan prior to loading any explosives.
- Utilize technology, such as face profilers and borehole probes, to obtain specific geometric details of the material to be blasted.
