**Narrative: 64 Dane St, Somerville, MA 02143 (Littlefield-James House)****Replacement/ Demolition of Front Porch (updated)**

September 3, 2025

Project: 64 Dane Street, Somerville, MA  
Re: Structural analysis of historic porch posts  
Project Number: 25003

# HANGER GRODD FRONT PORCH RECONSTRUCTION

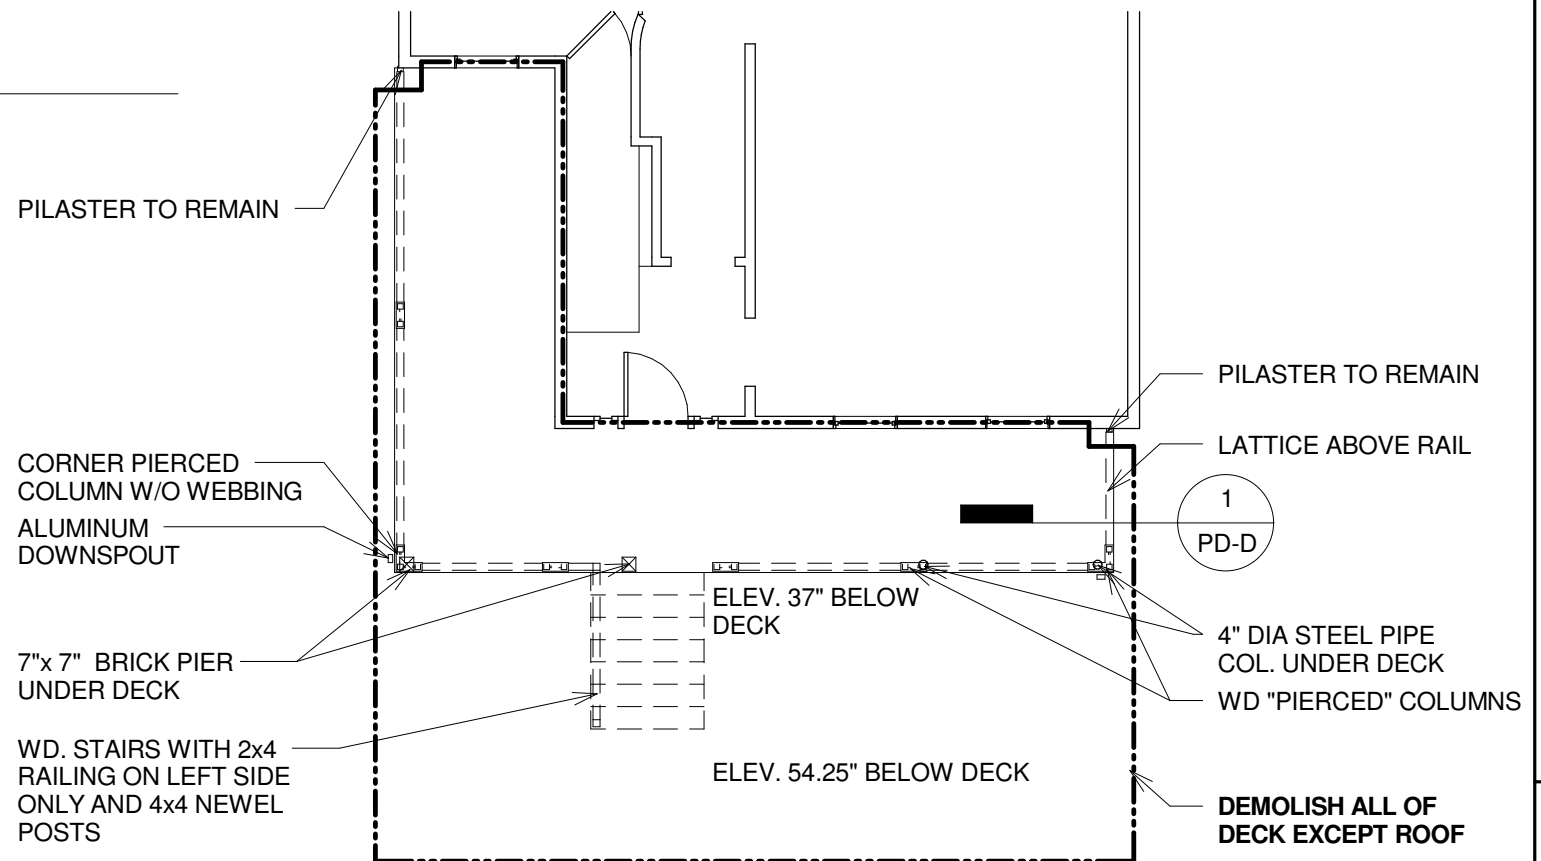
**1 FIRST FLOOR- DEMOLITION PLAN**  
1/8" = 1'-0"

**Deck structure** is unsound. The three concealed 8x8 brick piers and two 4" steel pipe set into concrete are degraded and need to be replaced and repositioned to better support the loads. The framing needs to be replaced due to rot and degradation.

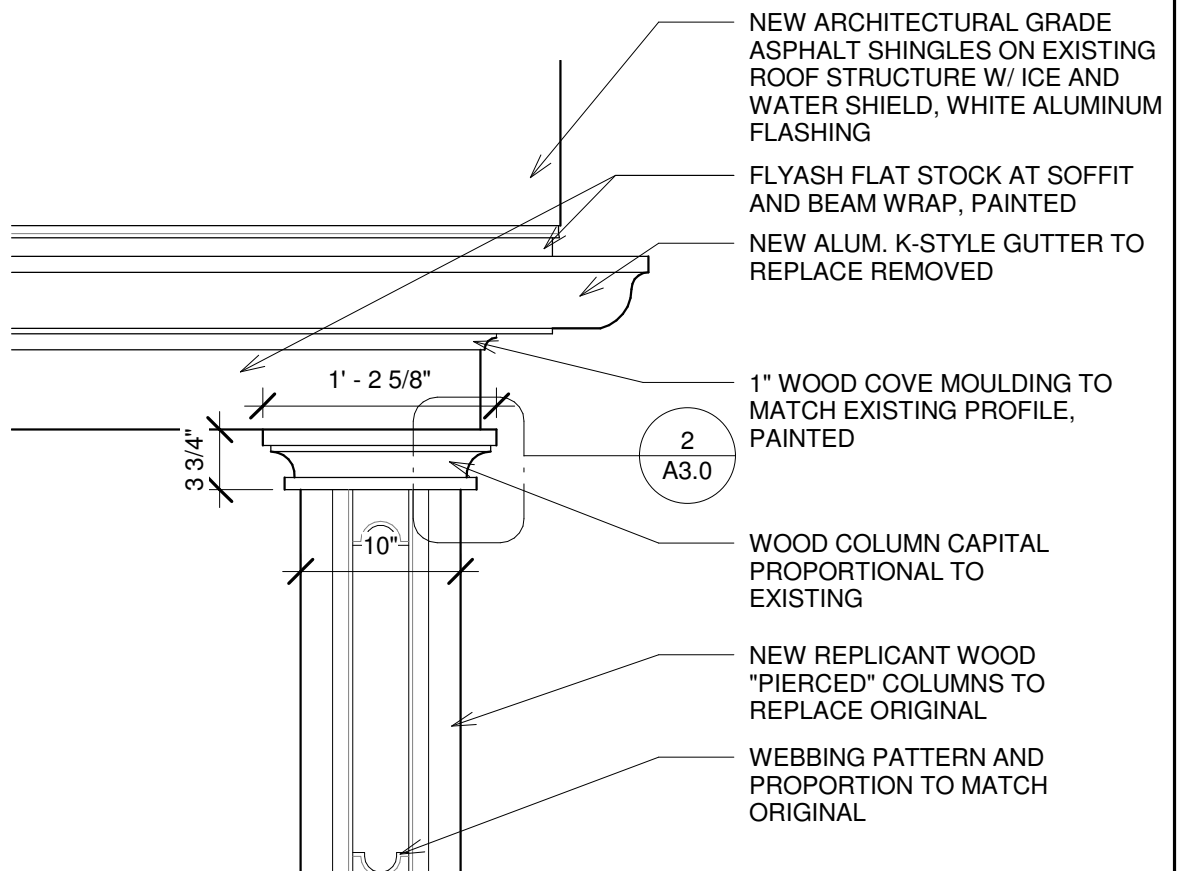
1 COLUMN DETAIL  
1" = 1'-0"

The pierced **columns** are in various stages of decline. Refer to included letter from structural engineer. They have rot at the base and the corner column had the webbing removed completely to accommodate downspout. ~~A structural engineer has reviewed the existing columns and stated that while the columns could be replaced with replicas they would have to be with larger members that would alter the scale and width of the new replica columns. The homeowner would like to replace the pierced columns with simple square ones of similar proportion to the front facing width of the existing columns, 10". The capital would replicate the cove crown and the flat base at the bottom proportionally. The column will be cast fiberglass w/ wood crown and fly ash (TruExterior) base, painted.~~

*A structural engineer has reviewed the existing columns and stated that the columns could be replaced with replicas. The replacement columns will be made of wood, replacing what was original with duplicates to be painted.*

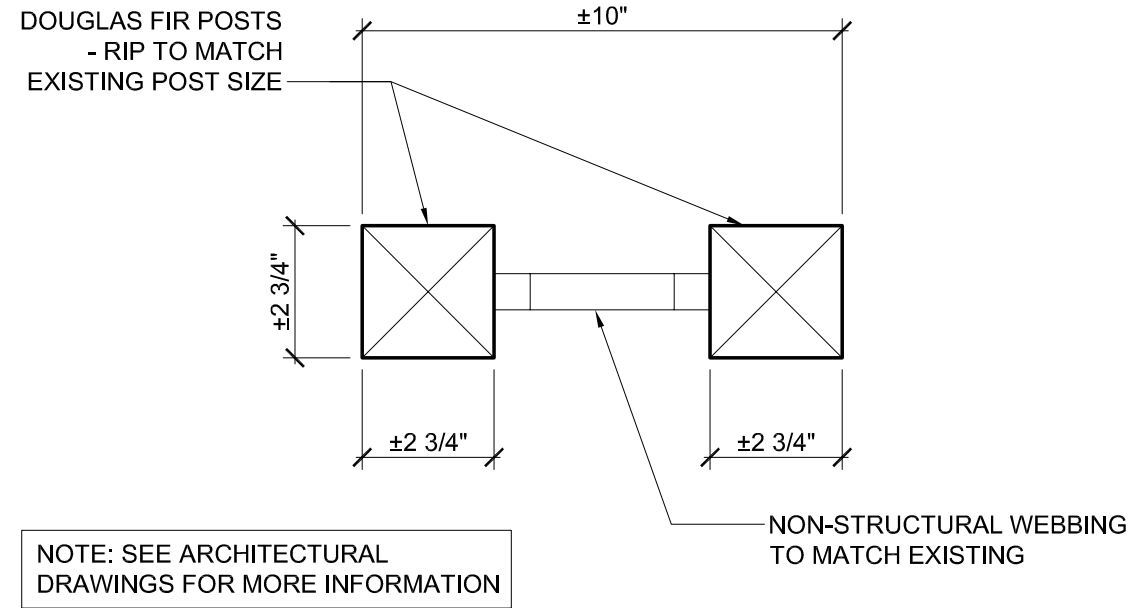
**2** **SCHEMATIC POST SECTION**  
SCALE: 3" = 1'-0"

The existing posts are double 3"x3" nominal lumber (approximately 2 3/4" x 2 3/4" actual). Many of the posts are in poor condition due to age and rot and will need to be either substantially repaired or fully replaced during the renovation work. The existing foundations and porch floor framing are also in poor condition and will need to be replaced during the work.

BE analyzed the posts to determine if they can be repaired or rebuilt with the same narrow profile and still support the code required loading. **Based on the analysis, the existing posts are too narrow and are inadequate to support the required snow drift loading on the porch roof. BE recommends that the posts be replaced with a larger profile during the renovation project.**
