HISTORIC PRESERVATION COMMISSION

Case #: HPC 2019.085
Date: November 19, 2019

PRESERVATION STAFF REPORT

Site: 33 Warren Avenue

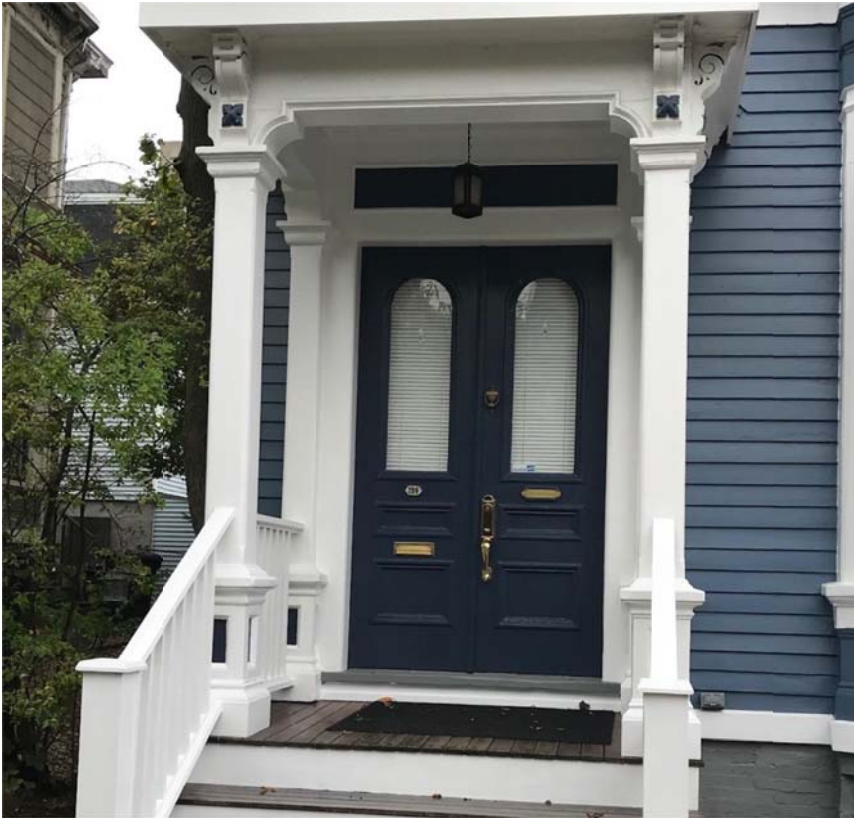
Proposed door style

Staff also finds the replacement of the existing front door with period appropriate wood double doors to match other houses on the street to be in compliance with the Guidelines and recommends a Certificate of Appropriateness be issued for that alteration. See attached photos.

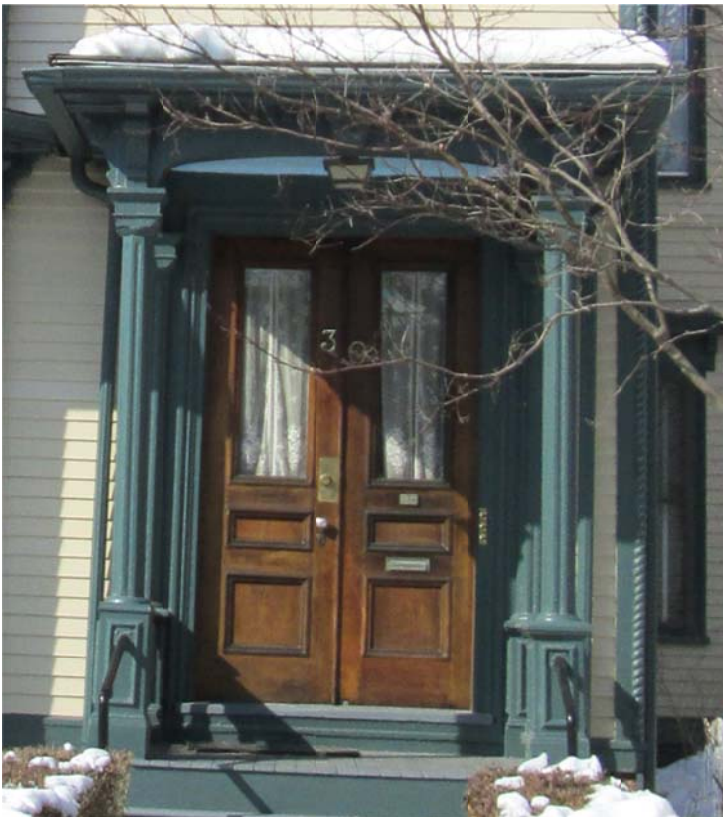
30 Warren Avenue showing alternate door style and rope corner molding
