CITY OF SOMERVILLE, MASSACHUSETTS
MAYOR JAKE WILSON
DEPARTMENT of INFRASTRUCTURE & ASSET MANAGEMENT
ENGINEERING DIVISION

SOMERVILLE IDDE INVESTIGATION – PERMIT YEAR 7 CATCHMENT INSPECTION

The purpose of this memorandum is to summarize investigations conducted by the City of Somerville, Massachusetts (City) in support of the MS4 General Permit (Permit) Illicit Discharge Detection and Elimination (IDDE) requirements. This memorandum describes the IDDE activities conducted to locate a suspected illicit connection located in Catchment 7 on Weston Avenue and recommended next steps.

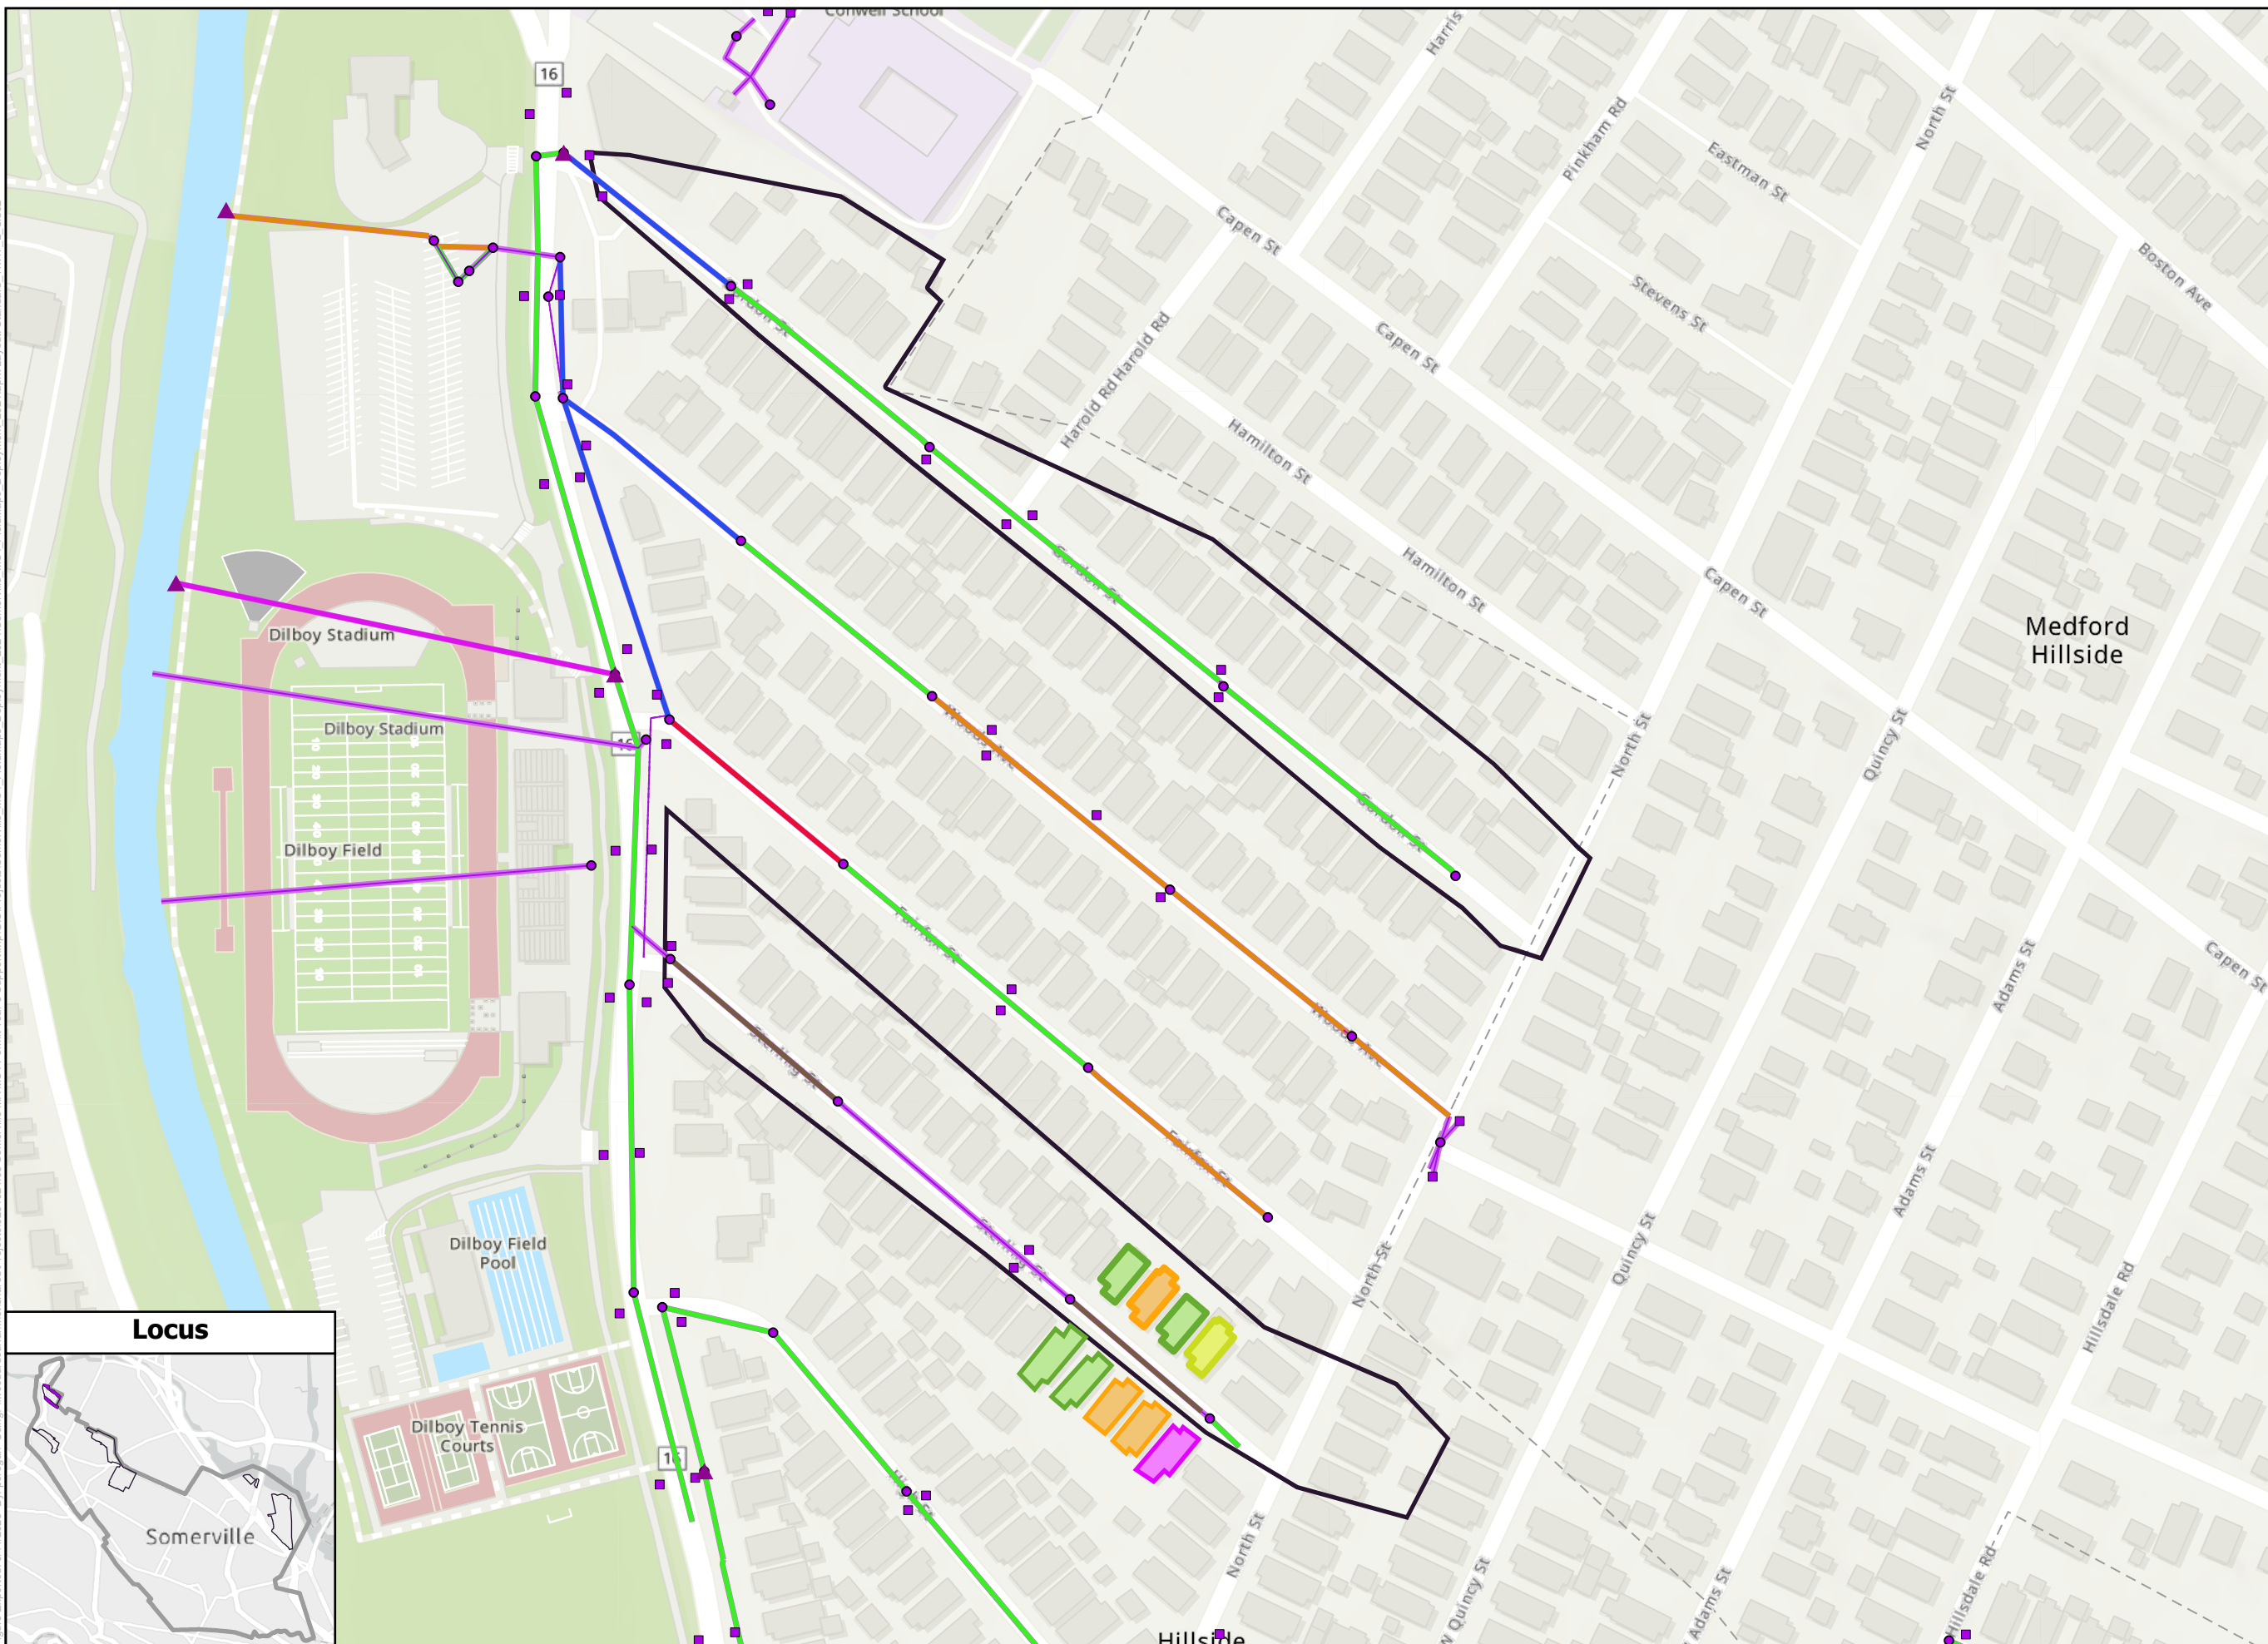
Catchment Investigation Status Map

6/17/2025	18 STERLING ST	N/A	Legal	Basement sink connected to a pipe that went to the ground. Washing machine in basement connected to main sewer stack. Only one stack observed. Tested basement sink, 1st floor sink and toilet. Unable to test 3rd floor washing machine due to it being built into the wall.	10

City of Somerville, MA
Permit Year 7
Catchment 10
