**Tree Health Assessment Report**  
**Kennedy Schoolyard**

Somerville Parks Tree Health Program

IFB 25-26

February 8, 2025

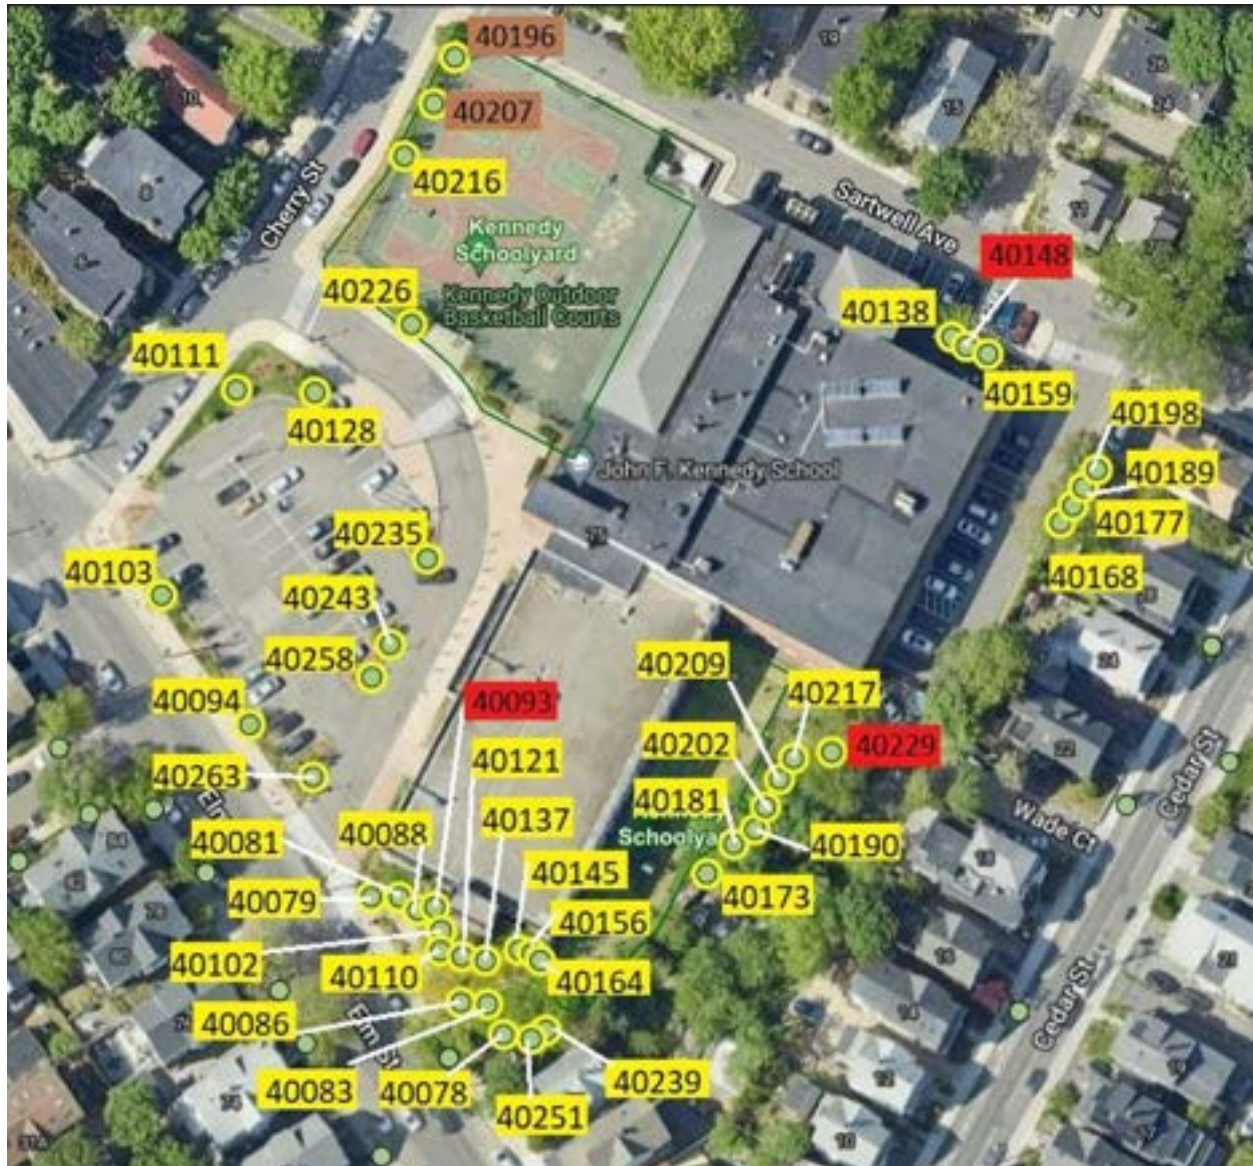
## Kennedy Schoolyard Tree Map

There is also an *Ailanthus* tree 40229, labeled in red on the Tree ID Map, and several unlisted *Ailanthus* volunteers, located on the eastern border by a play area, that are growing through a fence. This invasive plant species is a preferred host of a recently introduced invasive insect pest known as Spotted Lanternfly (SLF). SLF populations have been increasing and encroaching into this area with the potential to infest trees and cause damage to surrounding structures. This is because they secrete a substance called honeydew while feeding which can subsequently produce sooty mold that can cover anything below the tree. The honeydew also attracts stinging insects. We recommend removing all *Ailanthus* specimens, 40229 and the adjacent volunteers, to help stop the spread of these invasive pests and prevent potential sooty mold or stinging insects from this active schoolyard.

There are (2) trees listed as Littleleaf Lindens (40196 and 40207), labeled in brown on the Tree ID Map), both located in the northern portion of the site along Cherry Street, that have been removed and need to be updated in the inventory. We recommend grinding the stumps that remain of these trees to remove a tripping hazard and make room for new plantings. We will also recommend grinding the stump of the declining Mulberry 40148 in the northeast portion of the property after removal.

There is a Mulberry 40148, labeled in red on the Tree ID Map, located in the northeastern portion of the property growing against one of the school buildings. See photo at right. Due to poor structure, an extensive trunk wound with significant decay, and its proximity to the building we recommend removing this tree to make way for a healthier plant.

There is also a Black Locust, labeled in red on the Tree ID Map as 40093, located against a school building in a crowded grouping of trees on the southern portion of the site along Elm Street. We recommend removing this likely volunteer specimen to open up space for current plantings and because of its close proximity to the building. See photo below.

*We recommend removing this Mulberry 40148*
