**Subject: 2018 USEPA CCR Surface Impoundment Annual Inspection Report  
Brunner Island Ash Basin No. 6**

This report presents the findings of the 2018 annual inspection for the Brunner Island Ash Basin No. 6 facility. This inspection was performed by a Talen Energy employee on October 11<sup>th</sup>, 2018. The annual inspection was conducted in accordance with the requirements of the United States Environmental Protection Agency (USEPA) 40 CFR Parts 257 and 261 Hazardous and Solid Waste Management System; Disposal of Coal Combustion Residuals from Electric Utilities; Final Rule, April 17, 2015 (CCR Final Rule).

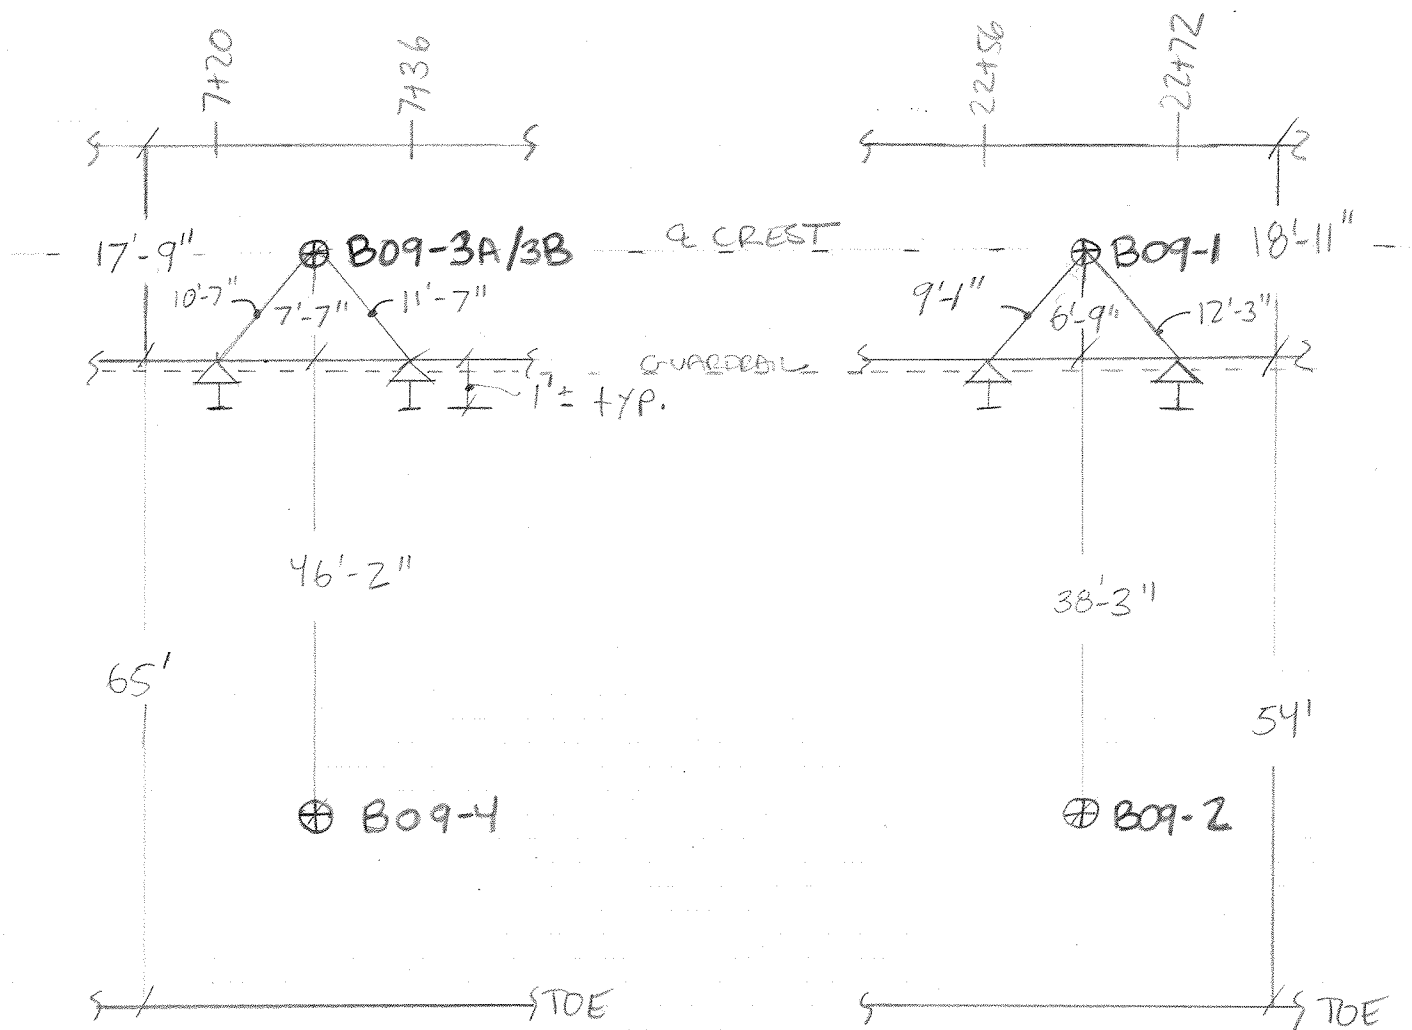
STATION 22+60 +/- :  
(SECTION 1-1)

Four piezometers were installed in the east embankment in 2009 along two sections at approximately Stations 22+60 and 7+30 as seen in the figures in Appendix B. The piezometers at Station 22+60 were installed adjacent to a repaired sloughed area, while the piezometers at Station 7+30 were installed in an area with no nearby sloughs. Two piezometers were installed at each section; one piezometer was located in the crest road and the second was located on the slope approximately 1/4 to 1/3 of the way up from the toe. During previous inspections, the road box cover for Piezometer B09-1 was observed to be broken and the riser was filled with bentonite but the piezometer tube was intact. It appears that piezometer B09-1 started to become blocked in March 2017 and Talen attempted a cleanout in early 2018. Talen reports that they are actively working with the PADEP Division of Dam Safety to permit the installation of a new piezometer in the dam crest and properly abandon the blocked piezometer.
