Inspection Report

Property Address:
4901 Buchanan Ave SW
Wyoming MI 49548

Acuity Inspection Professionals, LLC

General Repair Summary

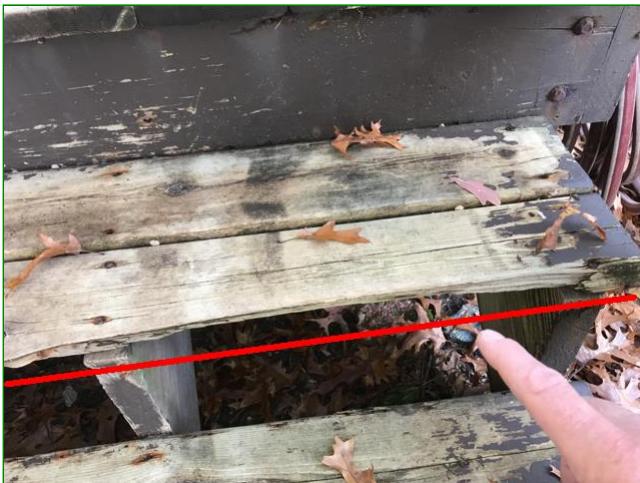
1 (2) The side porch had a broken edge on one of the wood steps. The damaged board should be replaced.

Item 1 - Broken Step Edge

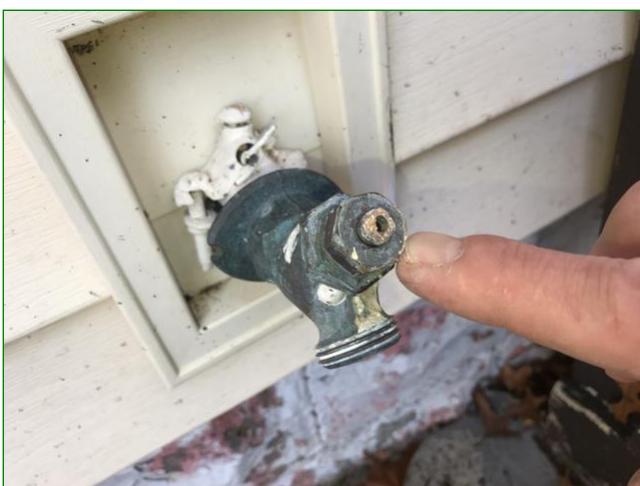
2 The exterior water spigot appeared to be in good working condition. However the exterior spigot had a broken valve handle and could not be tested in operation. The valve needs to be examined and repaired or replaced.

Item 2 - Missing Spigot Handle

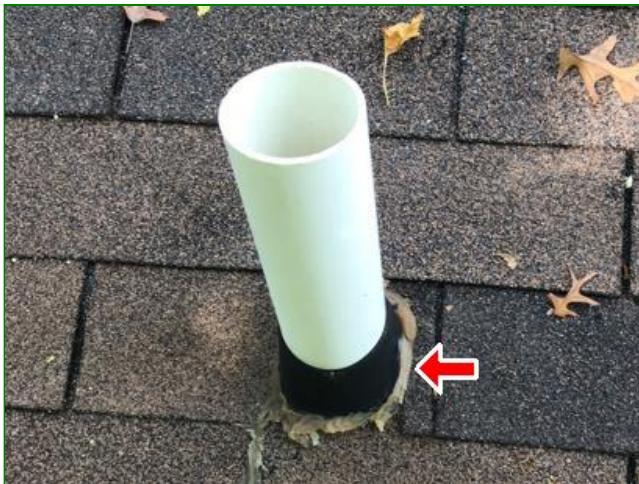
3 The roof penetrations were intact and did not appear to have leak points at this time. However the boot on the pipe vent was improperly installed and was surrounded by shingles. This type of installation can create a condition for entrapping water beneath the shingles at the pipe. Consequently the area around the boot had to be sealed with silicone

caulk. Consideration should be given to reinstalling the pipe boot to permit water to flow freely away from the pipe vent penetration.

Item 3 - Caulked Pipe Vent

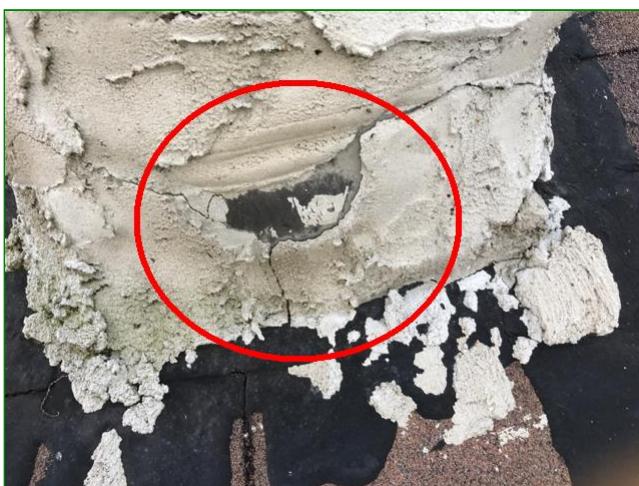
(2) The chimney brick was coated with a stucco like material. *The stucco was cracking and chipping away in a number of areas. The chimney surfaces should be examined and repaired or resurfaced.*

Item 4 - Deteriorating Stucco

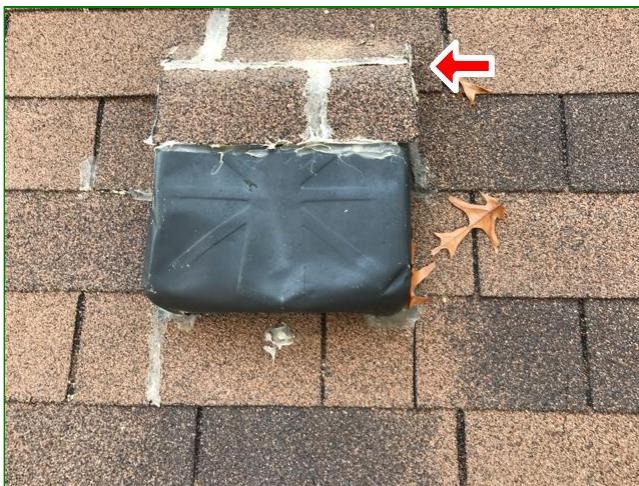
(2) The roof vents were intact. *However the vents were improperly and crudely installed. Although there did appear to be any leaking at this time. Consideration should be given to reinstalling the roof vents properly.*

Item 5 - Improperly Installed Roof Vent

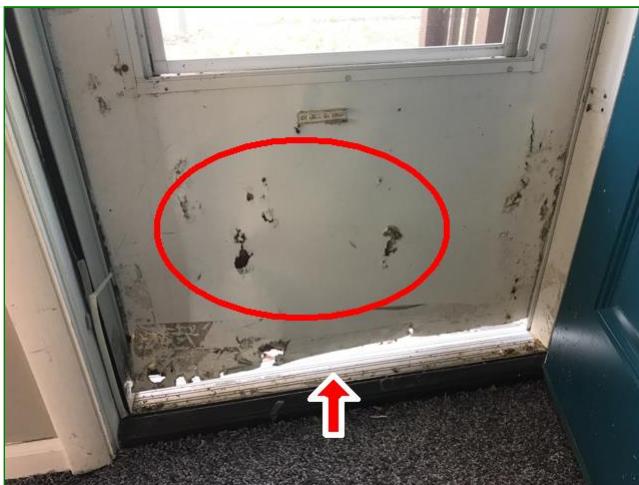
6 (2) **The bottom panel of the front storm door was damaged. The door should be replaced.**

Item 6 - Damaged Storm Door

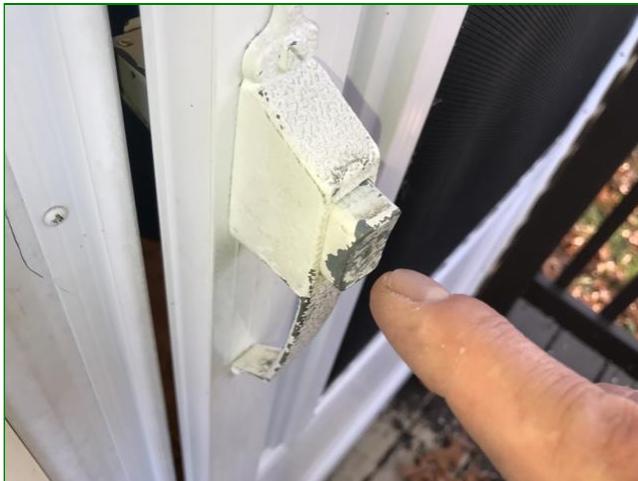
7 (2) **The storm door was intact and in relatively good condition. However the door handle was broken and malfunctioning. The door handle should be examined and repaired or replaced.**

Item 7 - Damaged Exterior Handle

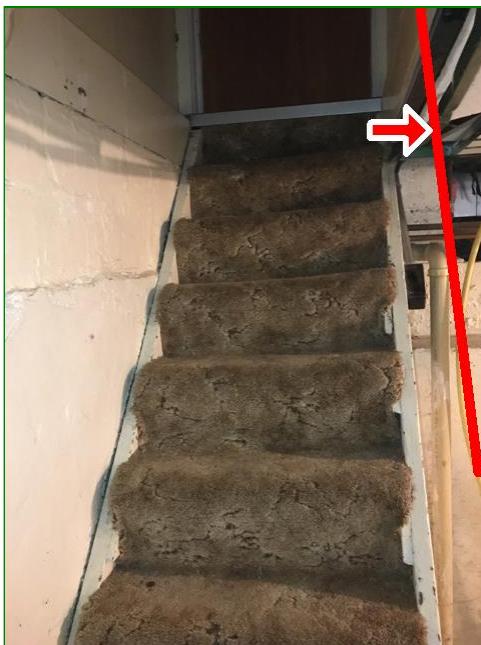
9 **The steps and stairway were secure, solid and in good condition. However there was no handrail attached. Handrails are necessary on staircases as a safety code requirement. We recommend installing a secure handrail approximately 30 inches above the step surfaces.**

Item 9 - Proposed Handrail

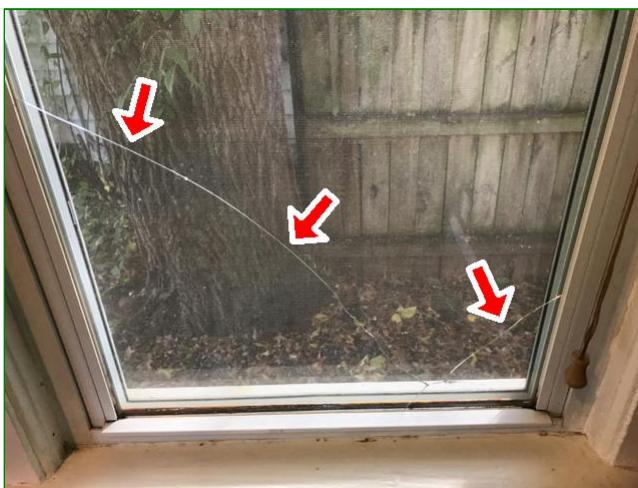
10 (2) The window on the south east corner was cracked. The broken glass should be replaced.

Item 10 - Broken Window Pane

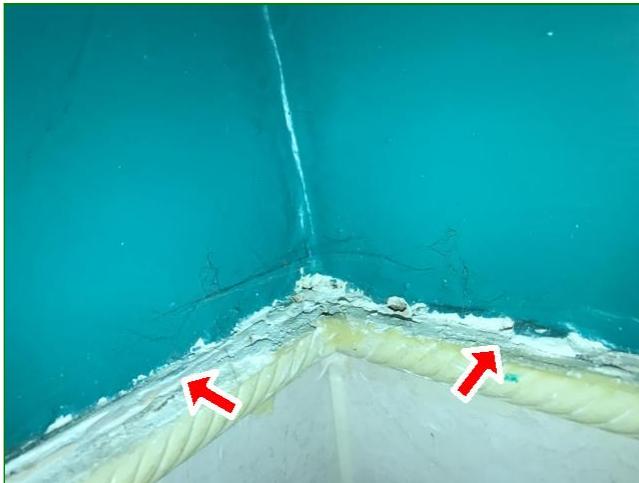
11 (2) The caulk sealant along the top edge of the shower surround walls was poorly installed and deteriorating. The silicone caulk should be applied around the seams where the walls meet the shower surround.

Item 11 - Deteriorating Caulk

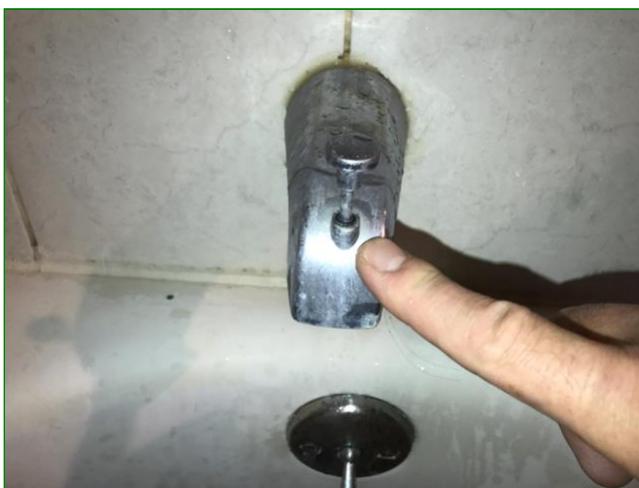
12 (3) The water flow diverter of the tub spout was stuck in the shower head position. Consequently the spout could not be used to fill the bath tub. The spout needs to be examined and repaired or replaced.

Item 12 - Stuck Water Flow Diverter

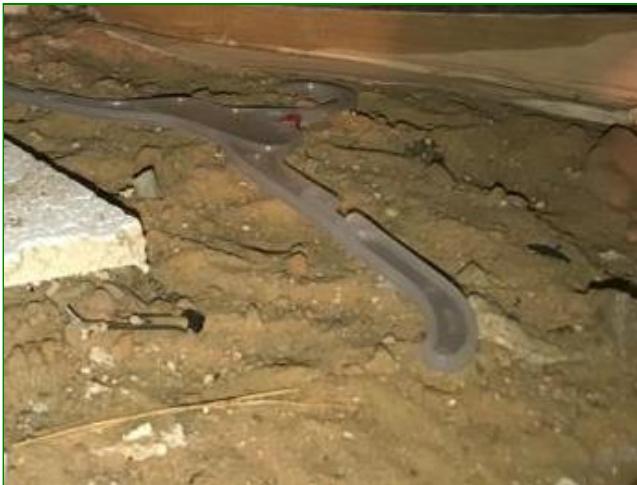
13 The crawl space floor did not have any vapor barrier. The dirt floor should be lined with a plastic sheeting throughout. NOTE: Vapor barriers protect the crawl space from moisture leaching up from the ground and creating an environment where fungal organisms can breed. Some fungal organisms are health hazards.

Item 13 - Missing Vapor Barrier

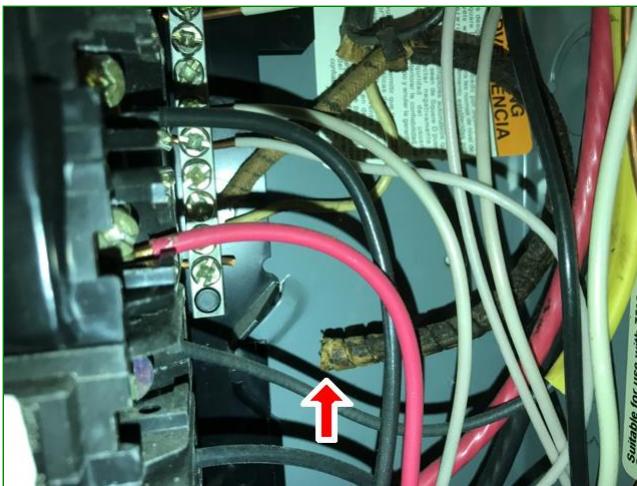
14 (2) There was a 6" long section of wire with an exposed uncovered end. The wire was terminated at the neutral bar of the panel. **Unterminated wires inside an electrical panel could cause arcing and are potential safety concerns. The wire should be removed from the electrical panel.**

Item 14 - Exposed Wire End

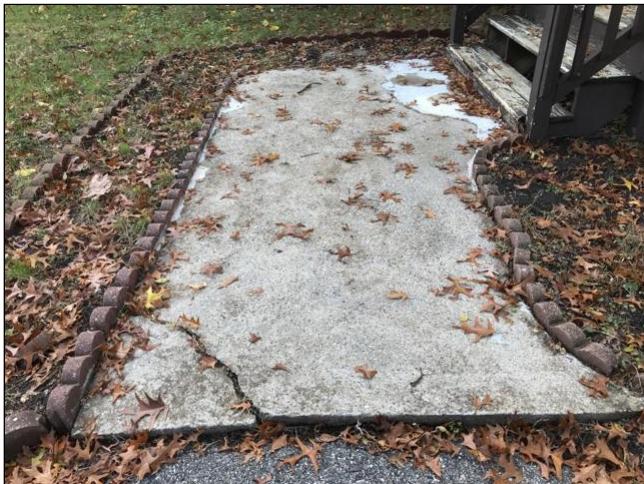
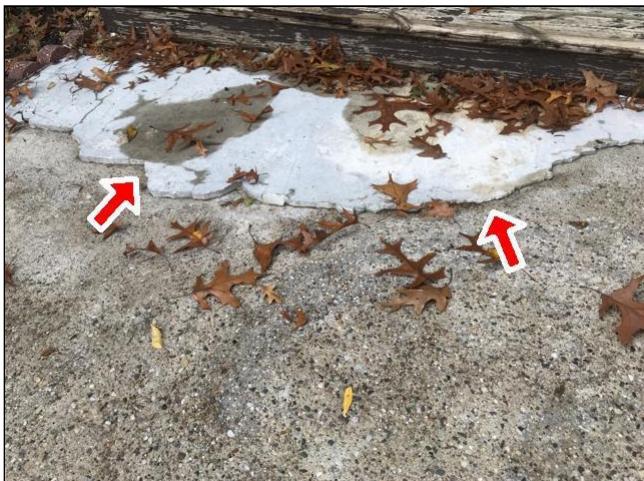
1.1 The front concrete walkway was in relatively good solid condition with some defects. **If possible the defective areas should be examined and repaired to prevent further deterioration.**

1.1 Front Walkway

1.1 Poor Surface Patch

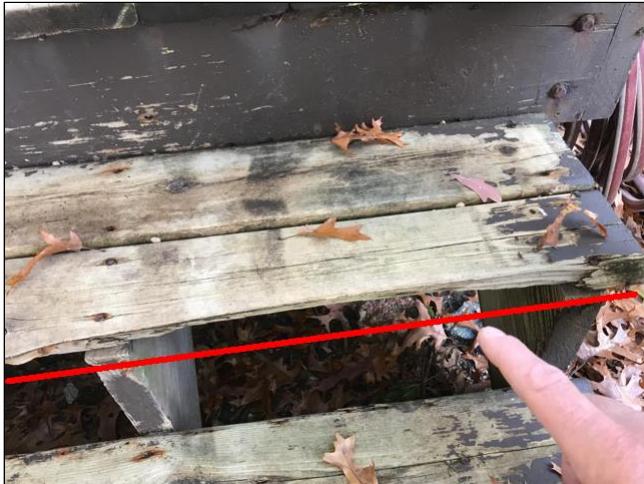
(2) The side porch had a broken edge on one of the wood steps. The damaged board should be replaced.

1.3 Broken Step Edge

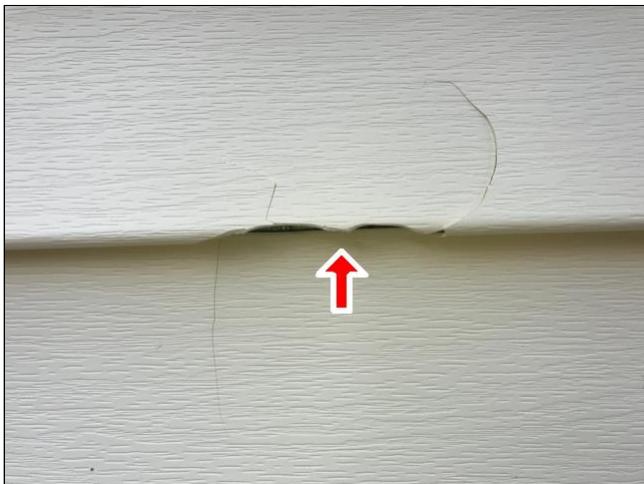
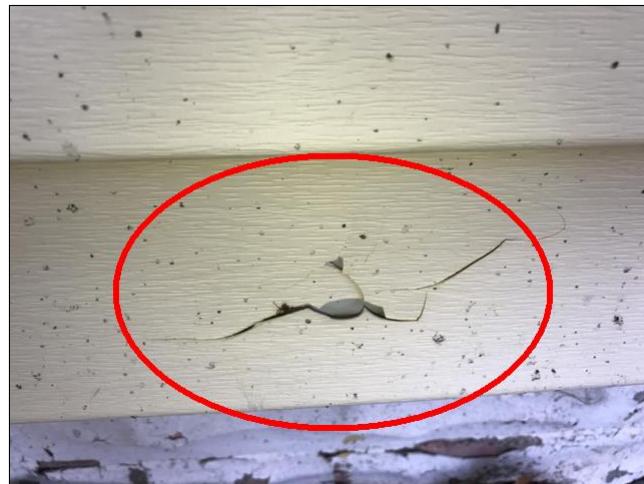
(2) The exterior siding had some minor defects. The defects appeared to be primarily cosmetic and did not affect the stability of the siding.

1.4 Chipped Siding

1.4 Cracked Siding

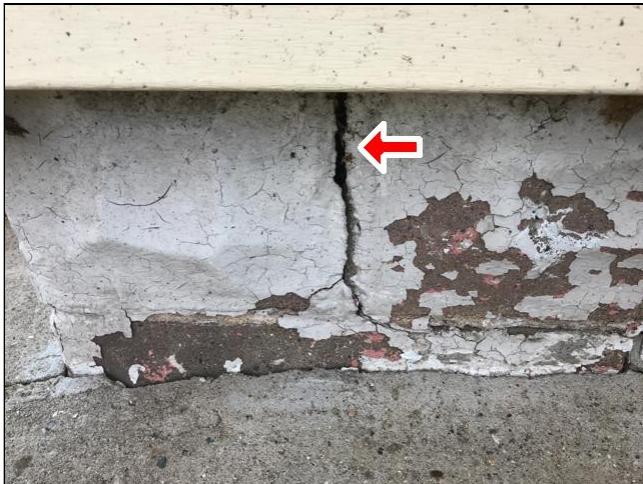
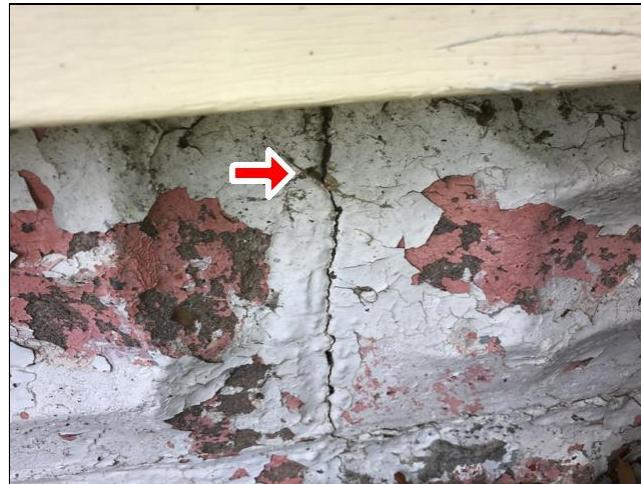
1.12 Viewed from the exterior, the foundation appeared to be in relatively good solid condition with no visible evidence of consequential water penetration. **However the foundation had a number of areas that had cracks. Although the cracks did not appear to affect the structural integrity of the foundation at this time. NOTE: All foundation cracks and gaps should be filled and sealed whenever found to prevent moisture intrusion and further deterioration.**

1.12 Foundation Crack

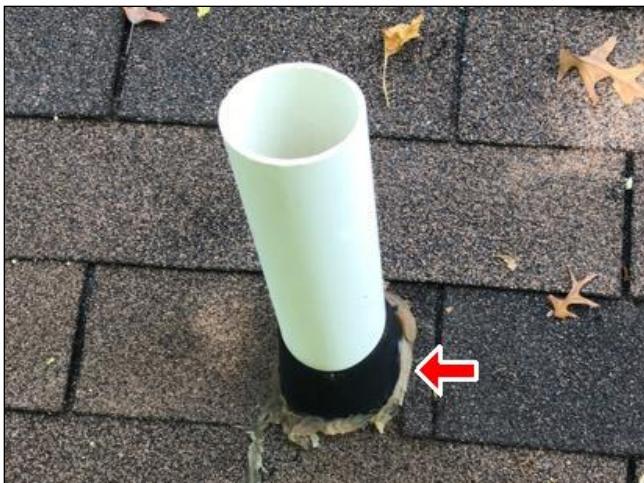
2.3 The roof penetrations were intact and did not appear to have leak points at this time. However the boot on the pipe vent was improperly installed and was surrounded by shingles. This type of installation can create a condition for entrapping water beneath the shingles at the pipe. Consequently the area around the boot had to be sealed with silicone caulk. Consideration should be given to reinstalling the pipe boot to permit water to flow freely away from the pipe vent penetration.

2.3 Caulked Pipe Vent

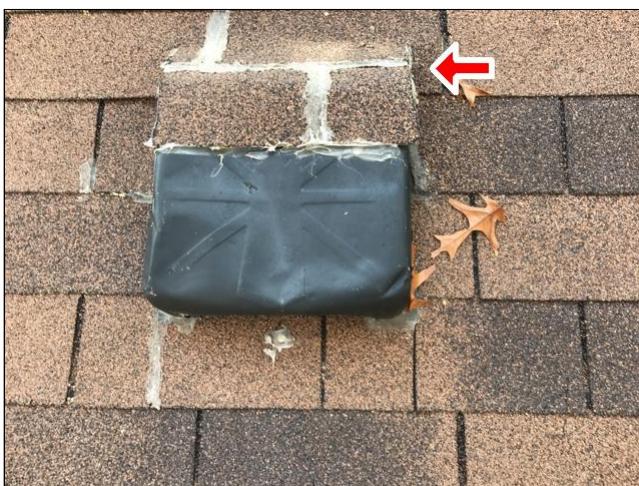
**(2)** The roof vents were intact. However the vents were improperly and crudely installed. Although there did appear to be any leaking at this time. Consideration should be given to reinstalling the roof vents properly.

2.6 Improperly Installed Roof Vent

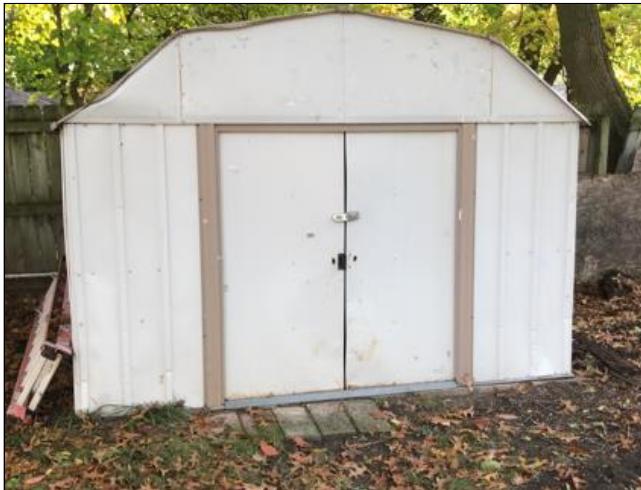
3.0 There was a shed on the property. The shed was not requested to be inspected. **However, from the exterior the shed appears to be in good condition with no major defects.**

3.0 Metal Yard Shed

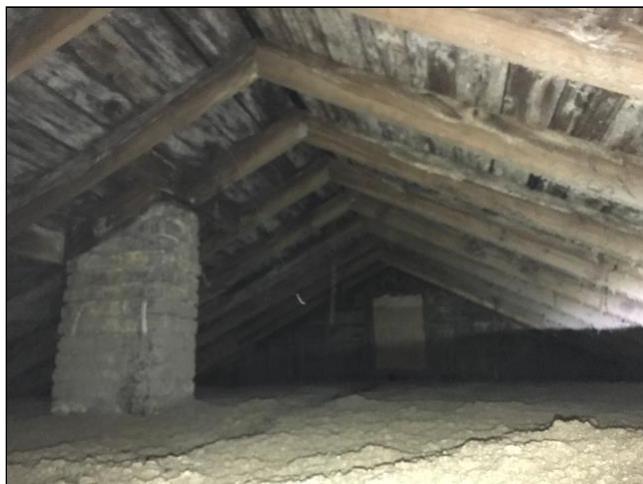
4.1 The interior attic structure was in good solid condition with no evidence of water penetration or damage. It appeared to be properly constructed and provides ample roof support.

4.1 Attic Structure

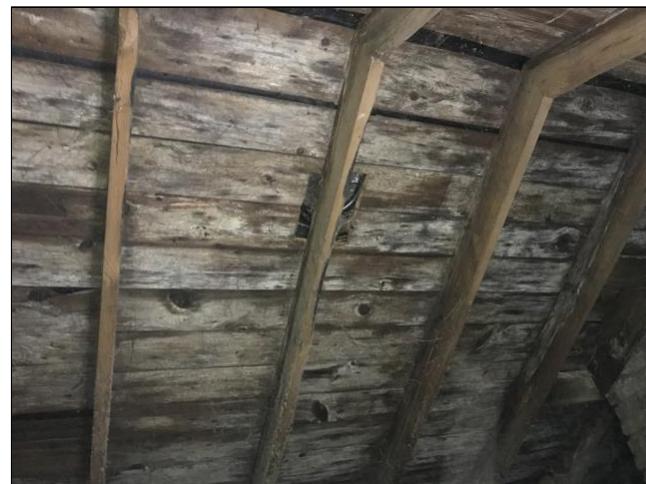
4.1 Roof Structure

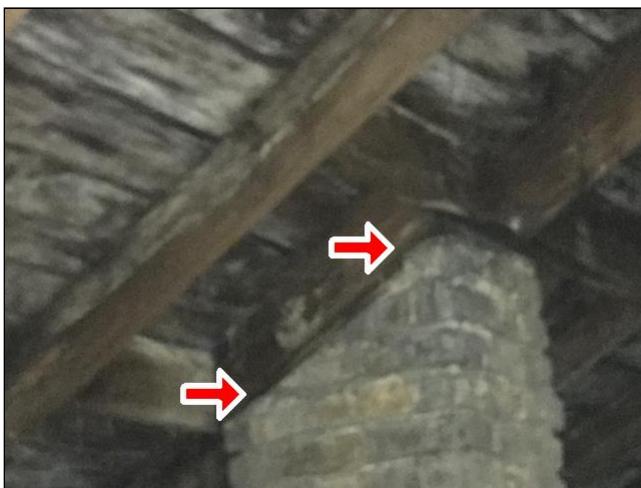
4.2 The attic penetrations were in good secure condition with no evidence of recent water penetration.

4.2 Chimney Penetration

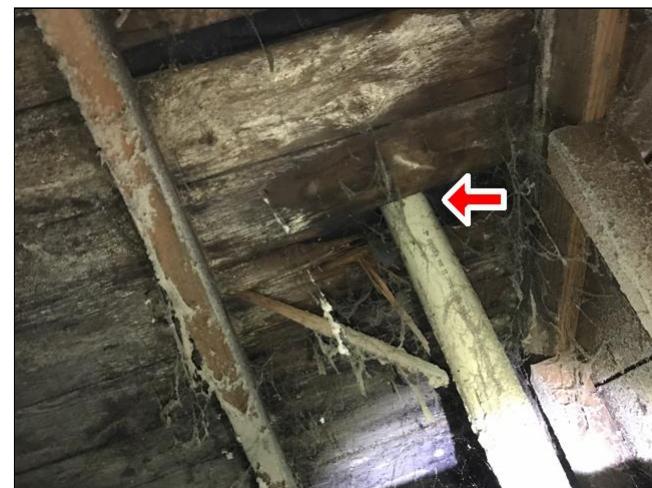
4.2 Pipe Vent Penetration

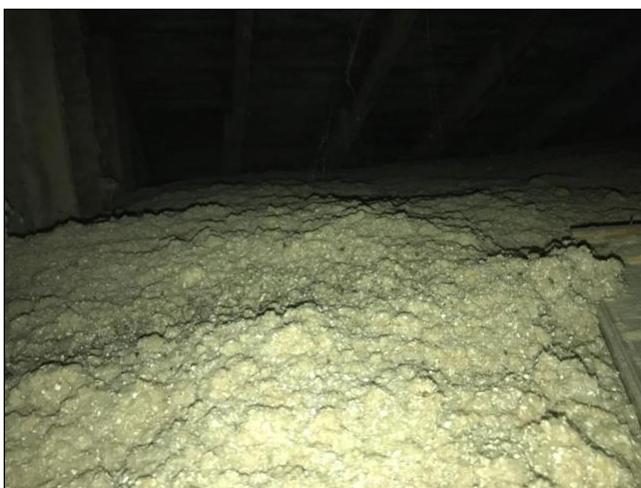
4.3 The attic insulation was a blown in Cellulose insulation and is about eight inches thick or just over 29 R-Value.

4.3 Cellulose Insulation

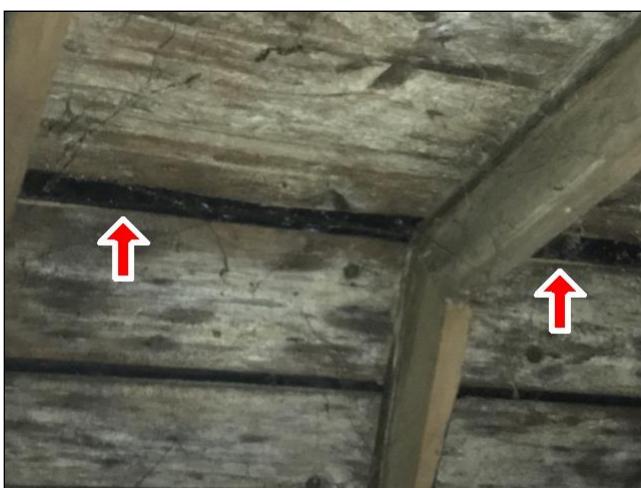
4.4 The attic ventilation was unobstructed and in good condition.

4.4 Ridge-vent Openings

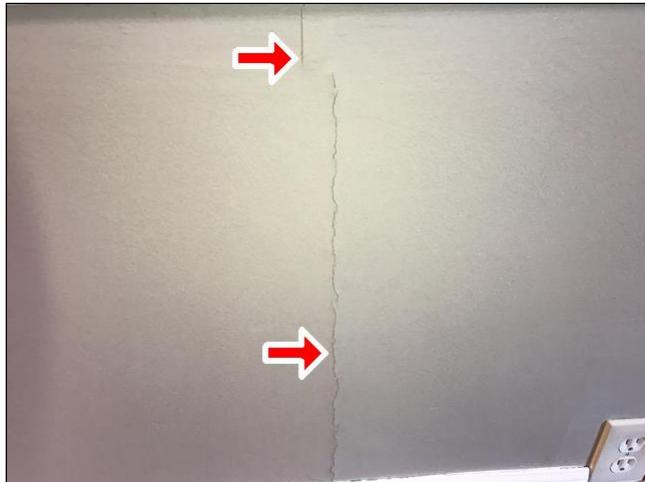
5.2 The walls were in relatively good condition with cosmetic defects.

5.2 Wall Crack

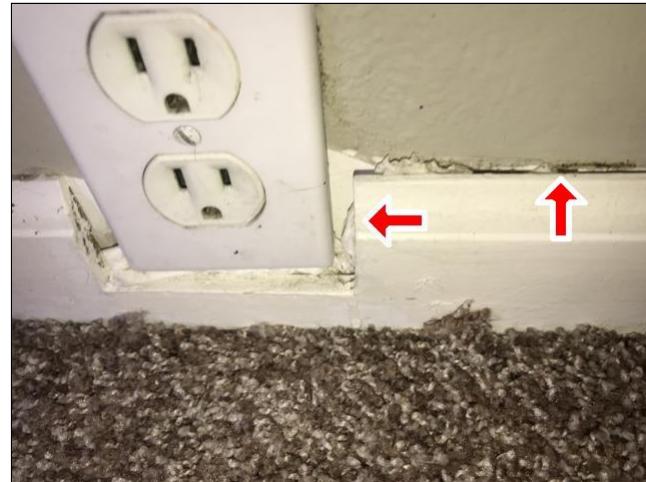
5.2 Crudely Installed Trim & Wall Cracking

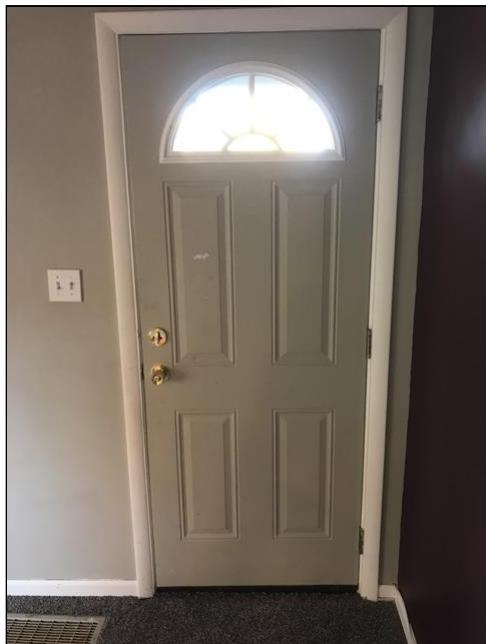
5.3 (1) The front entrance door from the exterior of the house was in good operable and lockable condition with no apparent defects.

5.3 Front Entrance Door

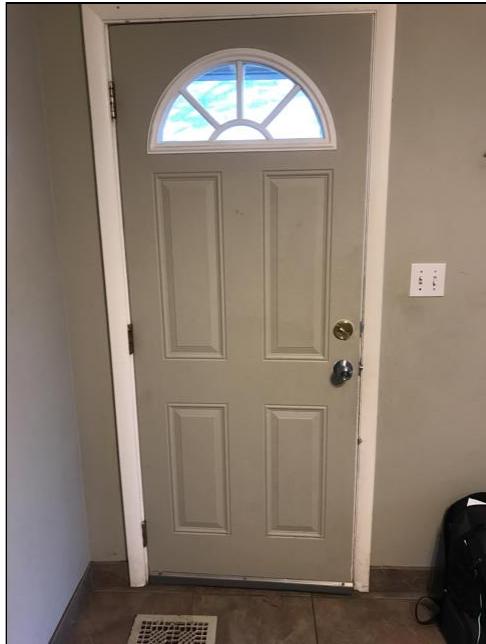
6.5 (1) The exterior entrance door was in good working and lockable condition with no apparent defects.

6.5 Exterior Entrance Door

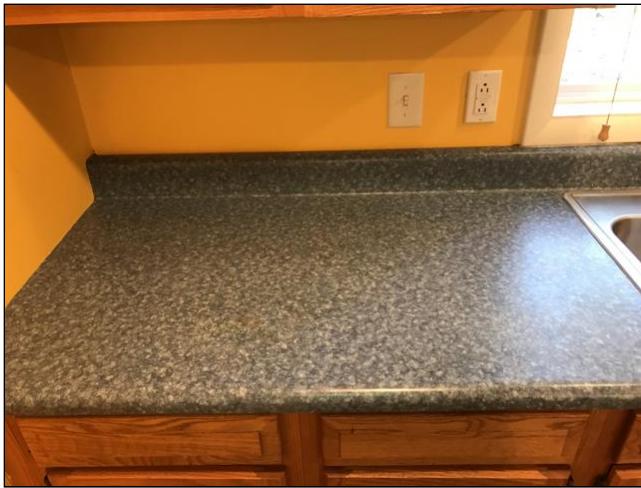
6.8 (1) The counter tops were in good solid condition with no major defects.

6.8 Counter Tops

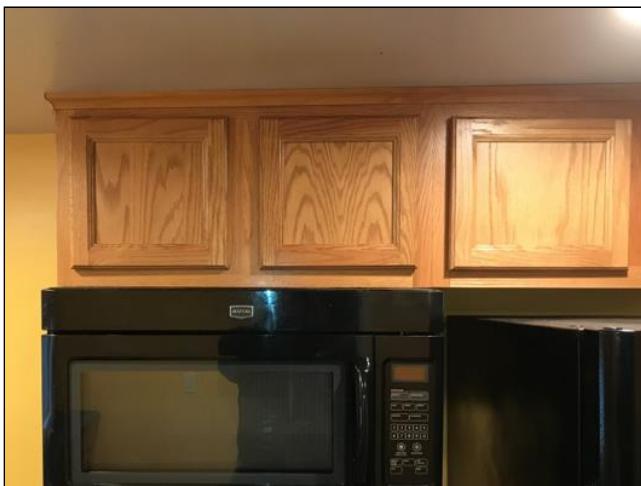
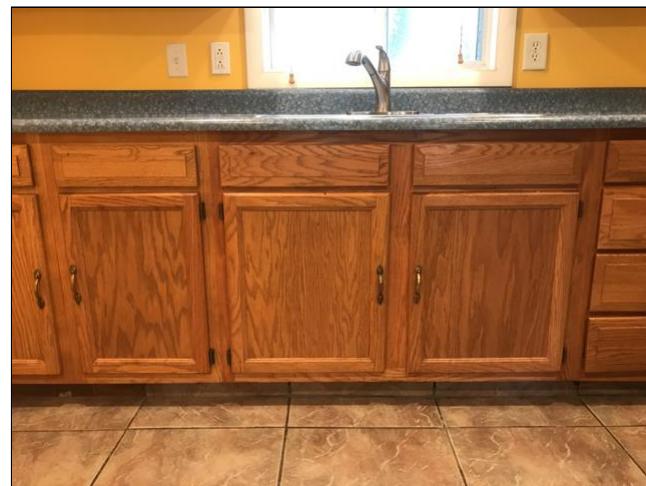
(2) A representative number of cabinets doors and drawers were inspected. They were in good working order.

6.8 Kitchen Cupboards

6.8 Kitchen Cabinets

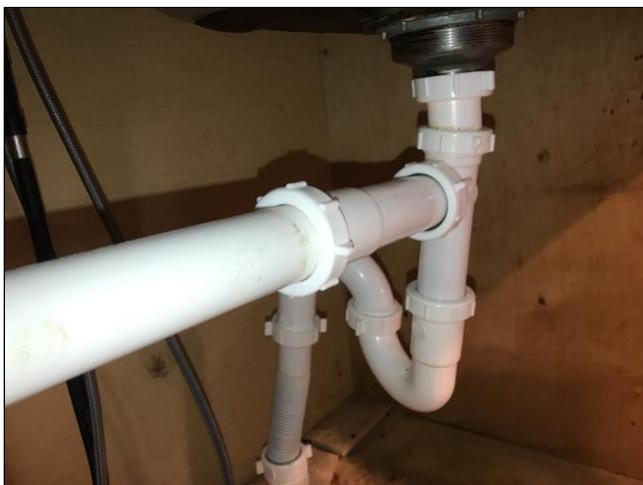
6.9 The kitchen plumbing drain and vent systems were in good working condition and appeared to have proper drainage.

6.9 Sink Drains

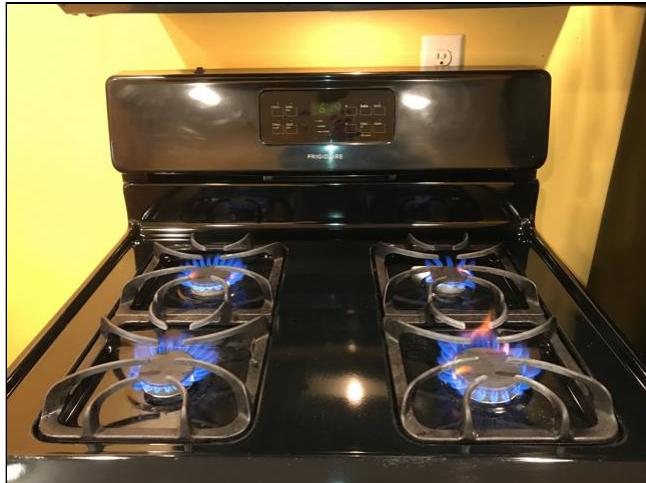
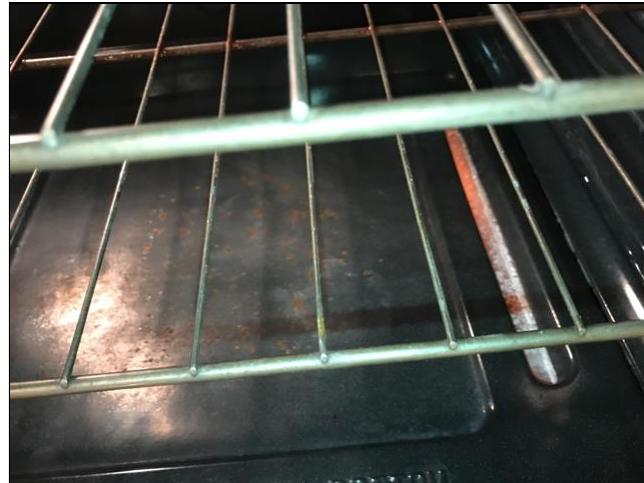
6.12 The Range/Oven/Cooktops were in good working order. A representative number of settings were tested and no apparent defects were found.

6.12 Range Top

6.12 Functional Oven

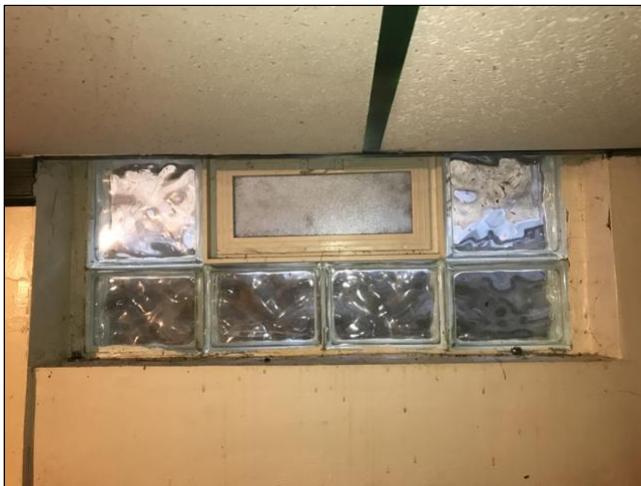
7.4 The basement window appears to be intact with no apparent defects.

7.4 Basement Window

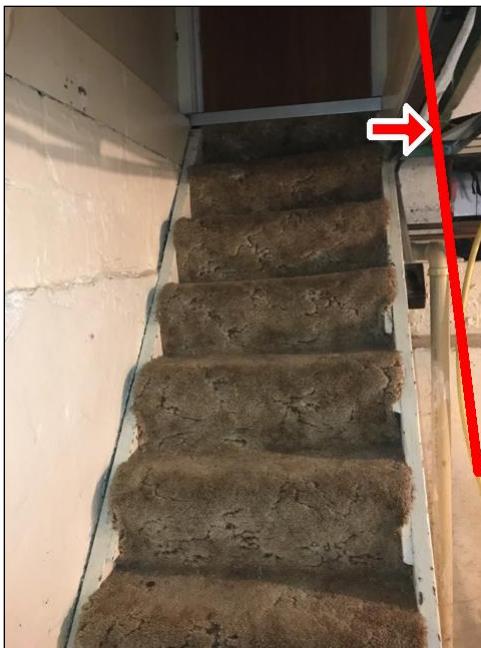
7.7 The steps and stairway were secure, solid and in good condition. However there was no handrail attached. Handrails are necessary on staircases as a safety code requirement. We recommend installing a secure handrail approximately 30 inches above the step surfaces.

7.7 Proposed Handrail

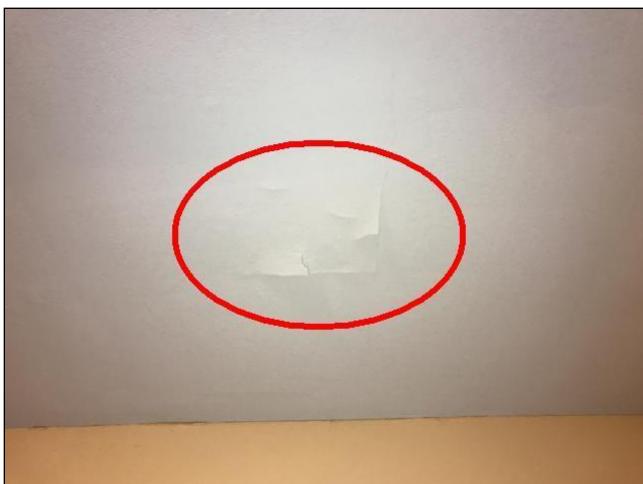
8.1 (1) The bedroom ceiling was in relatively good condition with cosmetic defects.

8.1 Flaking Ceiling Surface

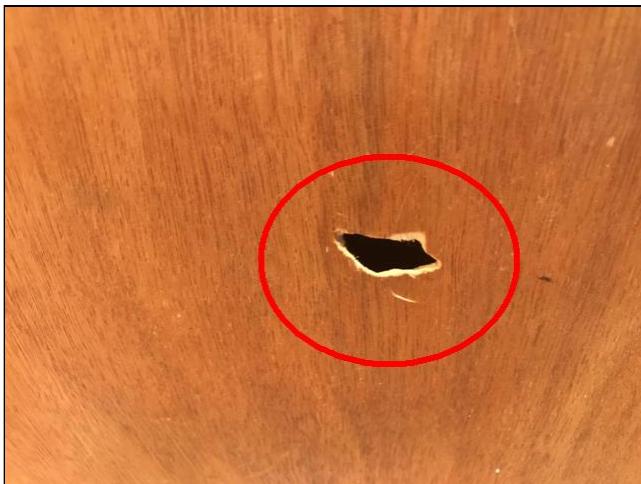
(2) ***There was a puncture hole in bathroom door surface. Consideration should be given to patching or replacing the door.***

10.5 Puncture Hole

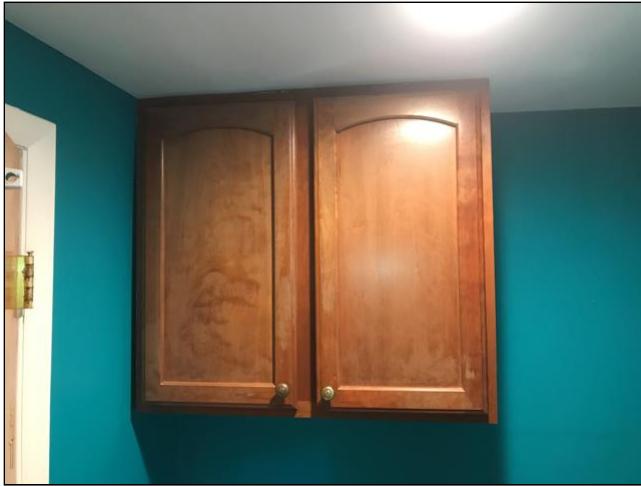
10.9 The cupboard was in good condition with no apparent defects.

10.9 Bathroom Cupboard

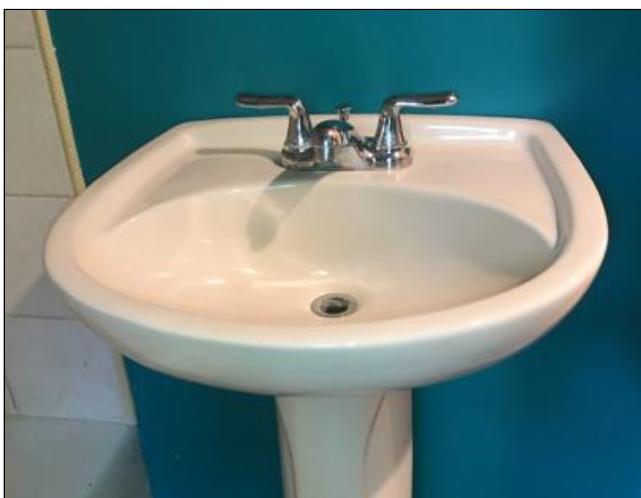
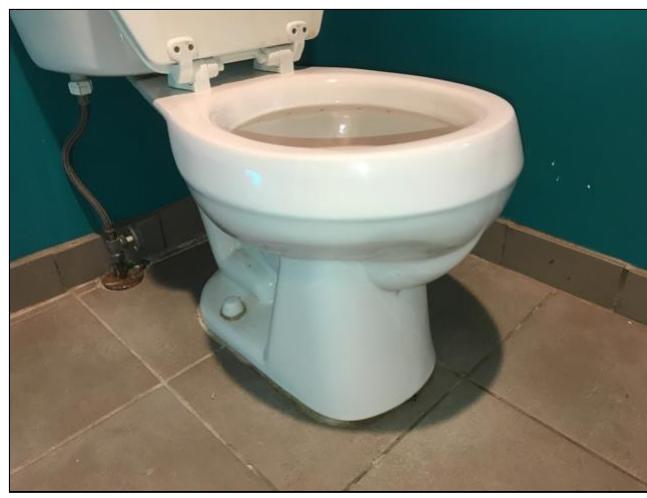
10.10 (1) The plumbing fixtures in the bathroom were in good working order with no apparent defects. The sink and toilet fixtures were in good working condition with no apparent leaks or defects.

10.10 Pedestal Sink

10.10 Toilet

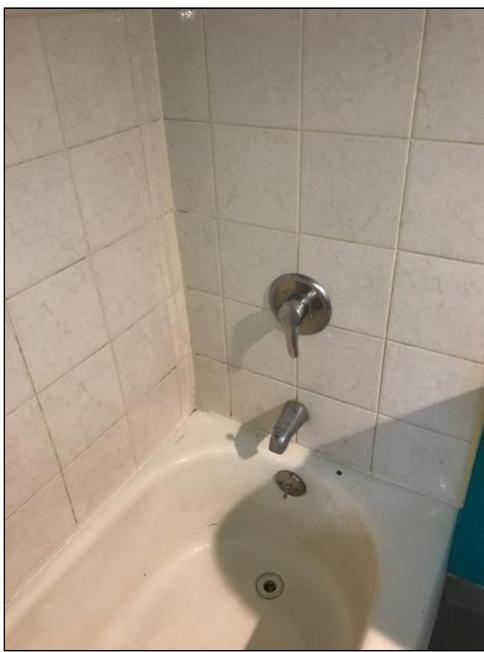
(2) The tub and shower fixture was in good working condition with no apparent leaks or defects.

10.10 Tub & Shower

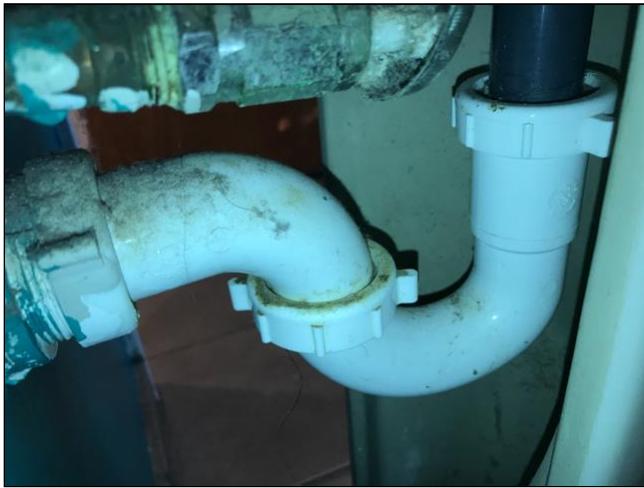
10.12 The bathroom plumbing drain and vent systems were in good working condition with proper drainage.

10.12 Sink Drain

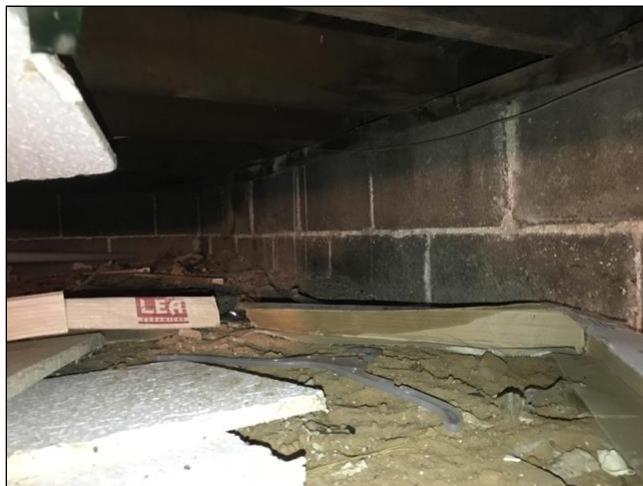
11.1 The crawlspace was under the addition off the rear of the house. The crawl space was concrete block walls with a dirt floor and open floor joist overhead surfaces.

11.1 Crawl Space

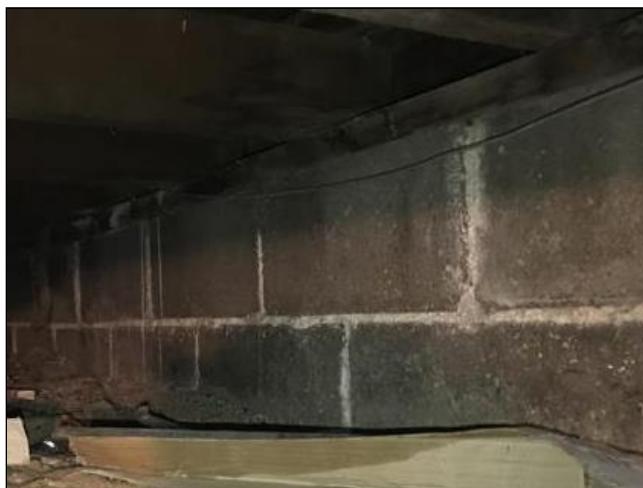
11.3 The foundation walls were concrete blocks and mortar and were in good plumb condition with no evidence of water penetration.

11.3 Block Wall

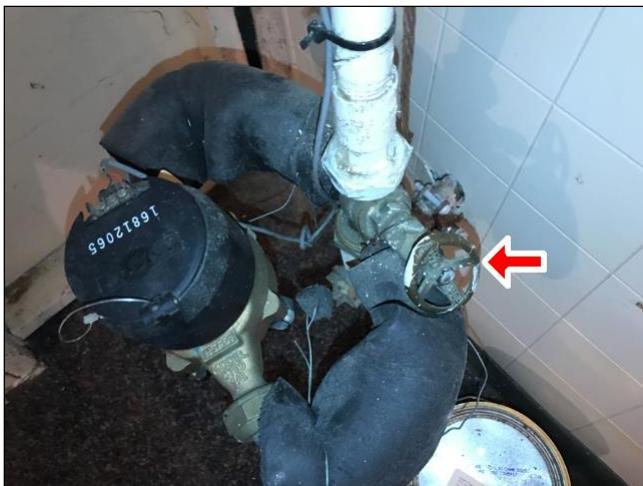
12.1 The main water shut off valve was located at the base of the water meter. The meter was located in the basement.

12.1 Main Water Valve

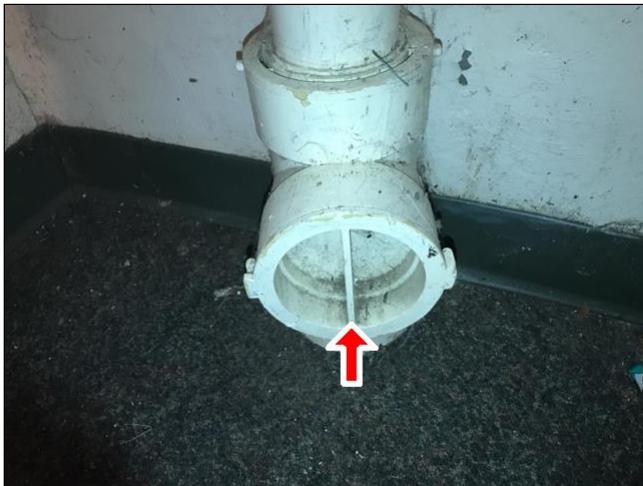
12.2 The waste and drain lines were PVC and in good secure condition. The drain lines had accessible clean out points and the lines appeared to be properly installed and properly sloped to provide adequate drainage.

12.2 Drain Clean-out

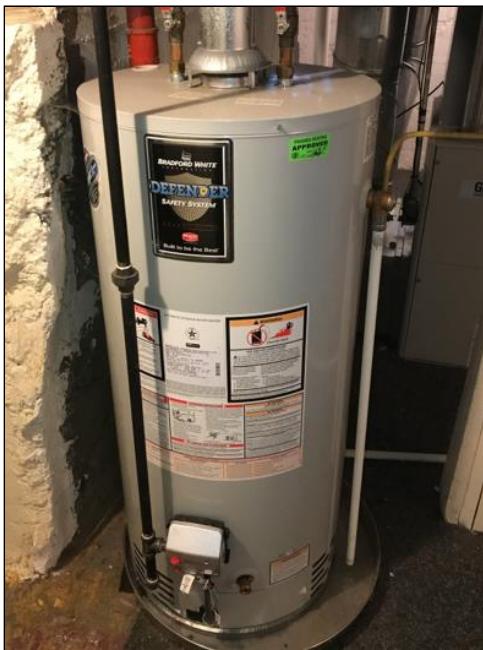
12.4 (1) The water heater, water supply, and gas venting were in good secure condition with no evidence of leaks or improper installation. The pressure release valve drained properly to within 6" of the floor.

12.4 Water Heater

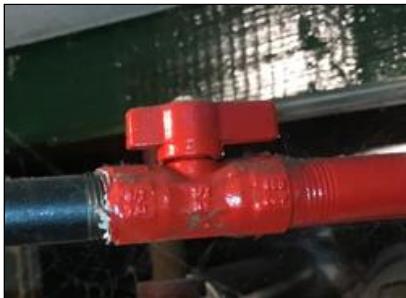
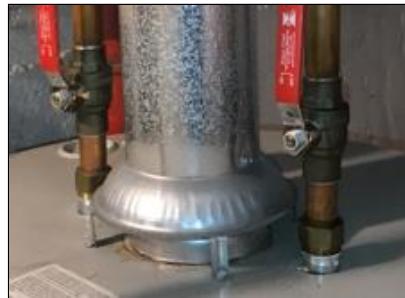
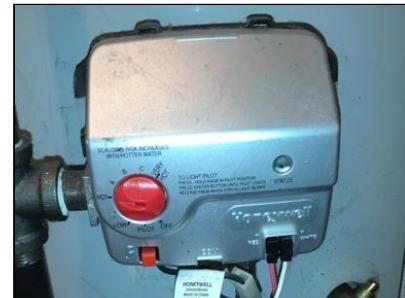
(2) The components of the water heater all appeared to be in good operable condition with no apparent defects.

12.4 Gas Valve

12.4 Exhaust Stack

12.4 Exhaust Inducer

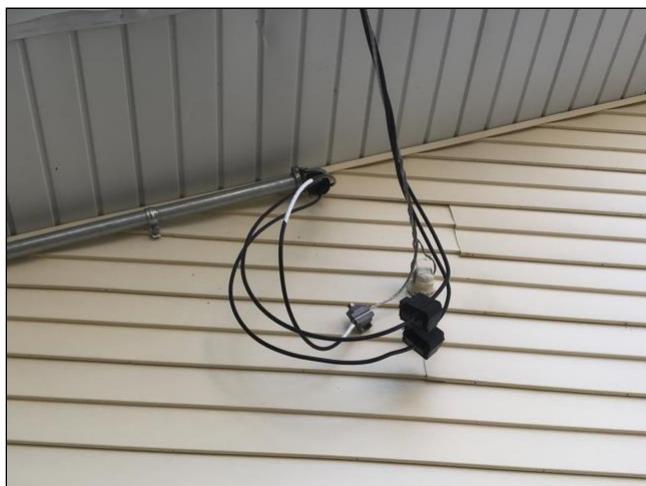
13.0 Service Mast

13.0 The main overhead service entrance conductors were in good clean and secure condition with no evidence of overloading or overheating.

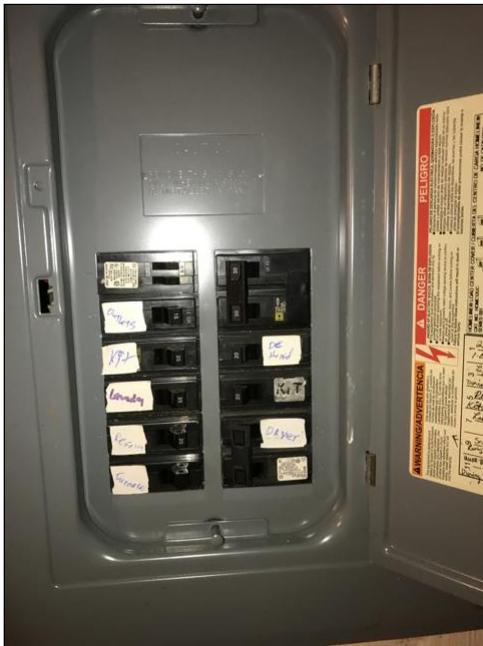
13.1 Breaker Panel

13.1 The main electrical distribution panel was located in the basement. The panel was 100 amp panel with no spare spaces for additional expansion.

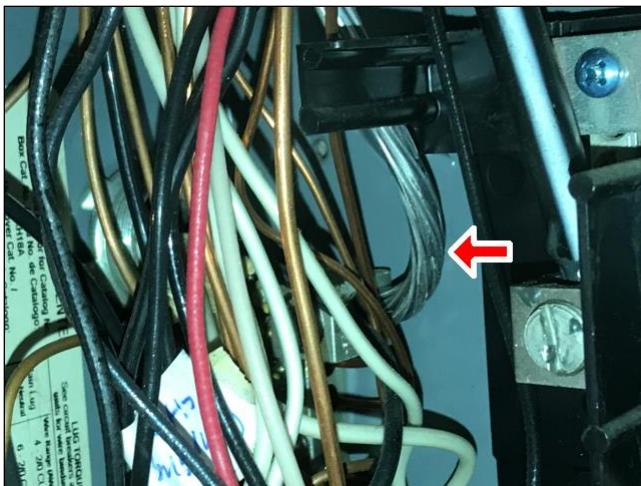
13.2 Ground Wiring

13.2 The main grounding wires were in good secure and clean condition.

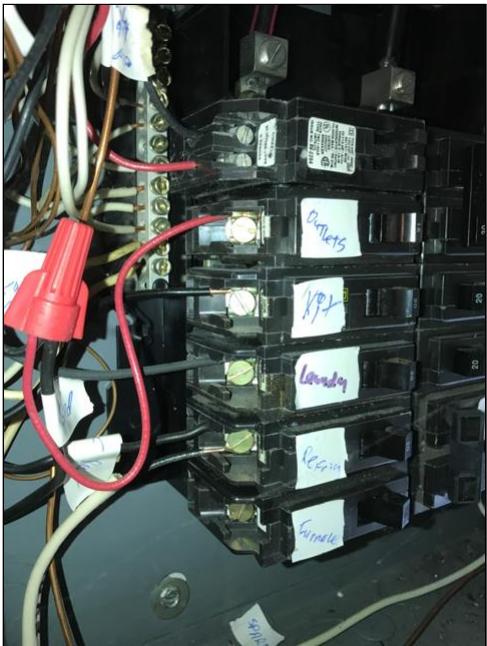
13.3 Breaker Circuits (Left Bank)

13.3 (1) The breakers and their associated circuit wires were in good secure condition. The breakers were properly sized for the attached circuit wires.

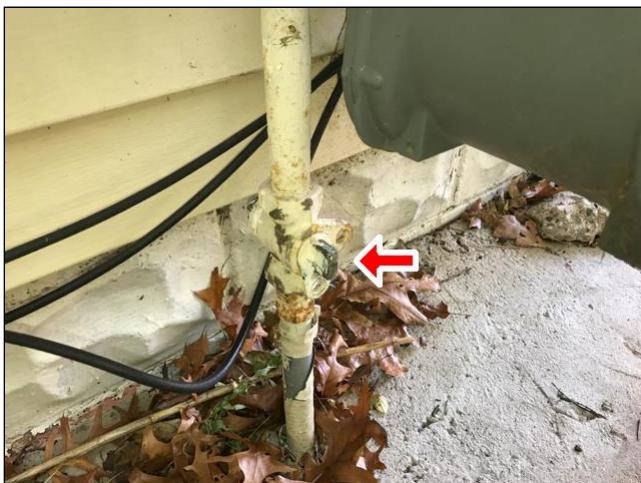
14.0 Main Gas Valve

14.0 The main fuel shut off was at the gas meter outside.

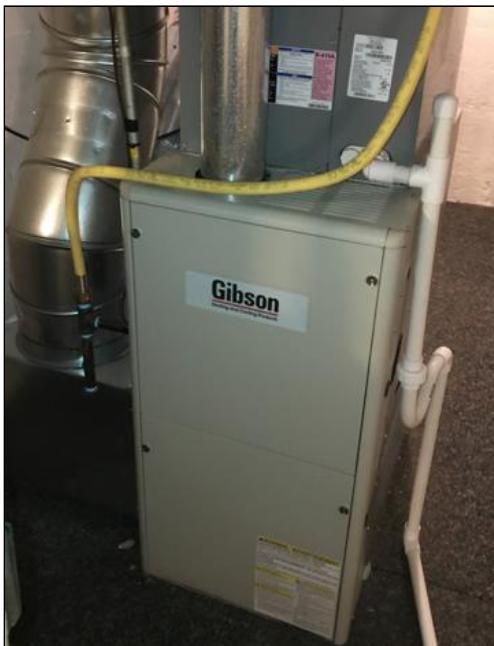
14.1 Furnace

14.1 The heating for this house is via a natural-gas forced-air system.

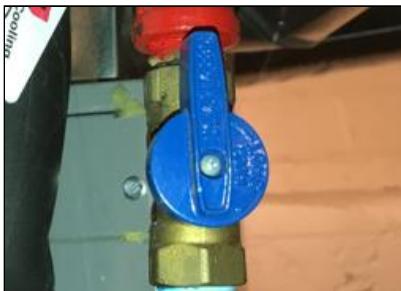
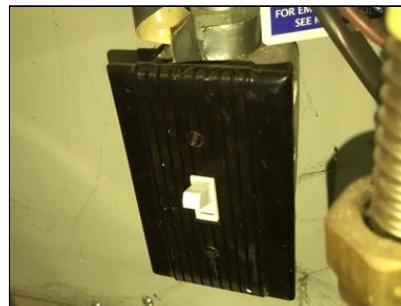
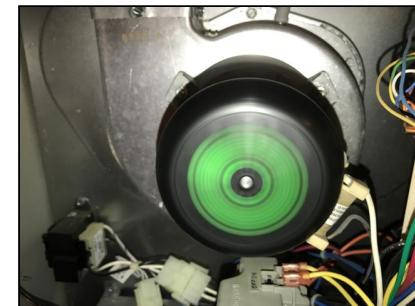
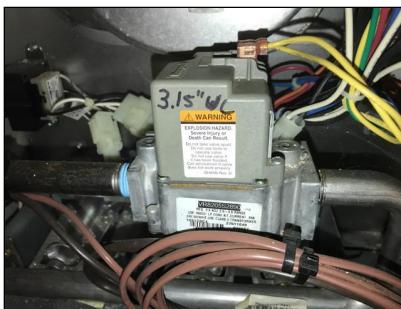
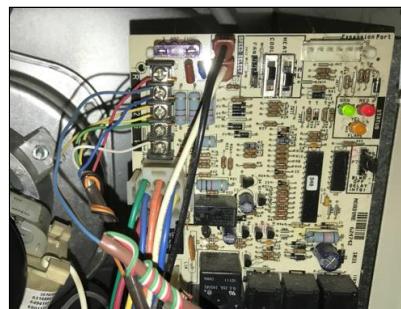
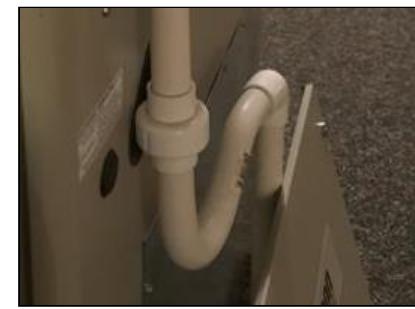
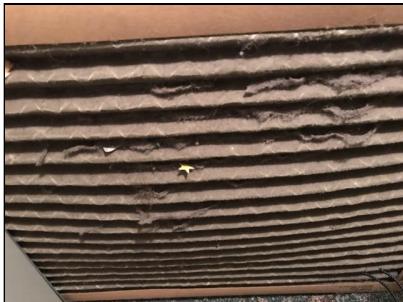
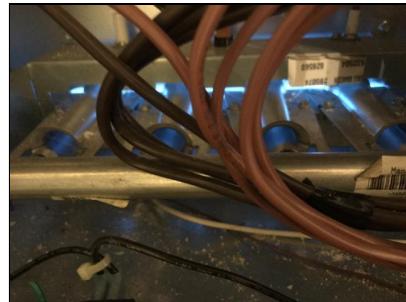
14.2 The components of the furnace all appeared to be in good operable condition with no apparent defects.

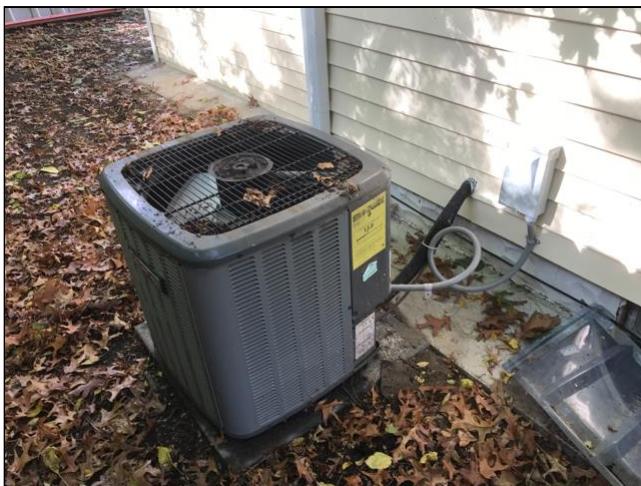
14.3 AC Condenser

14.3 The exterior condenser appeared to be in good condition. The coolant line appeared to be properly insulated and the electrical safety switch was within sight of the condenser. **NOTE: The air conditioning was not tested in operation because operating it when the outdoor temperature is below 65 degrees could damage the system.**
