Inspection Report

Property Address:
4901 Buchanan Ave SW
Wyoming MI 49548

Acuity Inspection Professionals, LLC

General Repair Summary

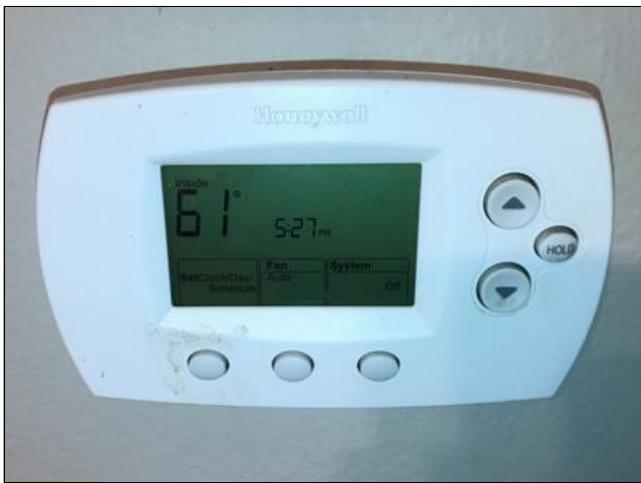
14.4 Thermostat

14.4 The thermostat is a programmable thermostat in good working condition.

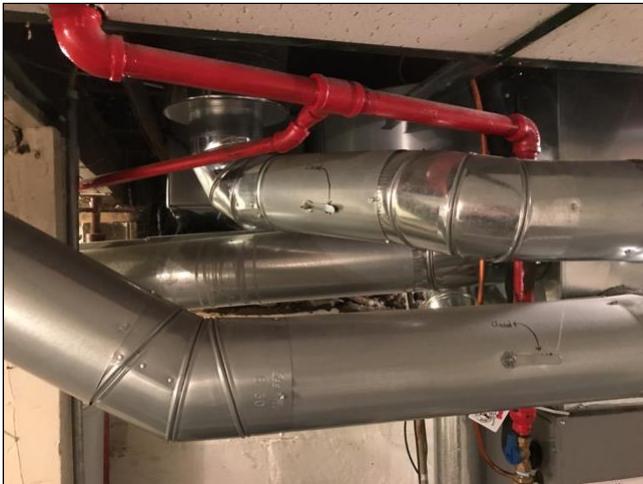
14.6 HVAC Duct System

14.6 The HVAC duct work appeared to be in good secure condition.

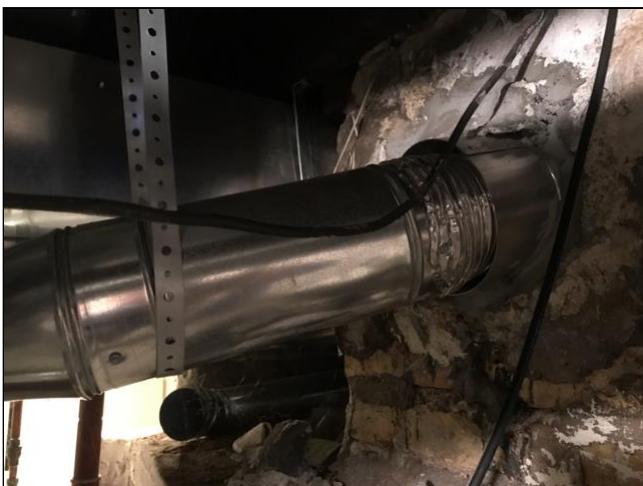
14.7 Furnace Exhaust Stack

14.7 The exhaust vent appeared to be in good secure condition with no evidence of leakage or improper installation.

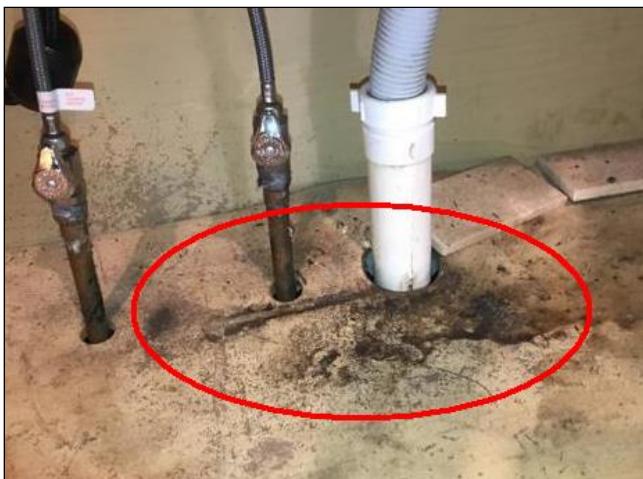
15.1 Organic Fungal Material

15.1 Evidence of organic material was found under the kitchen sink. **NOTE: Organic fungal growth in a house is a potential health hazard. An analysis of the fungus was not requested by the buyer.** Regardless of the variety or strain of the fungus it should be removed and eradicated.
