INSPECTION REPORT

For the Property at:
2048 WALKER AVENUE
PETERBOROUGH, ON

Prepared for: TEAM VANRAHAN
Inspection Date: Tuesday, June 8, 2021
Prepared by: David Sharman

RE: Report No. 3509
2048 Walker Avenue
Peterborough, ON

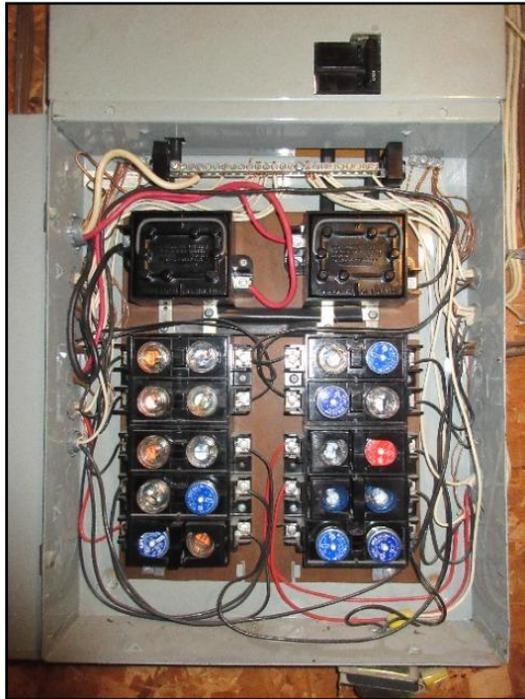
8. Fuses - utility room

6. Condition: • Fuses too big

Implication(s): Equipment overheating | Fire hazard

Time: As soon as is practicable

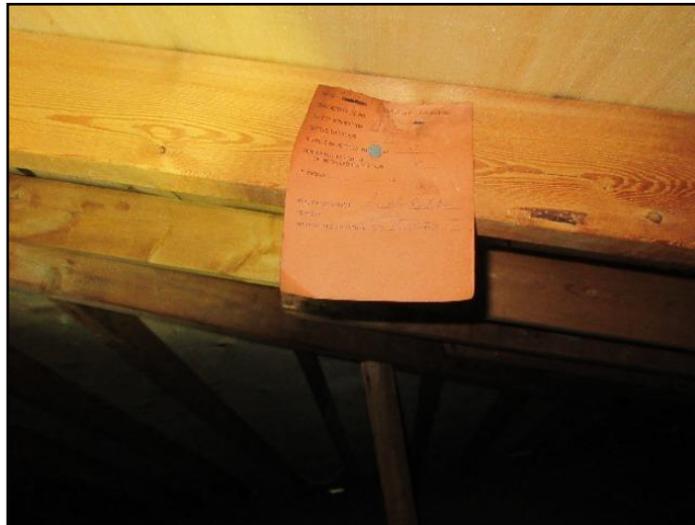
23. R-28

12. Condition: • Amount less than current standards

Although not meeting current standards is not a deficiency, the home may benefit from an increased level of attic insulation.
