INSPECTION REPORT

For the Property at:
42B SPRINGBROOK DRIVE
PETERBOROUGH, ON

Prepared for: TEAM VANRAHAN
Inspection Date: Saturday, May 1, 2021
Prepared by: David Sharman

RE: Report No. 3442
42B Springbrook Drive
Peterborough, ON

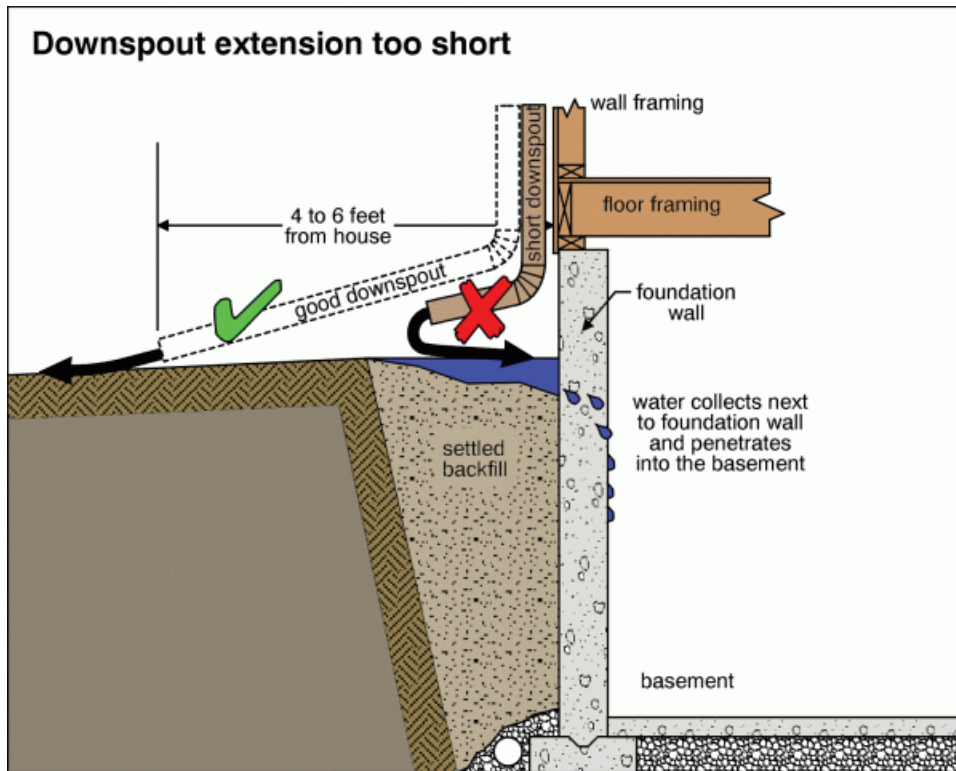
2. Condition: • Discharge too close to building

Implication(s): Chance of water damage to structure, finishes and contents

3. Discharge too close to building

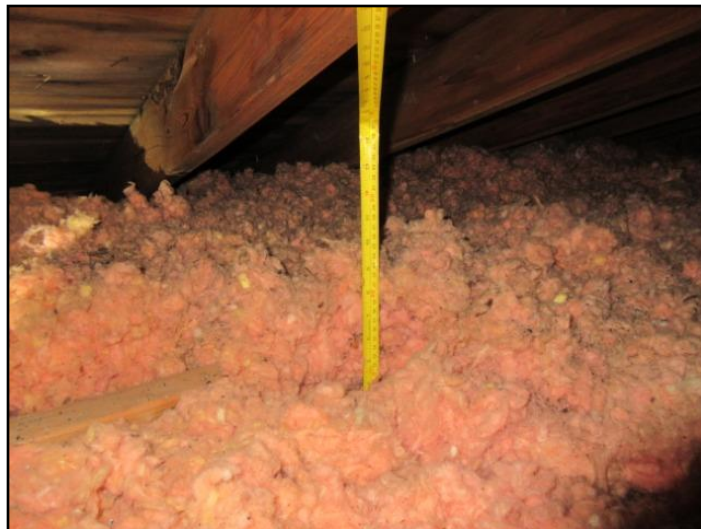
17. *9 inches*

10. Condition: • Amount less than current standards

Although not meeting current standards is not a deficiency, the home may benefit from an increased level of attic insulation.

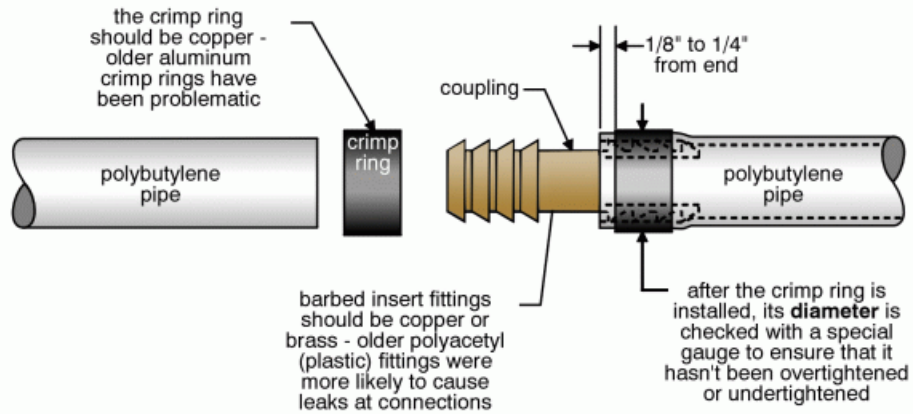
Polybutylene pipe - crimp fitting

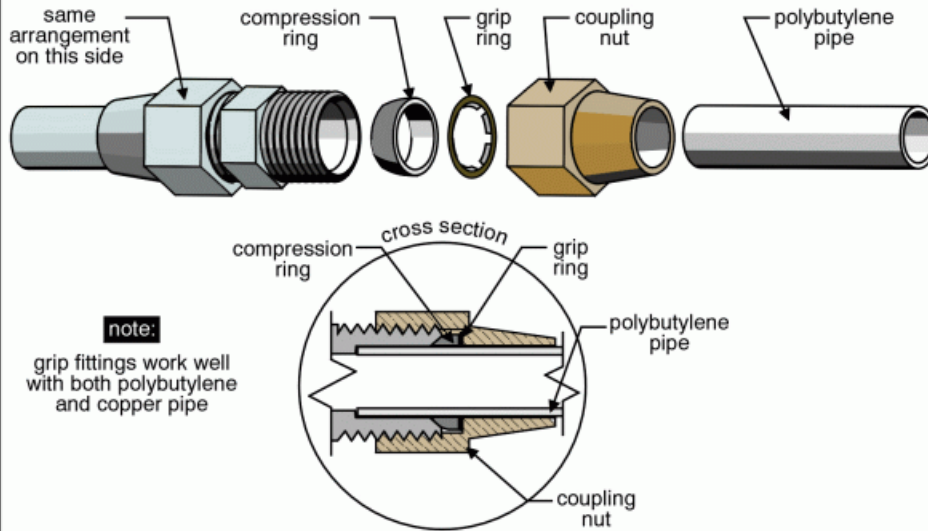
11. Condition: • Polybutylene

Implication(s): Chance of water damage to structure, finishes and contents | Leakage

23. Polybutylene

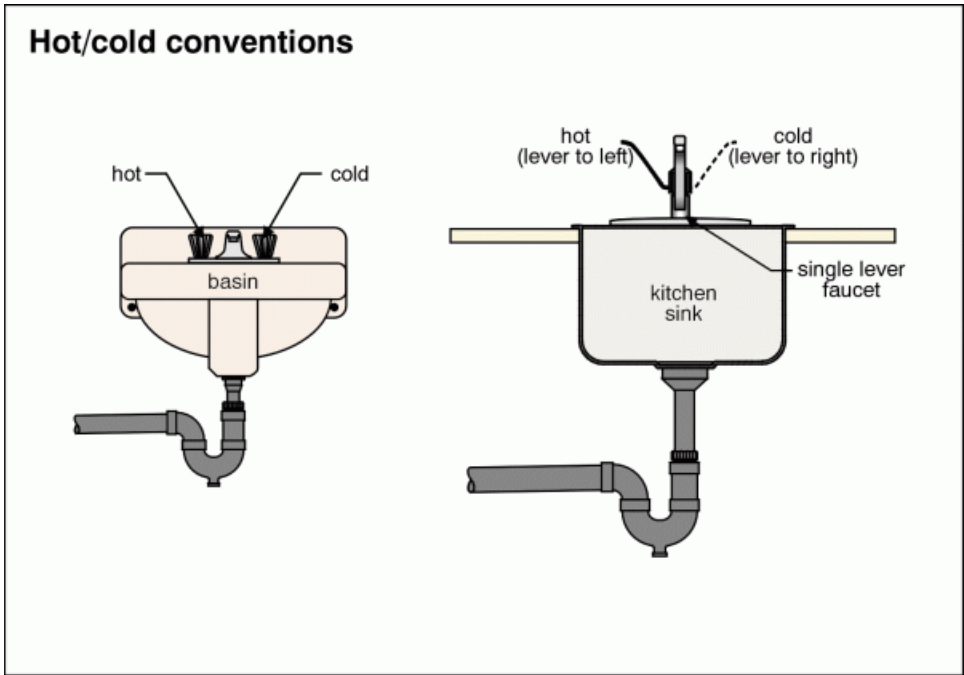
12. Condition: • Hot and cold reversed

24. Hot and cold reversed
