REPORT DETAILS

| Report No. | PRI-SAMPLE-001 | Date | June 22, 2026 | Inspector | Sample Inspector |
| Property Address | Fictional demo property - Charlottetown area, PE | | | Postal Code | N/A |

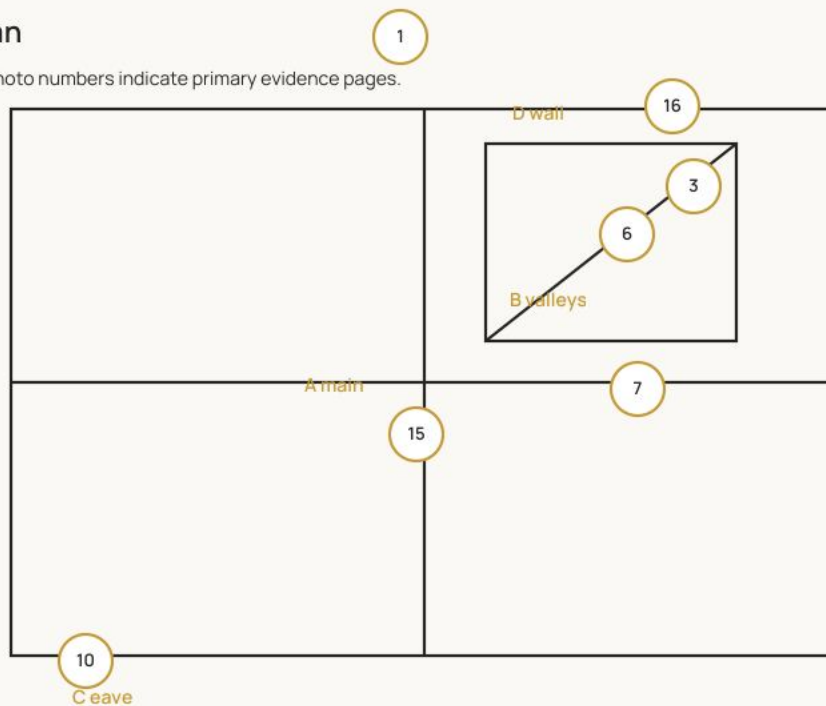
### Sample Roof Plan

Diagram is not to scale; photo numbers indicate primary evidence pages.

A = main gable. B = rear valley/dormer tie-ins. C = lower eave/gutter run. D = rear wall transition. Photo markers correspond to the photo evidence pages.
