# The Safety Aspects of The Highland Council's Practice of Placing Small Wind Turbines in School Playgrounds

## A Review by Stuart Young Consulting on behalf of Caithness Windfarm Information Forum

Stuart Young Consulting has been asked to review THC's risk assessment and mitigation measures for Castletown Primary School, being a representative sample of the installations.

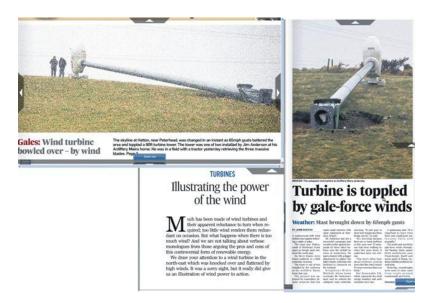
A wind turbine was reportedly blown over near Peterhead on 17<sup>th</sup> April 2013 during what is described as "gusts up to 65 miles per hour". Below is a compilation of extracts from the North East edition of the Press and Journal (P&J) of 18<sup>th</sup> April. A more readable version is appended.

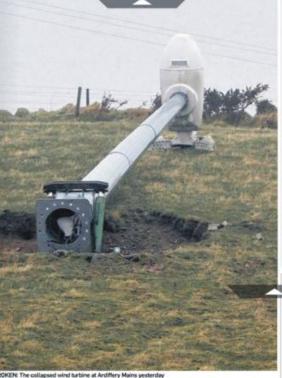
# Turbine is toppled by gale-force winds

#### Weather: Mast brought down by 65mph gusts
