BROTHER® TN450 TONER CARTRIDGE

# REMANUFACTURING THE BROTHER HL-2240/2270 SERIES TN420/450 TONER CARTRIDGES

#### By Mike Josiah and the Technical Staff at UniNet

#### **Updated 10/2011**

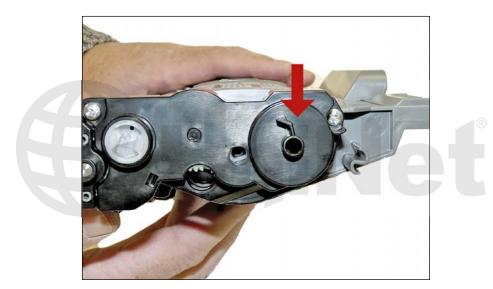
There is a reset gear (pictured here) that resets the printer each time a new toner cartridge is installed.

In our machine, the starter cartridge was marked just "TN" and had the reset gear section completely blocked off.

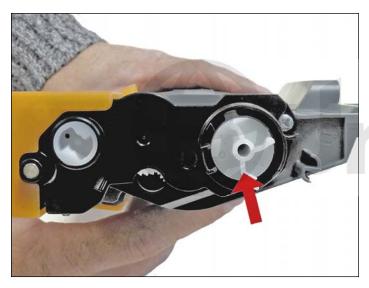
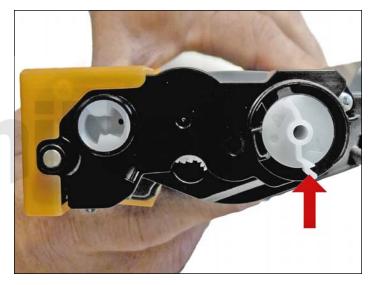
In order to recycle starter cartridges, the proper reset gear and the end cap must be replaced. Both the TN420 and the TN450 cartridges use different reset gears. The TN420 gears have three flags on them, versus two flags for the TN450. That is how the machine knows if there is a standard or high yield cartridge installed. New reset gears and an end cap are available, so that low yield cartridges can be made into high yield, and starter cartridges can be recycled into either one.

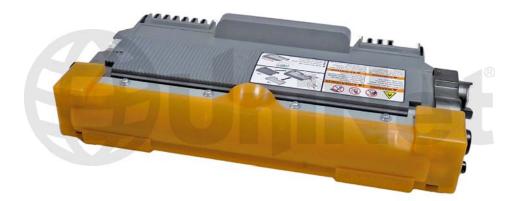
These cartridges also use a completely new developer roller cover, as shown here.

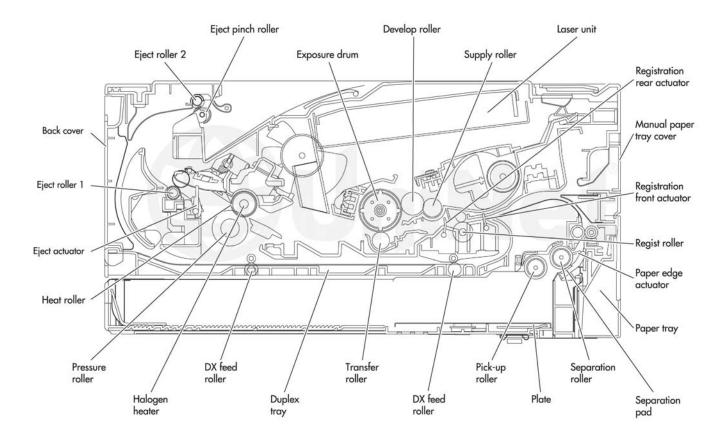
# FRONT SIDE

The above diagram shows how the toner and drum cartridges relate (position-wise) to the rest of the printer.

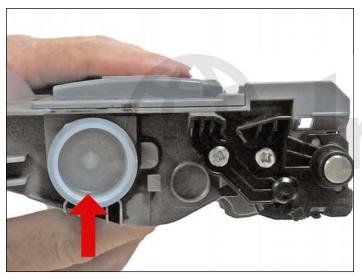
1. Vacuum the exterior of the cartridge. Remove the fill plug from the toner cartridge. Dump the remaining toner and vacuum/blow out the cartridge. Even though on these cartridges the gears are covered, we have found it best to keep one hand over the gear side to protect them.

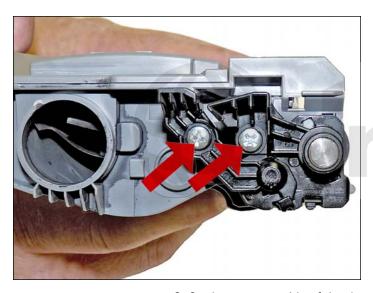
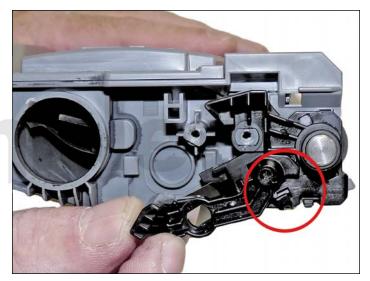
2. On the non-gear side of the developer roller, remove the two screws.

Remove the two plastic arms.

The smaller arm needs to be turned to release the lock.

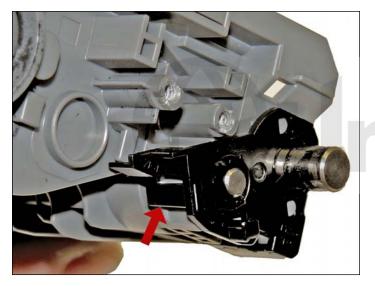
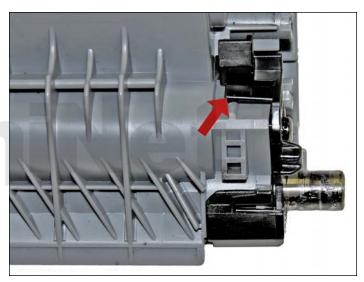
3. Remove the drum axle plate by lifting up on the two tabs as indicated.

Pry the plate off.

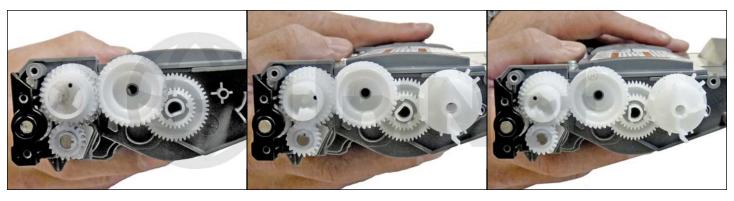
5. The reset gear is spring loaded and must be positioned correctly for the printer to accept a new cartridge. Our printer came with a starter cartridge that did not have a reset gear, and the end cap blocked us from adding a new one in. Starter cartridges will need to have a reset gear and replacement end cap before they can be used. As stated before, the TN420 and TN450 cartridges both have different reset gears. All three types are shown here.

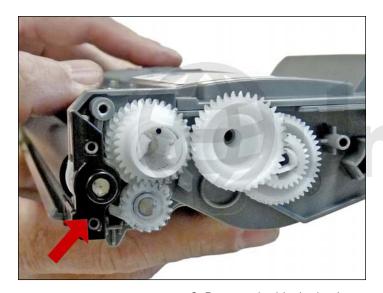
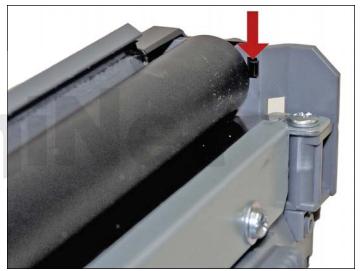
6. Remove the black plastic spacer from the developer roller shaft.

Press in on the back tab to release.

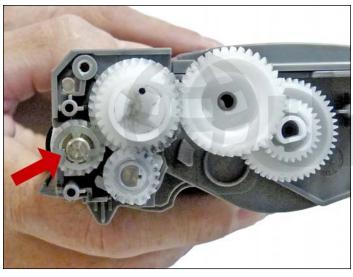
7. Remove the E-Ring.

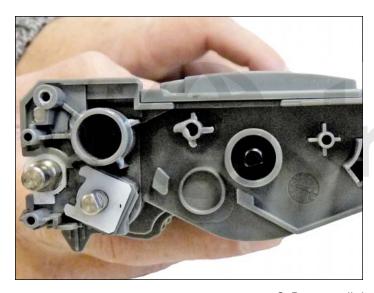
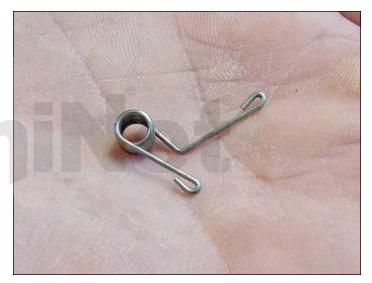
8. Remove all the remaining gears.

Do not lose the reset gear spring!

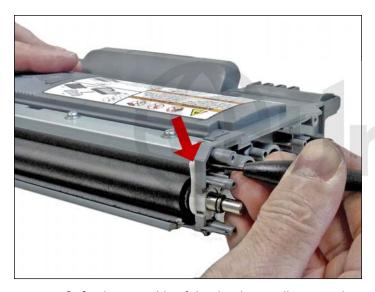
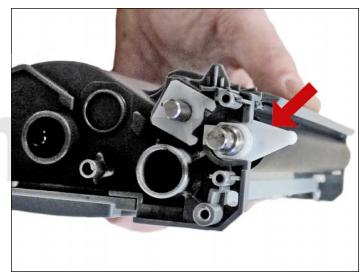
9. On the gear side of the developer roller, press in on the locking tab, and rotate the developer roller lock up.

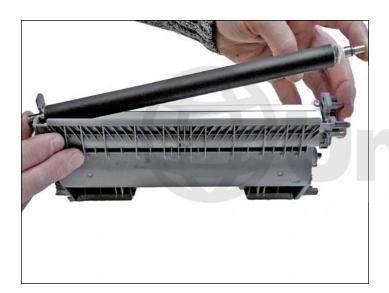
10. Remove the developer roller.

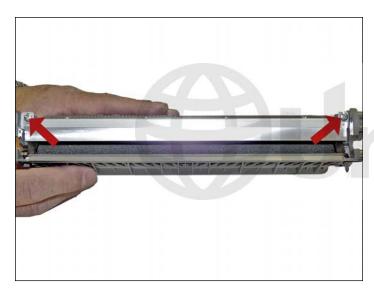
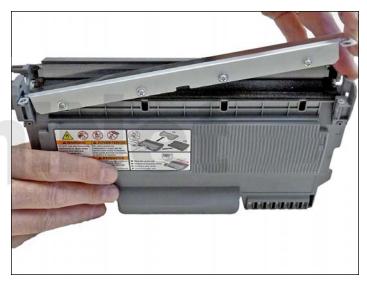
11. Remove the two doctor blade screws and the doctor blade.

Unlike previous TN cartridges, the doctor blade is not physically attached to the seals, so it can be removed for cleaning.

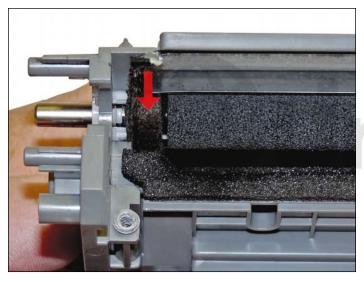
13. Inspect the magnetic roller felts. If they are compressed (shiny), rough them up with a small screwdriver.

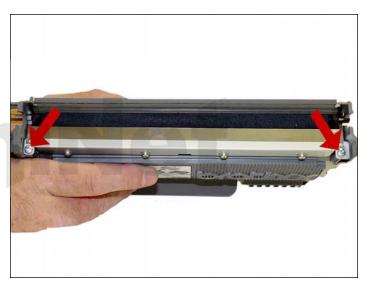
14. Carefully wipe the doctor blade down with a lint-free cloth. Be very careful not to bend or damage the blade in any way. Install the blade and two screws.

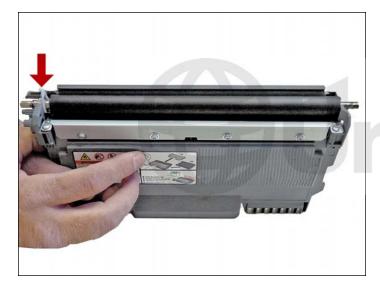
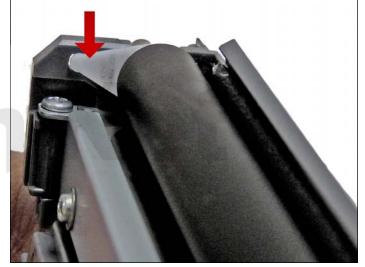
15. Clean the developer roller with a lint-free cloth and a dedicated developer roller cleaner for Brother rollers. Do not use any chemicals other than a dedicated cleaner for Brother rollers to clean the roller. Re-install the developer roller long-shaft side to the gear side, with the white lock pointing up. Turn the lock towards the doctor blade until it locks in place.

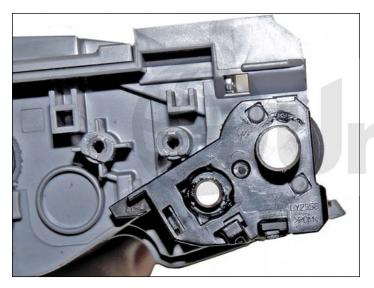
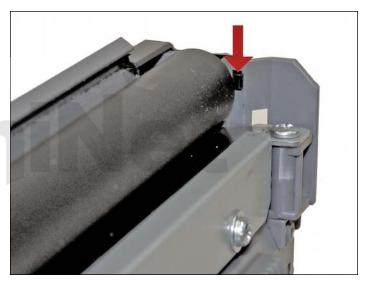
16. Install the non-gear side axle plate.

Make sure the tabs lock in place.

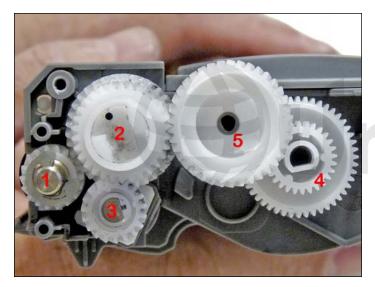
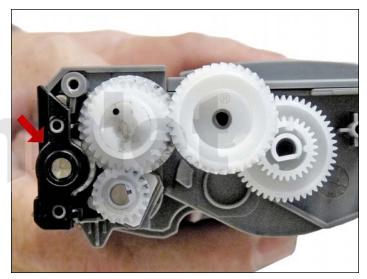
17. Clean the gears, making sure that they have no toner on them. This is a good time to also check the gear shafts to make sure there is enough grease. If the shafts appear dry, or the grease is contaminated with toner, clean the shaft and inside of the gear. Replace the grease with white lithium grease. Install the developer roller gear, E-ring, black axle spacer, and the rest of the gears in the order shown. Make sure all the gears are meshing properly.

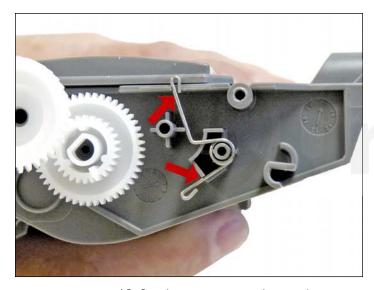
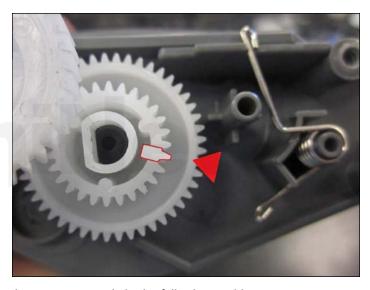
18. Set the reset gear spring as shown, ensure the actuator gear is in the following position

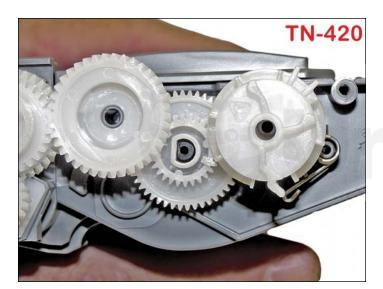
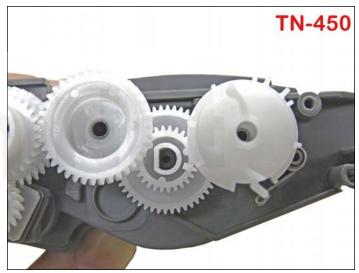
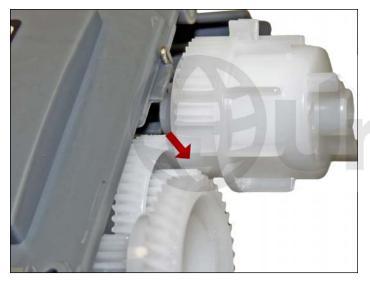
19. Depending on the cartridge you have, set the reset gears as shown for the TN420 (left image) and TN450 (right image).

Note that the gear teeth are not meshed when set, which is how it should be. The gear is spring loaded and will turn when driven by the printer.

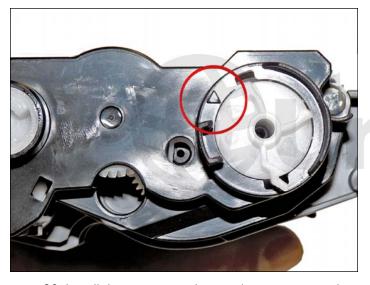
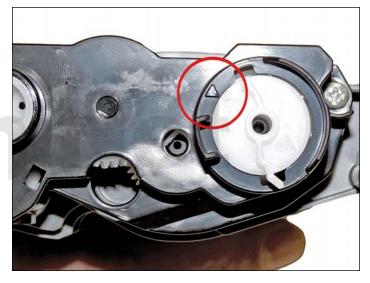
20. Install the gear cover plate, and two screws as shown for the TN420 (left image), or for the TN450 (right image).

Make sure the black arrow on the cover is aligned with the white arrow marked #3 on the TN420 gear, or #1 on the TN450 gear.

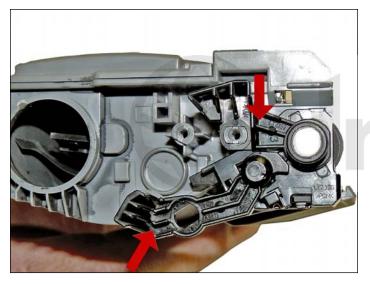
21. On the non-gear side, install the two plastic arms and screws.

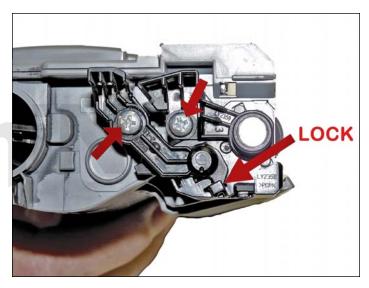
The smaller arm is installed last and has to be turned from the bottom up, so that the lock engages.

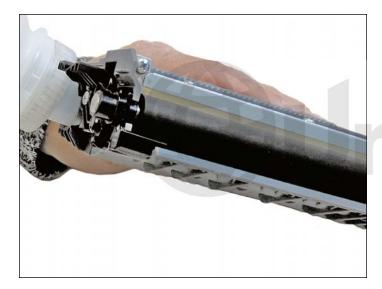
22. Fill the cartridge with the proper gram load of black toner for use in Brother TN420/450 (low or high yield).

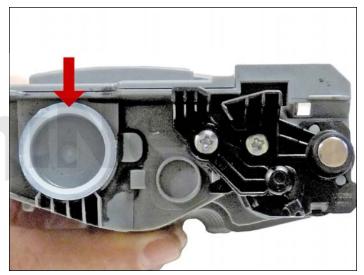
23. Replace the fill plug.

Wipe the cartridge down to remove any remaining toner dust.

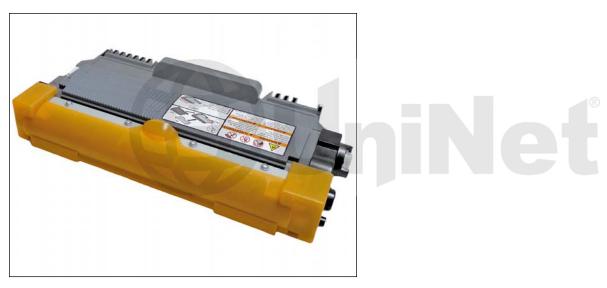
24. Install the developer roller cover.

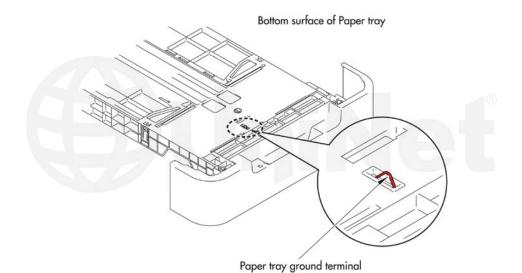
**NOTE**: If you are experiencing horizontal black streaks, and changing cartridges does not help, look in the bottom of the paper tray. There is a small metal ground terminal. If it gets bent or dirty, it can cause this.
