# BROTHER® HL-2230 • 2240 • 2270 • 2280 • DR420 • 450 OPC DRUM CARTRIDGE REMANUFACTURING INSTRUCTIONS

# REMANUFACTURING THE BROTHER HL-2280/DR420 OPC DRUM CARTRIDGE (DR2200 EUROPE/DR2225 ASIA)

By Mike Josiah and the Technical Staff at UniNet

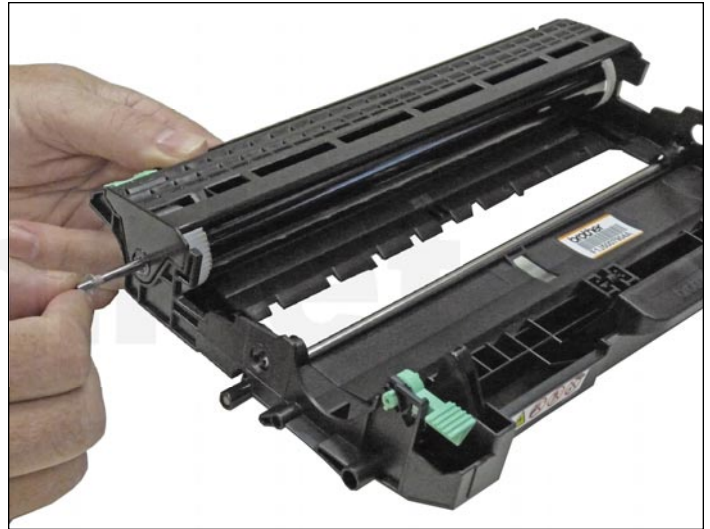
2. Remove the drum axle from the non-gear side of the drum. If you try to pull it out from the gear side, the shaft will jam up on the drum's ground contact, and damage the contact.

**Solid black pages:** Caused by a bad drum ground contact, probably from the drum axle shaft to the contact gear, inside the drum.

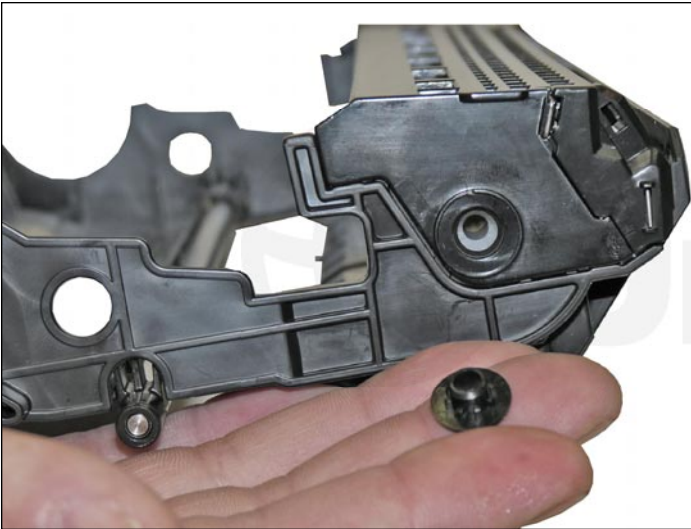
3. Be careful not to lose the round drum bushing, from the non-gear side of the cover!

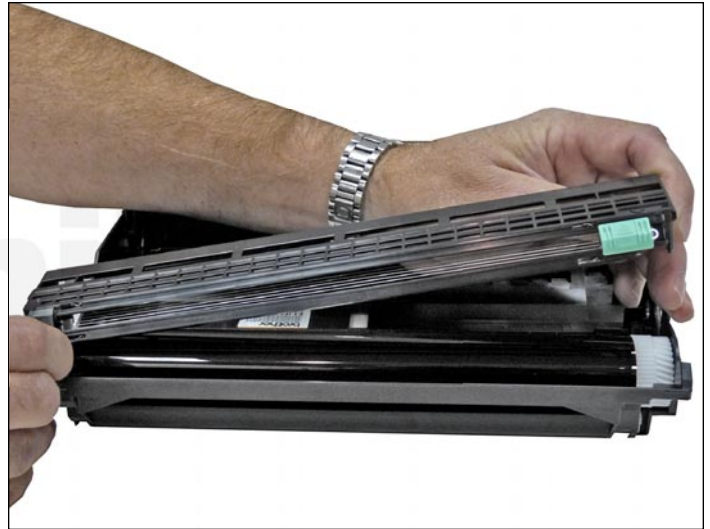
4. Carefully pry up and lift off the top cover/corona wire assembly from the cartridge.

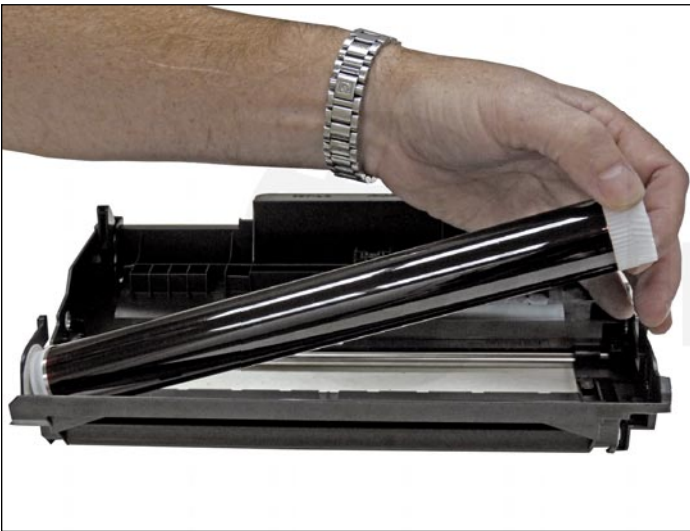
5. Carefully remove the drum.

Note that there is a one-piece drive gear, not two, as in previous Brother drum units.

The hub side is also spring loaded, and is not easily removable.

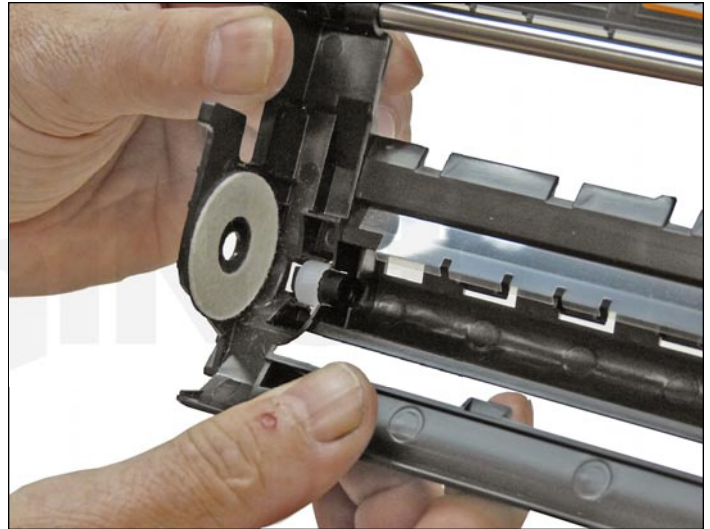
7. **IMPORTANT:** Note that there will be a small white bushing with an internal black plastic spacer left in the cartridge. This spacer keeps the transfer roller touching the electrical contacts on the left side of the cartridge. Be very careful not to lose this spacer! The cartridge will either print very light, or half pages, if it is missing. It is best to remove this spacer and bushing while cleaning the cartridge. With compressed air, blow off the transfer roller. Unless you have a statically grounded vacuum, do not vacuum this roller.

**Light or half-page prints:** This is caused by a missing transfer roller spacer. The spacer is a small piece of black plastic that sits next to the right end of the transfer roller. This piece keeps the transfer roller touching the electrical contact on the opposite side of the roller. If missing, the roller will move and can cause light or half-page prints.

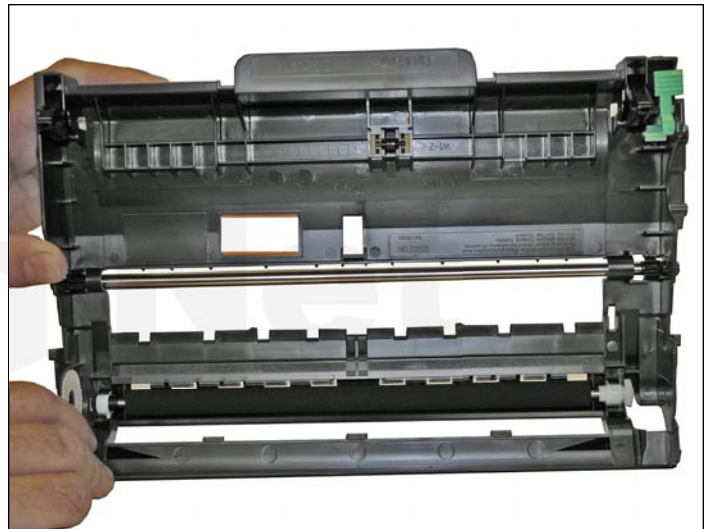
9. Install the transfer roller.

Make sure that both the white plastic bushings are clean.

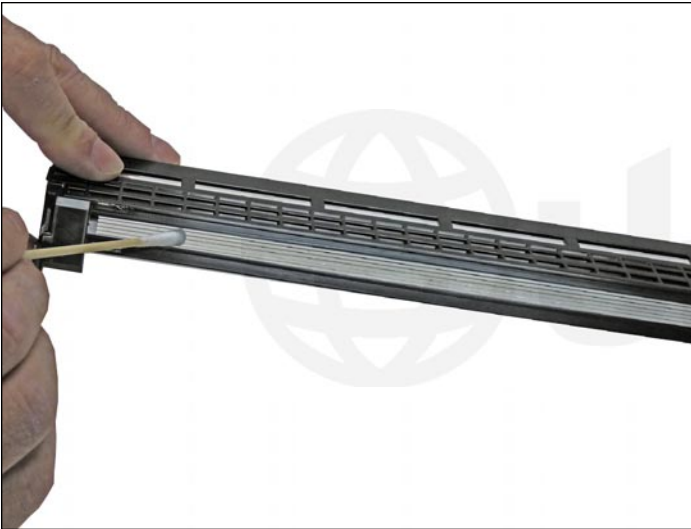
12. Clean the primary corona wire and grid with a cotton swab and alcohol.

**Dark black vertical streaks:** This is normally caused by either a dirty primary corona wire, or that the blue corona wire cleaner is not in its "home" position on the left side of the cartridge.

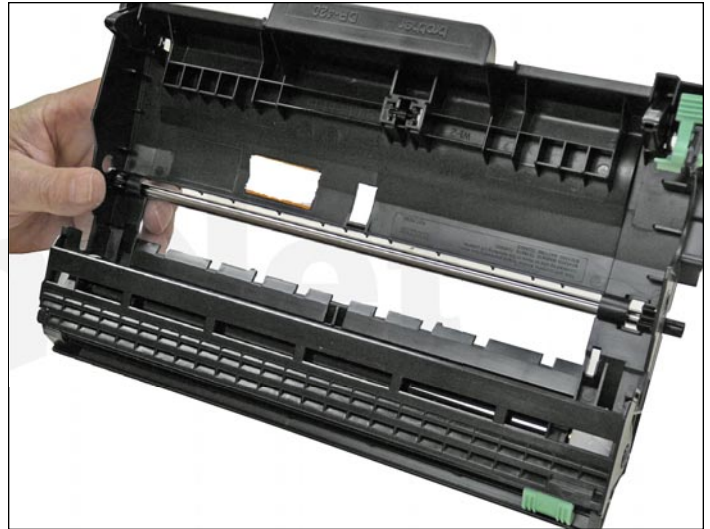
13. Install the top cover, pressing down so it snaps in place.

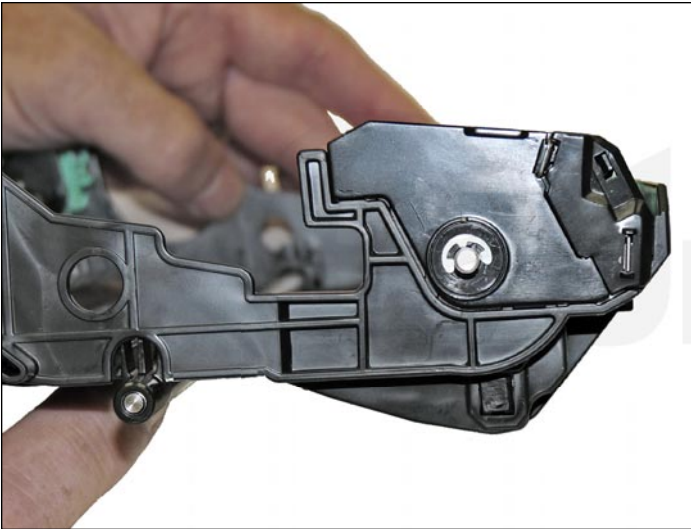
16. Install the E-ring on non-gear side of the drum axle shaft. Press the axle bushing in slightly so that the e-ring slot is accessible.
