PERMITTING SETBACK REQUIREMENTS FOR WIND TURBINES IN CALIFORNIA

PIER INTERIM PROJECT REPORT

November 2006
CEC-500-2005-184

Scott Larwood and C. P. van Dam
California Wind Energy Collaborative
Davis, California
Contract No. 500-02-004
Work Authorization MR-017

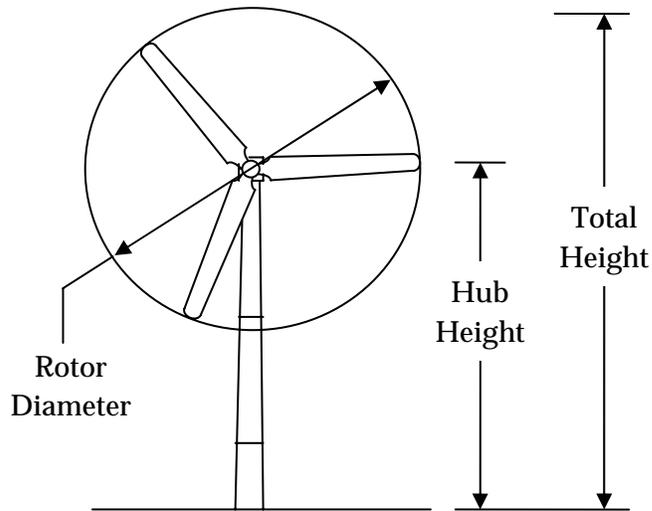
Figure 1. Wind turbine dimensions

Setbacks are established to minimize risk of damage or injury from component failure on property and personnel. The setbacks are usually a multiple of the total turbine height, from tower base to upper extreme point of the rotor (see Figure 1). Generally the setbacks can vary from 1.25 to 3 times the overall machine height. Larger setbacks are sometimes required for special areas. In contrast to these standards, counties in California with more rural development, such as Merced and San Joaquin, use building setbacks and do not distinguish wind turbines separately.

The layouts are shown in Figure 2 and Figure 3, with shaded zones representing the setback areas. The overall height is the sum of the tower height plus half the rotor diameter.

Table 2 compares setbacks for several of the counties organized by feature that the turbine must be displaced from, such as a property line. The distances are stated in multiples of overall turbine height (Figure 1). If a fixed distance is included with the multiple, then the maximum of the two values must be used for the setback.

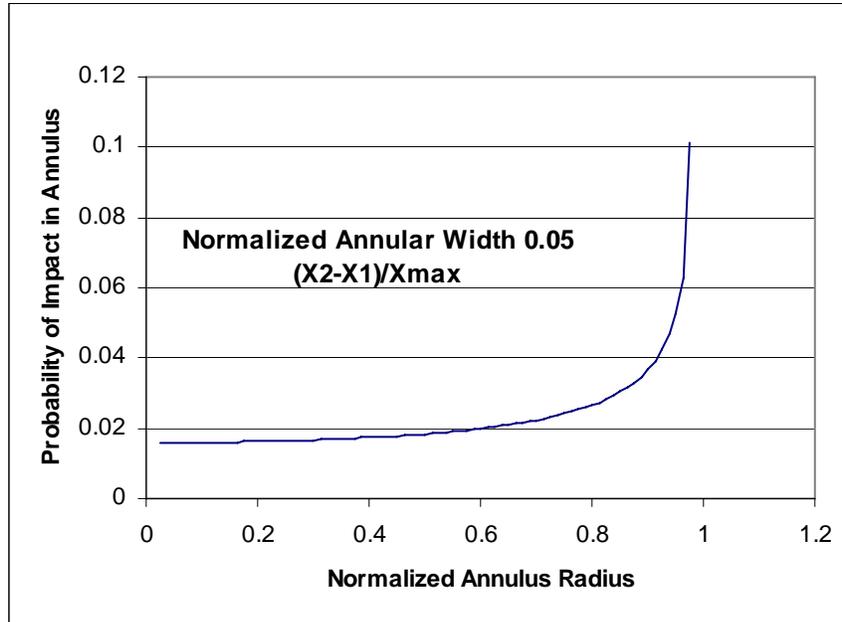
Figure 5. Probability of impact within an annular region

This relationship is plotted in Figure 5 for a normalized annular width of 0.05. Note that the relatively high probability of the fragment landing directly under the tower is not

shown. The nature of the equation results in an increasing probability of impact in the outermost annuli, due to a wide range of release angles that provide nearly the maximum range. However, the annular area increases with increasing radius.

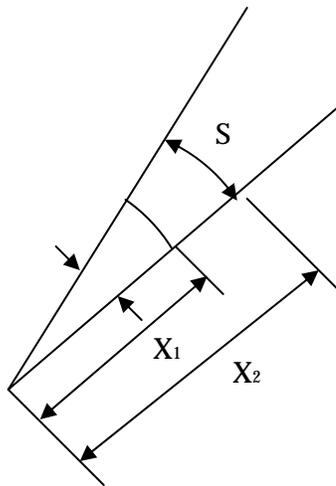
Figure 6. Target annular sector

We next assume that the target is an annular sector, as in Figure 6.

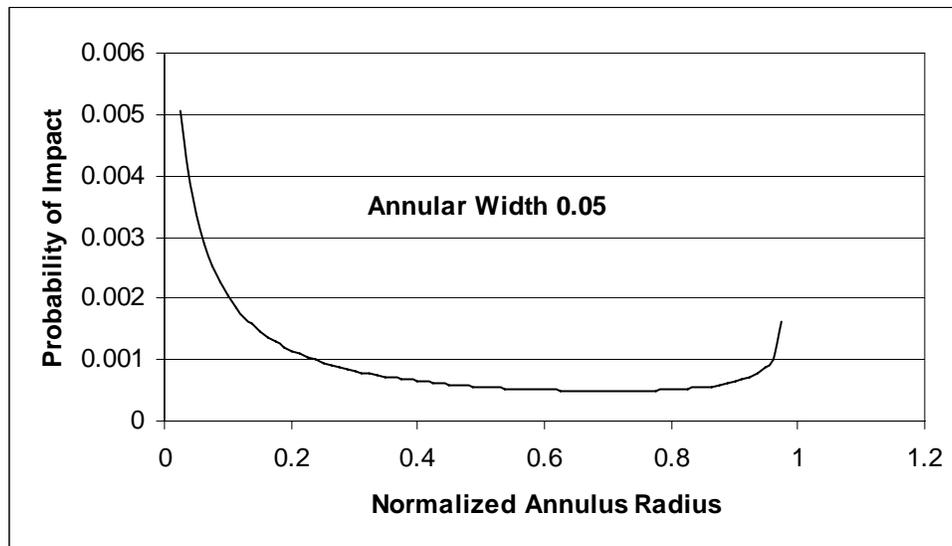
Figure 7. Probability of impact within annular sector

This relationship is plotted in Figure 7. This simplified model shows a peak in probability near the tower base, and then a relatively constant probability until the probability rises again near the maximum range. This behavior is similar to more complex models incorporating aerodynamics. The peak at maximum range places a constraint on the overall hazard and acceptable setback distances.

The probability of impact is weighted by area (per square meter), and assumes equal distributions in all directions. Probability distributions showed peaks near the tower and at the maximum range, similar to the results of the simplified model in Figure 7. The probability of impact was then a function of the target and fragment size. Macqueen reasoned that the rotor fragments would be large compared to target, making the probability independent of target size; however this would not be the case with a busy roadway, with many targets over a large area.

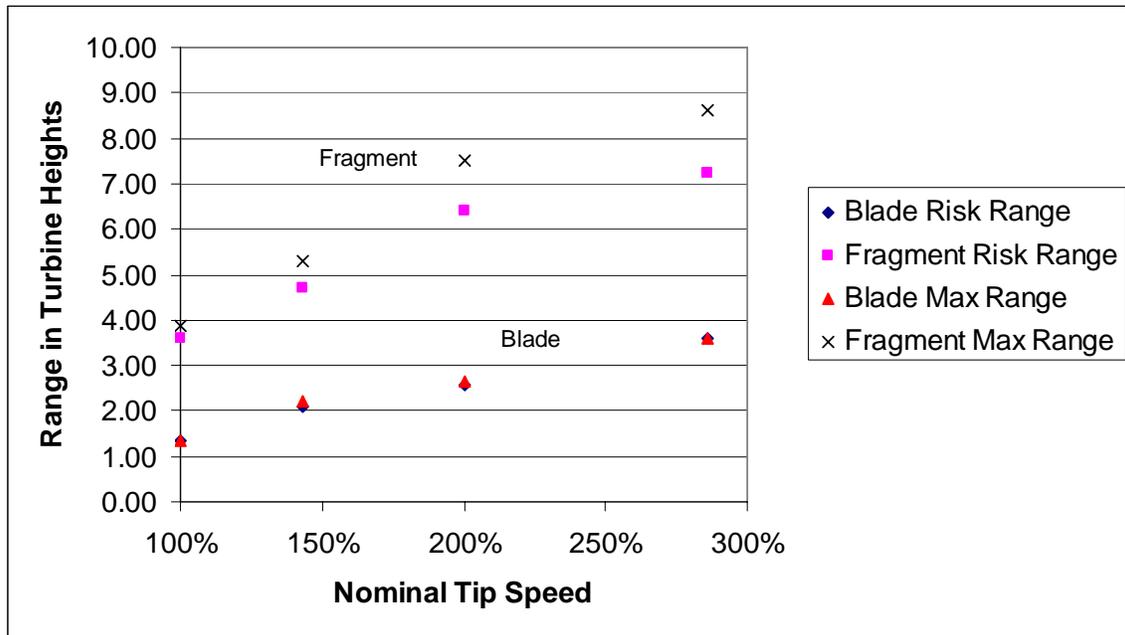
Figure 8. Throw distances in Sørensen conference paper with 1×10^{-4} probability risk range

Probabilities were only presented for the Project “K” turbine for a full 30 m blade throw and 10 m blade fragment throw. This turbine is of 1.5 to 2.0 MW size with a 60 m hub height. Release angle and wind speed were varied and multiple throws were calculated. The probabilities were presented as a function of tip speed. Results are shown in Figure 8, comparing the range with 10^{-4} probability (the “risk” range) to the maximum range.

The maximum ranges do not increase exponentially as would be predicted for a vacuum in Equation 4. This is the result of including the aerodynamic forces. Also, there is negligible difference for the full blade maximum range and range with 10^{-4} probability. This is not true for the fragment.

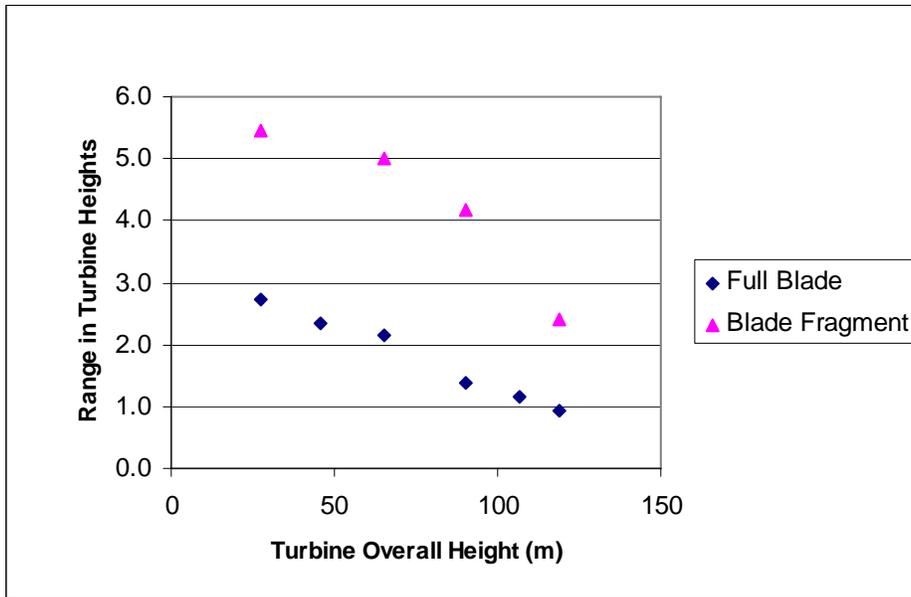
Figure 9. Comparison of rotor fragment analyses for maximum range at nominal operating conditions

Studies of example turbines were performed in all the analyses discussed previously. A comparison is shown below in Figure 9. The maximum attainable lateral throw distance, normalized by overall turbine height, for a failure at nominal operating conditions is shown for the various analyses. The results show the drop in the normalized maximum throw distance with increasing turbine size.

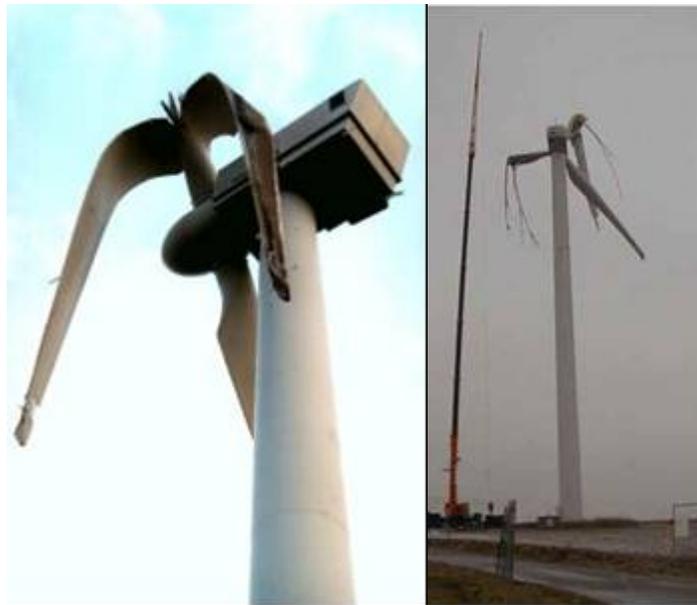
Fig. 2.2: Two examples of turbines that failed, but caused no danger to their surroundings.

- Most incidents are poorly documented, and the actual number of risk involved incidents cannot be determined for certain. EMD uses codes to indicate which component failed, the reason for failure, and whether parts were thrown from the turbine. From the codes it is difficult to determine the size of the thrown object, the distance thrown, and the order of events. In some cases this information is included in the comments. Between 1993 and 2000 the code was expanded. Between 1984 and 1992, the code was severely restricted. It was seldom even noted whether a compromised turbine had done damage to the surrounding area. This made it possible for a turbine that had a complete failure and lost many parts (see Fig. 2.1) to be reported exactly like a turbine that had a complete failure and posed no risk to the surrounding area (see Fig. 2.2).

In many cases it appeared difficult to indicate exactly whether a turbine had indeed lost parts as in Fig. 2.1, or was just heavily damaged as in Fig. 2.2. The final results from the selection of risk involved incidents are given in Table 2.2. The total can be seen in Table 2.3. This table includes the total number of operating years for each type. This number is obtained by summing the number of turbines in operation per year over all the years.

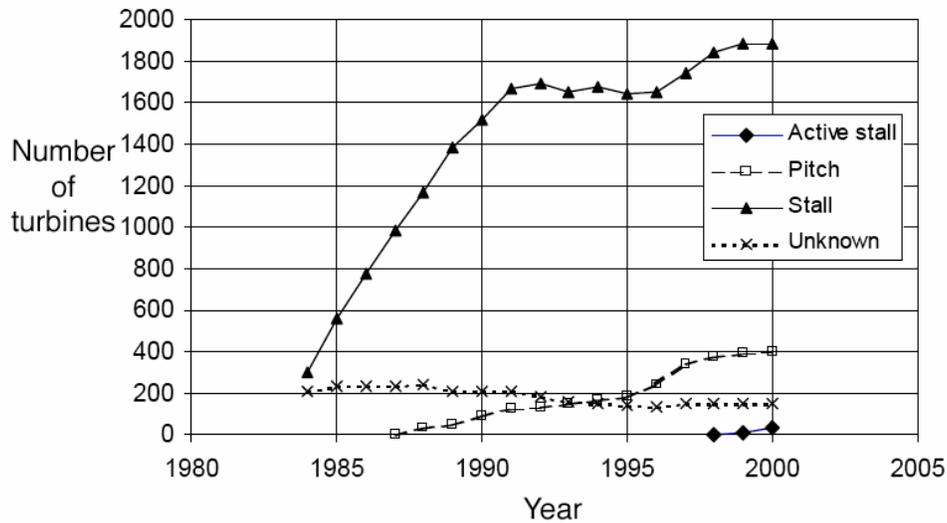
The turbine population from 1984 through 2000, as provided by EMD, is separated into the different types. The results are presented in Fig. 2.3. At the end of the year 2000 the total turbine population reached about 2900 turbines. The total number of operating years reached almost 30,000. By far the most turbines are stall regulated turbines.

Fig. 2.3: Number of wind turbines in the EMD database, separated by type.

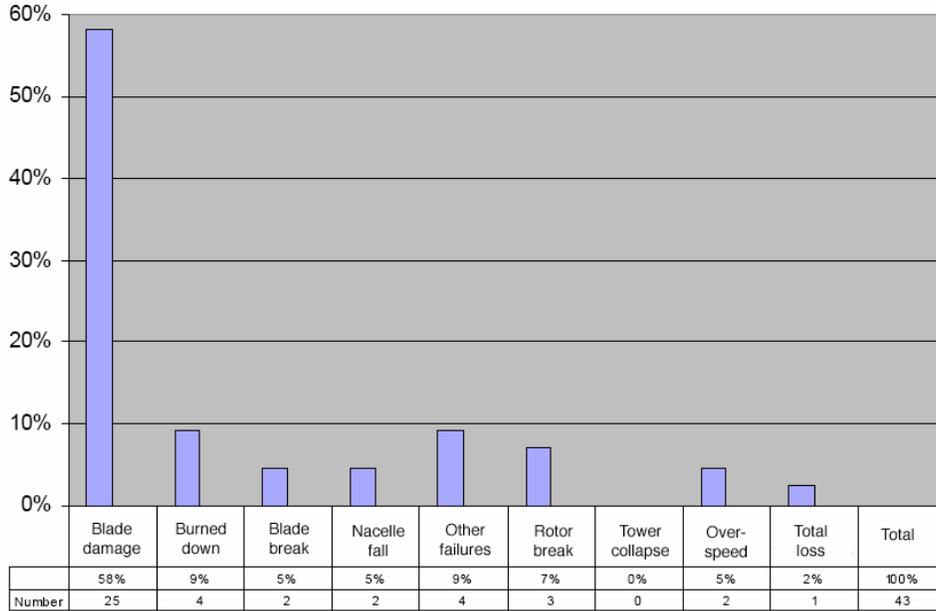
The 43 cases of turbine damage from the WMEP database are arranged by type of damage. The results are presented in Figure 3.1.

Fig. 3.1: Type of damage for 43 cases involving serious damage.

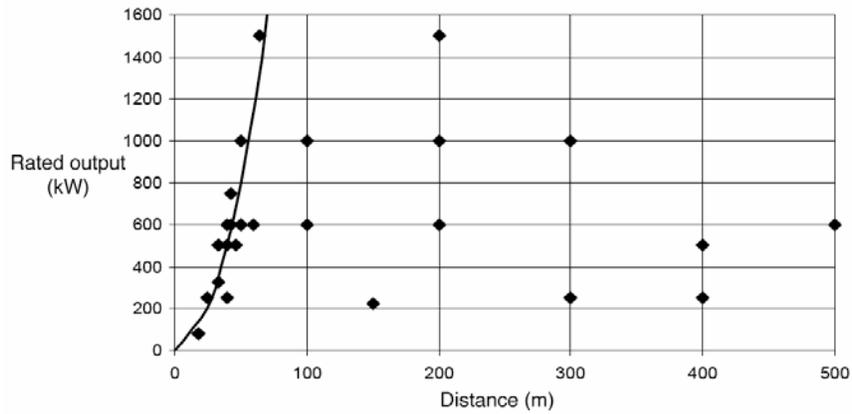
The results of the analyses are presented in Figures 5.1 through 5.4. In these figures, one for each type of incident, the reported throw distance is presented (x axis) as a function of the rated power (y axis). The curves in each graph relate the approximate rotor diameter associated with corresponding rated power level. The curves are added to put the throw distances in perspective.

Fig. 5.2: Throw distance of tips and small blade pieces as a function of the rated power output, the drawn line gives the rotor diameter.
